In-flight engine malfunction involving Cessna Citation 560, VH-PSU

296 km north of Brisbane Airport, QLD, 26 January 2018

ATSB Transport Safety Report Aviation Occurrence Investigation AO-2018-012 Final – 21 August 2018 Released in accordance with section 25 of the Transport Safety Investigation Act 2003

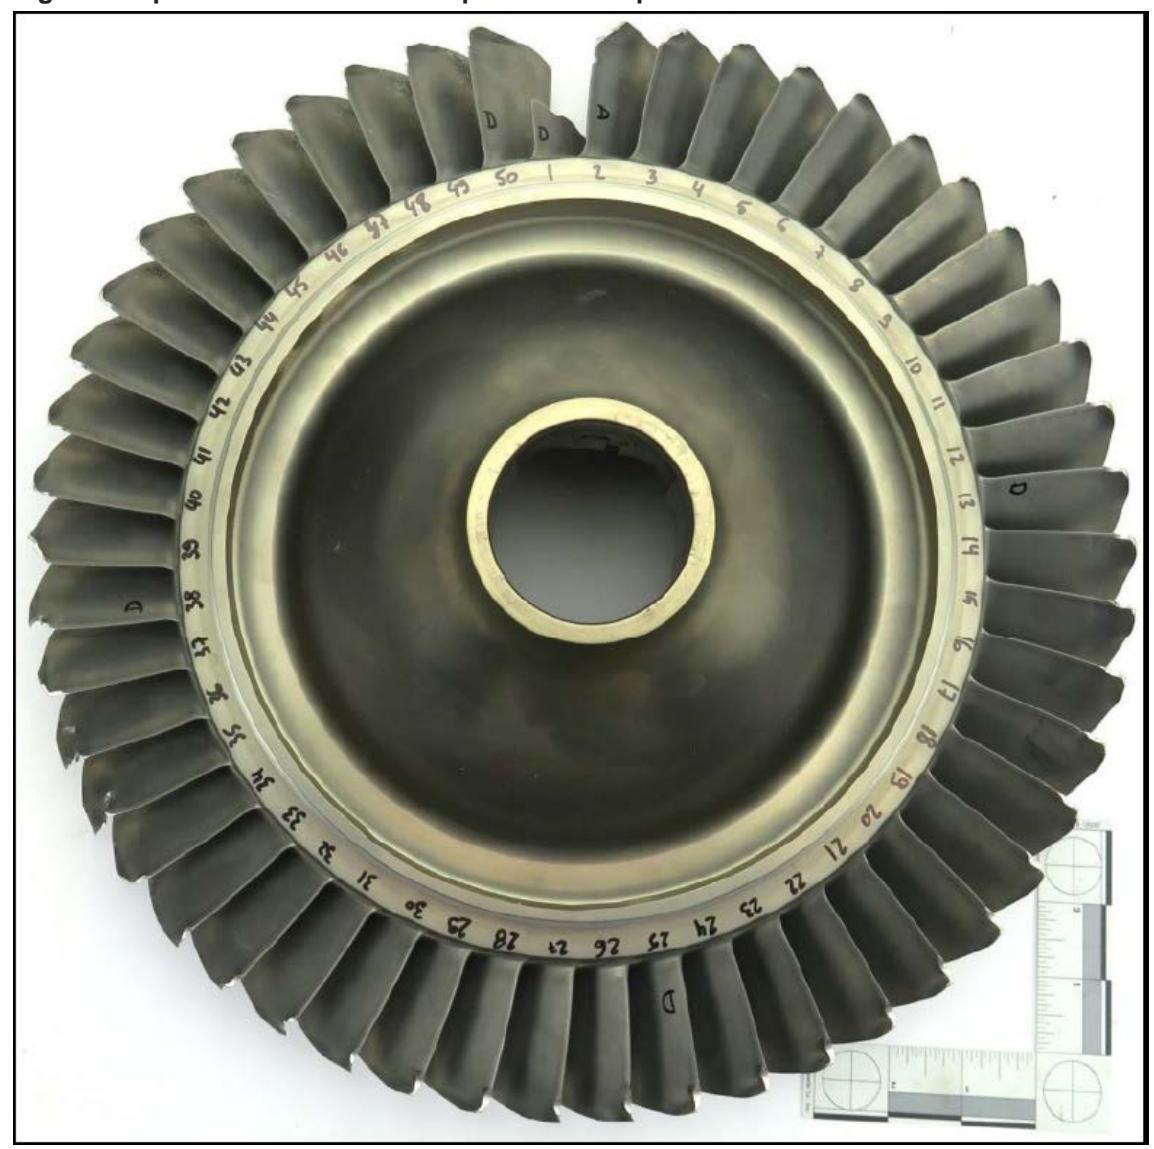
Figure 1: Upstream view of the low pressure compressor boost rotor

A general view of the boost rotor as received by the manufacturer can be seen in Figure 1. The aerofoils were arbitrarily numbered, beginning with number 1 at the fractured aerofoil. Figure 2 shows the damage on the aerofoils around the fractured one (nicks on the aerofoils are shown with arrows). Nicks, dents and deformation along the leading edge of all the aerofoils was observed, as well as rubbing and deformation along their tips. Dimensional analysis was performed on aerofoils 1, 2, 13, 25, 38 and 50. The aerofoil break edges were within requirements but the trailing edge root radius were all below minimum requirements.

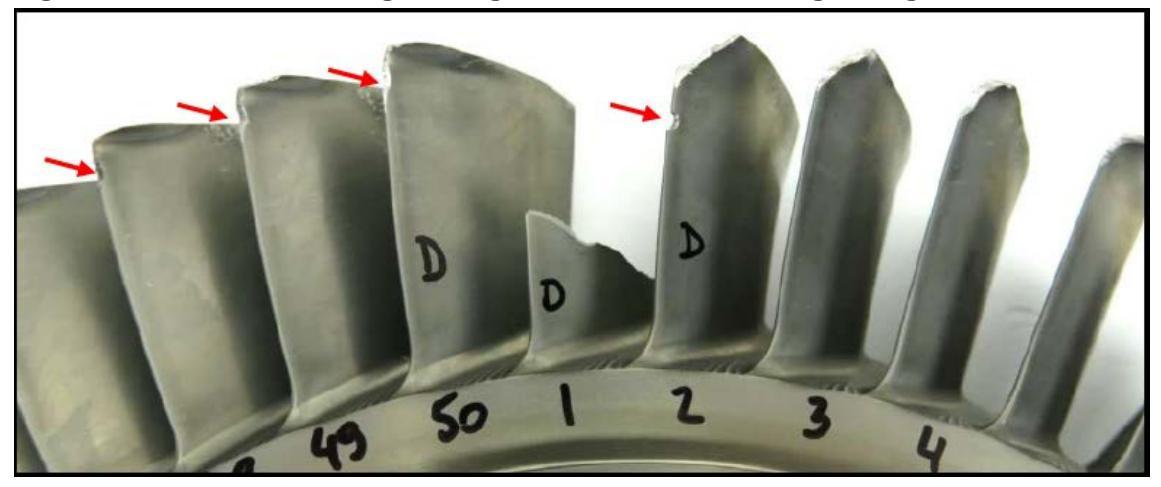
Figure 2: Boost rotor showing missing aerofoil and surrounding damage

Nicks, plastic deformation and foreign surface contamination were visible on the other aerofoils; they were likely the result of the release of the fractured aerofoil. The composition of the contamination on aerofoil 2 was consistent with projections of abradable coating, likely due to the rubbing that followed the aerofoil release.

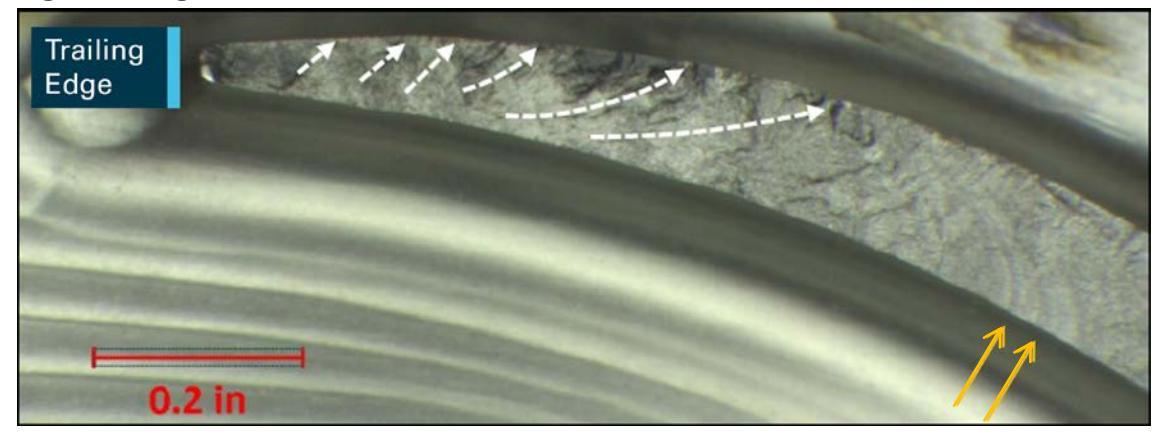
Figure 3: Magnified view of the aerofoil fracture surface

The (Figure 2, number 1) aerofoil fracture surface showed river marks (Figure 3, dashed arrows) and beach marks (Figure 3, arrowed), consistent with fatigue cracking. The markings indicated that the fatigue likely initiated at the trailing edge area along the pressure side and progressed towards the leading edge. The exact location of the fatigue origin could not be determined since the rubbing of the mating surface damaged the area. No anomalies were observed near the origin.

Aerofoil fracture surface showed crack progression lines from the trailing edge (white dashed arrows) along with beach marks (yellow arrows) which were indicative of a fatigue failure mechanism.

The manufacturer then examined the fracture surface using a scanning electron microscope. Observations included river lines, and striations, which indicated local crack propagation direction. The final fracture area exhibited a dimpled fracture surface typical of tensile overstress. No material anomalies were identified.

The manufacturer's report concluded that the aerofoil fractured as a result of fatigue cracking progressing from the trailing edge, pressure side towards the leading edge. The exact origin of the fatigue crack could not be determined, and no evidence of damage or material anomaly was found near the suspected origin area. The deviation observed at the trailing edge root radius (below dimensional requirements) was not believed to be a contributing factor to the crack initiation.
