JULY, 1953

Prepared by The Accident Investigation and Analysis Branch

DEPARTMENT OF CIVIL AVIATION

SAFETY DIGEST

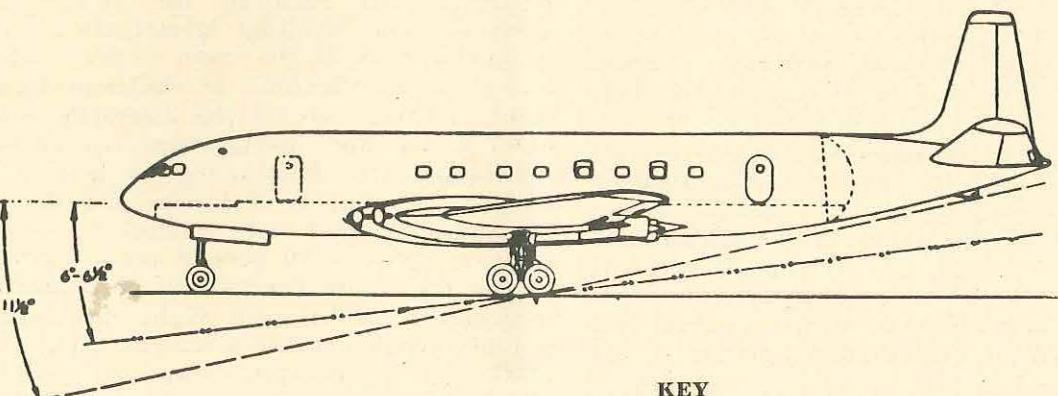
Represents Ground Line with Nose Wheel on Ground Represents Ground Line with Aircraft correct "Unstick" Attitude 6°-6½° Nose-up Represents Ground Line with Tail Bumper touching ground 11^{1/2} Nose-up In the above sketch, recommended fuselage incidence at "unstick" $(6^{\circ}-6\frac{1}{2}^{\circ})$ is compared

with the angle of incidence required (at least $11\frac{1}{2}^{\circ}$) for the tail bumper to touch the ground. The normal fuselage-incidence during the take-off run (between "nose up" and "unstick") is about 2°-3°.

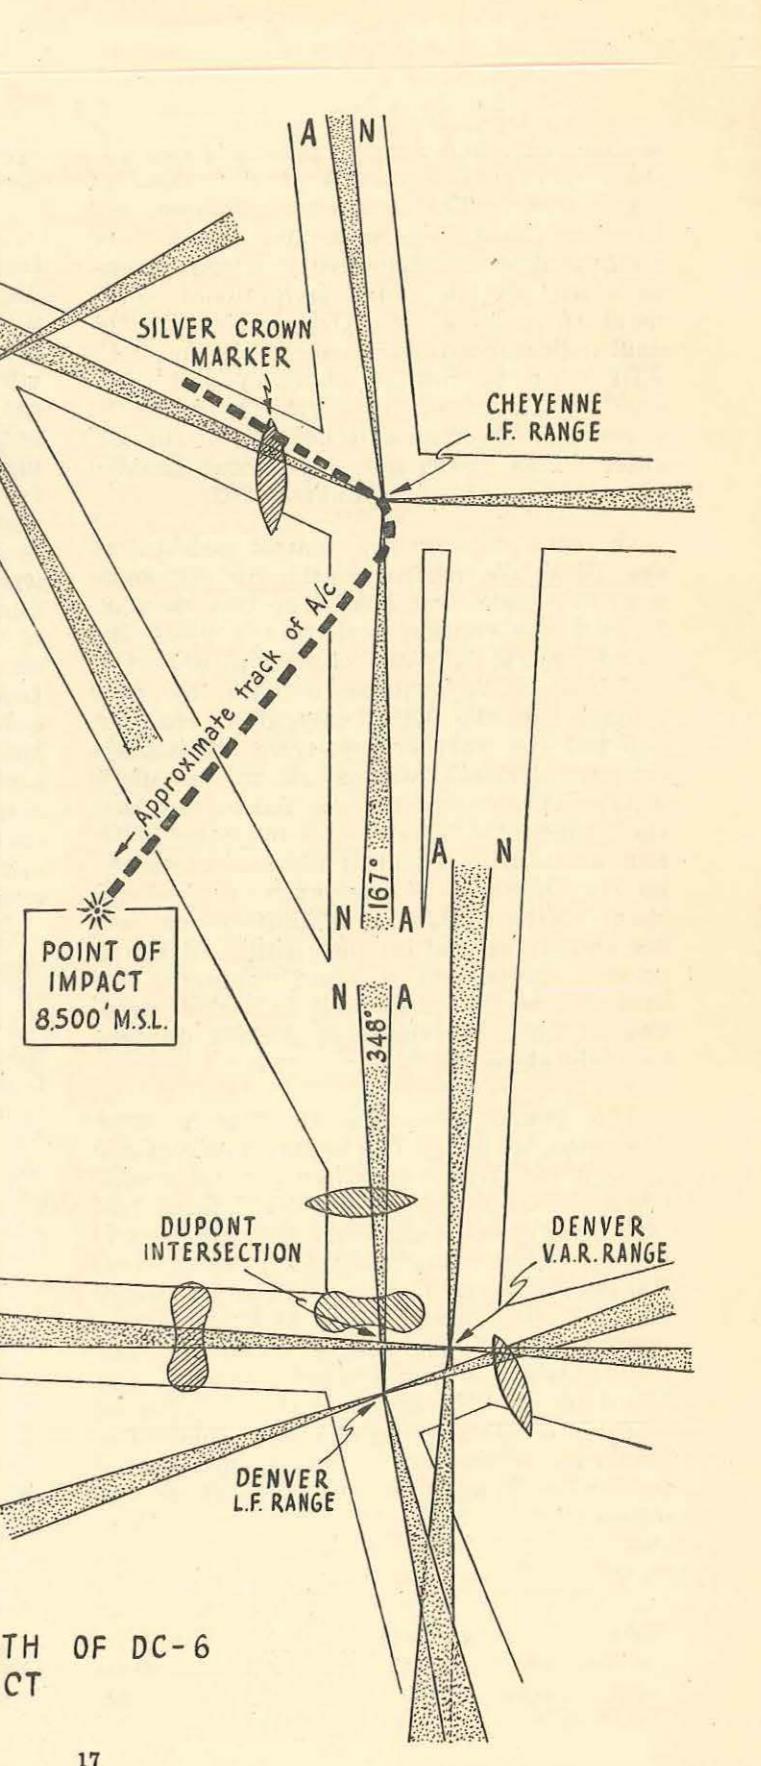
PROBABLE FLIGHT PATH OF DC-6 PRIOR TO IMPACT

This last fact was further substantiated by the condition of the directional instruments when recovered. In the cockpit were four heading indication instruments. There were two magnetic or master direction indicators operated by a flux gate compass 0147 - A/C passed Silver Crown at 15,000' Requested lower altitude Cleared to Dupont Intersection, descent to 8,500'

system, one each for the pilot and co-pilot; these were both jammed at a reading of about 210°. The magnetic compass and the directional gyro were also found to be reading approximately 210°. Furthermore. as a part of the radio navigational equipment there were two ADF receivers. The dual indicator azimuth scale of the co-pilot's ADF must be rotated manually and when used to determine a bearing it is set to agree with the magnetic heading of the aircraft. This instrument was found jammed at a reading of approximately 202°.

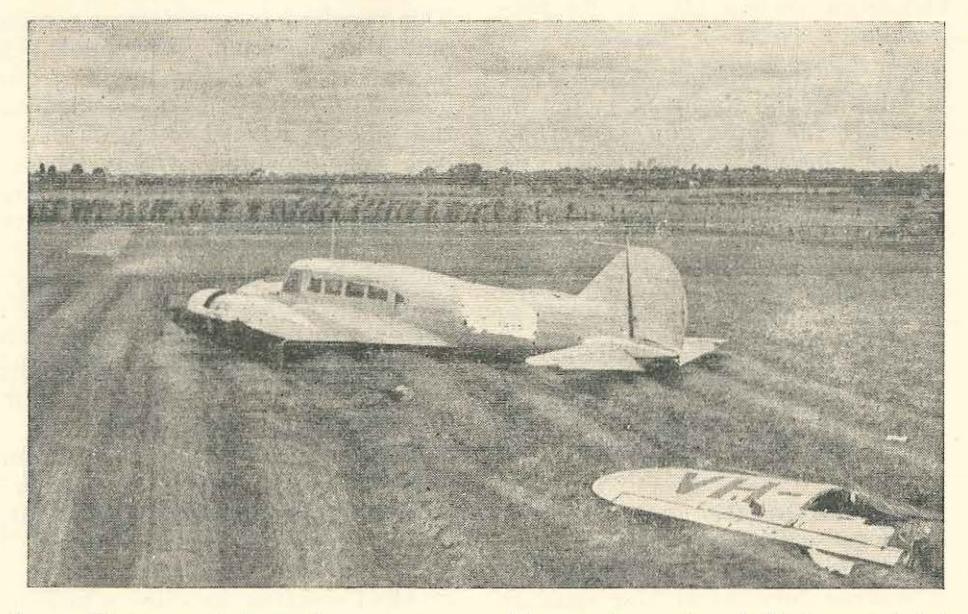
Take-Off Accident. Moorabbin Airport

Immediately after becoming airborne from Moorabbin Airport, Victoria, on 17th January, 1953, the port engine of an Avro Anson failed. The aircraft continued across the aerodrome a few feet above the ground until it struck a telephone post on the road at the northern boundary of the aerodrome and crashed into a field on the opposite side of the road. The crew of three were uninjured. The aircraft was extensively

An examination of the engines failed to reveal any defect, abnormality or evidence of malfunctioning that may have contributed to or caused the engine failure.

The testimony of the pilot and crew revealed that there had been an unnecessary, unorthodox and complicated manipulation of the fuel cocks prior to take-off which suggested that the engine failure could have been due to mismanagement of the fuel system.

The nature of the engine failure was consistent with fuel starvation. Furthermore, the stage at which the engine failed corresponds with the point an engine would fail if the fuel had been turned off at the pretake-off position.

The cause of the accident was the failure of the port engine, just after the aircraft became airborne, which resulted in the aircraft being unable to climb away. The engine failure was caused by fuel starvation probably due to mismanagement of the fuel system by the pilot.
