AVIATION SAFETY DIGEST

No. 12 DECEMBER, 1957

CONTENTS

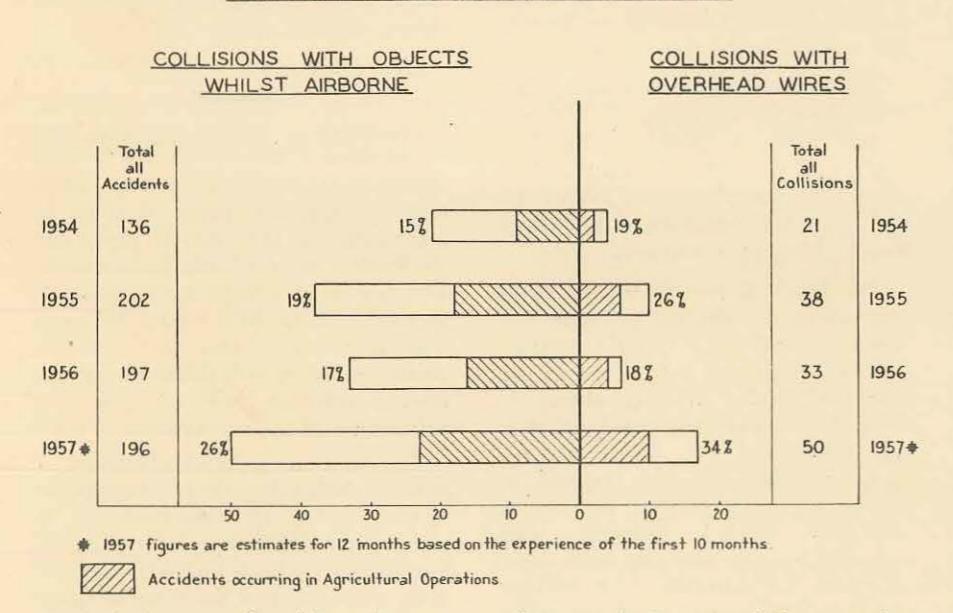
AIRBORNE COLLISION ACCIDENTS

total of all types of accidents has remained at a fairly constant level over the past three years and this suggests that the change in the pattern of accident types is a reflection of the changing pattern of the industry's activity. Low level agricultural operations have increased sharply in the past three years and, in the very nature of this work, there is a propensity for airborne collisions. This by no means contains the whole story of the rise in the collision accidents as the bar chart illustrates. The shaded portion of each bar represents the proportion of these accidents occurring in agricultural operations and the remaining portion represents collision accidents in flying training and private operations. You will notice that both groups have contributed almost equally to each year's accidents in this category and to the increasing proportion of the category in the whole pattern of accident types. It is not easy to explain the increased number of collision accidents in private and training operations but the circumstances of this year's accidents suggest that private pilots are not maintaining the careful watch for obstructions which flight at low level demands.

The right hand side of the table refers to collisions with overhead wires both in numbers and as a proportion of all airborne collisions with stationary objects. Here again the trend of increase is repeated both in training and private operations and in agricultural operations. Slightly more than half of the collisions with overhead wires occurred in agricultural operations but each group has contributed to the annual increase in accidents of this type. It is also interesting to note that, of the eight deaths which have occurred in the past four years from collisions with overhead wires, only two have occurred in agricultural operations whilst the remaining six, including five deaths this year, have occurred in private or flying training operations.
