# SAFETY DIGEST

# DEPARTMENT OF CIVIL AVIATION

No. 14, JUNE, 1958

No. 14 — June, 1958

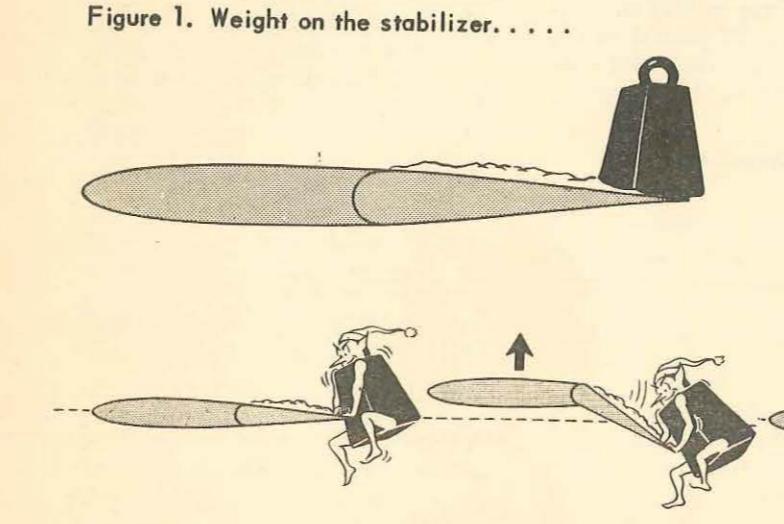
When the stabilizer translates (bends) up and down, the trailing edge of the elevator tends to remain fixed, due to the presence of this weight as shown in the series of movements in Figure 2. The relative motion of the elevator to the stabilizer is observed to be "out of phase", i.e., when the stabilizer bends upward, the elevator effectively rotates trailing edge downward and vice versa.

This "out of phase" motion of the elevator produces an aerodynamic lift force on the stabilizer which tends to drive the stabilizer in the same direction that it is moving. The phase relationship between the aerodynamic force and the motion of the stabilizer causes a net amount of energy to be fed into each cycle of oscillation. As a result, the amplitude of the stabilizer deflection increases with each cycle and may lead to the total destruction of the surface.

Figure 2. . . . can induce out-of-phase motion of elevator.

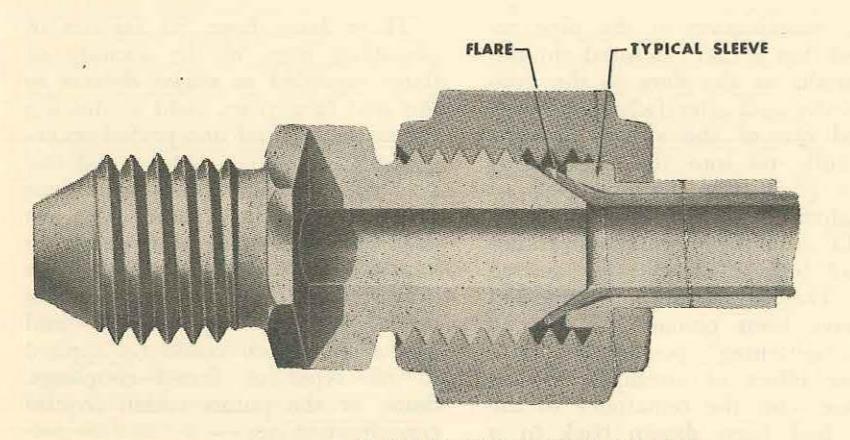
Fig. 1

**CORRECT TIGHTENING OF NUT**

- (i) Careful uncoupling of the fitting and examination of the flare, in cases where weeping or leakage is evident, before tightening.
- (k) Providing adequate support of plumbing lines to guard against excessive vibration and loading.

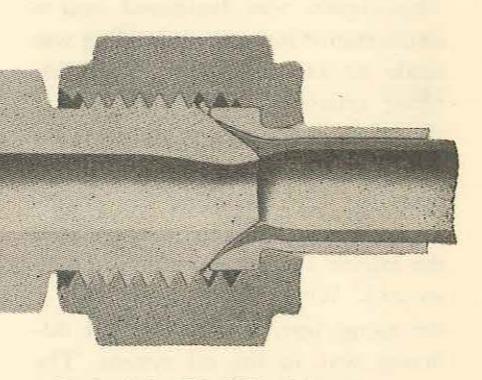
Fig. 2

TUBING FLARE SHEARED BY OVERTIGHTENED NUT

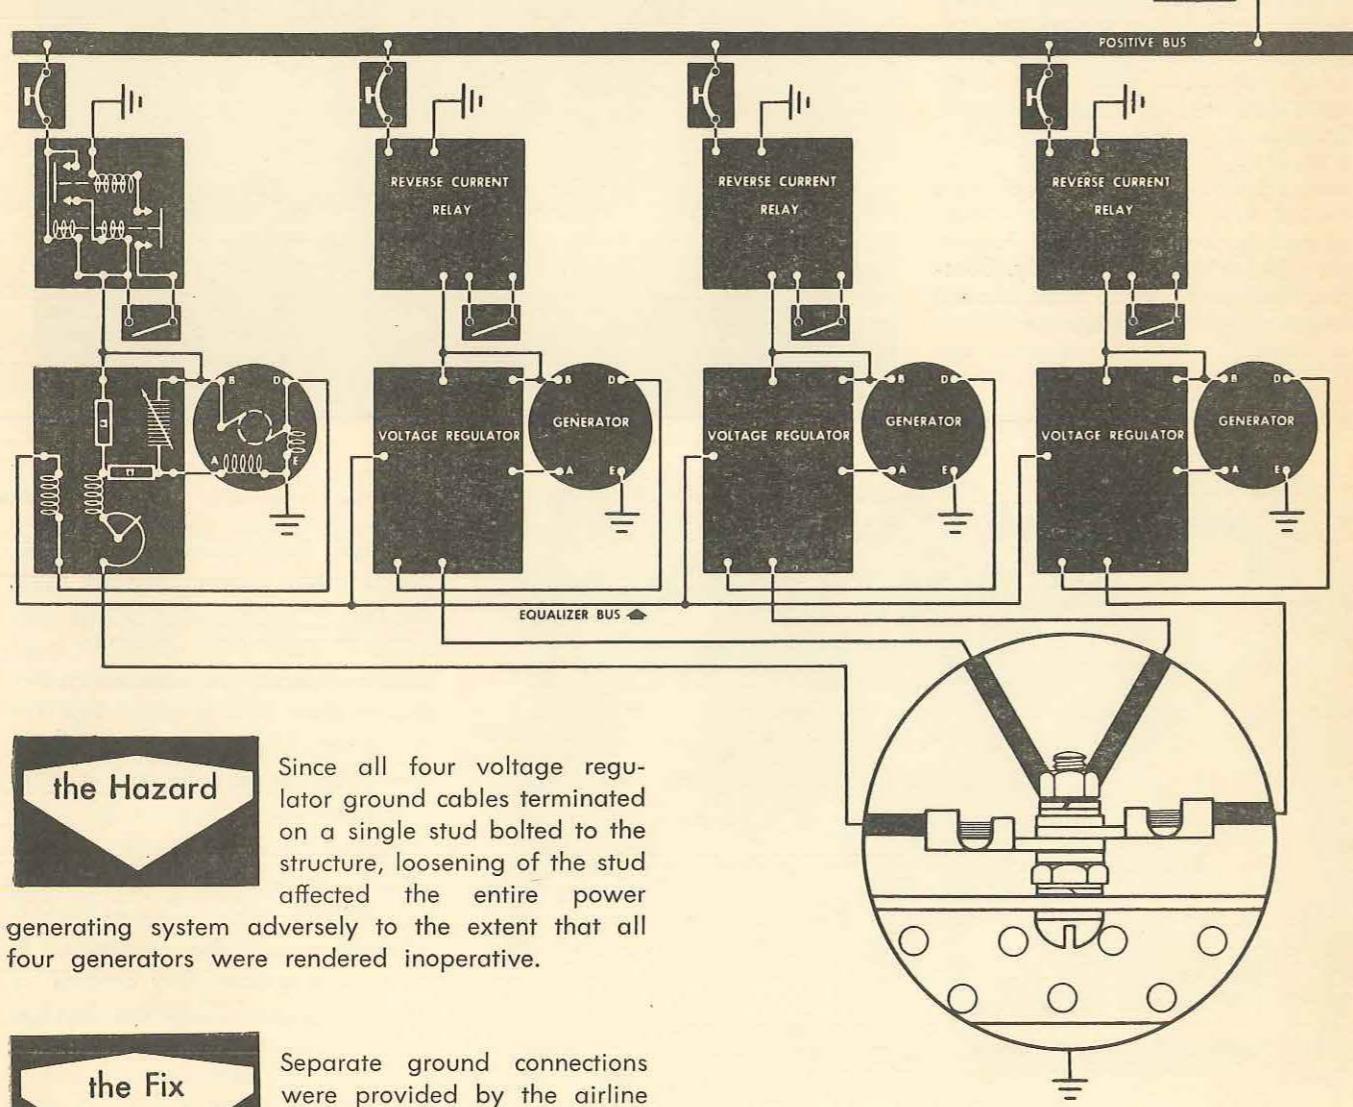
from all four engine-driven generators. The incident was fortunately discovered during ground run-up by an alert inspector. Accidental discontinuity of the connection leading from the voltage regulator to ground causes the generator to go into overvoltage condition. The equalizer action would be insufficient to counteract this effect. The overvoltage relay of the fault detecting panel would cause the generator circuit breaker to trip out, resulting in a total power failure.

Four circuits grounded on a single stud.

only, and not the entire bank of generators would be affected.

operator for each voltage regulator. Should loosening of a ground occur again, one
