DIGEST SAFETY AVIATION

No. 22

JUNE, 1960

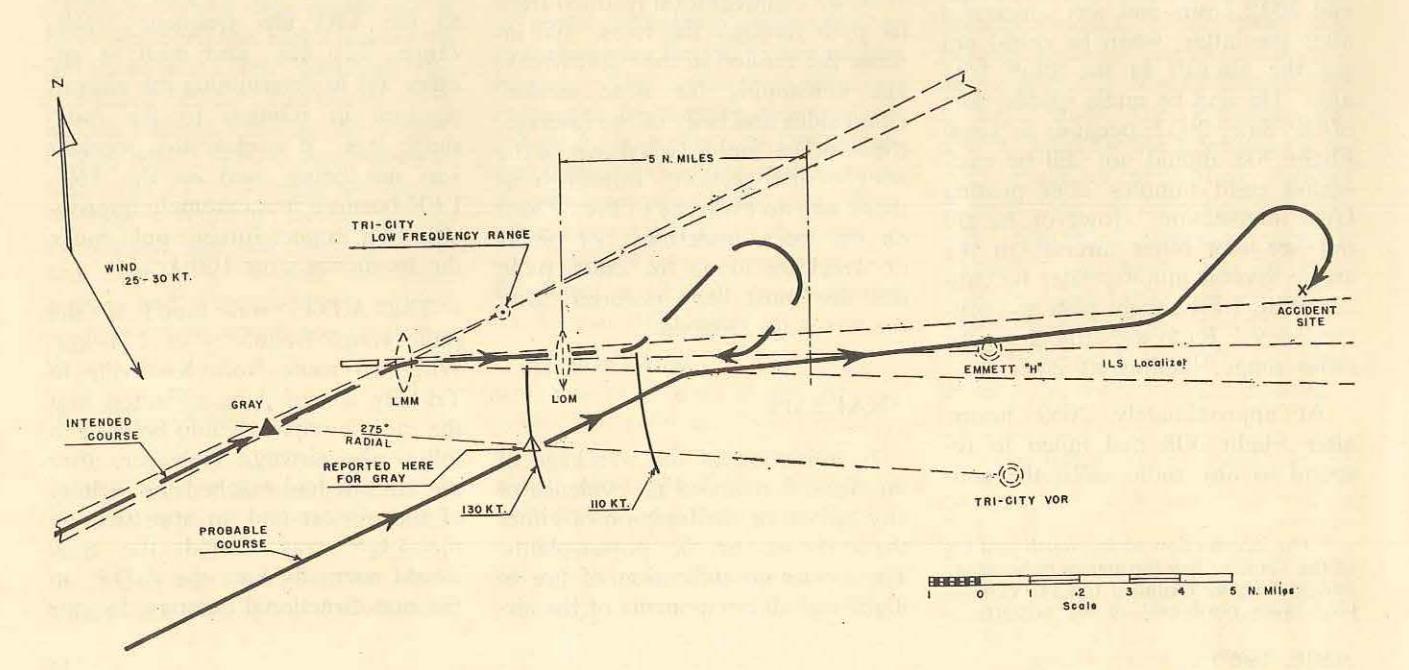
miles from Piedmont, at 2010 hours, it can be seen that the groundspeed of the aircraft was 152 knots. The next position report was over Gray, 32 miles from Bulls Gap. At a groundspeed of 152 knots, this segment should have taken 12.5 minutes. However, the flight did not report over Gray until 2024 hours, 14 minutes after passing Bulls Gap. At this same groundspeed the aircraft would have travelled 35.5 miles, or at least 3.5 miles closer to the accident site than Gray. In other words, when the flight reported over Gray it was actually 3.5 miles or 1.5 minutes beyond Gray. By plotting this distance (35.5 miles from Bulls Gap) on a chart, it was found to cross the 275-degree radial of the Tri-City omni at the same approximate point as the line of position calculated for a manoeuvring speed of 130 knots. Again referring to the sketch, it can be seen that a course from Bulls Gap to this point would pass approximately two miles east of Gray.

As stated before, the Board believes that the A.D.F. was inoperative as reported by the captain who flew the aircraft to Nashville. It further believes that the flight from Knoxville to Tri-City was made in instrument weather conditions without using the low frequency radio aids which define Green Airway 5. There was evidence at the public hearing that, in some instances, pilots were using the intersection of the 65-degree radial of the Knoxville V.O.R. and the 275-degree radial of the Tri-City V.O.R. as Gray intersection. The intersection of these radials is very indefinite because of the distance from Knoxville and it is possible to receive an indication which could place it several miles east of Gray.

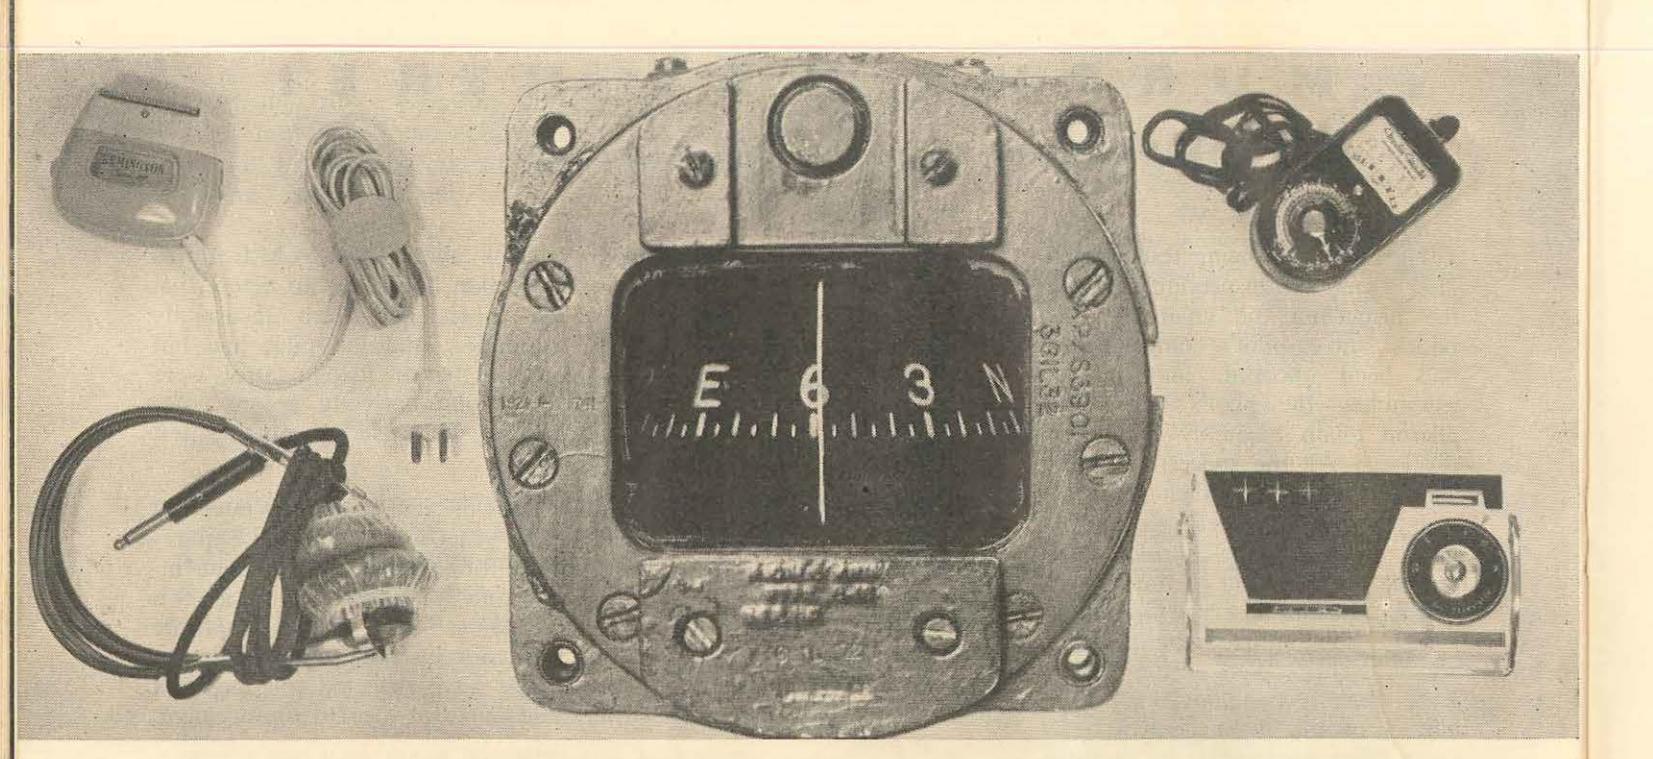
Meter	No. 1
eviation Degrees	Distance in Inches
Control Ma Care	16
5	12.5
10	9.5
20	7.5
30	6.5
40	5.5
50	5.25
60	4.25
70	4
80	3.25
90	2.00

Light meters, in common with almost all electric meters, and radio speakers contain small but powerful permanent magnets which, when placed near to the magnetic compass, will cause serious deviations. The position of many of the places commonly used for the convenient stowing of personal items in modern light aircraft is such that the stowage of items which have a magnetic field can cause very significant compass deviations.

Rotation of No. 1 meter, when at the closest point recorded below, produced a compass needle movement of 310 degrees. The same rotation of No. 2 meter caused the needle to swing through the full 360 degrees. At all distances recorded, rotation of the meter through 180 degrees caused a reversal of sense in the compass deviation.

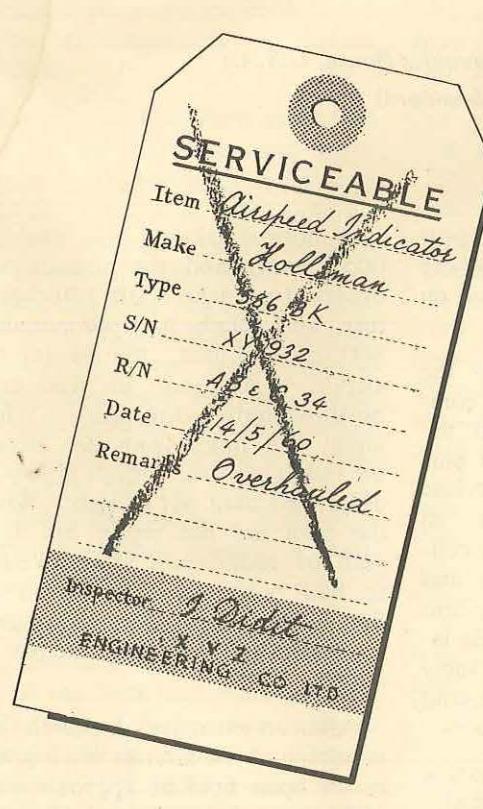
Recently, two rotatable assemblies were dropped. They had been damaged and were considered unserviceable, so were routed back to the shop for check and repair. However, the parts nearly got back into

Stores as serviceable because the Serviceable

Parts Tags were left on them.

Best "pull" the tag whenever the condition of a unit becomes questionable, so there cannot be even a remote possibility of it being used on aircraft.
