AVIATION SAFETY DIGEST

No. 29

MARCH, 1962

Accident to DC.4 at Brisbane

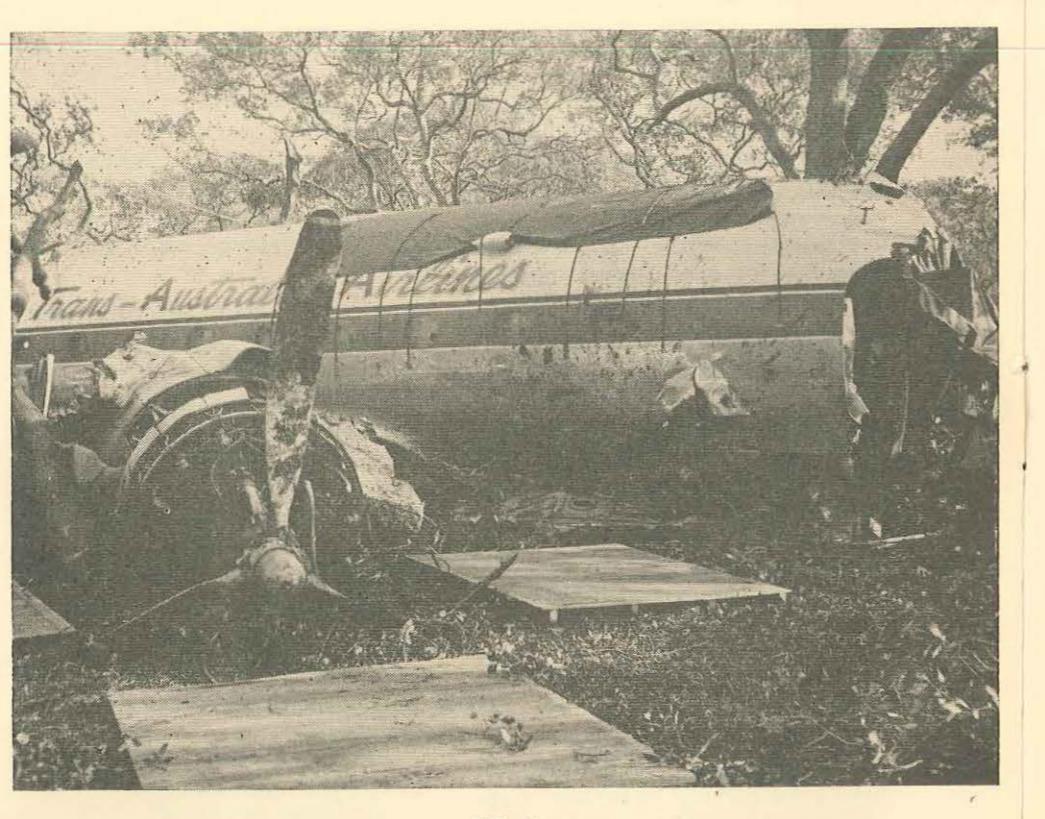
FIG. 4.

very severely damaged in the the impact it was not possible to impact (see Fig. 4), so that prac- confirm the accuracy of the load tically no significant informa- distribution sheet other than for tion was obtained from the arithmetic correctness. cockpit dial indicators and only corroborated evidence can be accepted in respect of the positions of most cockpit controls. Both crew seats were also severely damaged and had separated from the floor. First Officer Adams' body when found was still strapped into the right hand seat which had been adjusted prior to the accident to the lowest available position and fully forward. Captain Norriss' body was found some 5 feet from his seat, the belt of which was in the unfastened condition. The chair had been adjusted prior to the impact to the second lowest avaliable position and, although the fore-and-aft adjustment could not be reliably determined. it is probable that it was positioned against the aft stop at the time of impact.

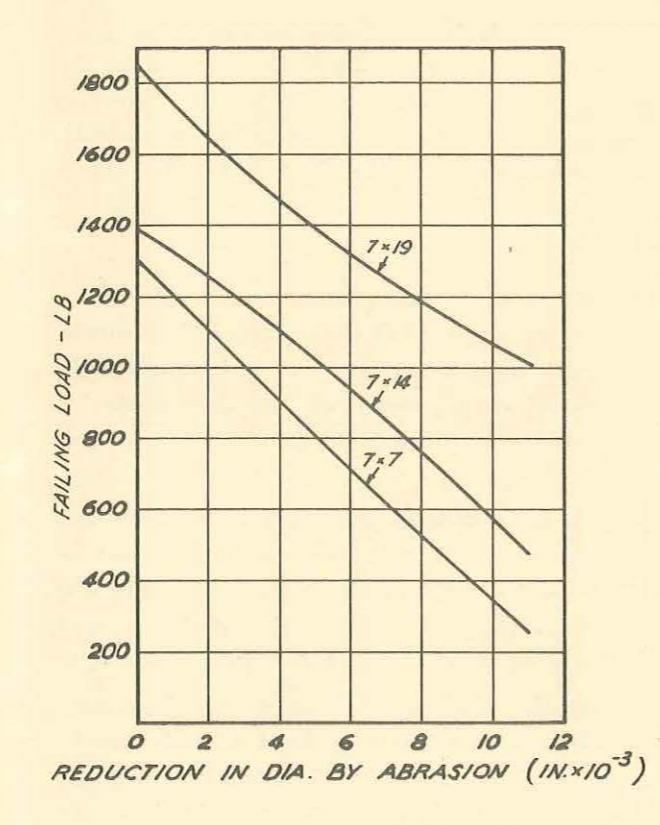
As a guide to the inspection of small cables any signs of corrosion, wear, broken wires or impaction between strands are grounds for immediate rejection. Cables in situ must be very carefully inspected where they pass over

pulleys, at terminal fittings and where they pass through fairleads. Run a "snag" cloth along the cables to detect broken wires and check that the cable diameter is uniform using a micrometer.

Let the motto be "If in doubt, cast it out", when carrying out this very important function.
