JANUARY, 1969

SOME PEOPLE NEVER LEARN (and what a way to treat a Tiger!)

Inadequate Undercarriage Maintenance

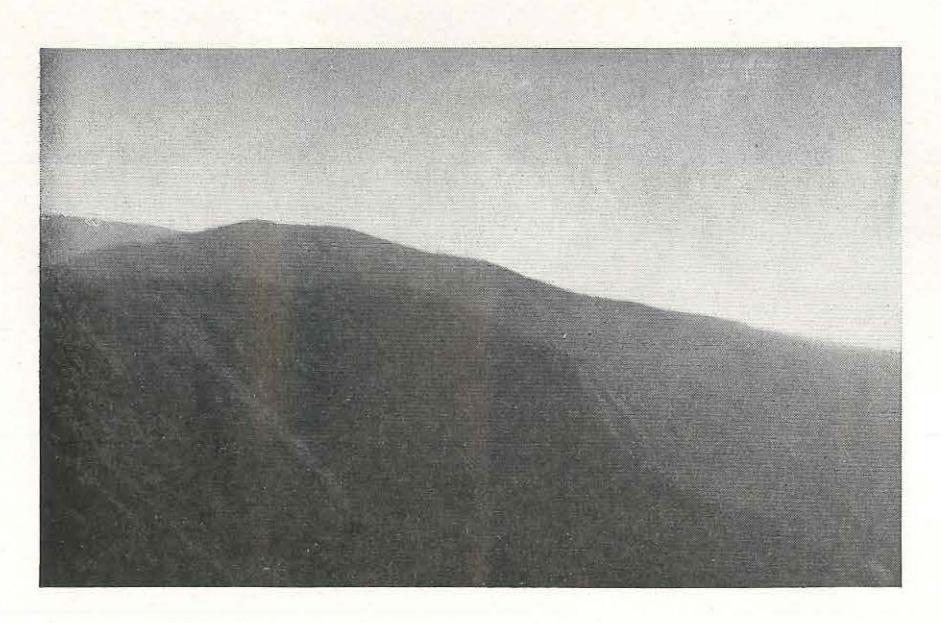
The steep-sided ridge on which the aircraft crashed. Note how the height of the ridge falls sharply to the right of the picture.

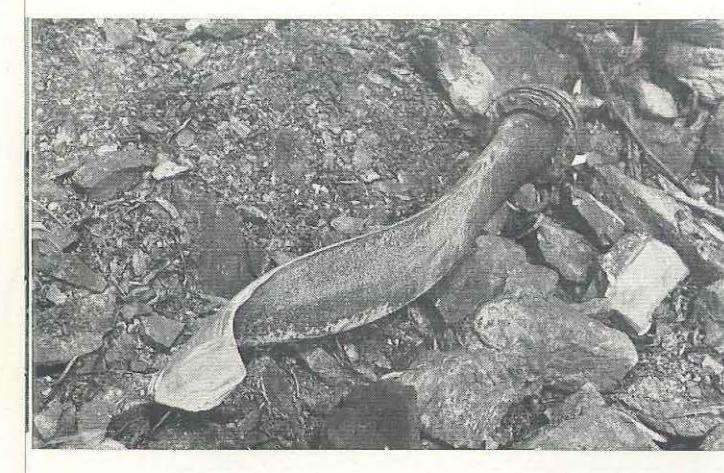
One of the propeller blades detached from its hub at impact. Damage to the blades indicated that the propeller was rotating at speed when the aircraft crashed.

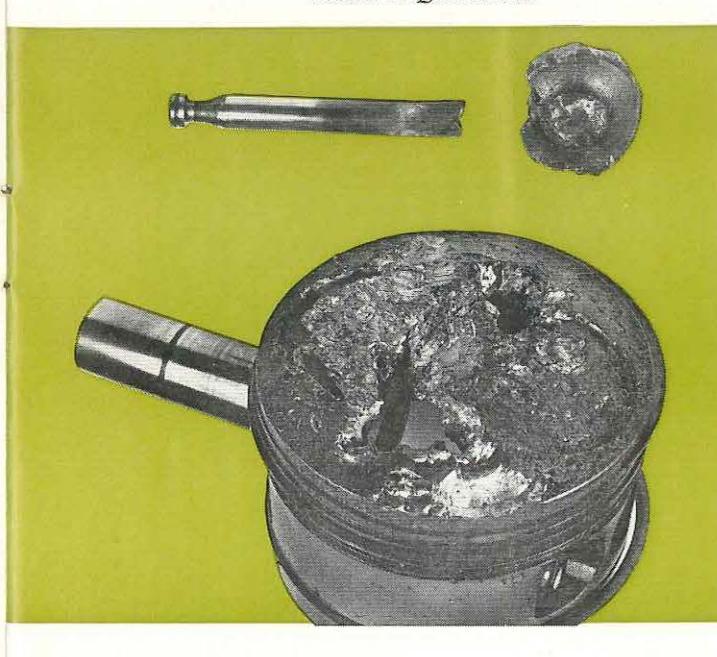
The broken exhaust valve and badly damaged piston, removed from the engine of the helicopter that forcelanded in Queensland.

Damage of this type occurs when the inlet valve mechanism is forced past its normal range of travel in the valve opening direction. Assuming that the correct valve springs are fitted, the only known way in which this can occur in service is by overspeeding the engine. The engine manufacturers have in fact advised that they are not aware of any operating condition, other than an engine overspeed, that can cause inlet valve collets to strike and deform the ends of the valve guides.

slippage with the likelihood of an engine overspeed. If a severe engine overspeed does occur, it is strongly recommended that, in addition to attention to the engine itself, the transmission be removed and the clutch and free wheeling unit be inspected for serviceability.

Although engine overspeeding may not always extensively damage the valve gear, it generally causes some damage to the valve guide ends. More important, overspeeding can have a destructive effect on the engine's dynamic counterweights, crankshaft lugs and their bushings, as well as connecting rods and bolts. It is vitally important therefore that a helicopter engine which has been subjected to a known or even suspected overspeed condition, in which the r.p.m. may have reached the limit prescribed by the manufacturers, should be given a very thorough inspection before being returned to service. This inspection should include dismantling the engine at least to the stage where the complete valve mechanism can be thoroughly checked. If any damage is found in the valve gear mechanisms, the engine should be further dismantled and inspected for damage to bearings, crankshaft counterweight assemblies (where fitted), connecting rod assemblies, etc. As recommended by the manufacturers, the engine should be fully dismantled and specified parts replaced, in the event of any

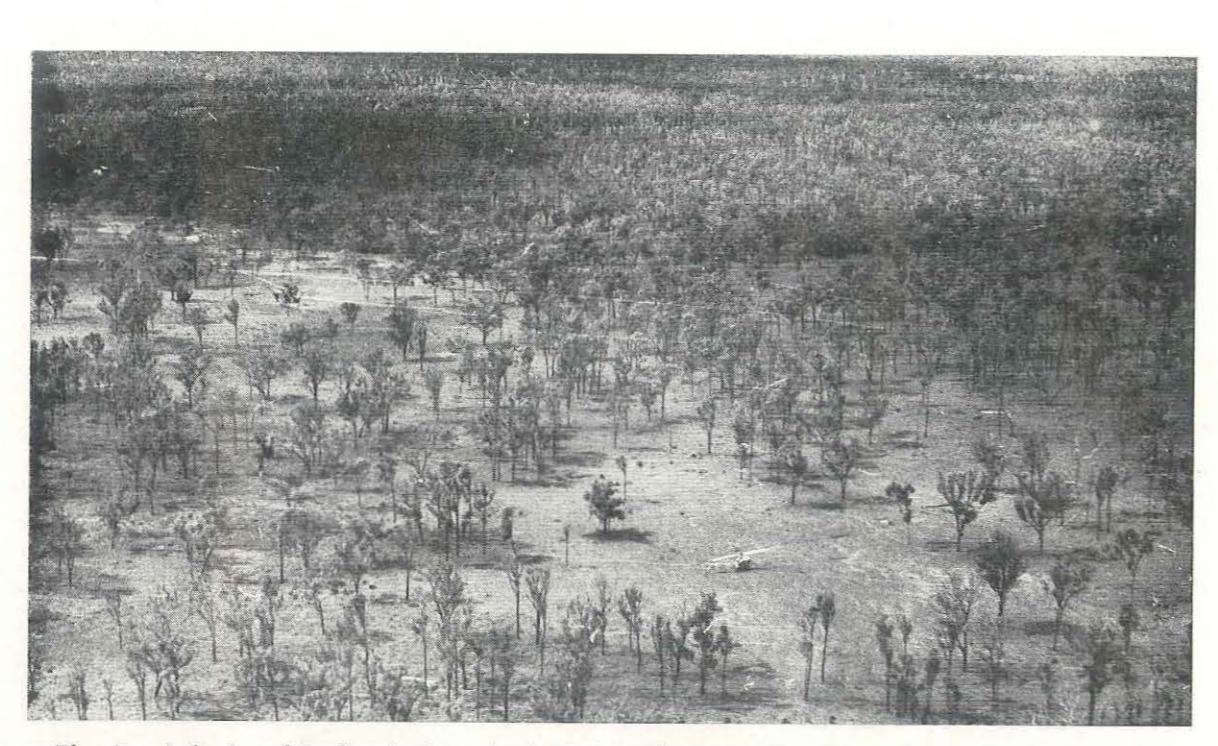
The site of the forced landing in Queensland. As is evident from the picture, the clearing in the timber was the only area in which there was any chance of making a successful forced landing.

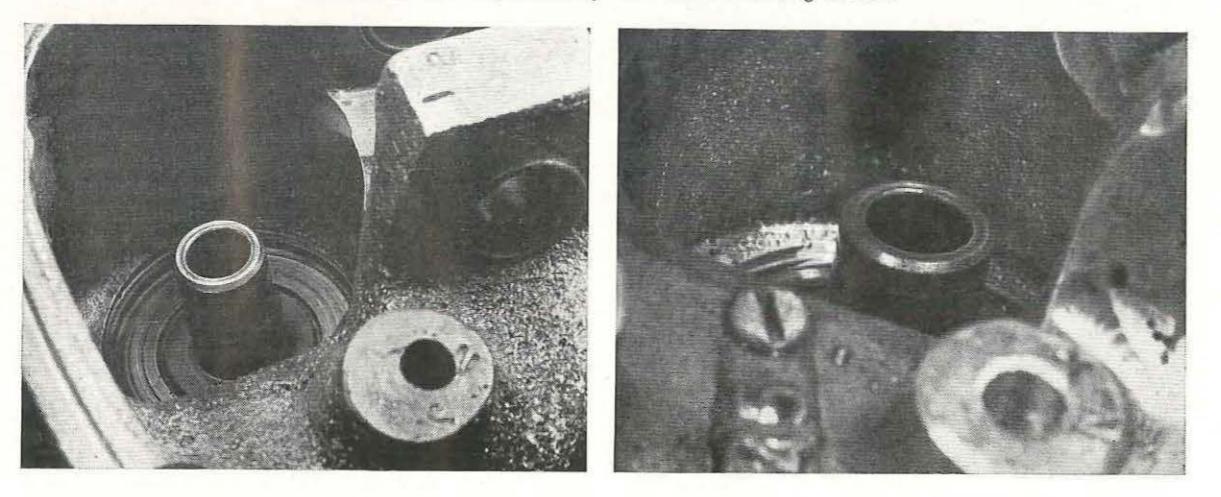
Inlet valve guide damage typical of that found in the engines of the three helicopters referred to in this article. These two photographs, taken on different engines, show how the valve guide ends have been hammered and deformed by the valve retaining collets.

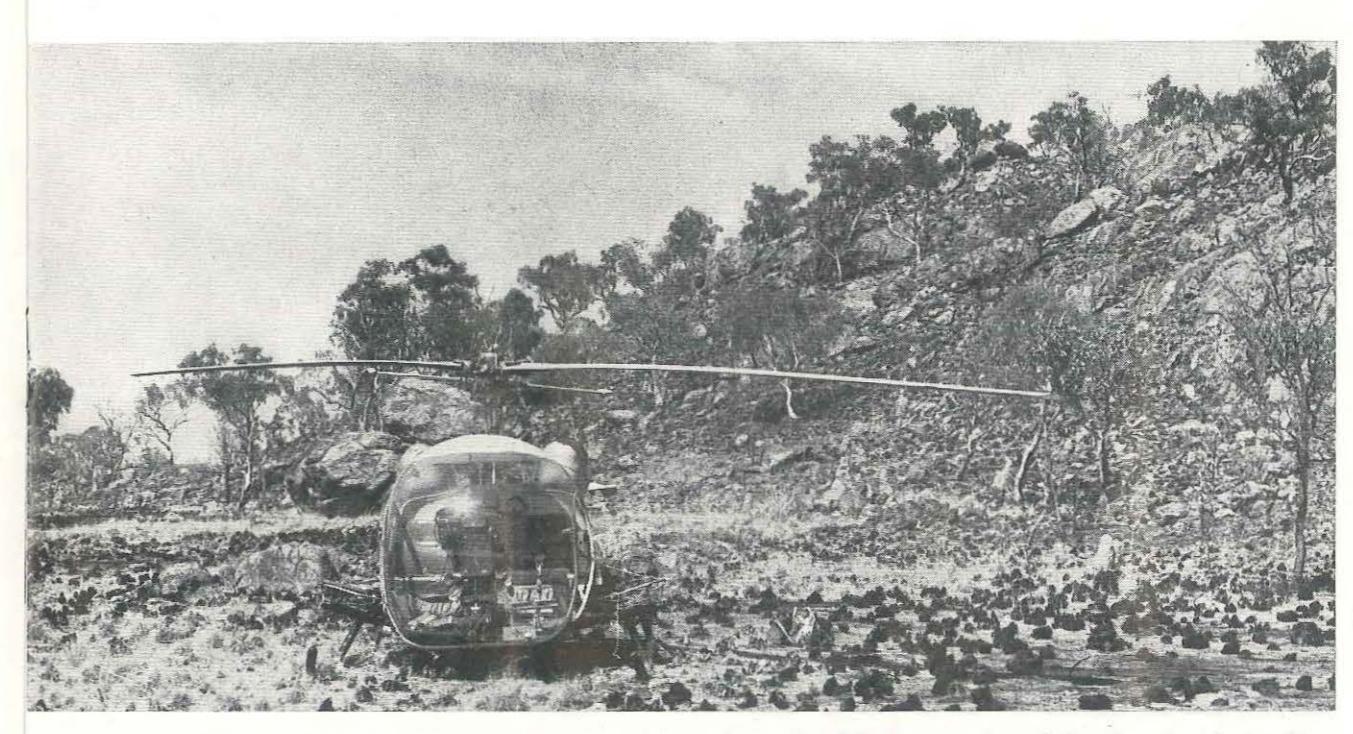
The site of the forced landing in Western Australia. The difficulty experienced by the pilot during his approach can be appreciated from the terrain in the background.

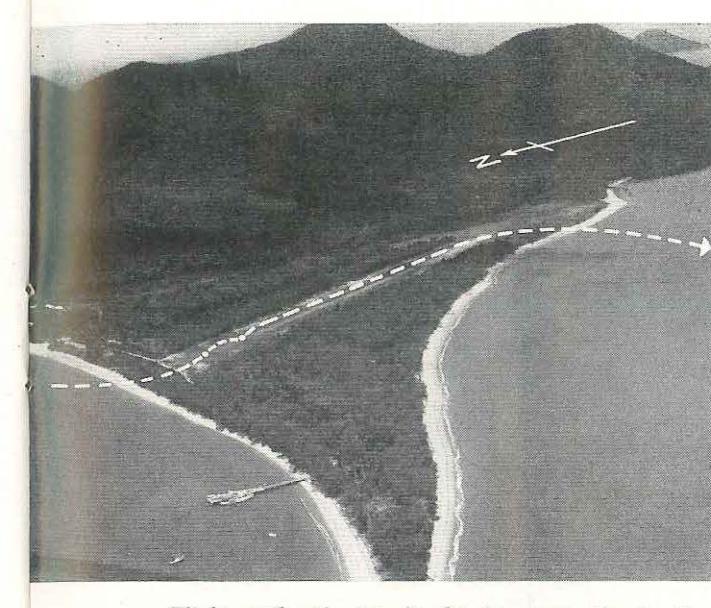
Flight path of aircraft showing approximate touch down points on Dunk Island strip, with subsequent track flown as the pilot attempted to go around.

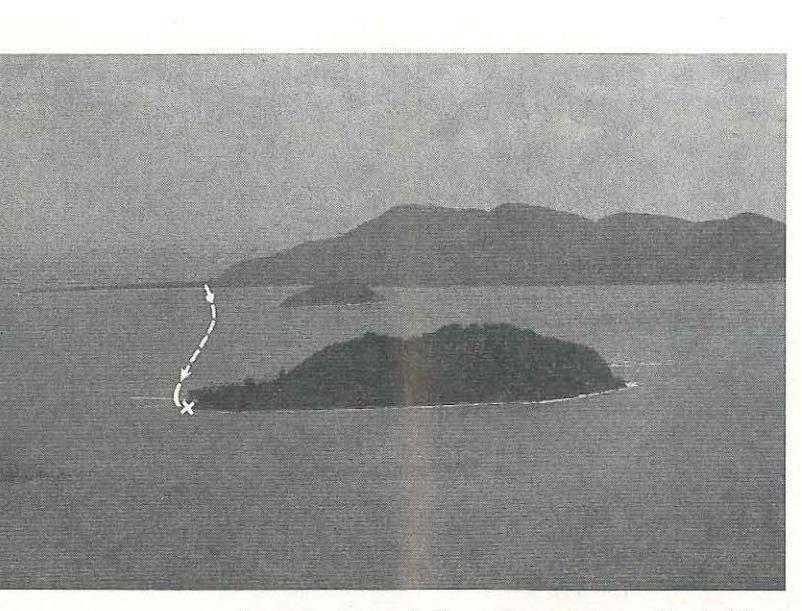
Approximate track flown from strip on Dunk Island (in background) to point of ditching alongside Thorpe Island.

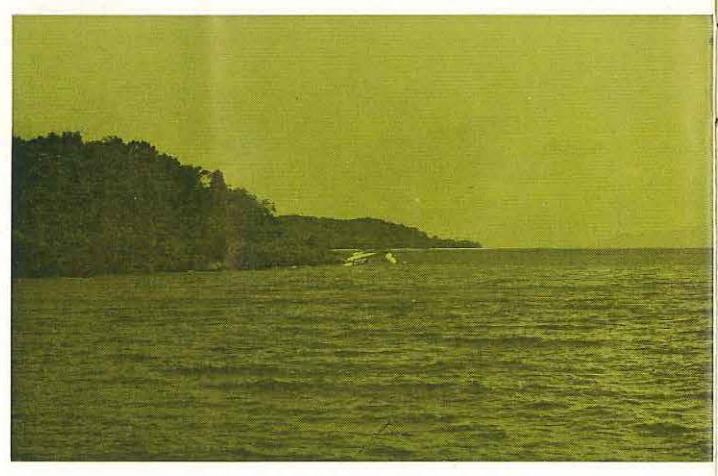
cables on the damaged aircraft were slack, allowing the control wheel to move freely through about 75 degrees, but this was found to have occurred during the ditching, when the aircraft overturned in shallow water, causing some deformation of the wings.

The aircraft upside down in shallow water by Thorpe Island, after the tide had gone out. The ditching took place at high water.

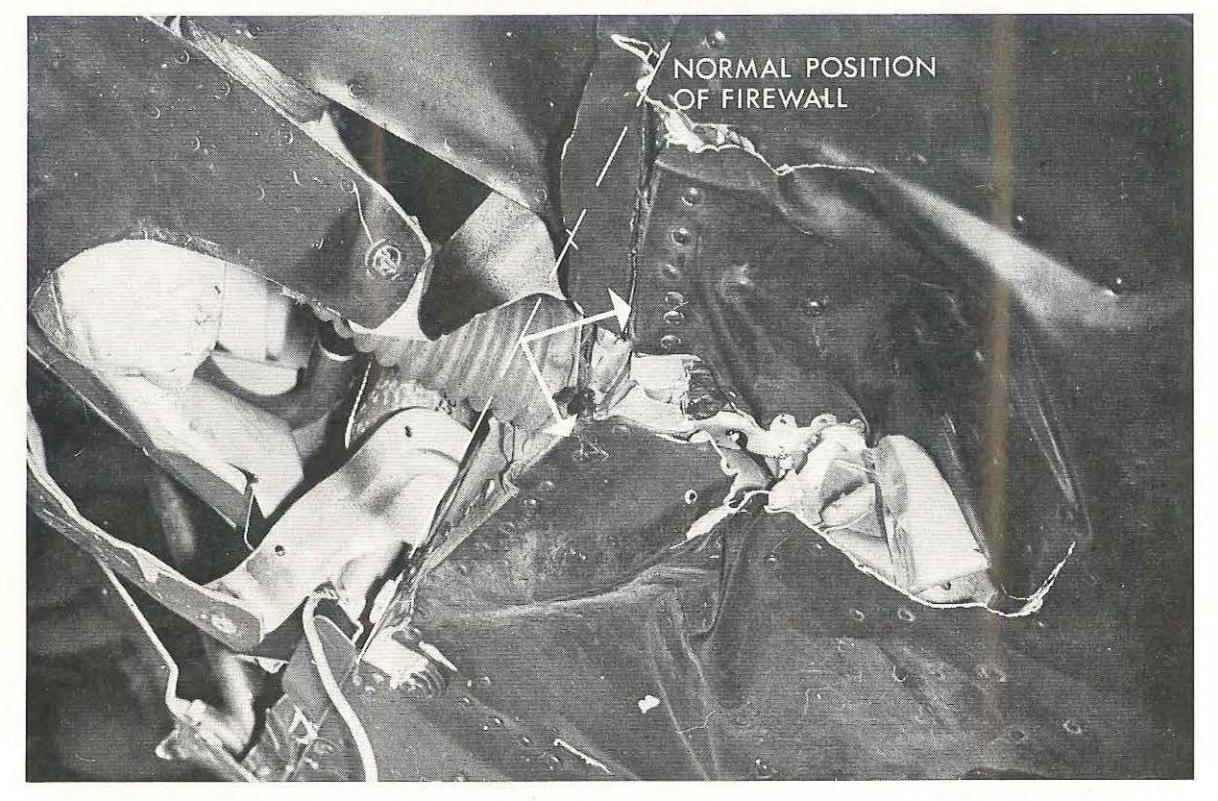
Although the nose wheel strut had broken off completely during the ditching, the degree of damage and buckling sustained by the firewall bulkhead and the underside of the fuselage in the vicinity of the nose leg attachment was inconsistent with the pilot's and passengers' statements that the ditching impact was not severe. It was also found that the impact forces which had caused the damage contained a large vertical component in addition to the rearward acting forces to be expected during a ditching. The damage was severe enough to have displaced an elevator control pulley, allowing the elevator control cable to become slack, producing about three and a half inches of free fore and aft movement in the control column. It was also discovered that the buckling of the lower fuselage near the firewall had restricted the movement of the nose wheel steering rod, which is attached to the port rudder pedal shaft. This, in effect, meant that although the port rudder pedal could be moved to the fully forward position, it could not be completely returned to the neutral position, and resulted in the rudder being offset some ten degrees to port.

In view of the pilot's description of the aircraft's handling characteristics immediately following the two heavy touchdowns at Dunk Island, together with the type of damage which the aircraft sustained in the firewall bulkhead area, it was clear that the control problem experienced by the pilot was the result of the slackness in the elevator controls, together with the continuous application of some ten degrees of port rudder. It was the

Underside of forward fuselage and engine compartment, showing rearward distortion of firewall sustained during the heavy landing on Dunk Island. The resulting displacement of a control cable pulley caused slackness in the elevator controls.

concerned can be inspected for possible hidden damage before it is flown again. The accident described in this article may be an extreme case, but it dramatically illustrates how far-reaching the effects of a heavy landing can be.

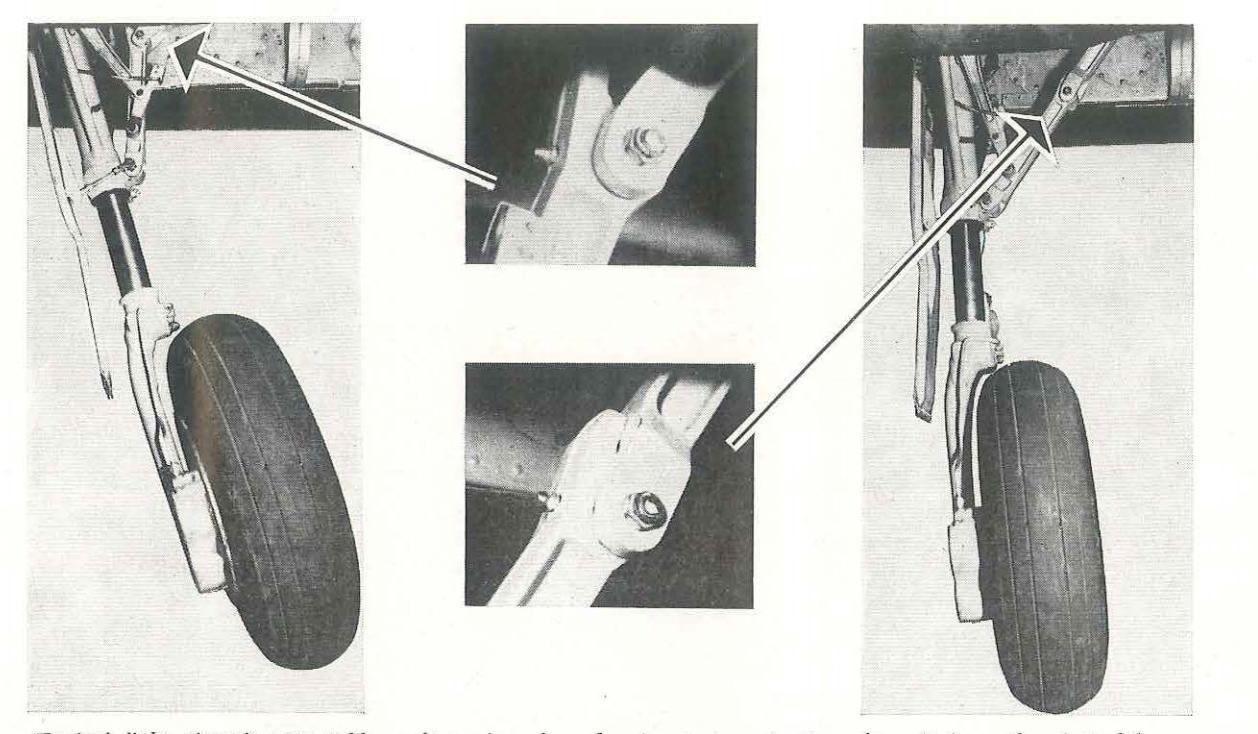
Typical light aircraft retractable undercarriage leg, showing over-centre type down-lock on the pivoted bracing strut. The operation of the mechanical stop can be seen in the insets. The stop allows the bracing strut to pivot beyond the specified over-centre distance, locking the undercarriage leg in the extended position.

undercarriage is thus said to be geometically locked and in this position is capable of carrying the loads for which it was designed. If however, the folding strut has not reached this over-centre position, it will naturally tend to return to the folded position as soon as compression loads are applied. When this occurs, a percentage of the load applied to the strut is transferred into the undercarriage retracting mechanism, the actual amount of the load transferred depending on the extent to which the folding strut is out of alignment. This situation is usually the beginning of the trouble which ultimately leads to the collapse of the undercarriage.
