No. 63 JULY, 1969 DEPARTMENT OF CIVIL AVIATION, AUSTRALIA

THE PRICE IRRESPONSIBILITY

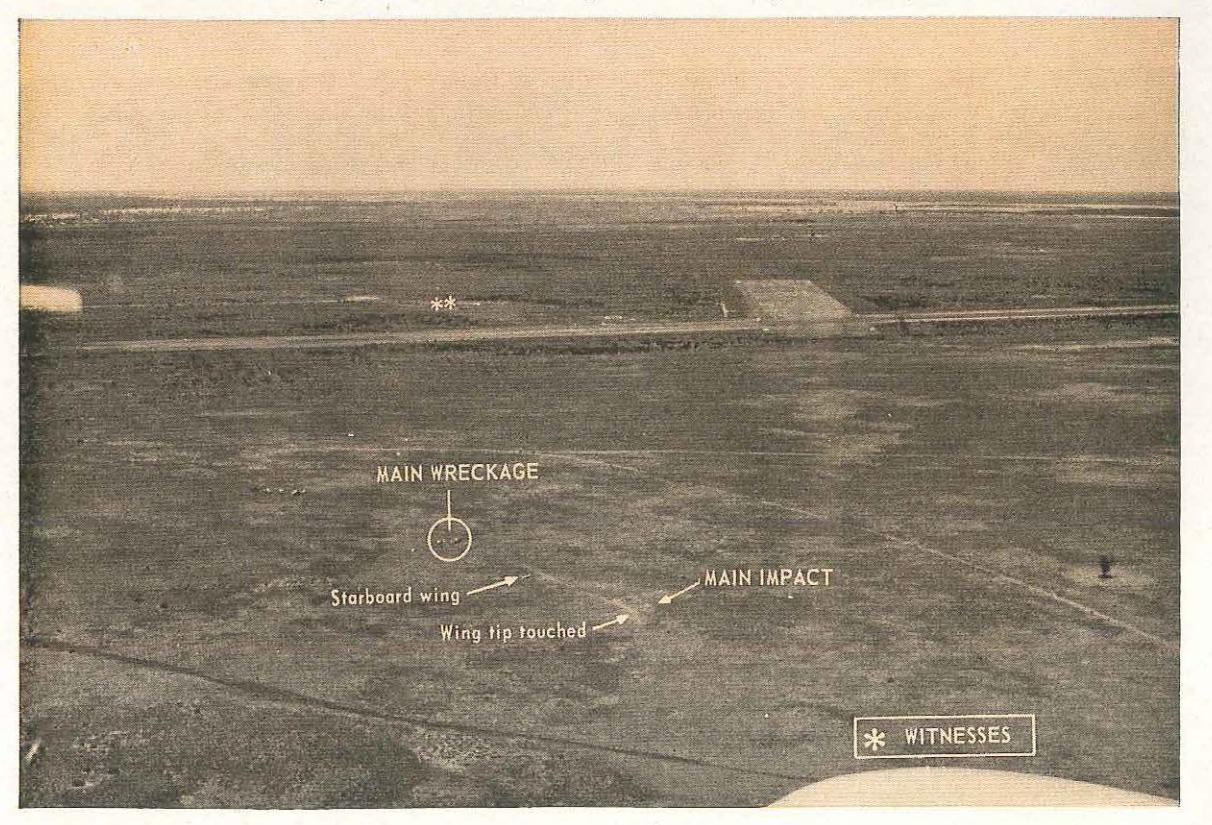
Aerial view of aerodrome area showing crash site and position of eye-witnesses.

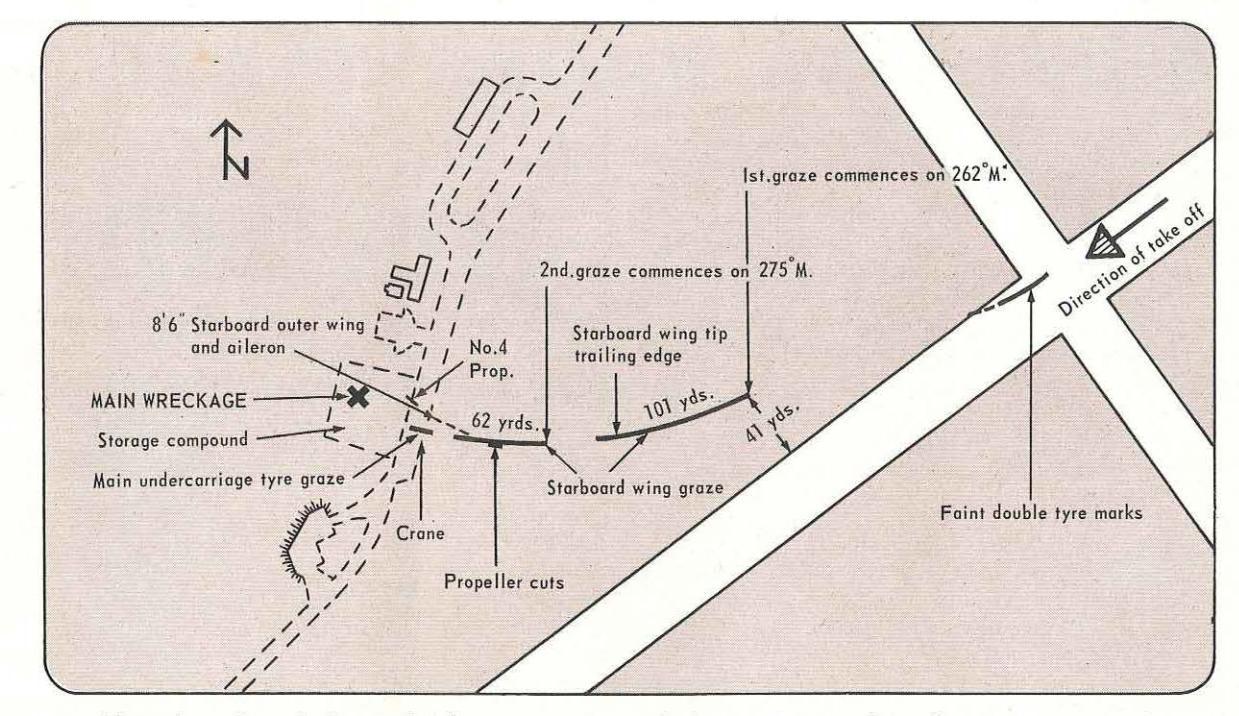
off. Altogether the marks indicated that the aircraft had progressed in a wide arc to the right when banked steeply at a height of less than half the wing span. The wing tip had dug into the ground with increasing force over a distance of 303 feet until about eight feet of the outer wing broke away. There was a break in the marks for 48 feet, then gouge marks showed that the inboard part of the broken wing had contacted the ground heavily for 186 feet. A series of propeller cuts approximately half-way along this second set of marks were made by No. 4 propeller which broke off shortly afterwards. From the nature of the propeller cuts it was clear that the No. 4 propeller was not in the feathered position. Furthermore, from the progressive increase in pitch between successive slash marks, it was apparent that the propeller was windmilling a dead engine.

Plan of portion of airport showing runway from which aircraft was taking-off, scrape marks made by wing, and main wreckage site.

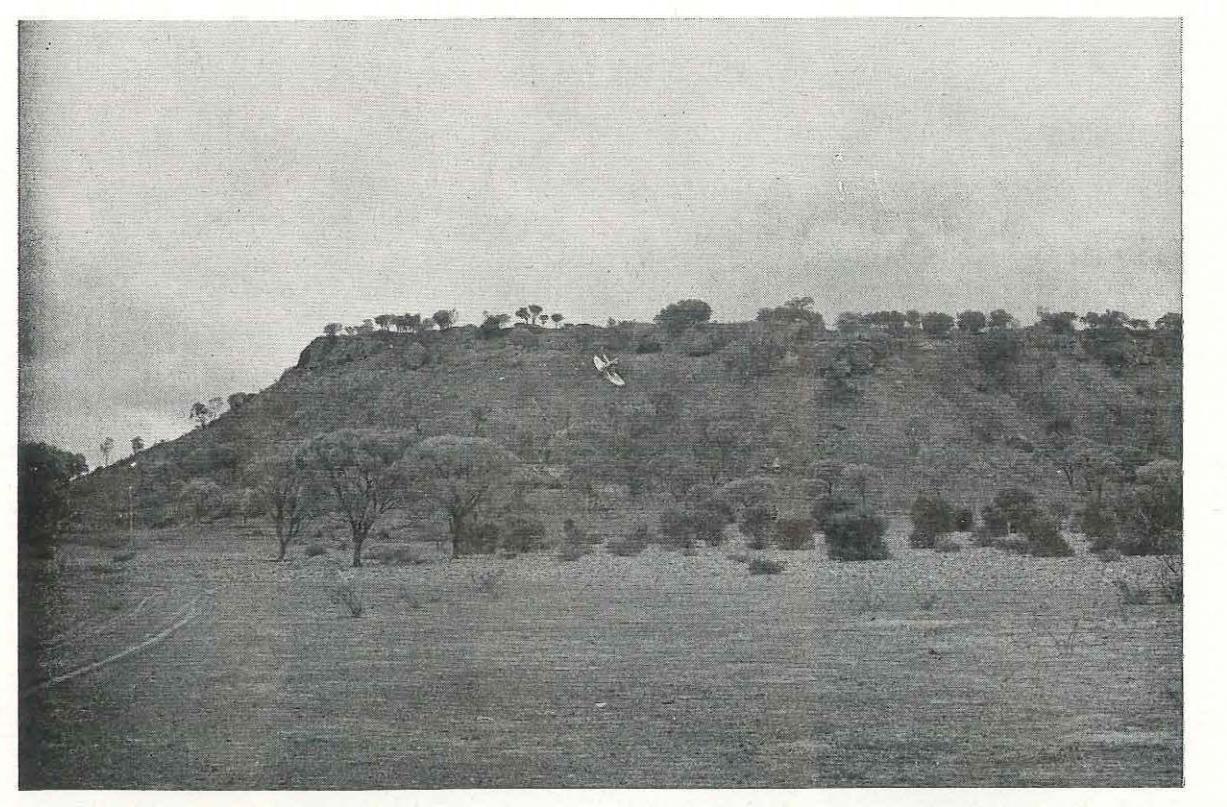
Crash site on hillside. Note prominence of escarpment above surrounding level terrain.

Examination of the wreckage produced no indication of any pre-impact defect having developed in the aircraft which could have contributed to the accident. There was evidence that the engine was developing substantial power when the crash occurred. The disposition of the wreckage and the severity of the damage it sustained indicated that the aircraft was travelling at considerable speed when it collided with the hillside. At impact the aircraft was in a near-level attitude, with 20 degrees of flap lowered.

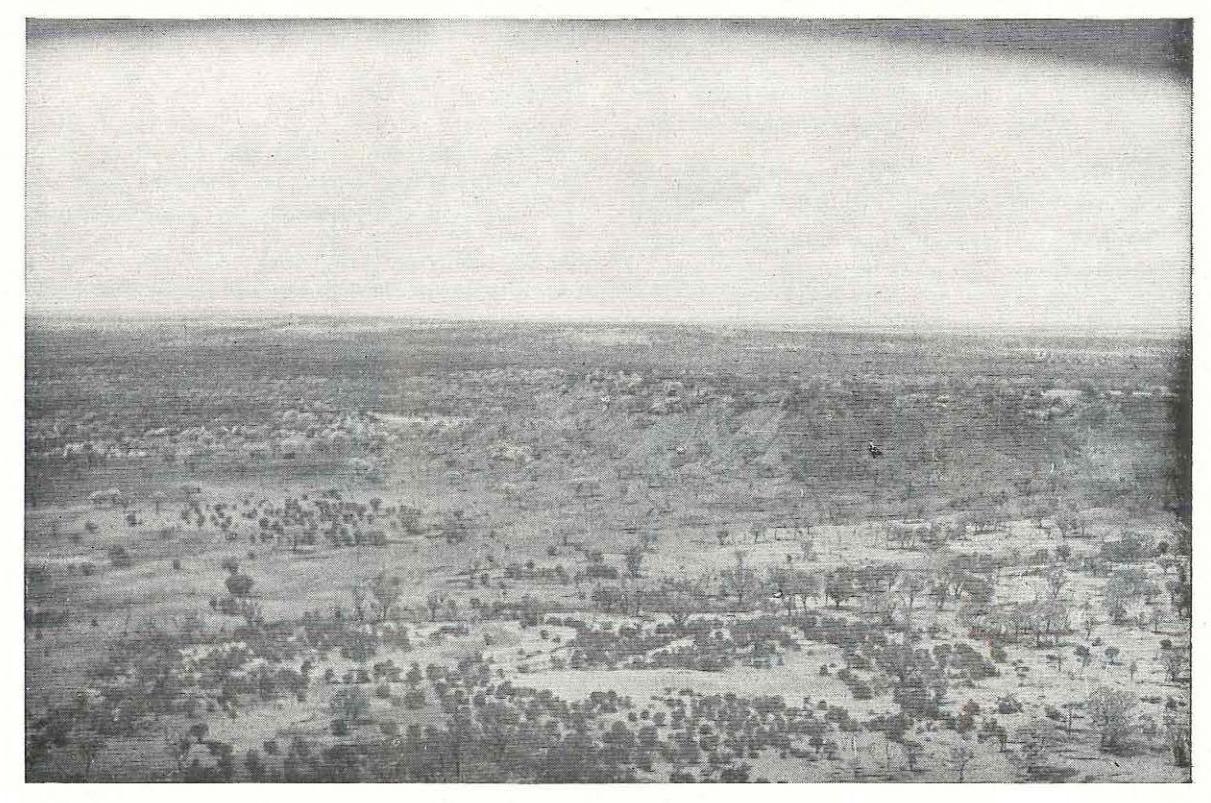
Aerial view of hill and crash site, taken from approximate position at which aircraft turned.

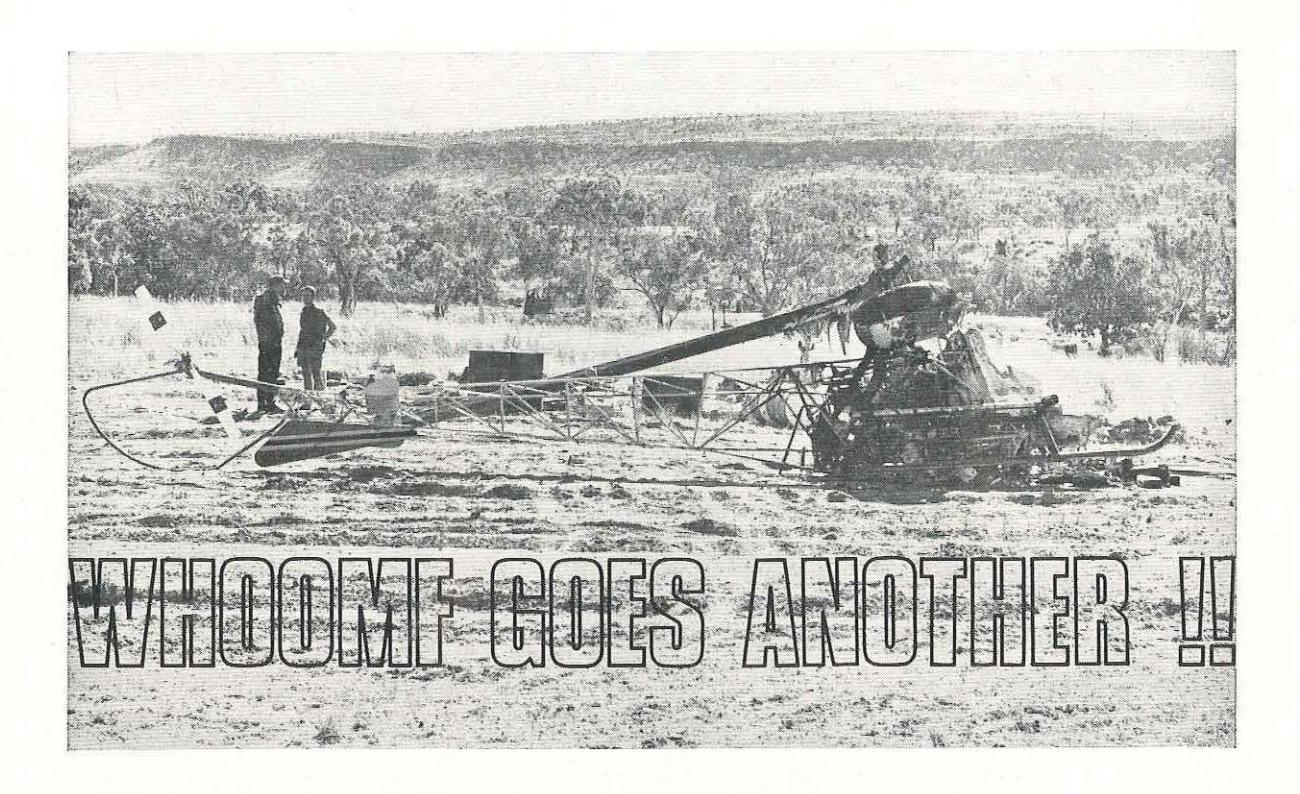
The photographs of the burnt-out Bell 47 tell most of the story. Operating in Western Australia on mineral survey work, the helicopter had been parked at the end of the day's flying, for maintenance and refuelling. Some 40 minutes after the engine had been shut down, by which time it was dark, the pilot and a ground engineer began to refuel the helicopter by torchlight. Using a quart

The actual mechanics of how the fire started is not certain. What is certain is that none of the recommended refuelling procedures were followed. Neither the helicopter nor the refuelling equipment were bonded to earth or even to each other. and the hose was evidently of a type that cannot

Apart from the fire danger aspects, the refuelling was also unsatisfactory in that no funnel and chamois or other approved type of filter was used and no proper test for water was made before the refuelling began. The only "precaution" evidently taken was to pump several strokes of fuel on to the ground from the drum when it was first opened, ostensibly to remove any water or sediment in the base of the drum. Such a procedure hardly suggests that a great deal of care was being taken with the operation, and would do nothing to mitigate the effects of a fire, once it had started.

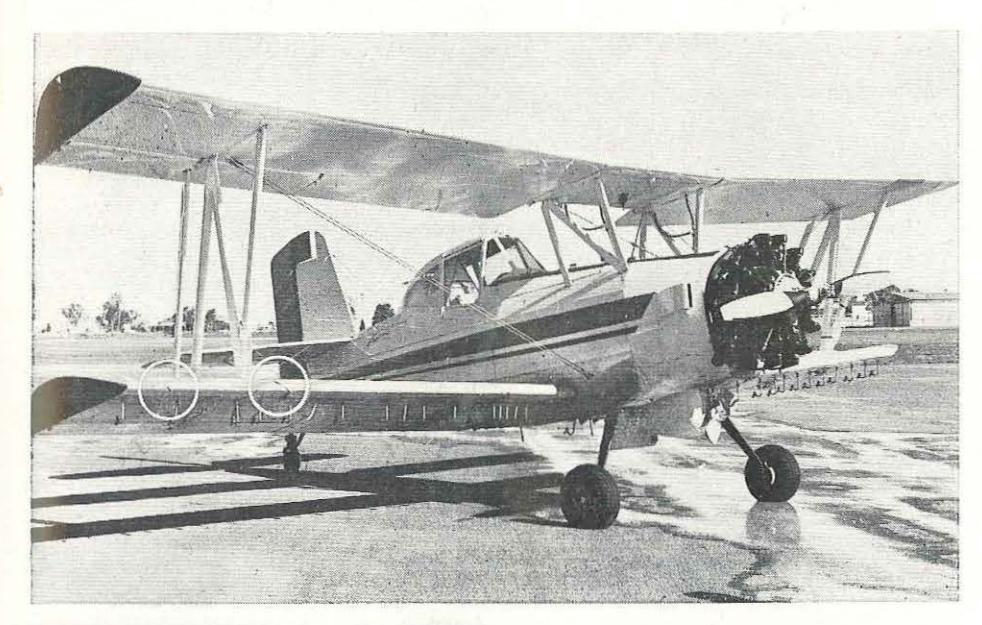
THE Grumman Agcat shown in the picture was engaged in spraying a crop of bananas on a property in hilly country on the north coast of New South Wales. The highly experienced pilot flying the aircraft had treated the same area some weeks before, but had found some difficulty in spraying it downhill. After making one spraying run downhill on this occasion, he decided it would be better to complete the spraying of the area by flying a pattern which followed the contours of the slope.

Approaching for the first contour run, almost at right angles to his previous flight path, the aircraft collided with a pair of steel cables which formed part of a "flying fox" system used to transport bananas from an adjoining field. The wires flattened about a foot of the leading edge of the port upper wing and tore deep, jagged gashes in the leading edge of the starboard lower wing before breaking free, leaving the aircraft trailing two long pieces of wire. The pilot immediately applied full power and despite the retarding effect of the trailing wires which were snagging in the crop, he kept the aircraft under control and lifted it clear.

"Plan the whole operation, including the finishing runs, in relation to all obstructions which are observed at this time. Further, if you decide to change your plan of operation, it is essential that you consider if your new plan takes into account previously insignificant obstructions."

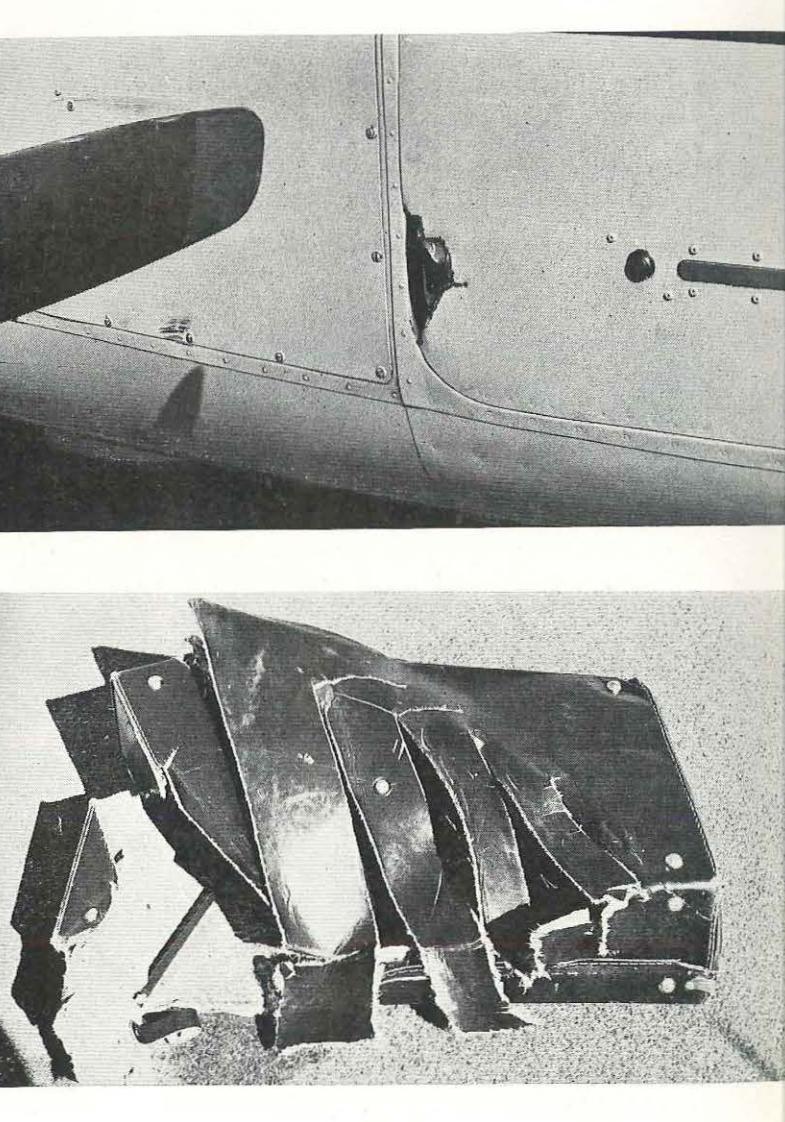
Damage to the aircraft was found to be confined to a small section of the nose locker door, and minor abrasions to the starboard propeller.

Above: View of damaged "trailing edge" of nose locker door and scuffed starboard propeller. The door handle is in the fully closed position, flush with the surface of the door.

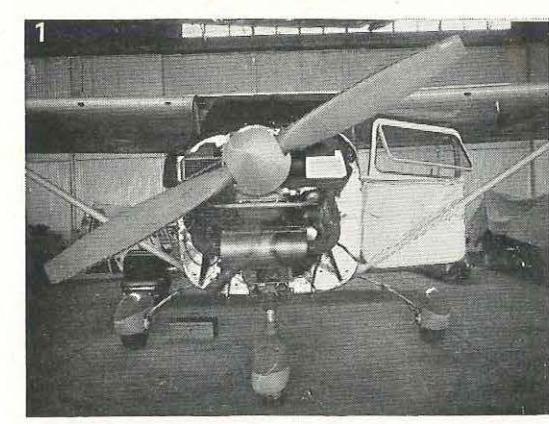
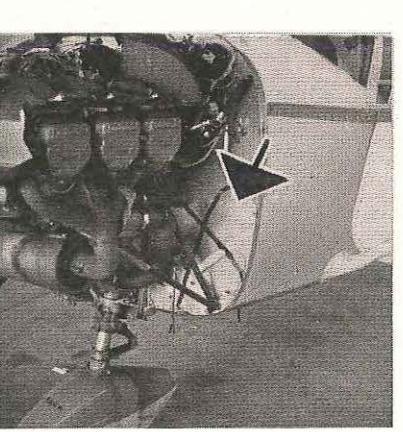
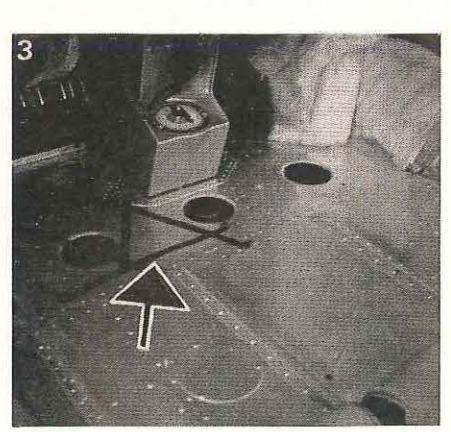
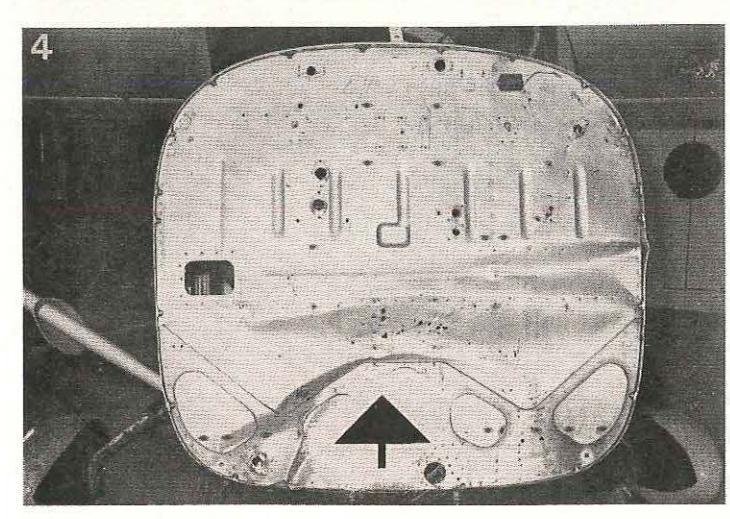
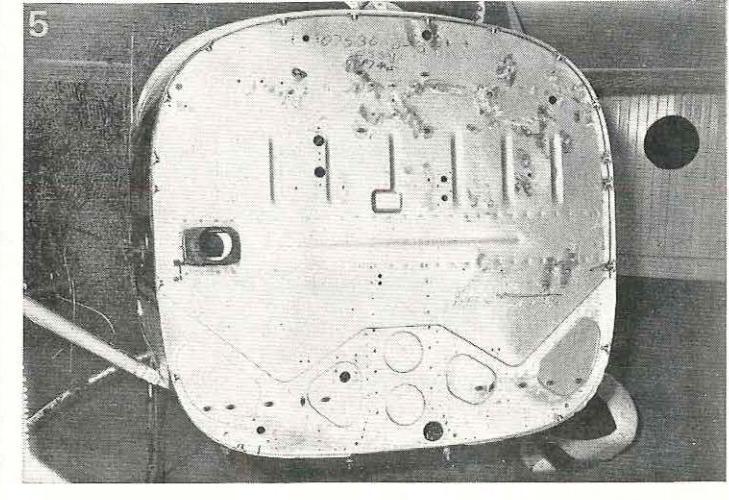
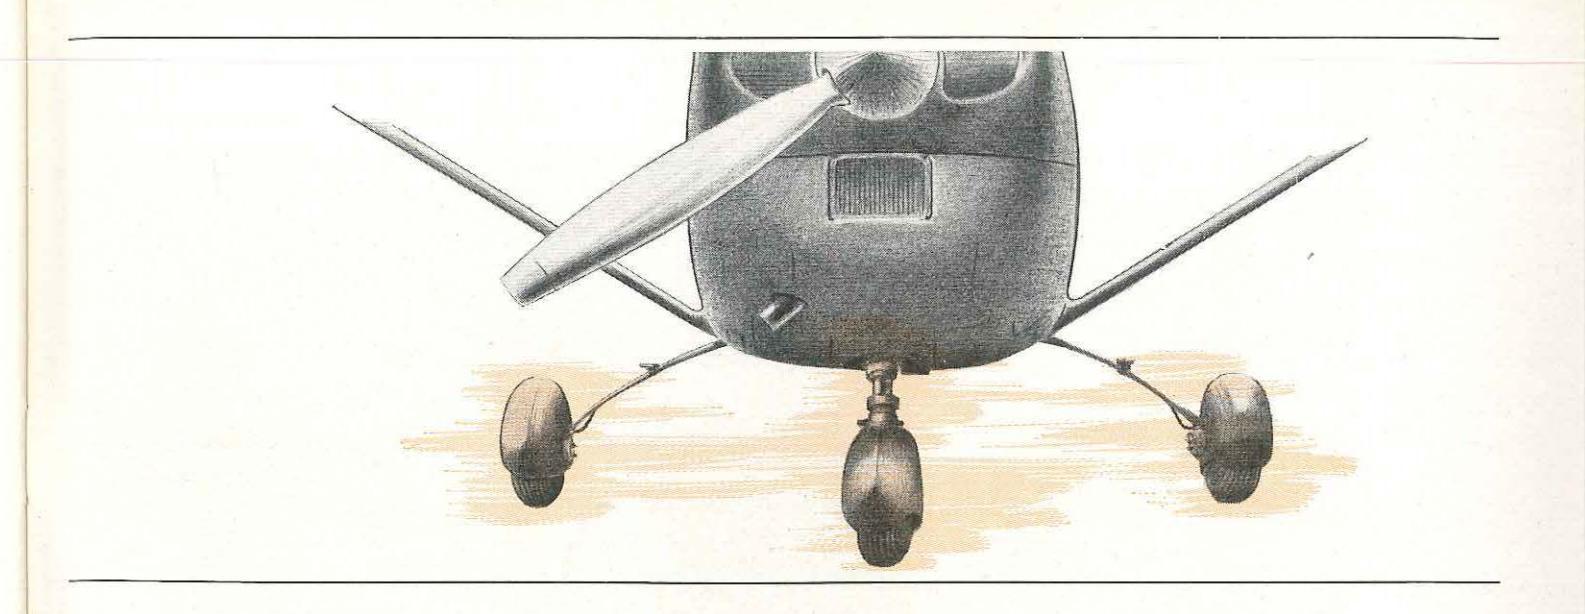
1. Damage to aircraft may not be in evidence at all until engine cowlings have been removed and structure in vicinity of nose leg attachments can be inspected. 2. Tell-tale buckles in firewall bulkhead confirm the worst. Bulkhead is a major structural member of fuselage and buckling represents serious loss of strength and rigidity. Bulkhead must therefore be replaced. Areas of damage in picture are marked by black adhesive tape applied to affected parts of fuselage structure. 3. Structural damage (again represented by buckling and distortion) may also extend to lower fuselage skin and cockpit floor. 4. Full extent of damage to firewall bulkhead is visible to camera only after engine, accessories, engine mounting structure, nosewheel strut attachments and electrical wiring have been stripped from fuselage. Note severe buckling in lower centre of bulkhead where nose strut attaches. 5. Comparison with condition of replacement firewall emphasizes degree of distortion sustained in heavy landing. 6. Actual replacement of firewall involves major structural work. First damaged bulkhead is removed from fuselage by drilling out rivets. Next, damaged panels on underside of fuselage, and on cockpit floor are drilled out and new panels rivetted into place. New firewall bulkhead is then rivetted into place. Finally engine and nose leg assemblies are refitted and repair is at last complete.

There was nothing to indicate that the club aircraft had been damaged until it went in to the workshop for a 100 hourly inspection. Only then was it found that the firewall had been buckled and the adjacent lower fuselage skin had been distorted. Immediately, the maintenance engineers who discovered the damage checked the maintenance release, but there was no mention of any occurrence that could explain the damage. Next they checked with the operations staff but they also had no knowledge of the damage or of how it might have been caused. All the pilots who had flown the aircraft since its previous major inspection were then interviewed.

Very often, although the damage incurred in a heavy landing, may appear quite slight, it is very serious indeed, and major repairs are necessary before the aircraft is safe to fly again. The sequence

It should be obvious from these photographs that the consequences of not reporting a heavy landing could be quite catastrophic if an aircraft continues to be flown in such a seriously damaged condition. There have been a number of cases where, after a seemingly normal landing, an aircraft's nose strut has collapsed, causing further major damage to the aircraft. In other cases, heavy landings in some types of aircraft have led to control problems in the air. One example of this was graphically illustrated by the accident described in the article "And All Because of a Heavy Landing" in Digest No. 60, January 1969, in which the aircraft became a total loss.

For your own protection as well as for that of your fellow pilots, it is vital that you report a heavy landing. The next pilot flying a damaged aircraft could well be you!
