No. 71 NOVEMBER, 1970 DEPARTMENT OF CIVIL AVIATION, AUSTRALIA

Boeing over-runs runway when take-off discontinued

Soon after departing from Gurney in eastern Papua, on a charter flight to Esa'ala on Normanby Island, a Piper Aztec failed to out-climb a saddle in a mountain ridge that lay across its path and crashed on the mountain slopes in dense jungle. The pilot and the eight passengers on board were killed and the aircraft was destroyed.

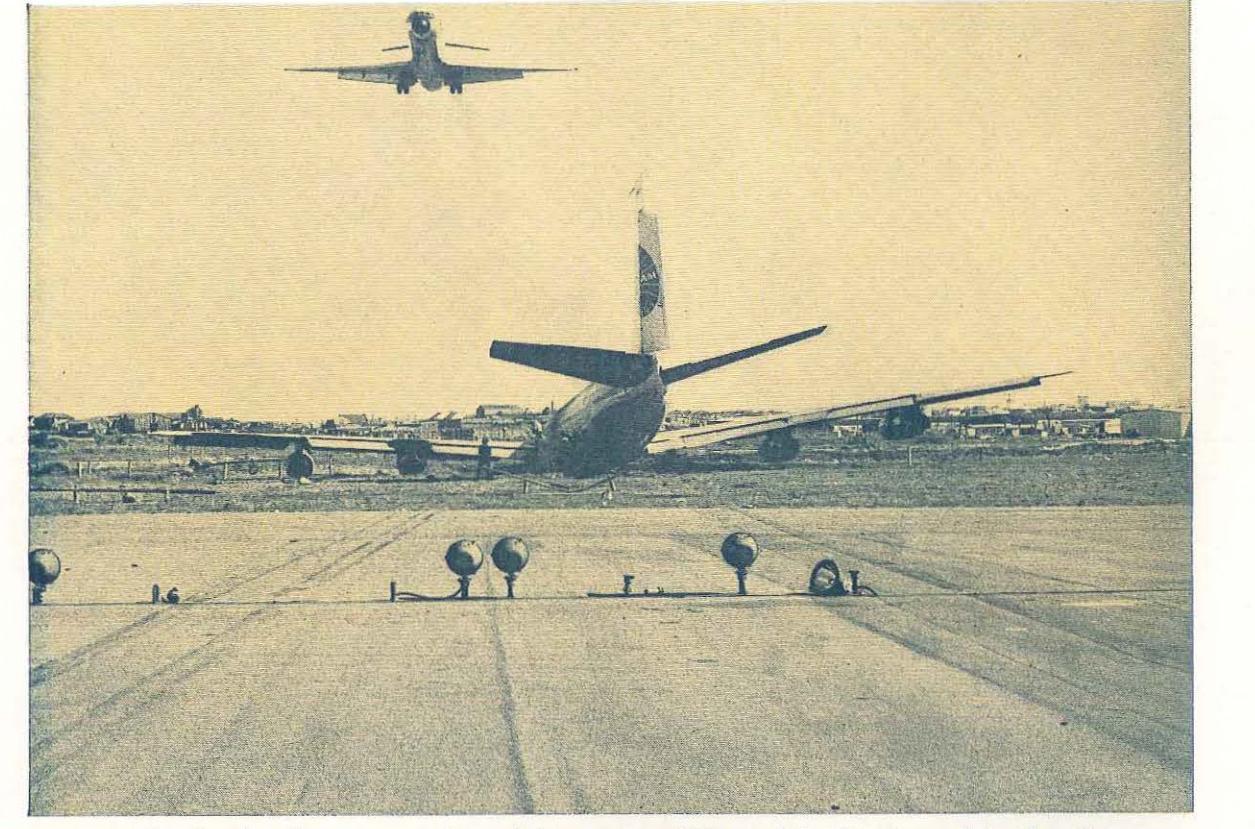
The aircraft as it came to rest beyond the over-run of Runway 34. The damaged first bar of the precision approach lighting installation is in the foreground.

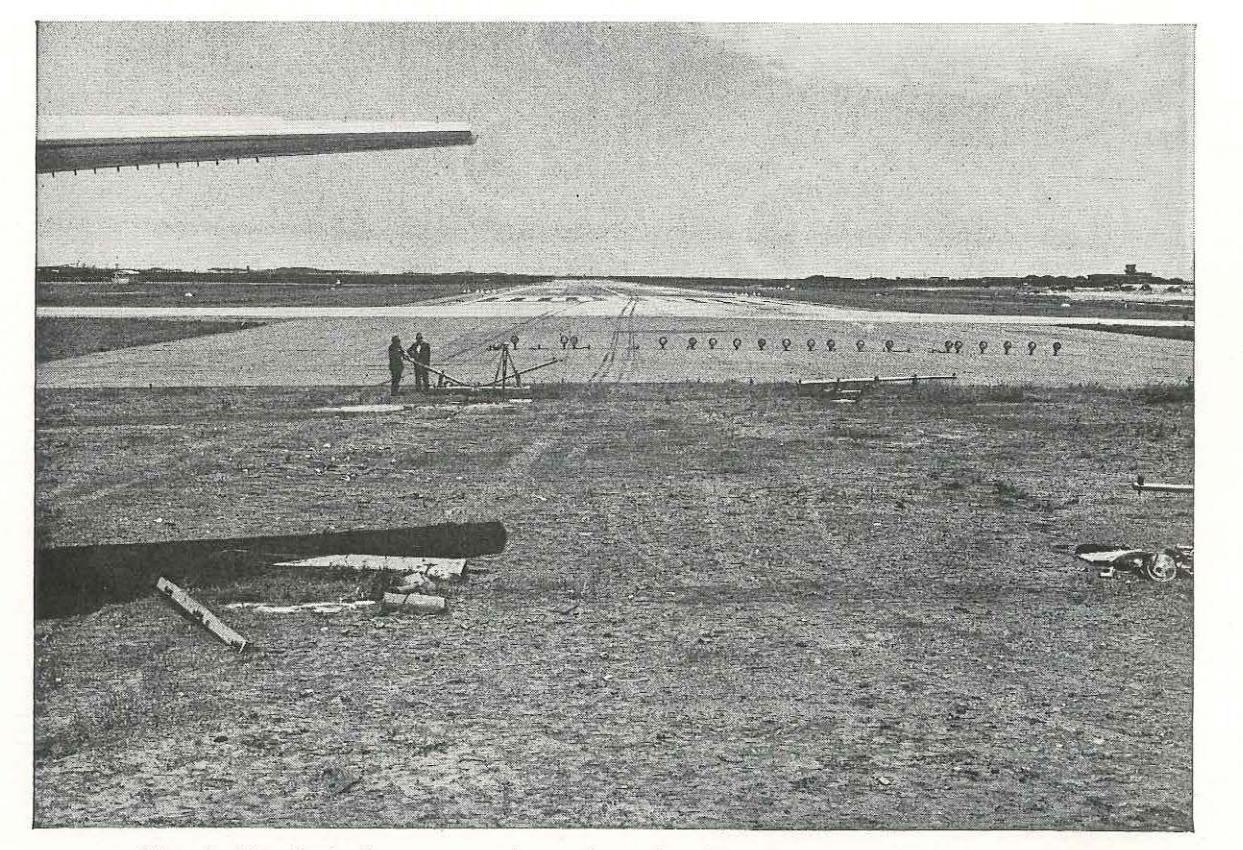
View looking back along runway from where aircraft came to rest, showing tyre marks indicative of heavy braking.

It was not possible to determine precisely when the wheel brakes were applied, but the possibility that there was some delay in their application was supported by the fact that the wheel marks commenced 620 feet from the assumed engine failure recognition point. In the zero headwind case of the performance study this would represent a delay of about two seconds. The certification transit delay times established for the aircraft type provide for brake application to be made 0.39 seconds from the time of engine failure recognition. The need for immediate brake application is obviously vital in the case of an abandoned take-off, but the technique of applying brakes as a first step, even before the throttles are cut, is one which is contrary to normal practice. In a landing roll, which is of course the deceleration phase most usually experienced by pilots, the normal technique is to close the throttles, actuate the speed brakes and then, when reverse thrust has been selected, to apply the wheel brakes. Whether or not a pilot, in the split second decision of an abandoned takeoff, can be expected to make the conscious effort to

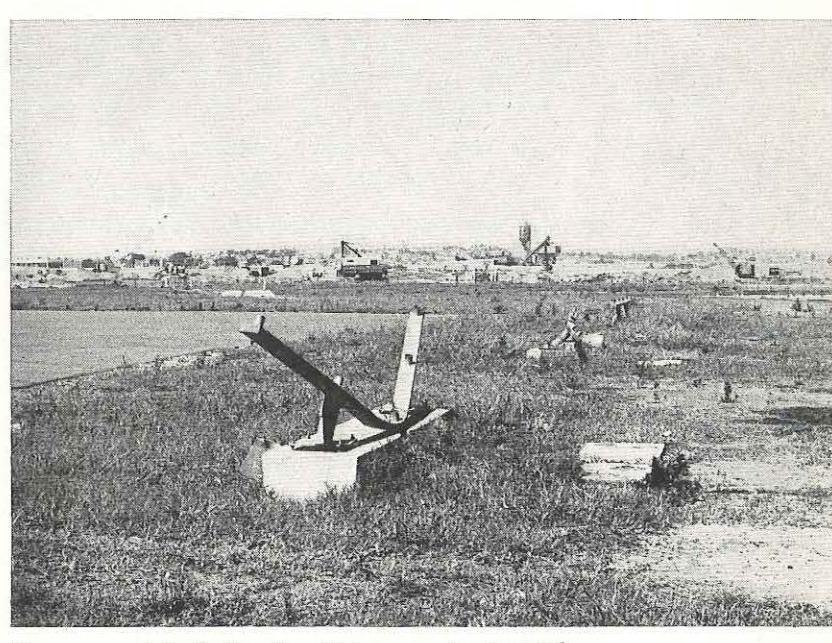
Damage sustained by the first row of approach lighting bar-ettes, which the aircraft struck after overrunning the end of the low strength pavement on the left of the picture.

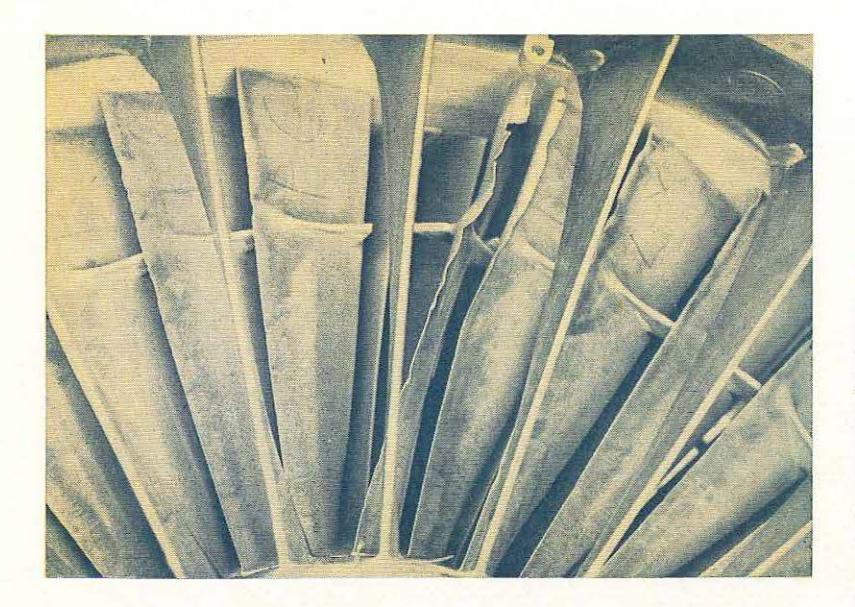
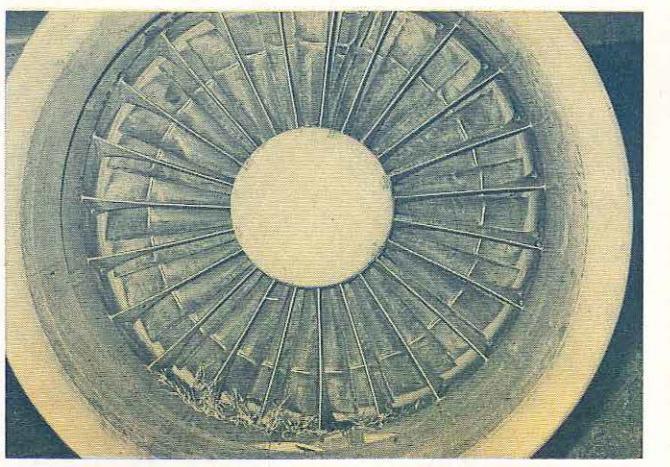
Staining and bird remains on the inside of the intake cowl, the fan dome, and the inlet guide vanes indicated that at least one bird had entered the No. 2 engine intake, and one blade in the first stage of the compressor had been severely deformed. The ingestion of one or more birds and the observed damage to the No. 2 engine compressor blade would probably have been sufficient to cause engine surge and the observed fluctuation in power.

Left and Below: Blade damage sustained by the fan stage of the No. 2 engine.

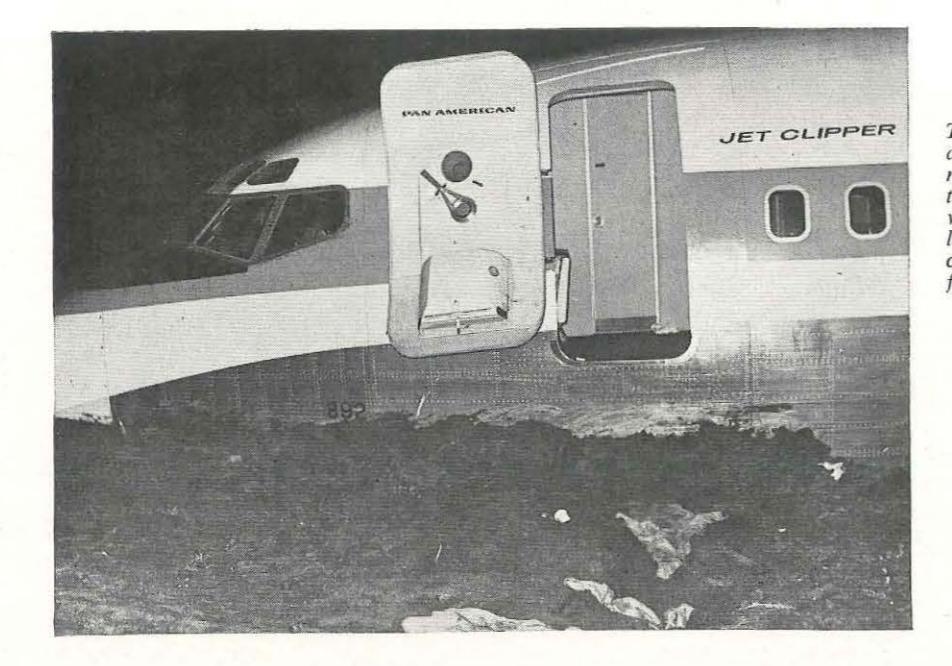
The nose of the aircraft as it came to rest in the muddy ground. The fact that the main cabin door was close to ground level facilitated the evacuation of the passengers from the aircraft.

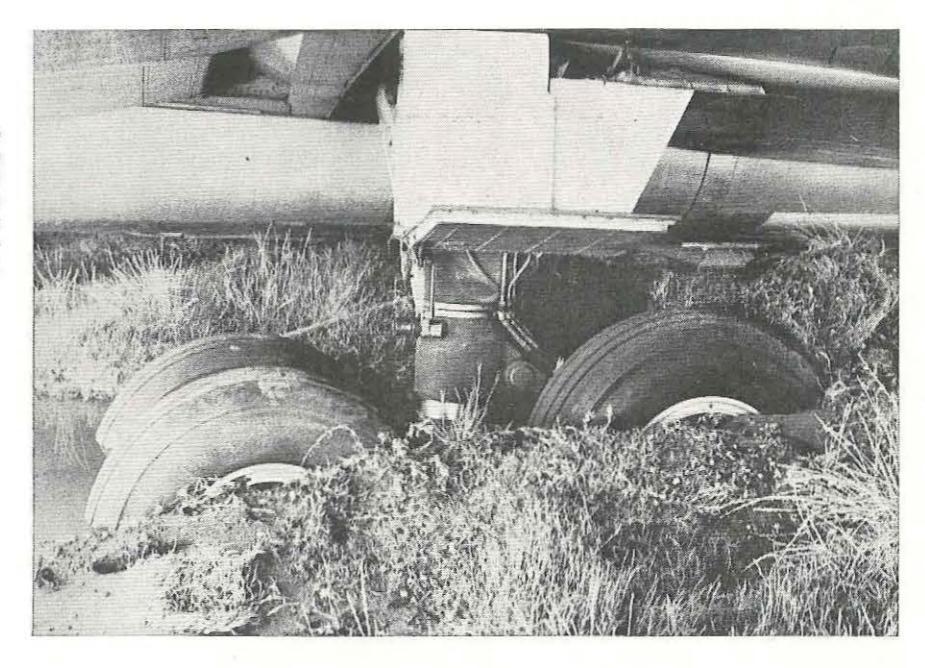
The softness of the ground in which the aircraft came to rest is clearly evident from this photograph of the bogged starboard undercarriage.

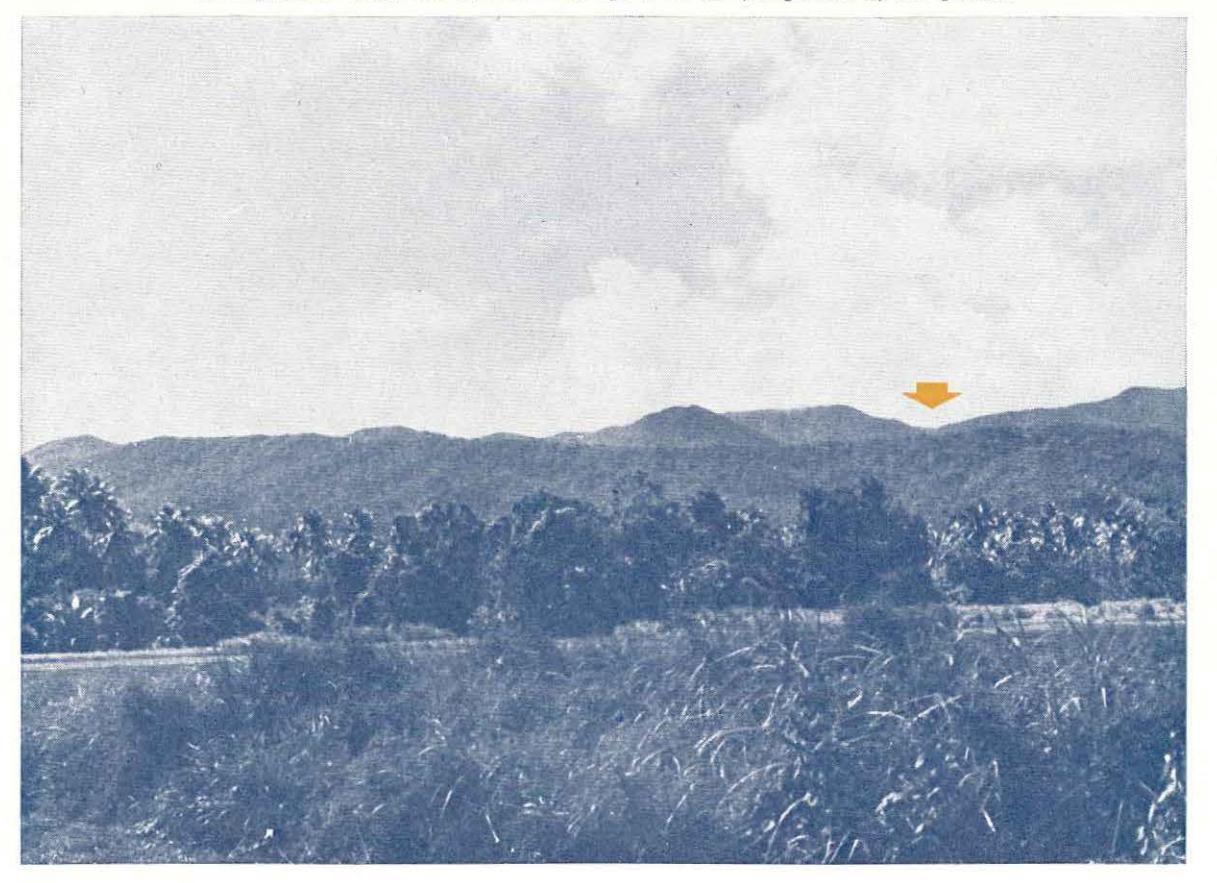
The saddle in the mountain ridge through which the pilot was attempting to climb. Gurney airstrip, from which the aircraft took off, is in the foreground of the picture.

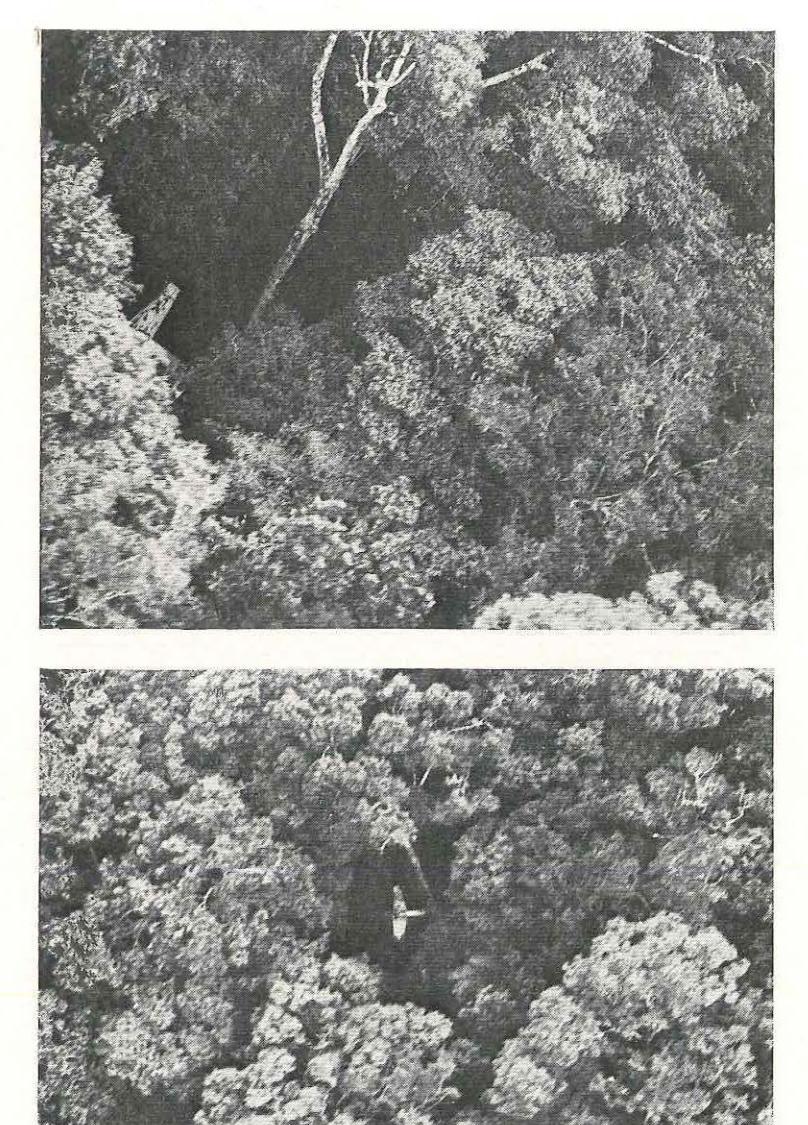
The wreckage on the heavily timbered mountainside,

as it was first sighted from the air, ten days after the aircraft had disappeared.

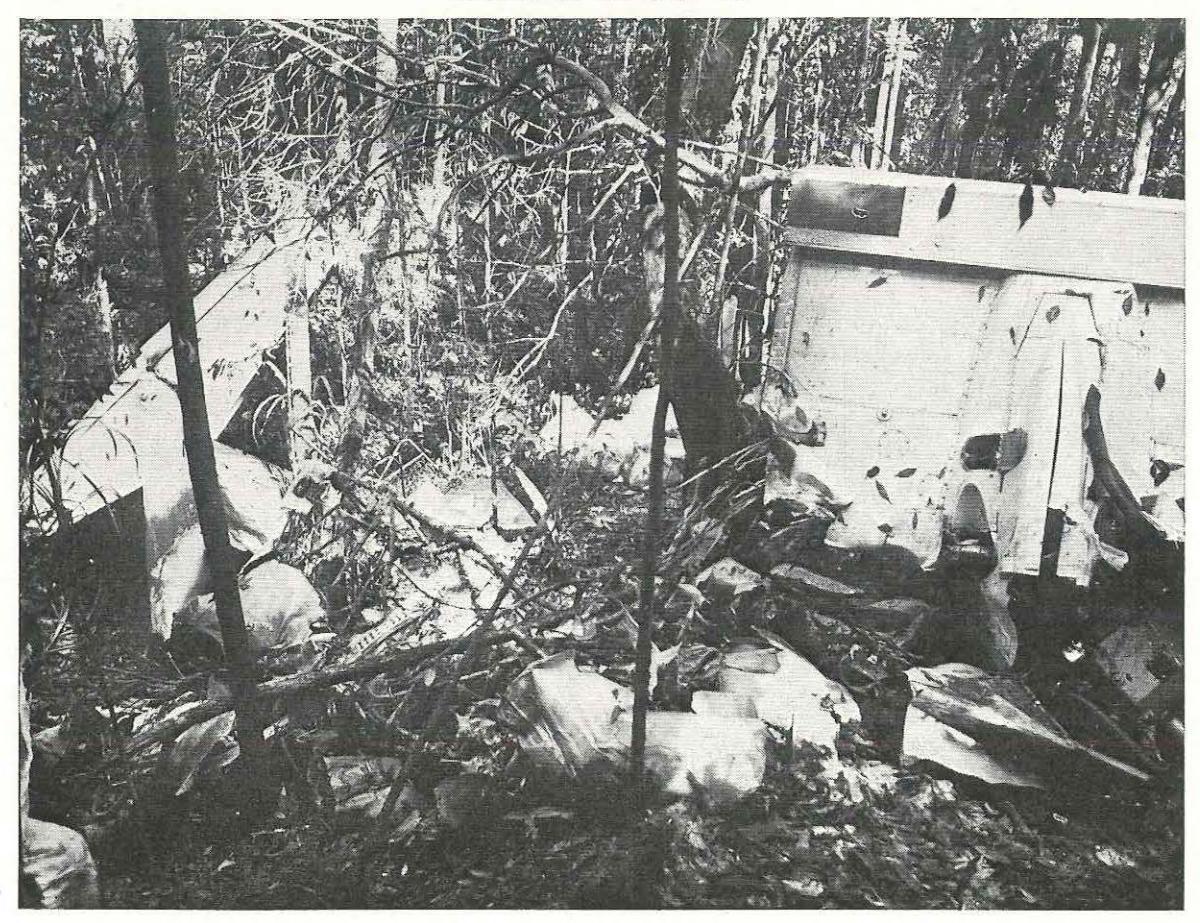
> The burnt-out wreckage of the Aztec, as found by the investigation team. The starboard wing and engine nacelle is on the right hand side of the picture, separated from the main wreckage by the large tree.

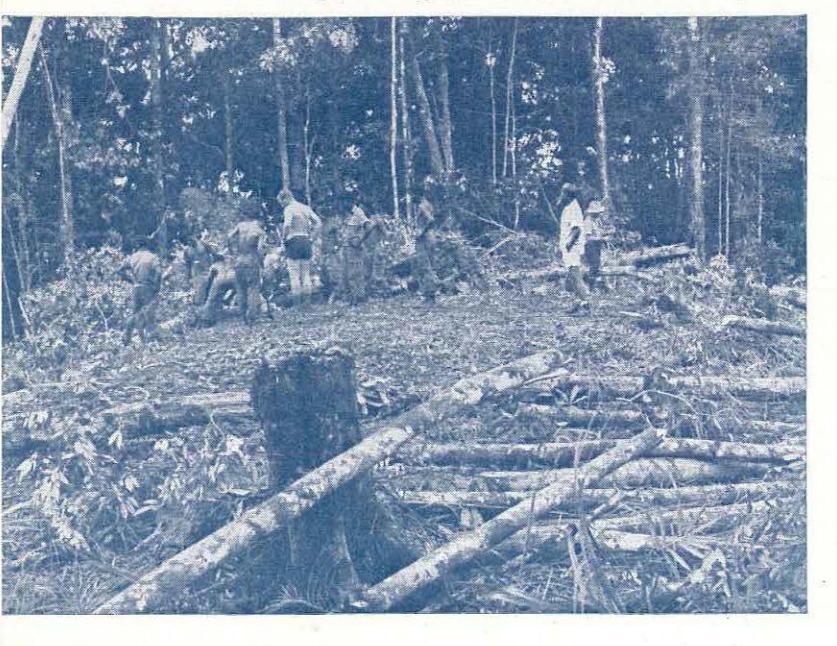
Above: View from the wreckage site, looking back in the direction of impact. The gap that the descending aircraft tore in the forest canopy, is clearly evident.

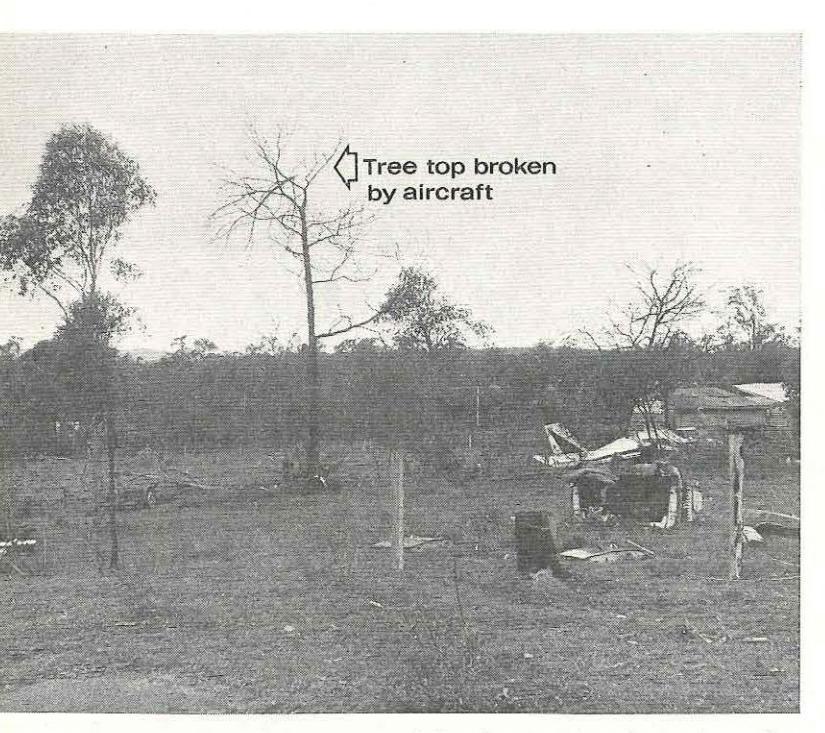
The steepness of the aircraft's final descent is evident from this picture. The top of the tree has been broken off only a short distance from where the aircraft finally came to rest.

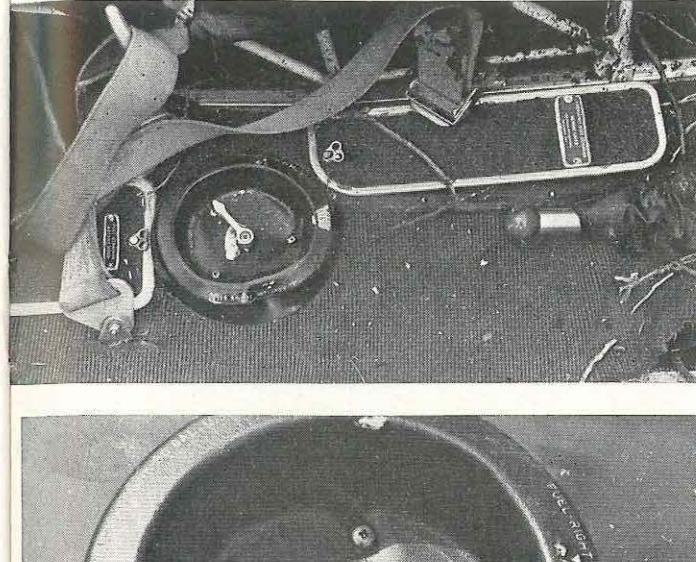
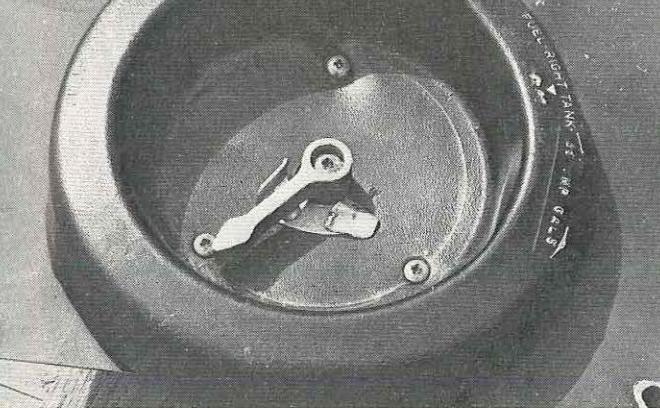
the selector seemed devoid of "feel" and he had gained the impression that the selector movement was not effective. He was "feeling for a notch" in the fuel selector movement but could not find one. Examination of the fuel selector cock however, showed that the selector movement from one position to the next was very smooth and that a very positive indication was felt when it reached either detent position. But to move the selector from the starboard tank position to the position in which it was found after the accident, it was necessary to force it over the bent aluminium tab. This required a significantly greater effort than was required to move the selector from the "OFF" position to either one of the "ON" positions.

The position in which the fuel selector was found after the accident. The enlarged picture shows one tab of the aluminium stop plate bent flat, as though the selector lever had been forced over it from the starboard side.

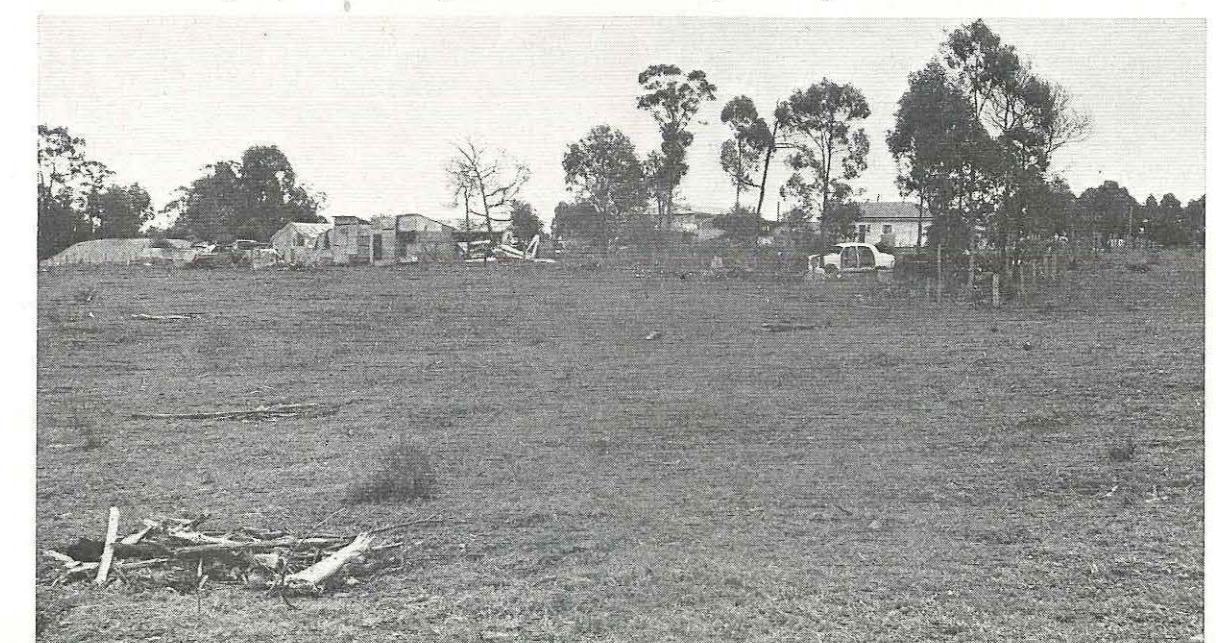
The relationship of the impact point to the shape of the field in which the accident occurred is evident from this picture. A gentle turn either to the right or the left during the final stages of the descent might have resulted in consequences a good deal less severe.

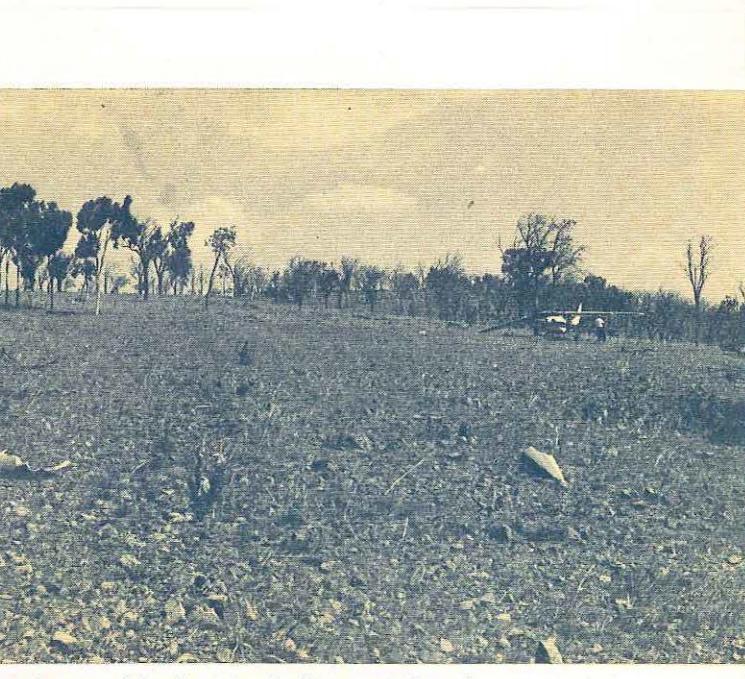
Above: The forced landing site, looking up-hill in the direction of touch-down. The aircraft has pivoted to the right about the tree and come to rest facing in the opposite direction. Note the rock-strewn surface and the broken wheel spat

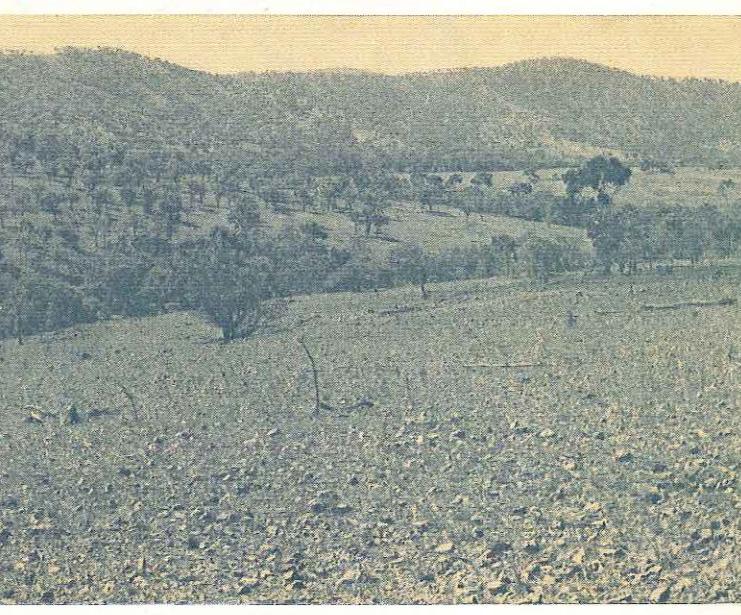
Below: This picture, looking down-hill, and back in the direction from which the forced landing approach was made, conveys some idea of the unenviable situation in which the pilot was placed when his engine lost power at comparatively low altitude.

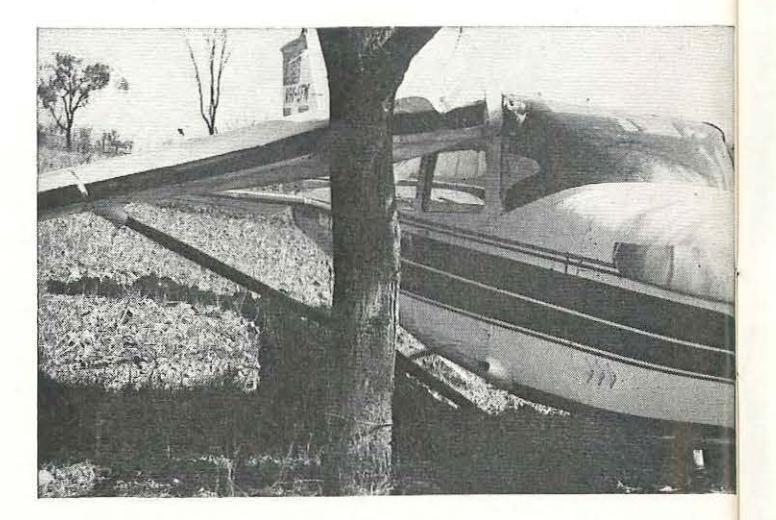
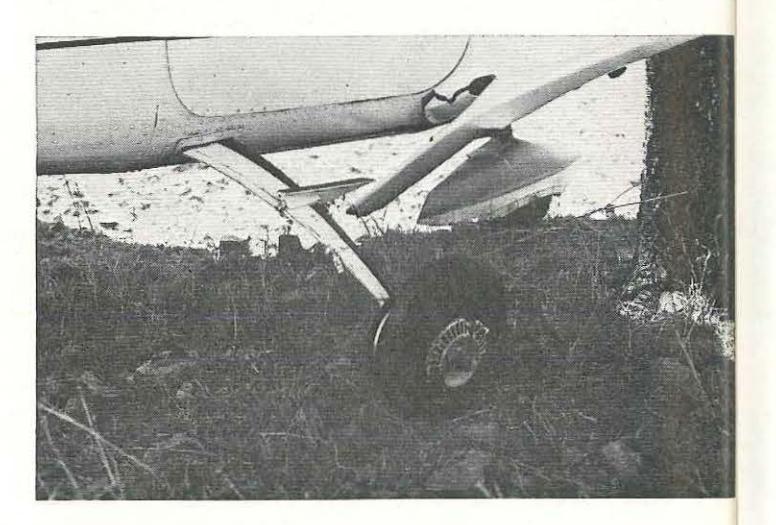
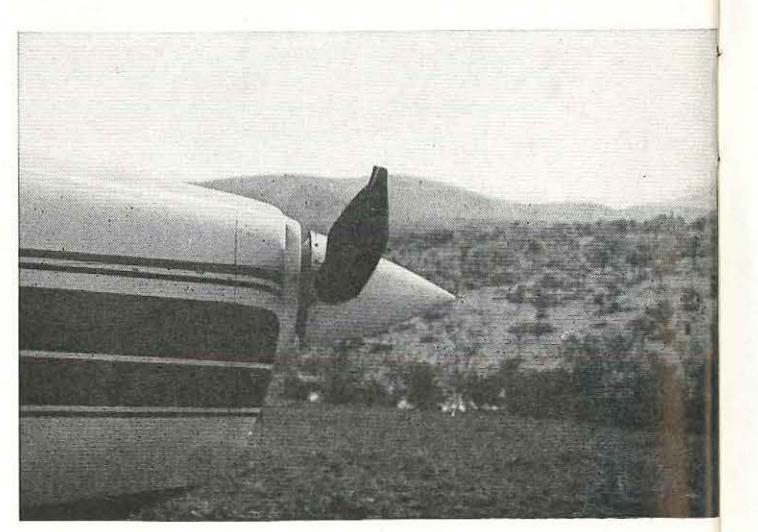
Right: These three photographs show the comparatively small extent of the damage sustained by the aircraft in the circumstances. Had a brake line not been fractured by a stone during the landing roll, there is every possibility that the forced landing would have been far more successful.

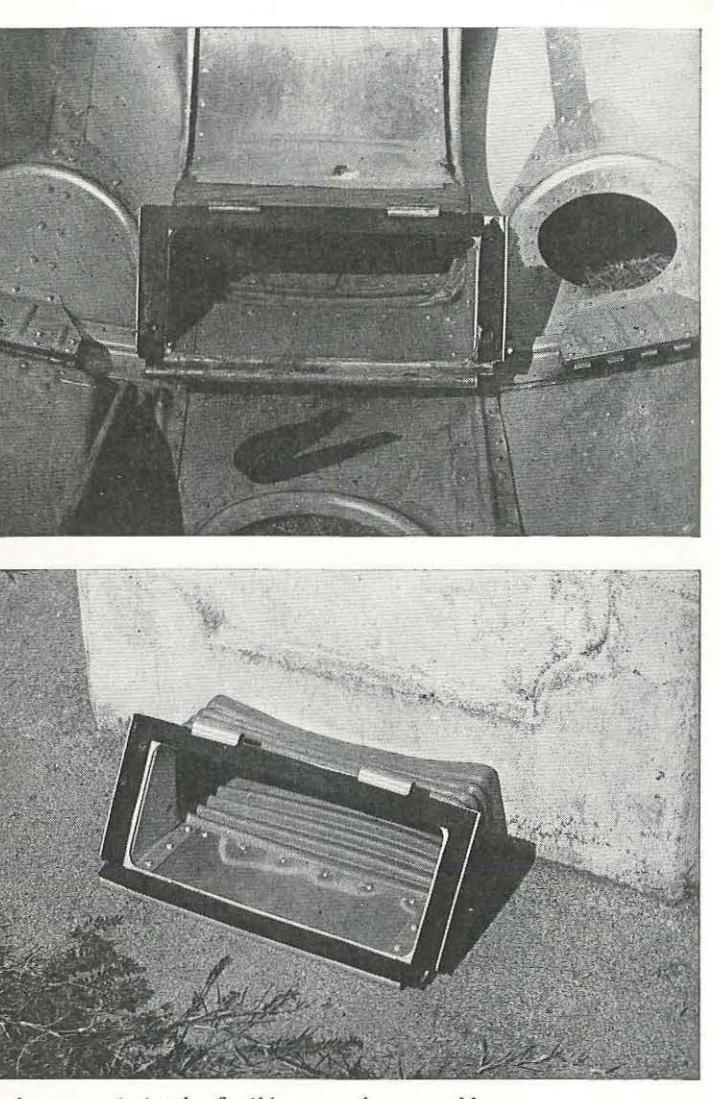
The carburettor air intake flexible expander assembly, in the lower engine cowling. The rubber strip which formed the lower section of the gasket on the rear face of the duct was detached and drawn into the carburettor throat. The lower picture shows a new fitting with a complete gasket. punctured the starboard tyre, depriving him of

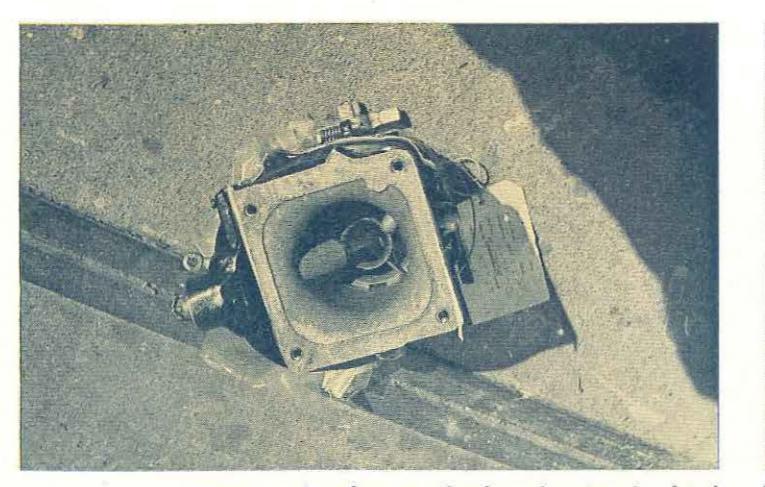
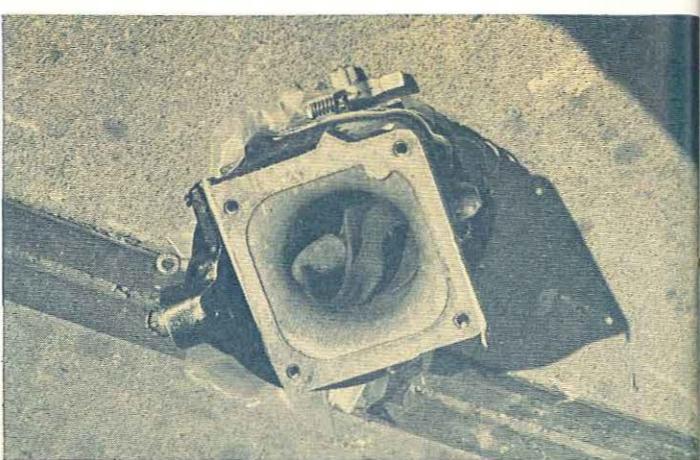
The type of carburettor fitted to the aircraft, showing the way in which the rubber strip probably lodged in the throat, upsetting the fuel-air ratio and causing a complete loss of power at cruising settings.
