DEPARTMENT OF CIVIL AVIATION AUSTRALIA

Number 73 March, 1971

## Forty Years Experience what has it taught us?

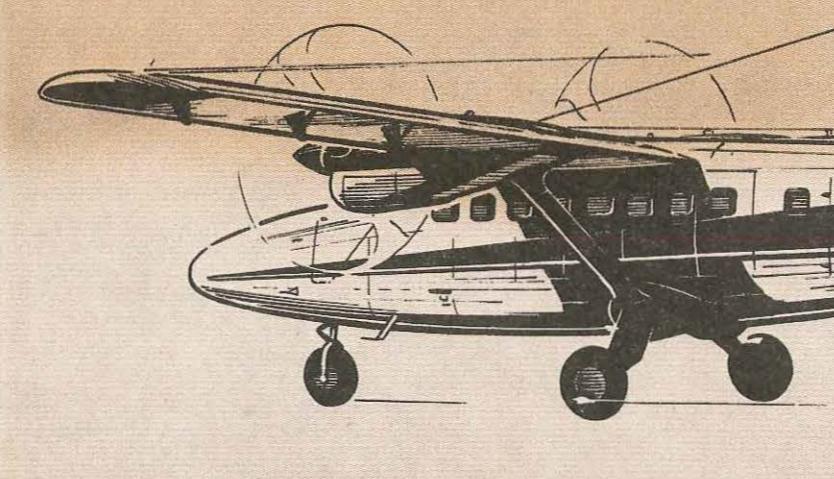
The initial impact had been against the main trunk of a large tree, which caused massive damage to the nose structure of the aircraft. The aircraft had then collided with other trees further up the eastern face of the ridge which had sheared off the outer starboard wing, the port wing tip and outer portions of the starboard tailplane and elevator. On the wings, the impact marks of the trees were predominantly against the lower sections of the leading edge indicating that the aircraft's attitude had been about 10 degrees nose-up when it flew into the trees. At the moment of impact with the ground, the aircraft was descending at an angle of about 30 degrees and banked 45 degrees to starboard. The damage sustained by the aircraft was consistent with the tree and ground impacts and there was no evidence of any defect having existed before the accident. A detailed examination indicated that both engines were operating at high power at the time of the collision with the trees, and established that no fault had existed in either the engines or the propellers before the crash occurred. It was also evident that at the time of the accident, the aircraft's gross weight and centre of gravity were within permissible limits.

The main wreckage as it came to rest, looking approximately in the direction of impact. Extensive damage to the starboard side of the fuselage caused by the collapse of the starboard undercarriage when the aircraft struck the ground is evident in this picture.

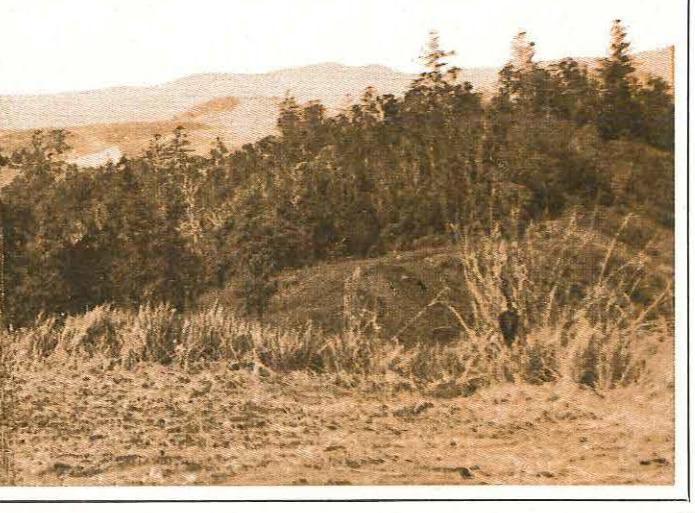
Bottom: Composite photograph of the saddle through which the aircraft attempted to pass on the latter stages of its flight from Goroka, looking towards the lower terrain in the direction of Kainantu aerodrome. The accident site is just out of view behind the marker post at left.

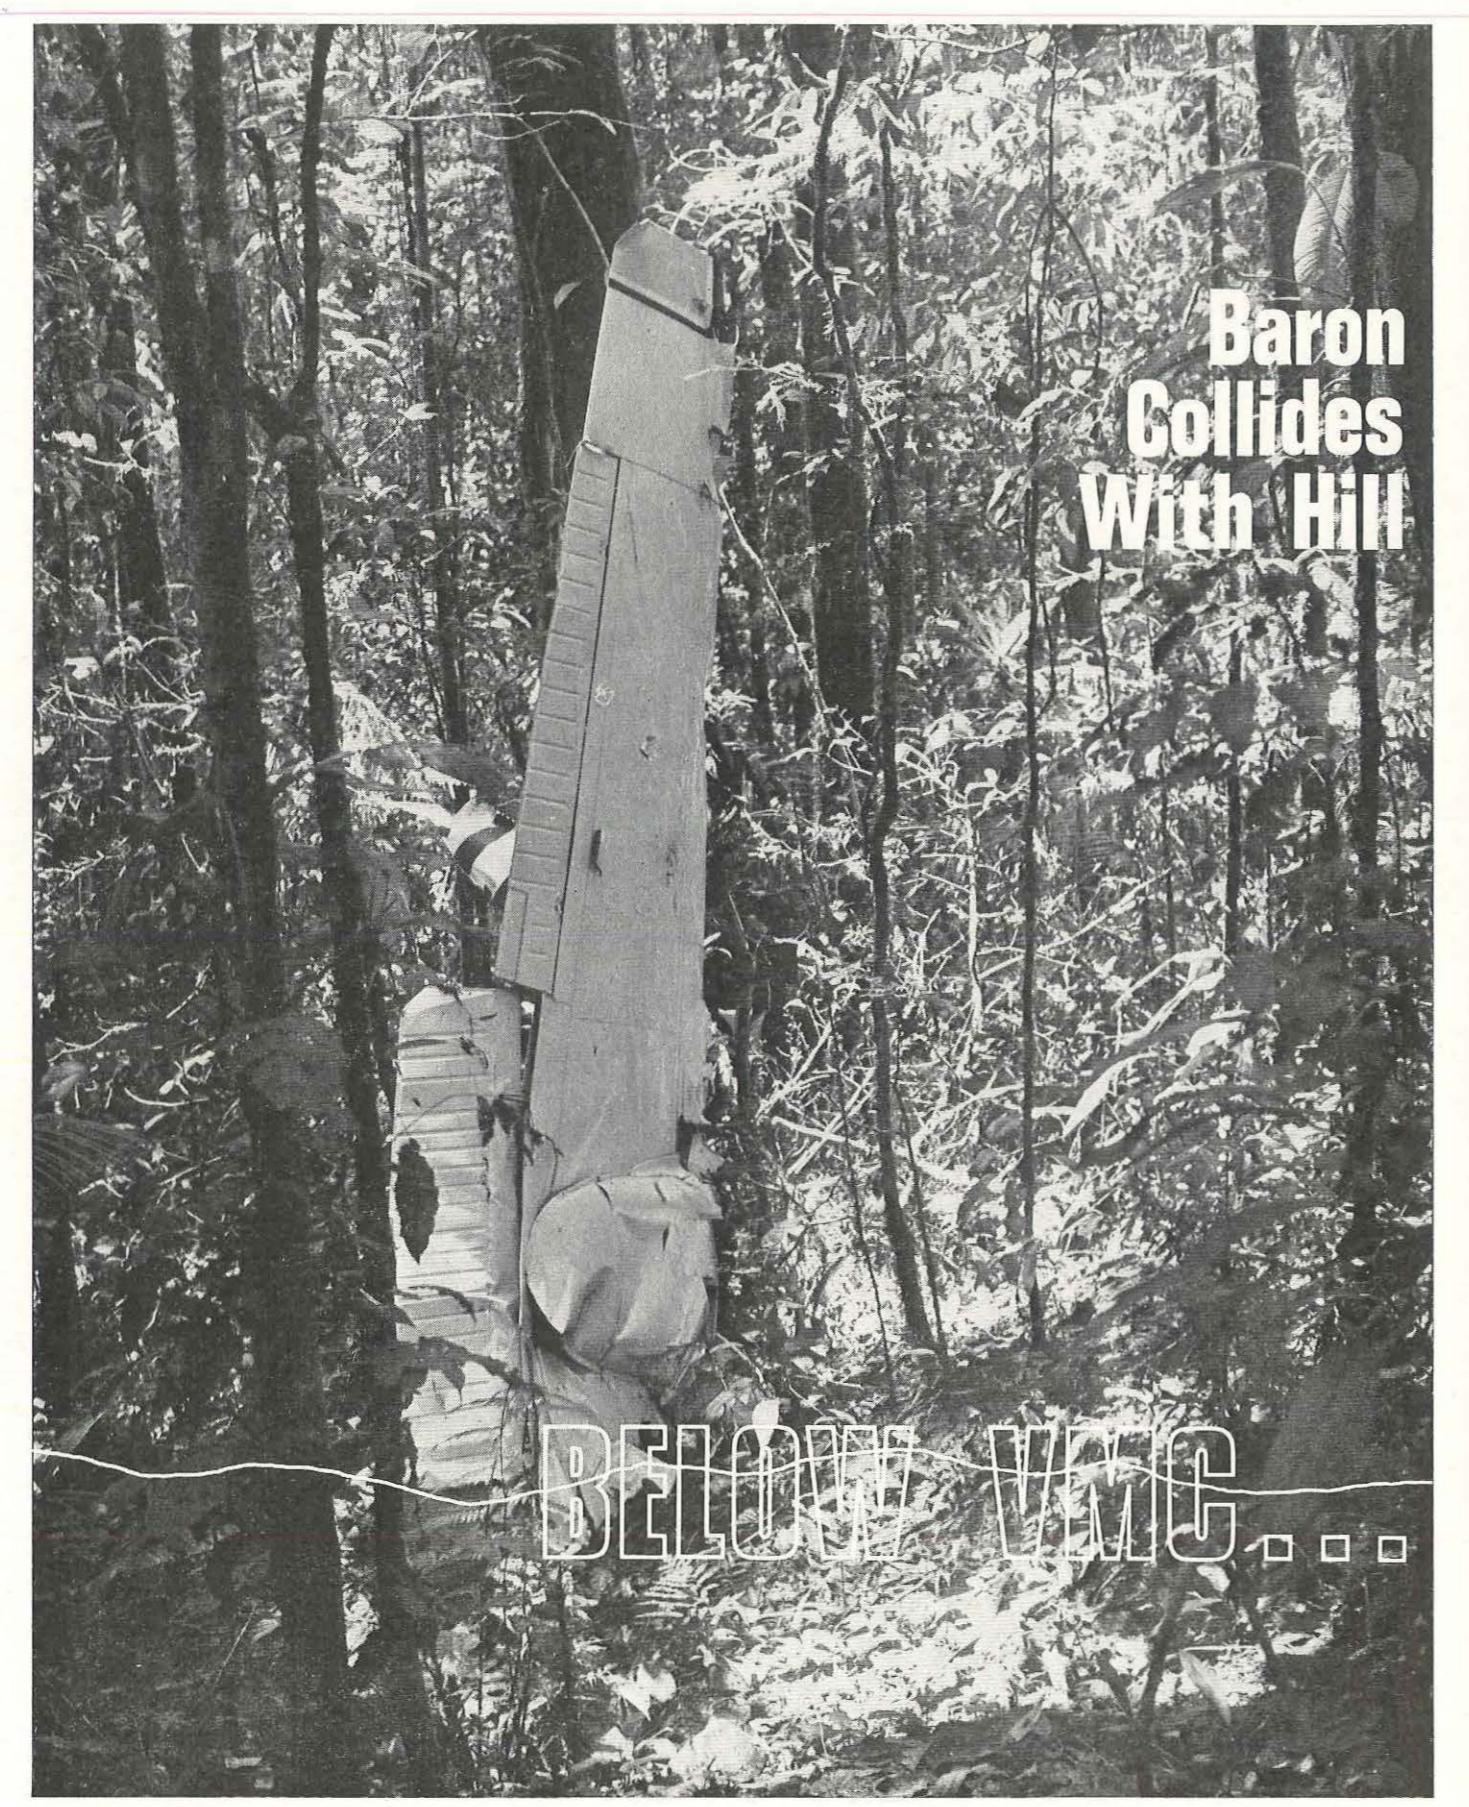
Opposite page: The port wing and engine nacelle structure of the Baron as found at the accident site. These components came to rest some 60 feet beyond the aircraft's nose section, in the direction of impact.

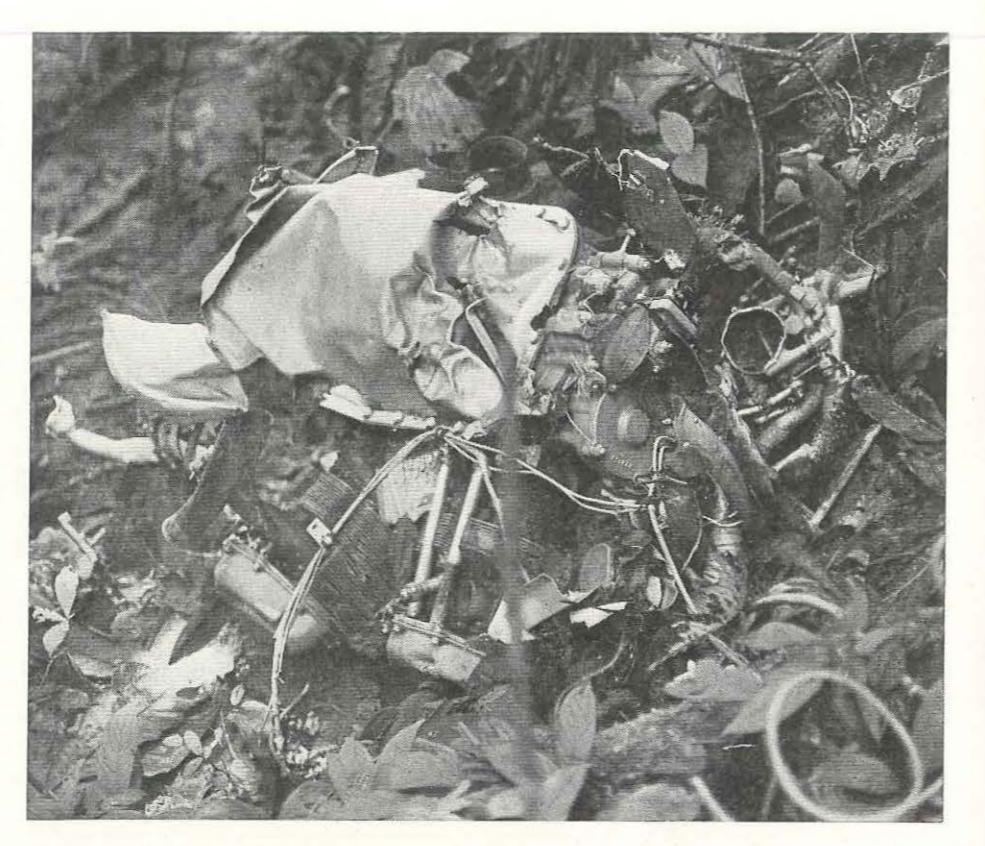
The severely damaged port engine as it came to rest some 90 feet forward of the fuselage nose section. The two front cylinders, the associated crankcase area and the crankshaft were completely broken away by the force of impact.

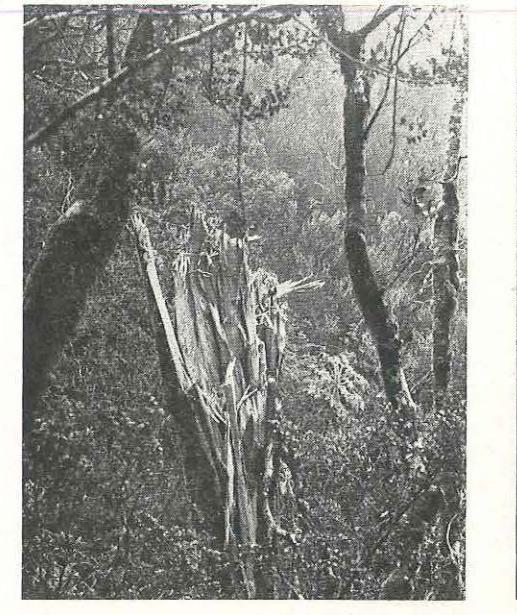
Left: One of the two large trees severed by the aircraft immediately before it struck the face of the ridge. The trunk of this tree was 22 inches in diameter.

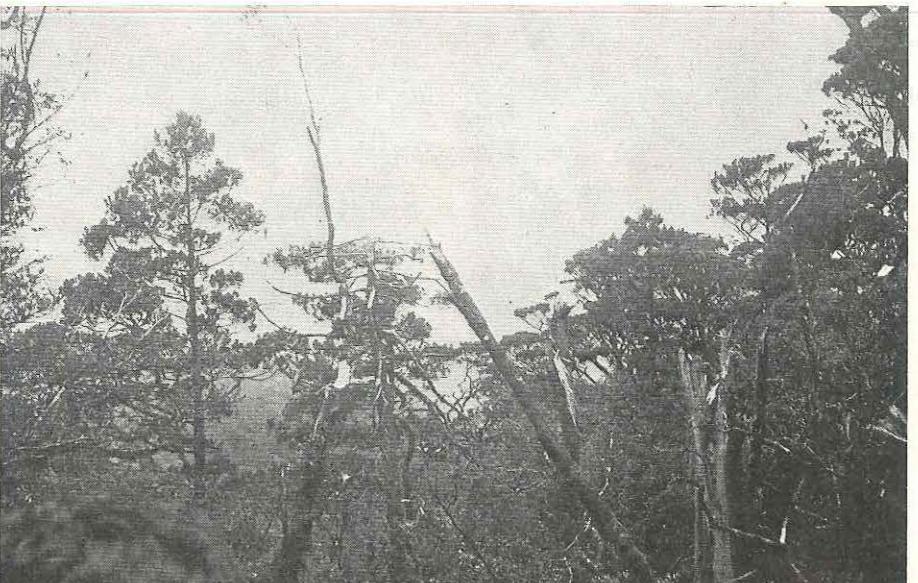
Right: View looking back along the impact path, showing the swathe cut by the aircraft in the jungle growth.

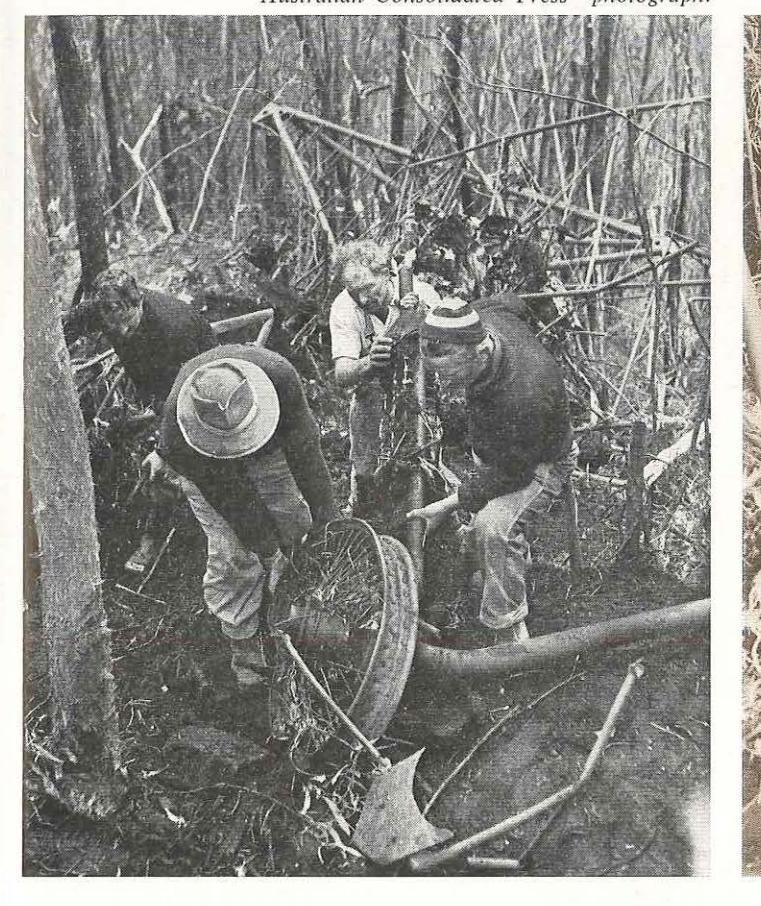
Left: Workmen digging out the starboard undercarriage. The fuselage frame can be seen in the background. -"'Australian Consolidated Press" photograph

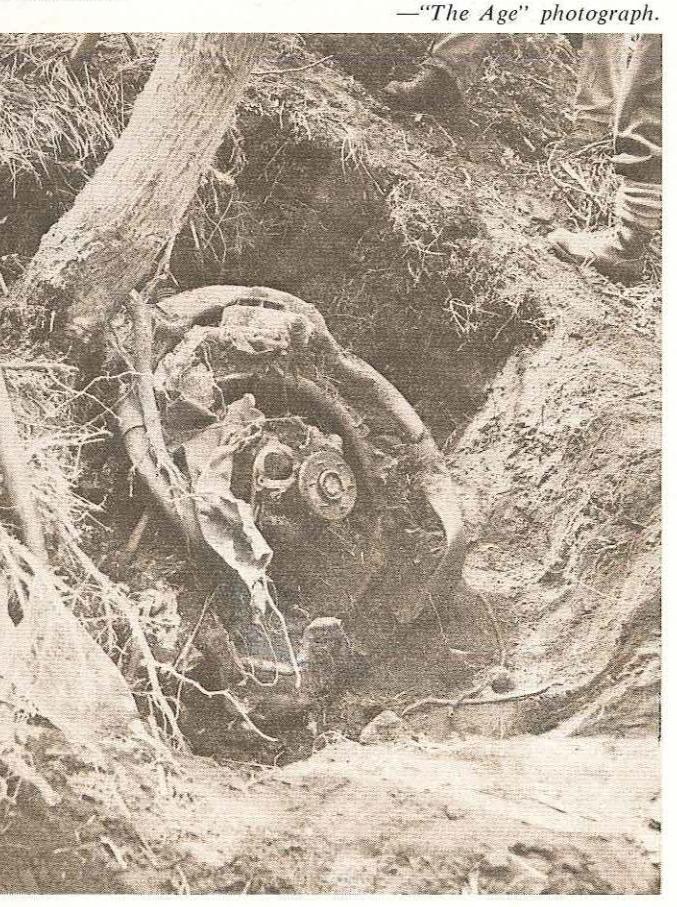
Right: The port engine excavated from the hillside in which it was embedded.

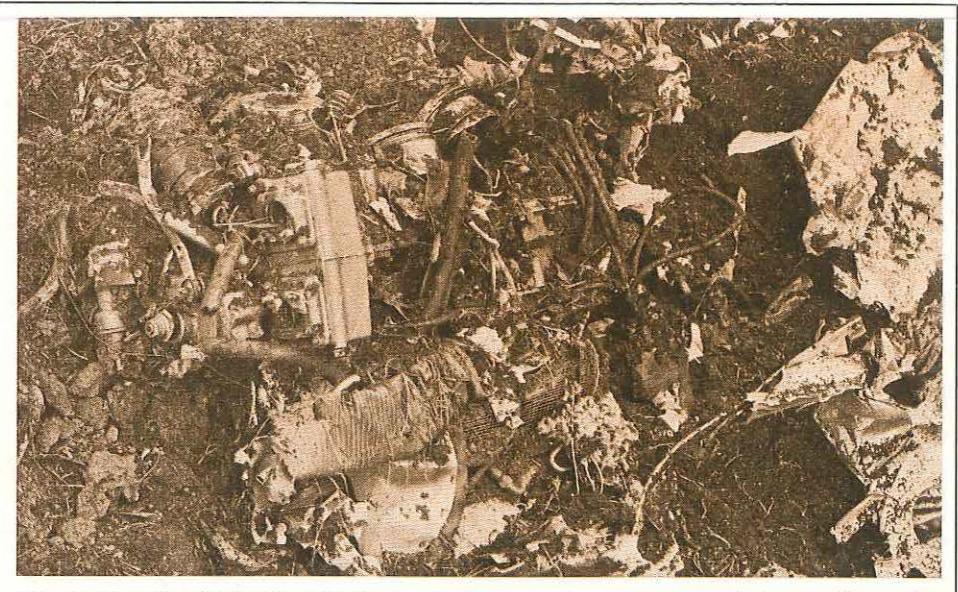
The force with which the aircraft struck the ground was so great that even the engine structure was fragmented. The rear of the engine is to the left of the picture.

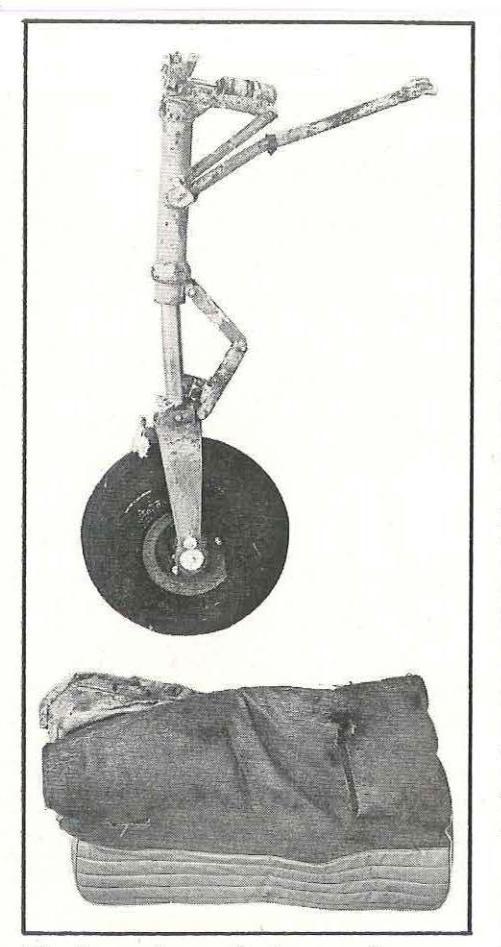
The damaged nose-wheel strut and rear seat squab from the Tri-Pacer found in the sea near Cape King on Umboi Island, were the only parts of the aircraft recovered.
