Number 74 May, 1971

DEPARTMENT OF CIVIL AVIATION AUSTRALIA

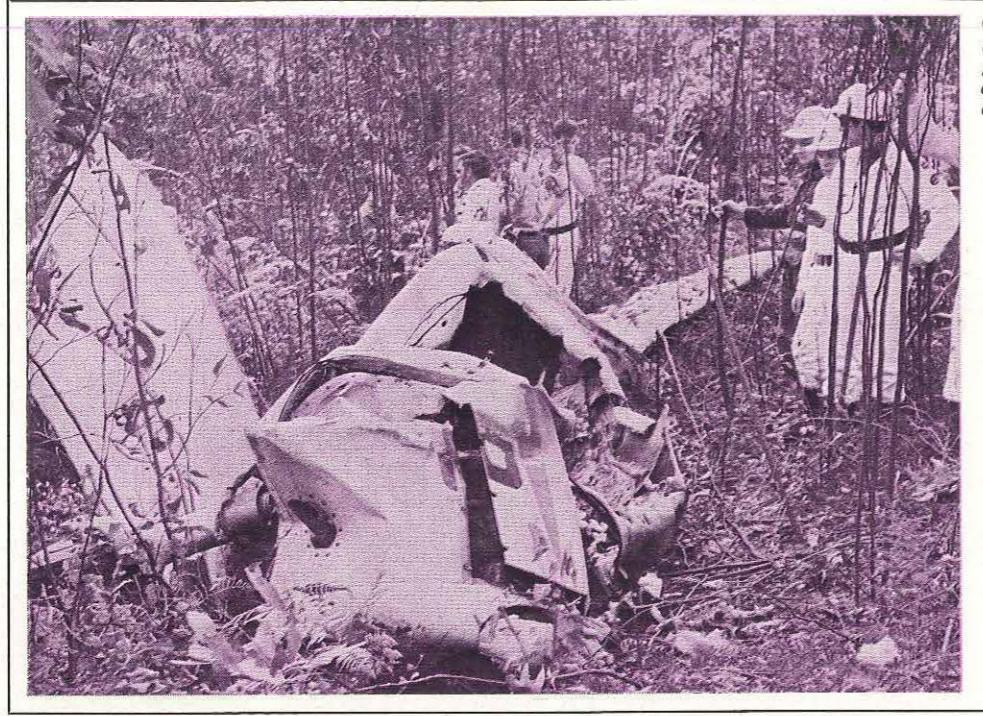
General view of the accident site, showing the main wreckage as it was found by the ground search party. The surrounding undisturbed vegetation indicates that the aircraft struck the ground at a steep angle.

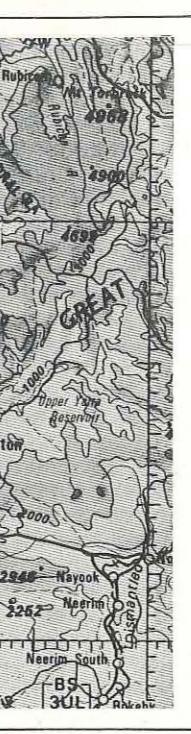
Map showing accident site and approximate position of advancing front at about the time the instructor made his first radio call to the Musketeer. The aircraft became trapped between the front and the high terrain to the north-east.

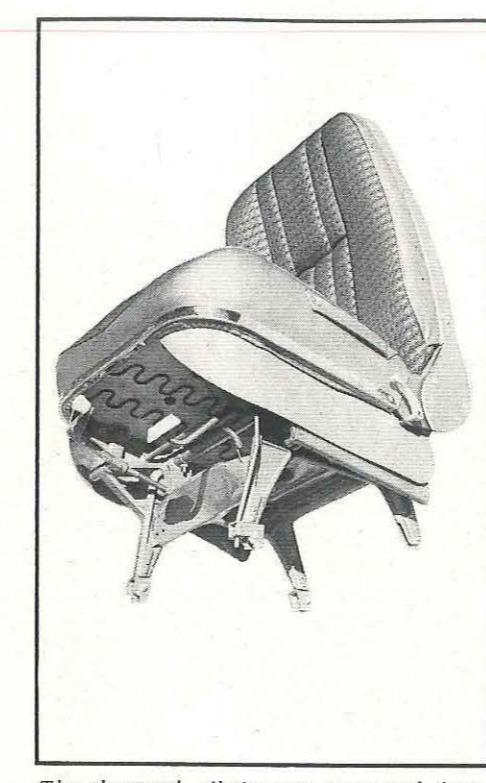
The damage sustained by the pilot's seat and other components found floating near the site of the crash was no more than typical of what could be expected in an accident of this type and gave no hint of any situation which could have caused the aircraft to fly into the water. The possibility of an engine malfunction was considered but could not reasonably be related to the circumstances of the accident. The aircraft had adequate fuel on board for the return flight to Sydney. atmospheric conditions at the time were not conducive to the formation of carburettor ice, and the witness evidence concerning the sound of the engine and the final flight path contained nothing to suggest that the engine was incapable of normal operation. In any case, even if an engine malfunction had occurred during the descent, a change in heading, either to the right or the left could have quickly positioned the aircraft closer to the shore. As it was, the aircraft descended towards the widest expanse of the lake on a long straight approach from a height of some 800 feet and over a distance of almost two miles. The witnesses described this descent as very similar to an approach to land on a runway.

The damaged pilot's seat recovered from the surface of the lake after the aircraft had sunk.

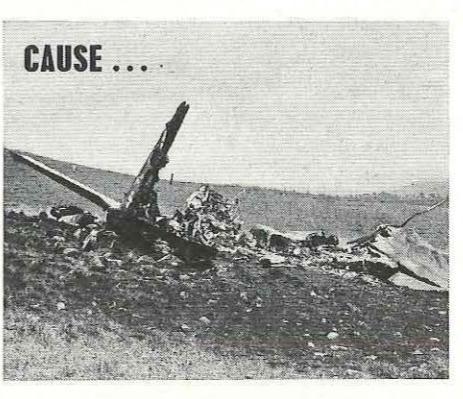
From an examination of the burnt-out wreckage and the nearby impact marks on the ground, it was evident that the aircraft had struck the ground with considerable forward speed in a nosedown attitude while banked to starboard. Impact forces had torn the propeller from the engine and one blade had been thrown 250 feet. The propeller hub, with the other blade still attached, was found buried in superphosphate amongst the main wreckage. It was evident from the damage sustained by the propeller that it had been rotating at high speed at the time of impact.

Close-up of the burnt-out wreckage of the Cessna 180. The engine and port wing are in the foreground.

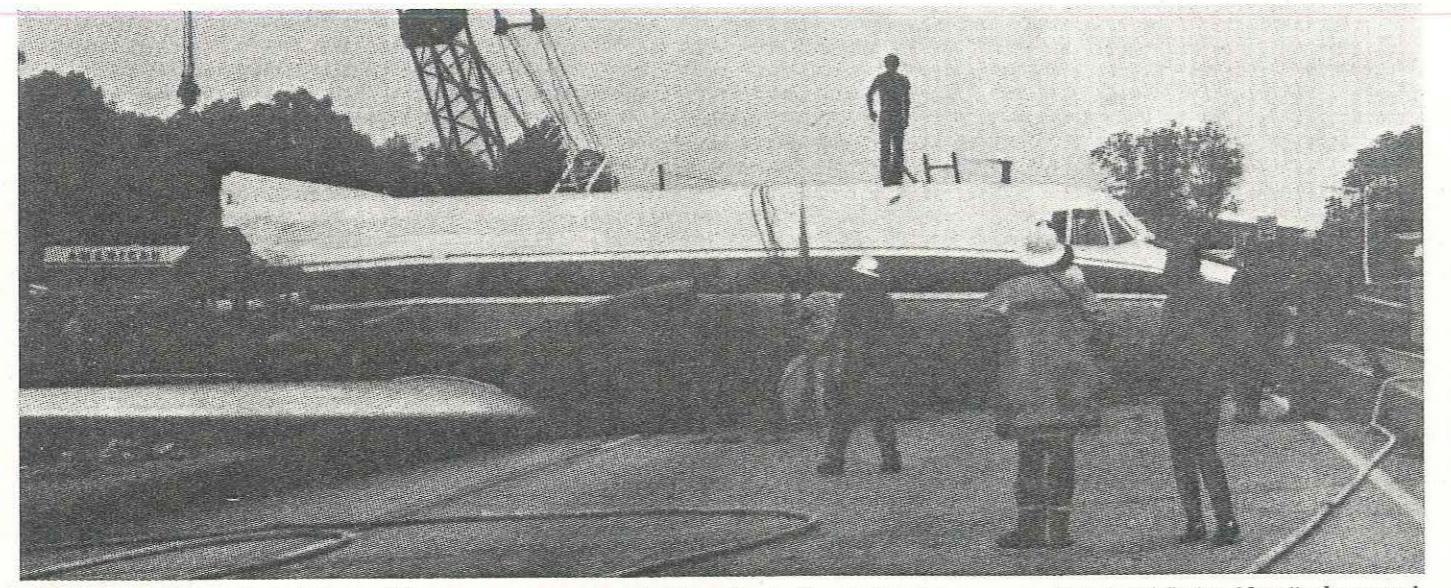
The main wreckage of the Martin 404 as it came to rest at right angles to the expressway.

The aircraft was fitted with two Pratt and Whitney R2800 CB17 engines. Examination of both engines revealed evidence of severe detonation. The pistons had been severely damaged by overheating and the spark plugs showed evidence of having been operated at temperatures above their designed operating range. Fuel samples were taken from the aircraft's fuel tanks, the fuel inlet lines to the carburettors, and the fuel strainers in the carburettors themselves and were subjected to laboratory analysis. This showed that the 100/130 octane fuel in the aircraft's tanks was contaminated by iet fuel. Further investigation then established that the aircraft had been refuelled with 200 gallons of Jet A fuel before departing for the flight. It was found that 100 gallons of jet fuel had been added to each of the aircraft's two fuel tanks when the total fuel load was brought up to 800 gallons. This was despite the fact that the aluminium cover plates fitting over the fuel tank filler caps on the upper surface of the wings were and had at one time been a helicopter each stamped "Fuel-100 Octane min. 685 US gal." The aluminium cover plates were unpainted and the markings were legible at the time the wreckage He worked for the company at weekwas examined.

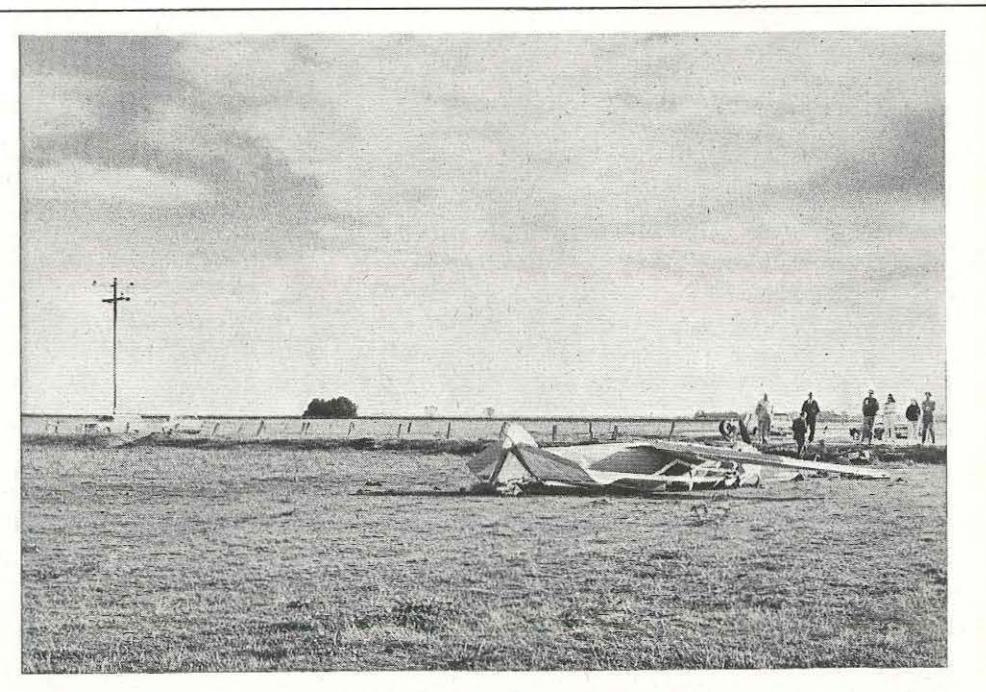
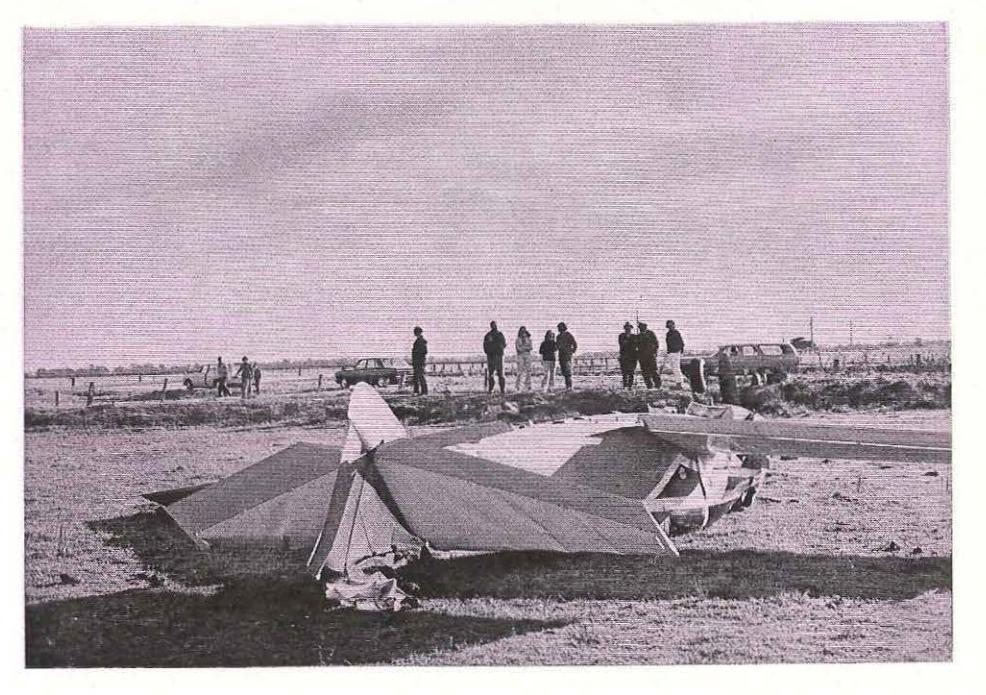
Above and below: The wreckage of the Mooney lying inverted in the field, almost 200 feet short of the strip threshold. A power pole which would have been on the pilot's right as he approached to land can be seen in the top picture.
