## Number 82 November 1972 DEPARTMENT OF CIVIL AVIATION AUSTRALIA

## Contents

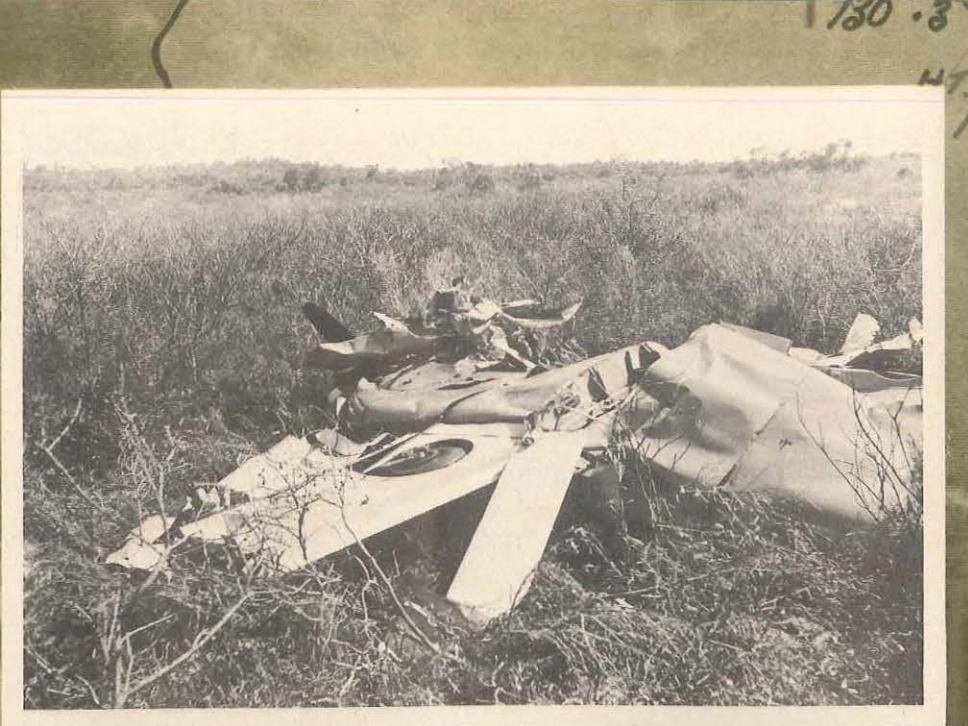
Inset: The inverted main wreckage of the Comanche, lying where it fell amongst the low scrub.

The Comanche had crashed in undeveloped, low-lying limestone country, covered with low scrub. The unburnt main wreckage, consisting of the fuselage with the engine and the stubs of both wings still attached, but minus the tail cone and empennage, was located four miles inland from the coast, which at this point almost corresponds with the direct Lancelin-Geraldton track. The main wreckage had struck the ground inverted in a flat attitude while descending almost vertically. Damage to the propeller blades and spinner indicated that the engine was running and developing some power at the time of impact.

The impact had been severe enough to break up the engine itself and some of the cylinder heads had been wrenched from their barrels. The stubs of both wings were approximately symmetrical, the failure in each case having occurred just outboard of the undercarriage wheel wells. The undercarriage itself was still in the retracted position. From the main impact site, a trail of wreckage extended some 6,000 feet in a south-easterly direction. Altogether, eighteen separate portions of the aircraft's structure were located along this wreckage trail. These comprised the outer sections of both stubs of the stabilator still attached, the fin and rudder, and various smaller portions of wreckage associated with these failures.

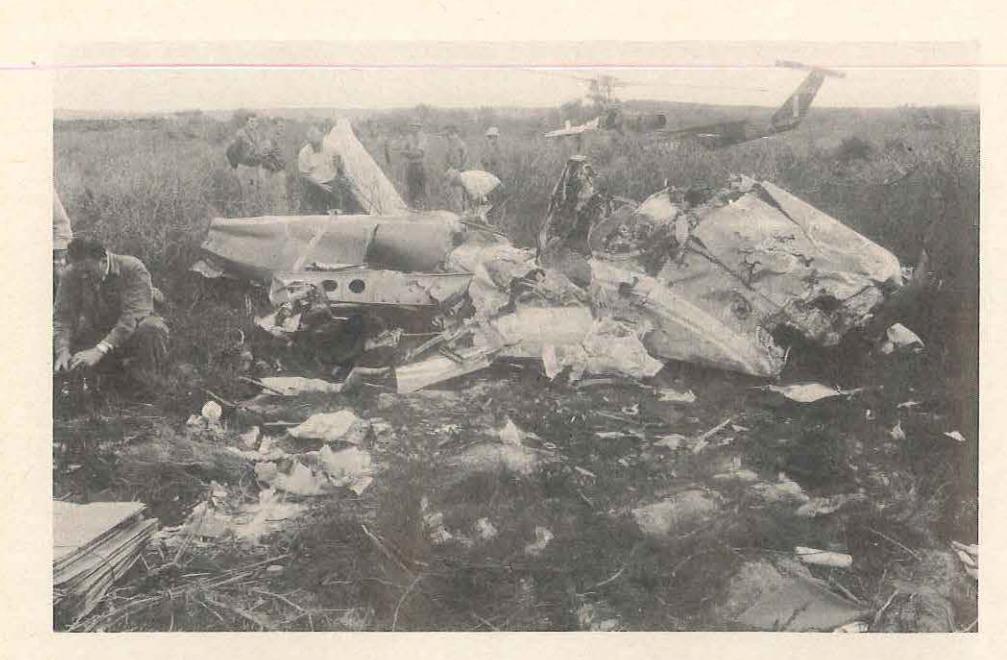
Both wings had failed in upward bending outboard from the fuel tank bays. The starboard wing had folded up and back across the fuselage, striking the fin as well as the starboard stabilator, breaking off both these tail components. The port stabilator was also struck by a separated part of the wing structure, but subsequently failed in downward bending as a result of aerodynamic loads. The tail

Left: The main wreckage after it had been turned upright during the investigation. The RAAF helicopter in the background was employed to locate other sections of the aircraft scattered along the wreckage trail.

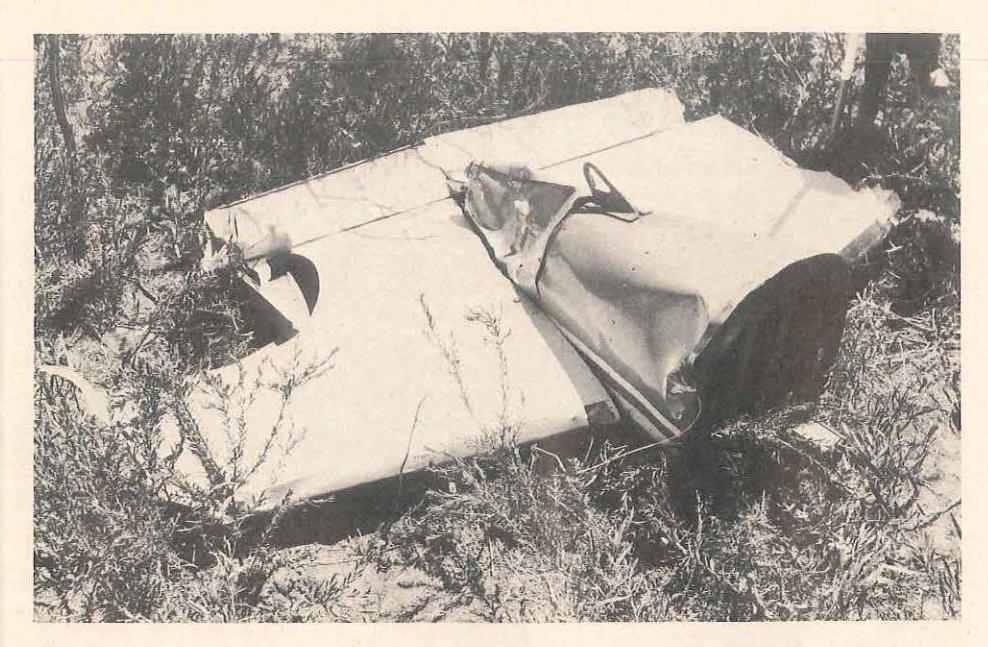
The tail cone of the Comanche, with the stubs of the stabilator still attached, as it was found along the wreckage trail.

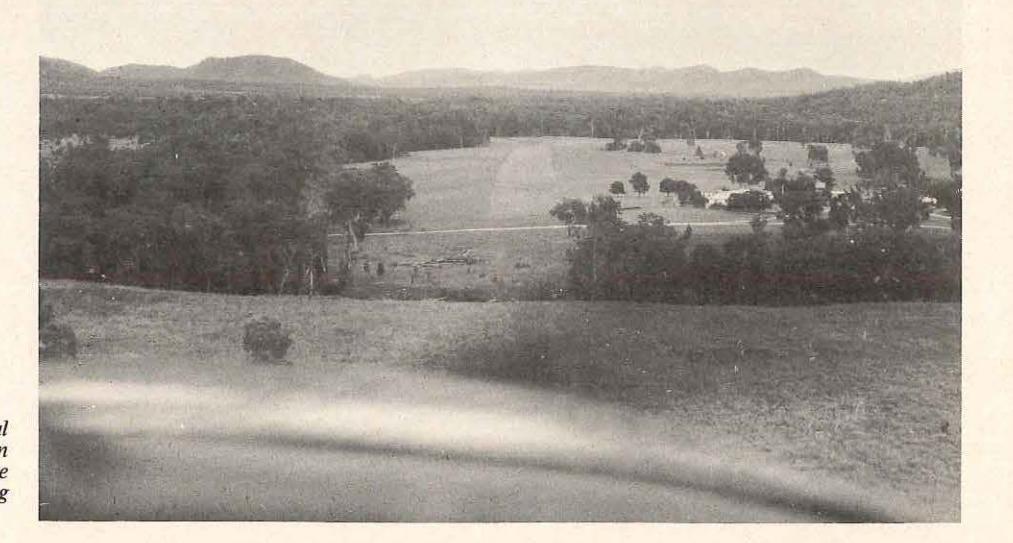
CAUSE:— The cause of the accident was that the pilot, not having adequately assessed the physical characteristics of the strip, then did not take proper action to achieve optimum landing performance of the aircraft.

The airstrip at Tierawoomba, as seen on final approach into the west. Note how the erosion gully immediately beyond the far end of the strip is indistinguishable from the surrounding terrain.

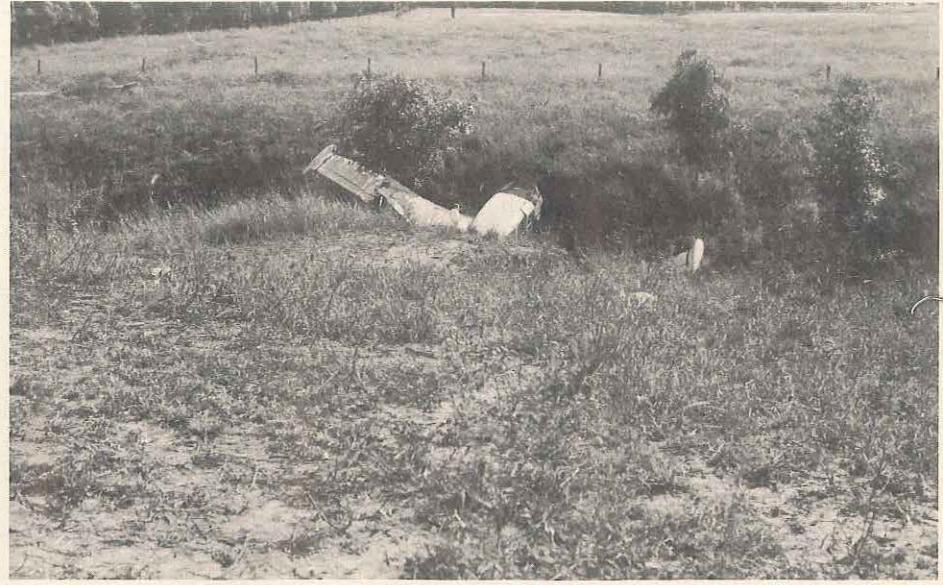
The wreckage of the Comanche, lying in the erosion gully, as seen from the western end of

the strip.

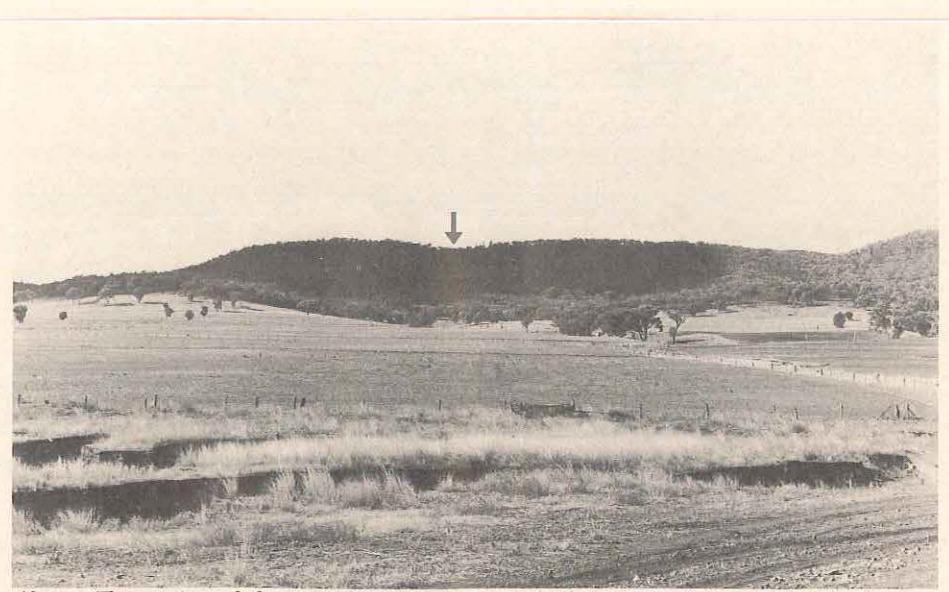
Above: The section of the Catombal Range on which the Debonair crashed, as seen from the western side. The arrow indicates the accident site.

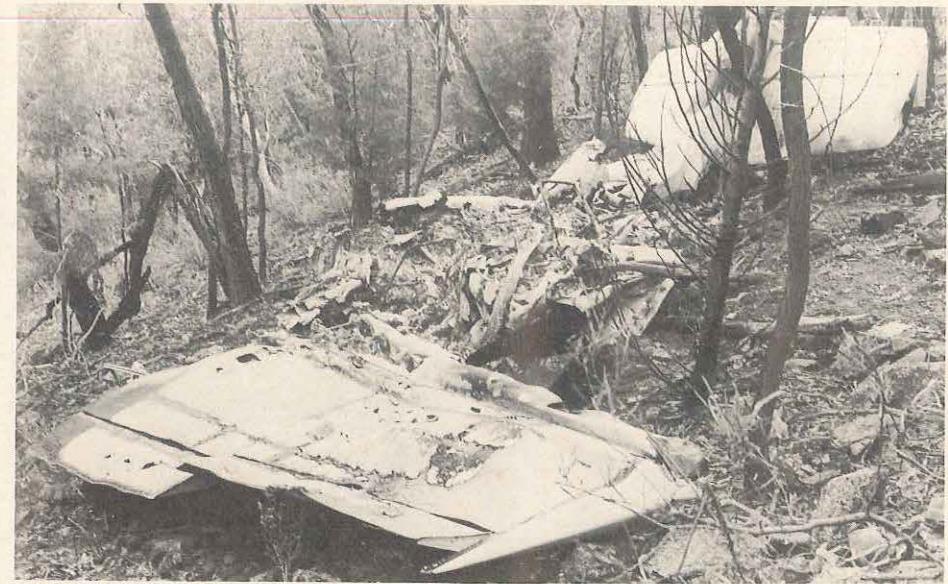
The almost total destruction of the aircraft by impact and fire rendered any assessment of its airworthiness before the accident extremely difficult, but what examination was possible, disclosed no sign of any pre-impact failure. As well as this, a detailed examination of the aircraft's log books revealed no evidence of any significant malfunctions throughout its entire operating life of less than 1.000 hours.

The burnt out remains of the Debonair. The almost vertical angle of descent is evident from the relatively undamaged surrounding tree foilage.

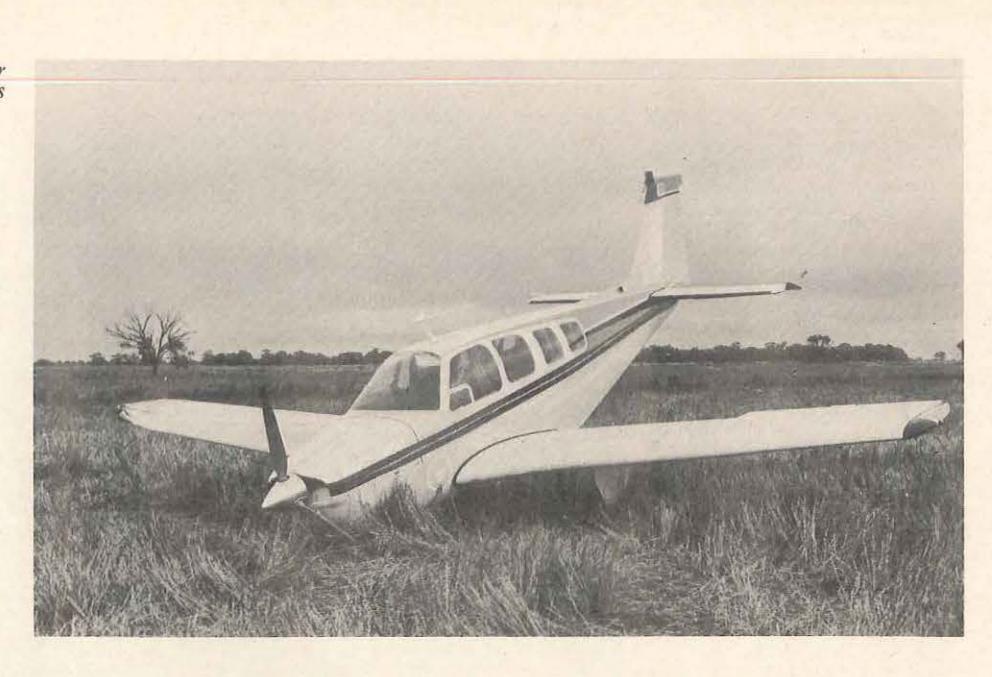
The end of the race! The Beech 36 after forced-landing in a paddock just short of its lectination

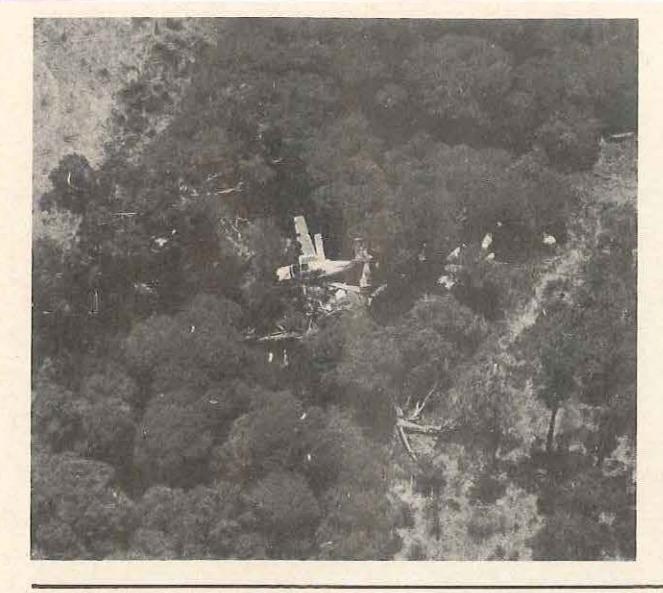
This Victa Airtourer crashed as a result of fuel exhaustion, only half a mile from Bunbury Airport W.A., after a NOSAR NO DETAILS flight from Kalgoorlie. The pilot did not prepare a flight plan before departing, but expected the trip to take about three hours. An hour and a half after departure, the weather deteriorated and the pilot was forced to descend from his cruising height to a few hundred feet above the ground, and to continue the flight beneath a layer of stratus cloud where there were occasional showers. The pilot selected full carburettor heat which he left applied, but did not adjust the mixture control. Arriving over his destination, after a flight lasting almost three and a half hours, the pilot began to circle the town before landing. Shortly afterwards, at 1,500 feet, the engine suddenly failed. The pilot began gliding towards the aerodrome, hoping to make a straight-in approach, but realised too late he would be unable to reach either the aerodrome or an adjoining field. The aircraft struck trees and crashed into a swamp and was damaged beyond repair. Happily, the pilot and his passenger escaped with only minor injuries, for despite the proximity of the crash site to the aerodrome, no one had seen or heard the accident and they waited five hours to be rescued! The pilot had not realised that continuous operation with full carburettor heat and a rich mixture selection would considerably increase the aircraft's fuel consumption.

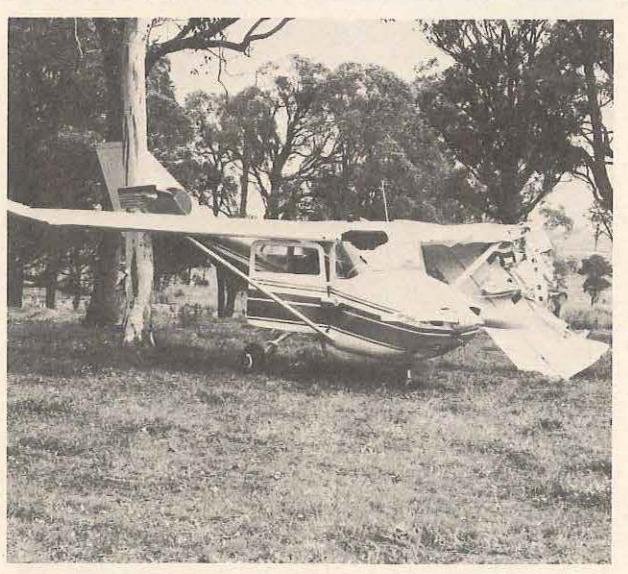
Departing from Bankstown in mid-afternoon, the pilot of this Cessna 172 flew NOSAR NO DETAILS to Tumut N.S.W., where he picked up two passengers. On departure from Tumut he realised that it would not be possible to reach Bankstown again before last light, so he decided to remain overnight at Mittagong. Flying below a layer of stratus cloud 10 miles south of his revised destination, the pilot found that it was darker than he expected. He also saw that there was cloud on the hills in the direction of Mittagong and decided it would be safer to make a precautionary landing.

In fading light he selected a paddock and began an approach. Crossing the boundary fence, the pilot flared for landing but as he did so, he saw a large tree in the darkness ahead. He applied power and attempted to bank away to the right, but the port wing struck the tree. The aircraft cartwheeled, then fell on to its undercarriage and careered backwards until the tail collided violently with another tree. Despite the severe damage, only the pilot sustained a minor injury. The pilot had been flying privately for more than 20 years and had accumulated nearly 2,000 hours, yet this flight seemed to be characterised by lack of planning. Asked why he had not landed at Goulburn rather than attempting to continue to Mittagong when it was obviously getting late, the pilot said the aerodrome at Mittagong was "more handy to town than at Goulburn".

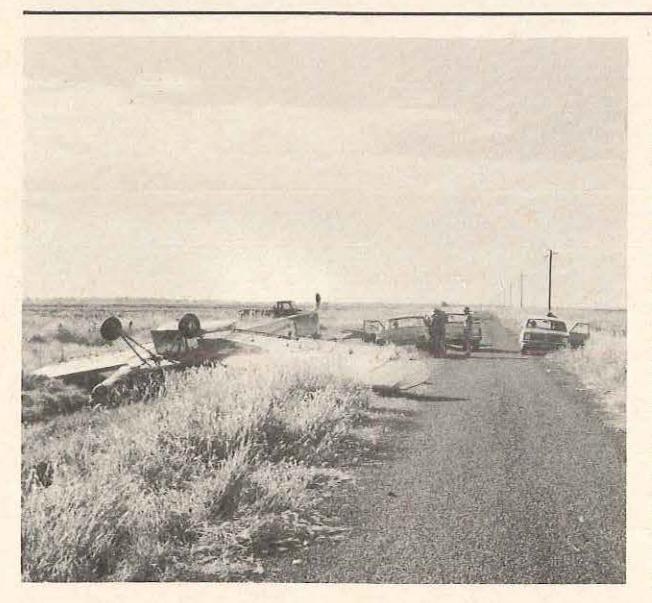
After heavy rain, an agricultural airstrip on the Darling Downs was unserviceable and the property manager suggested that the pilot of the Pawnee shown in the picture, should use a section of bitumen road close to the treatment area. The soft ground adjoining the road also made it necessary to confine the loader vehicle's movements to the paved surface, and a nearby intersection in the road was chosen as a loading base. Water flowing over the road on one side of the intersection, made it necessary to use the road as a "one way strip", landing towards the loader vehicle and taking off in the opposite direction away from it. This meant that, although the pilot was able to take-off into the 10 knot wind, he had to land downwind. He commenced spreading, and although all went well for the first three flights, the property manager saw that he was having some difficulty maintaining directional control on the narrow surface during each landing. Touching down normally after his fourth sortie, the pilot kept the aircraft straight at first but, as it decelerated, it swung off the bitumen. Plunging into the grass at the side of the road the aircraft ran into a flooded drain and overturned. The pilot, who was unhurt, was assisted from the aircraft by the loading crew. Examination of the road, showed that the bitumen was only 14 feet wide and flanked on both sides by narrow strips of tall grass and open drains about 20 feet wide.
