DEPARTMENT OF CIVIL AVIATION AUSTRALIA Number 83 February 1973

Contents

A Moment's Thoughtlessness
The Final Link in the Chain
It Really Can Start
Minor Distraction – Major Catastrophe
Oh, How Could You!
The High Price of Distraction
Nothing Surprises Us Any More
In Brief
Pilot Contribution

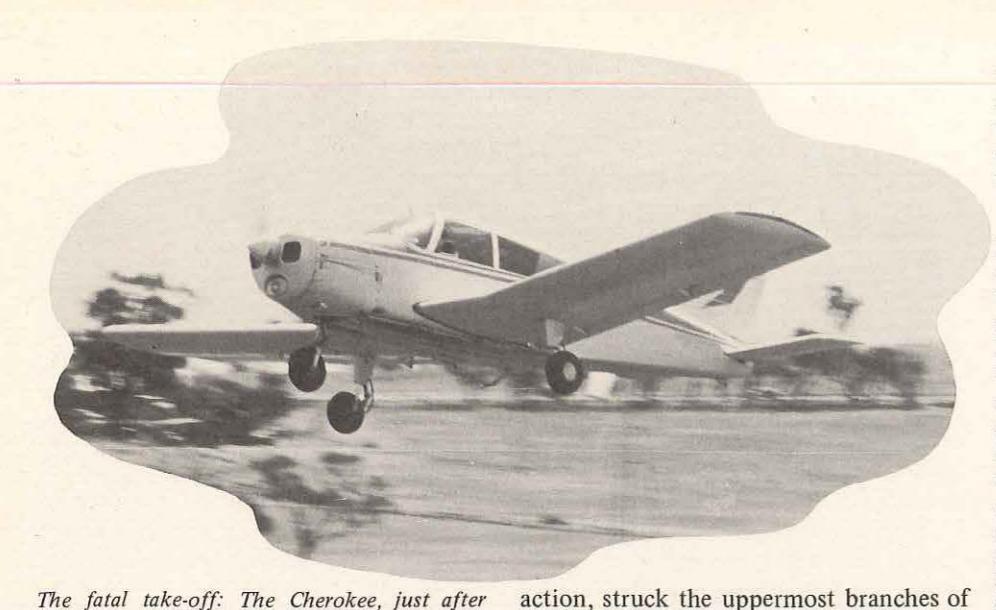
The fatal take-off: The Cherokee, just after lift-off, photographed by a bystander at the end of the strip. Note the wind sock in the background indicating a down-wind component.

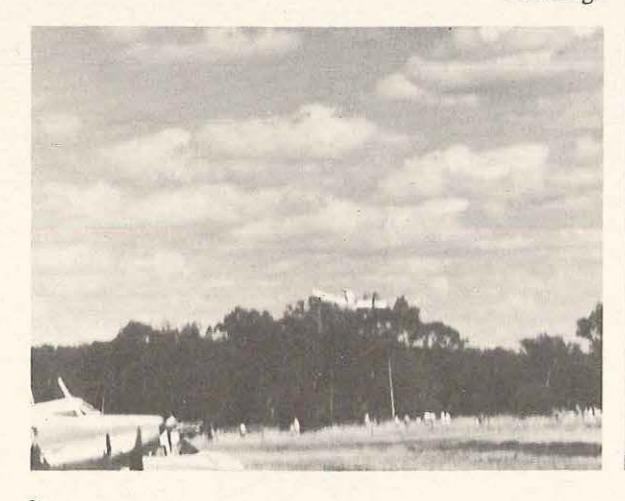
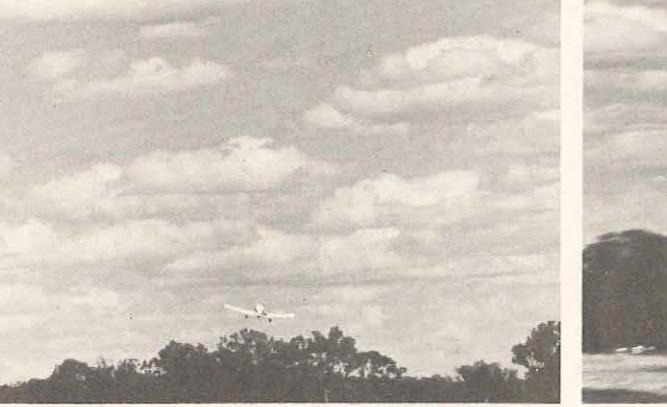
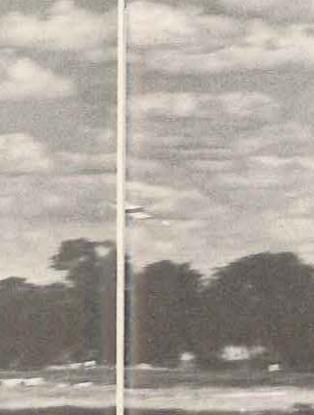
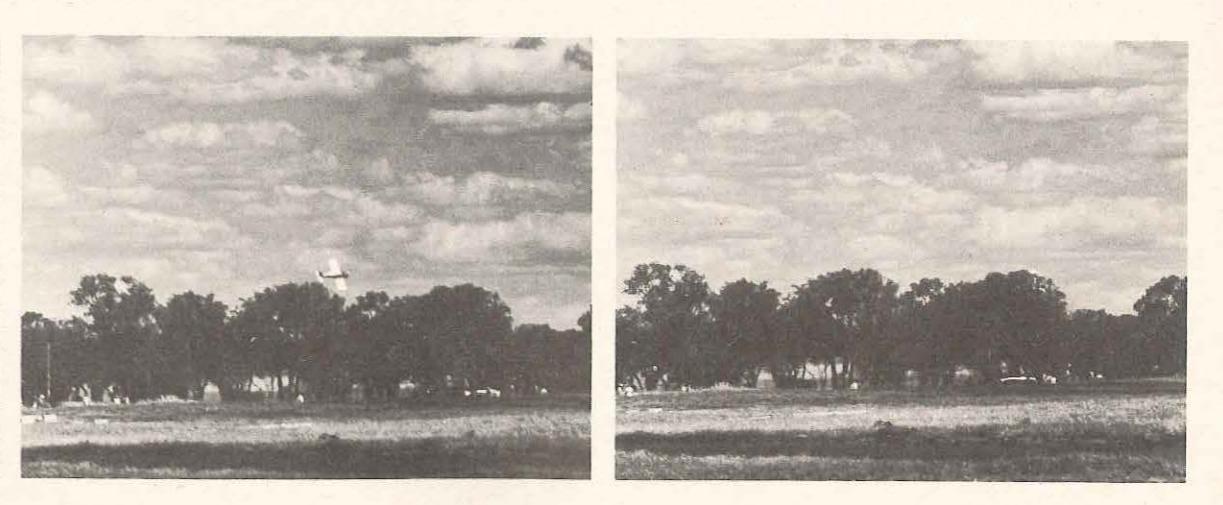
This series of photographs, taken by a professional photographer from a position alongside the strip, shows the Cherokee's last seconds of flight. In the first picture, the aircraft can be seen slicing through the uppermost branches. With obvious damage to the leading edge of the starboard wing, the aircraft continues to climb before commencing to turn. The turn steepens and, in the last picture, the aircraft, partly hidden by the trees, plummets steeply nosedown towards the ground.

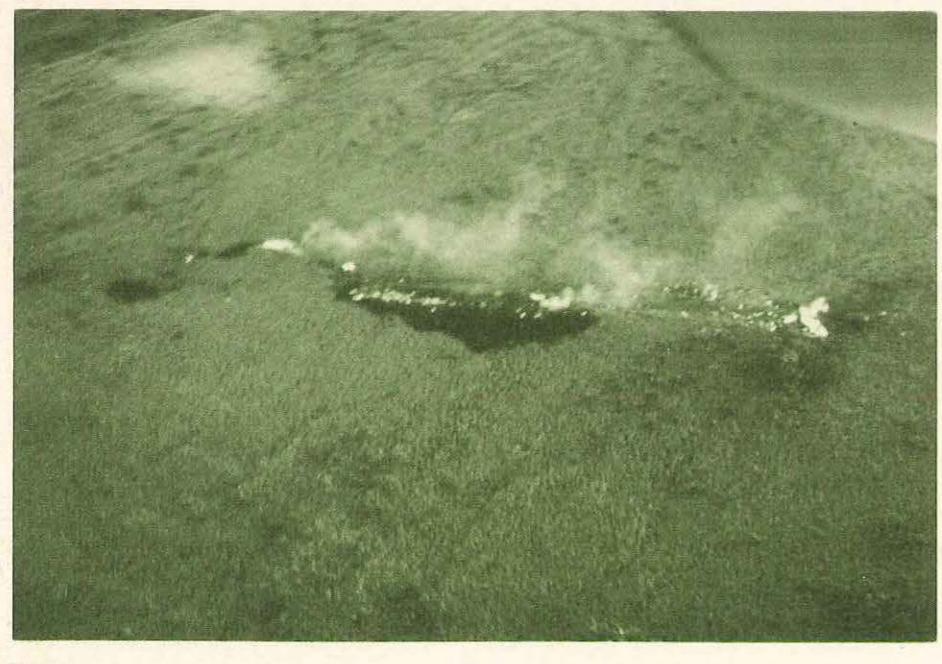
The still-burning wreckage trail of the Aztec, photographed from the Cessna 206, shortly after the crash. The initial impact point is at the left of the picture.

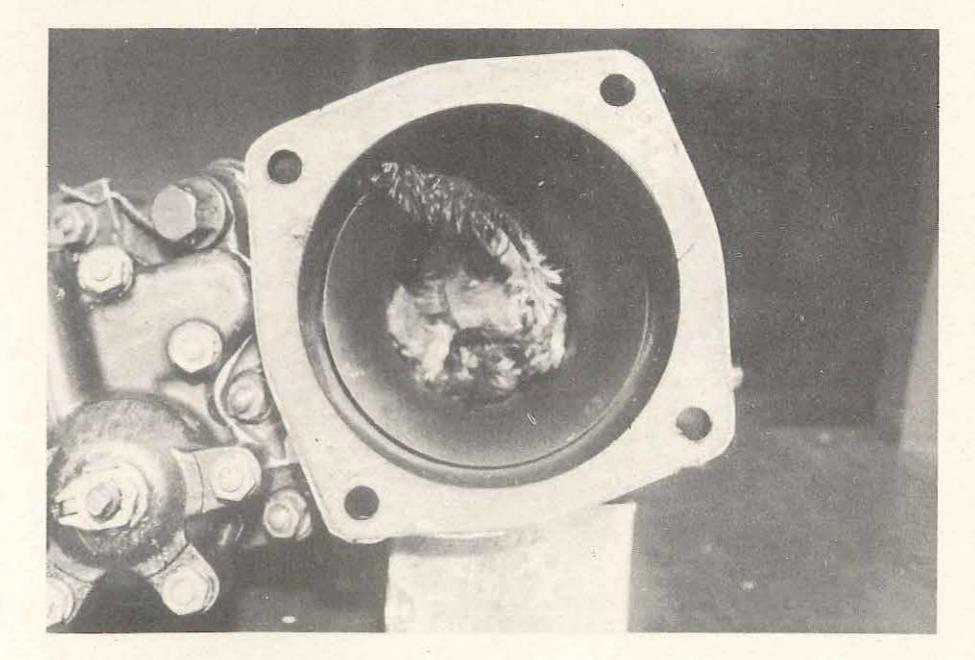
"... in the carburettor venturi extremely bedraggled bird.

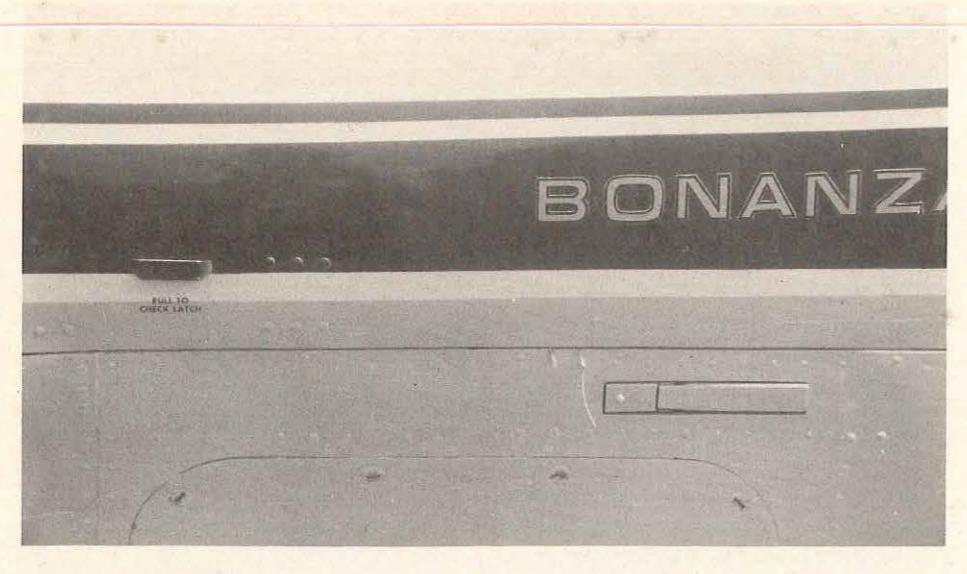
.... but the birds had flown!
