DEPARTMENT OF CIVIL AVIATION Number 86 August 1973

OUT OF EVERYTHING

CATASTROPHIC

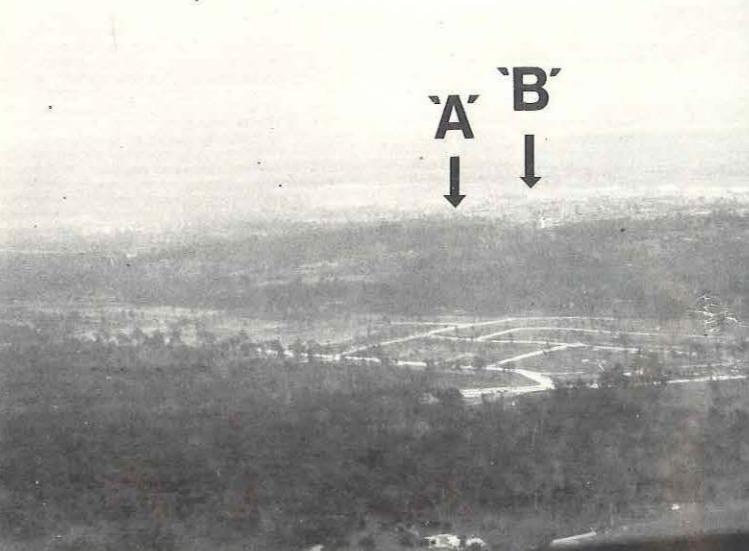
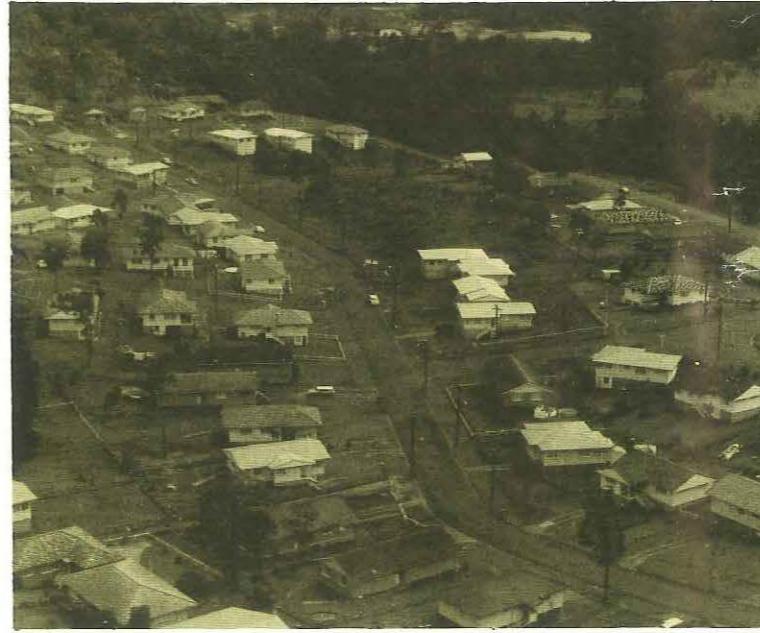
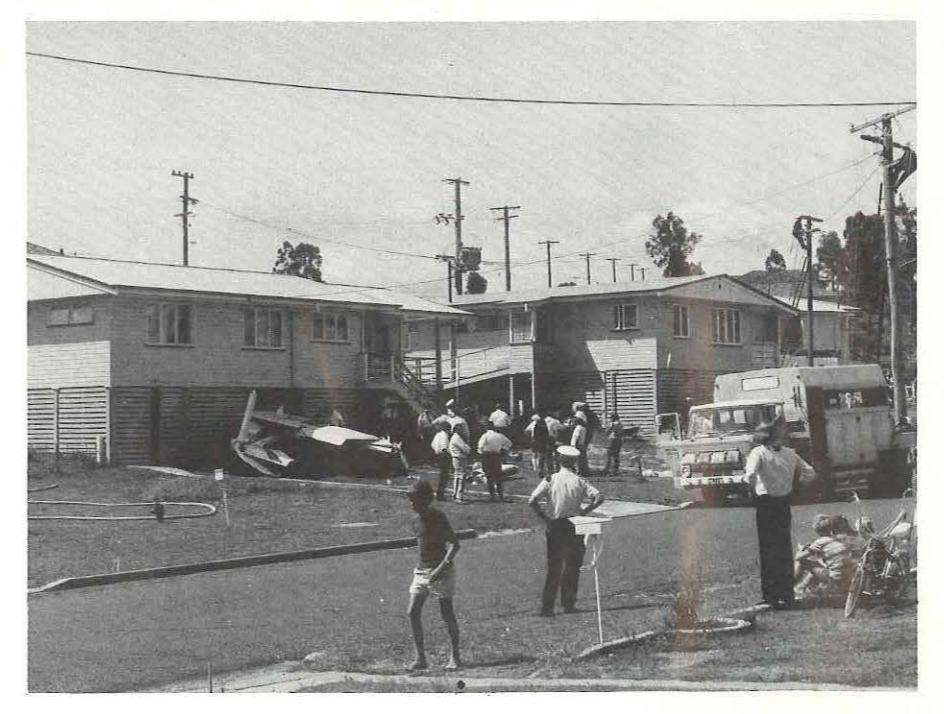
Photograph taken during investigation from point at which engine failed, showing (A) accident site and (B) Archerfield aerodrome. Note the lack of suitable forced landing areas within gliding distance. CENTRE

The scene of the accident shortly after it occurred. Note the proliferation of power lines surrounding the area in which the forced landing was attempted.

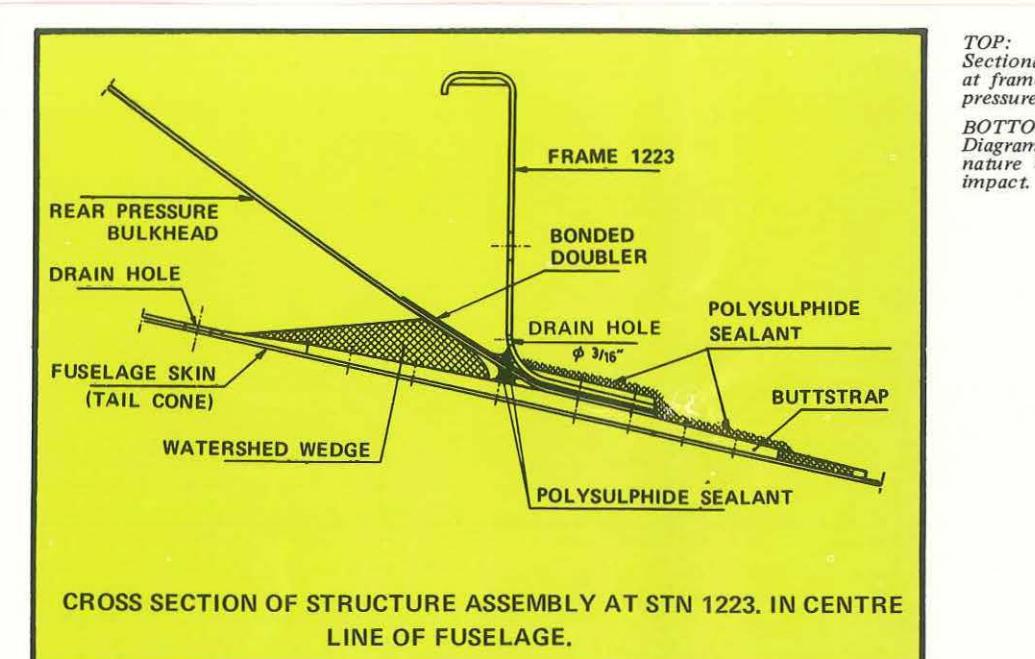
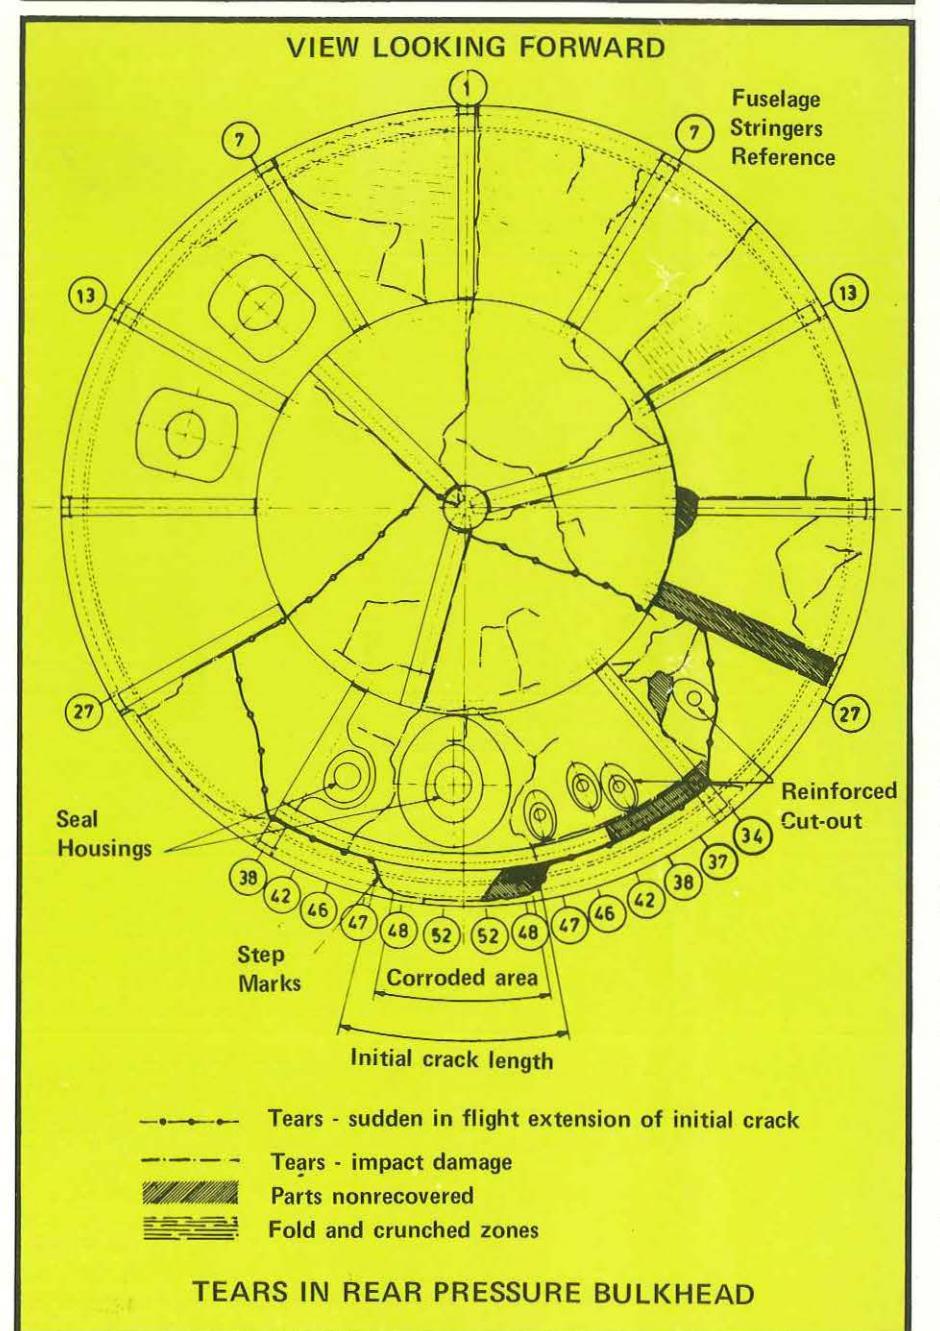
Sectional diagram showing fuselage structure at frame 1223, the frame to which the rear pressure bulkhead is attached. BOTTOM: Diagram of rear pressure bulkhead showing nature of damage sustained in flight and at

The reconstruction established that corrosion had occurred at the base of the pressure bulkhead, beneath the peripheral doubler plate bonded to its forward face. For a distance of 48 cm, roughly about the centre line, the bond was completely delaminated and bulkhead material corroded away. From the ends of the corroded area at each side, tears ran upwards and outwards, then upwards and inwards,

The severe corrosion present at the joint between the fuselage skin and the rear pressure bulkhead had been present unseen for an unknown period of time before the accident. From the

Because the extent of the problem at this bonded joint was not appreciated, no effective technique had been devised for inspecting the area. Since the accident however, improved inspection techniques, together with a modification to the aircraft to improve access for these inspections, have been introduced. It must be accepted that where hidden areas exist, corrosion is more likely to develop with increased age, and it is essential that techniques employed to inspect such areas, effectively detect any corrosion at its onset.

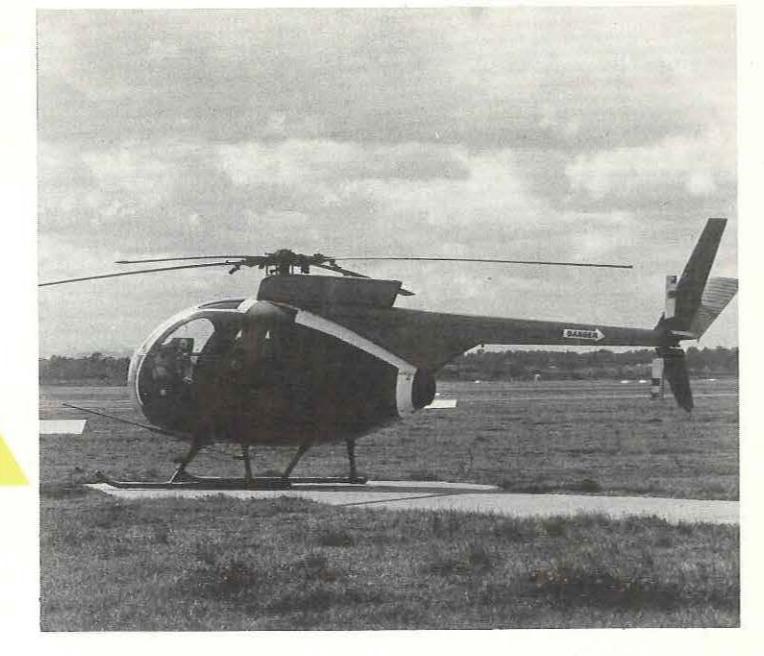
F you are not complying with the inspection reguirements, then it is a good bet that one of your Hughes 500 tail rotor drive shafts may wind up looking like the one in the accompanying photo. The pilot flying the aircraft in which this drive shaft failure occurred is no longer with us. Chances are that he would have been if an inspection of the drive shaft had been performed after a previously reported tail rotor blade strike occurred.

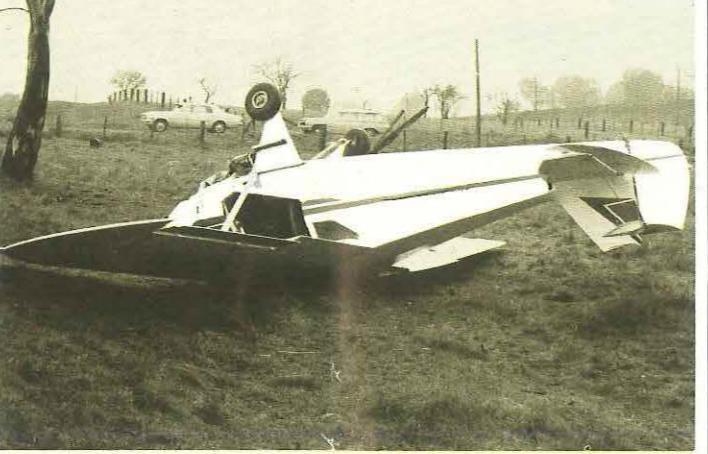
WITHOUT consulting a forecast or preparing a flight plan, a private pilot took off from Bairnsdale, Vic. late in the afternoon in overcast weather to fly to Benambra in this Piper Cherokee. Benambra is 55 miles almost due north of Bairnsdale in the heart of the Great Dividing Range. and place the aircraft on the ground. The nosewheel struck the ground first and collapsed, and the aircraft skidded to a halt as shown in the picture.
