Number 94 1976

AUSTRALIAN DEPARTMENT OF TRANSPORT

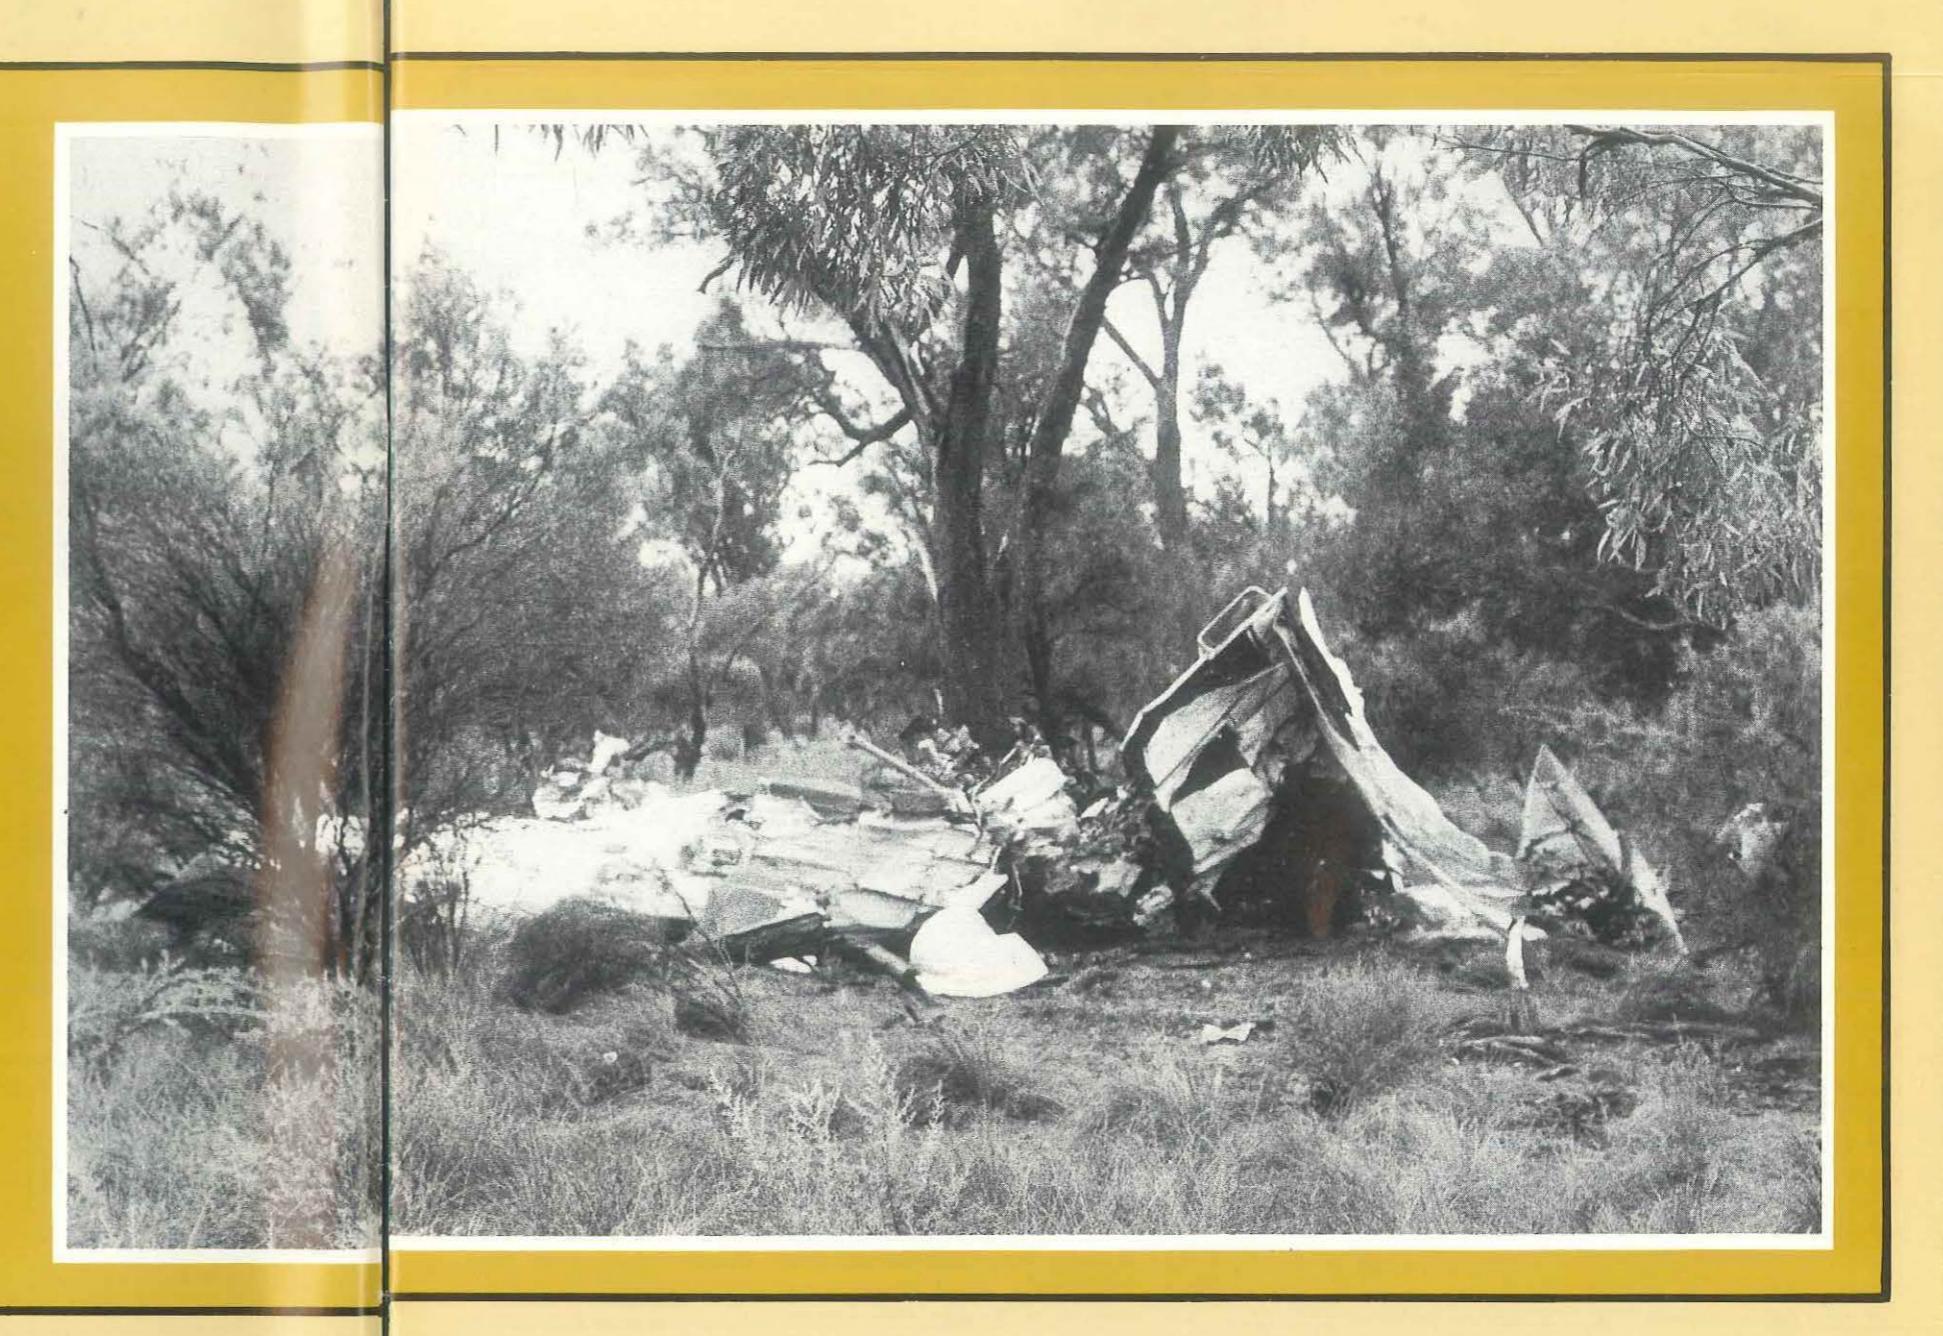
Examination of the wreckage showed that both elevators, together with the port tailplane

and a major portion of the starboard tailplane, had separated from the aircraft before it struck the ground. These components were found scattered amongst the trees 550 metres short of the main wreckage. The heading of the aircraft at the time of impact had been about 290 degrees M, and it had made initial contact with the ground in a nose-down attitude while banked to starboard. Both engines had been switched off, and full flap selected before the aircraft struck the ground.

Detailed examination of the separated elevators and tailplane portions, showed that these had failed in flight as a result of aerodynamic overload. The failure had begun with a downward bending collapse of the port tailplane, under the effect of a substantial upelevator control input. There was no evidence of any constructional defect, nor of vibration or flutter having preceded the structural failure.

Top right: Diagram of 310's tailplane and elevators, showing in-flight failures.

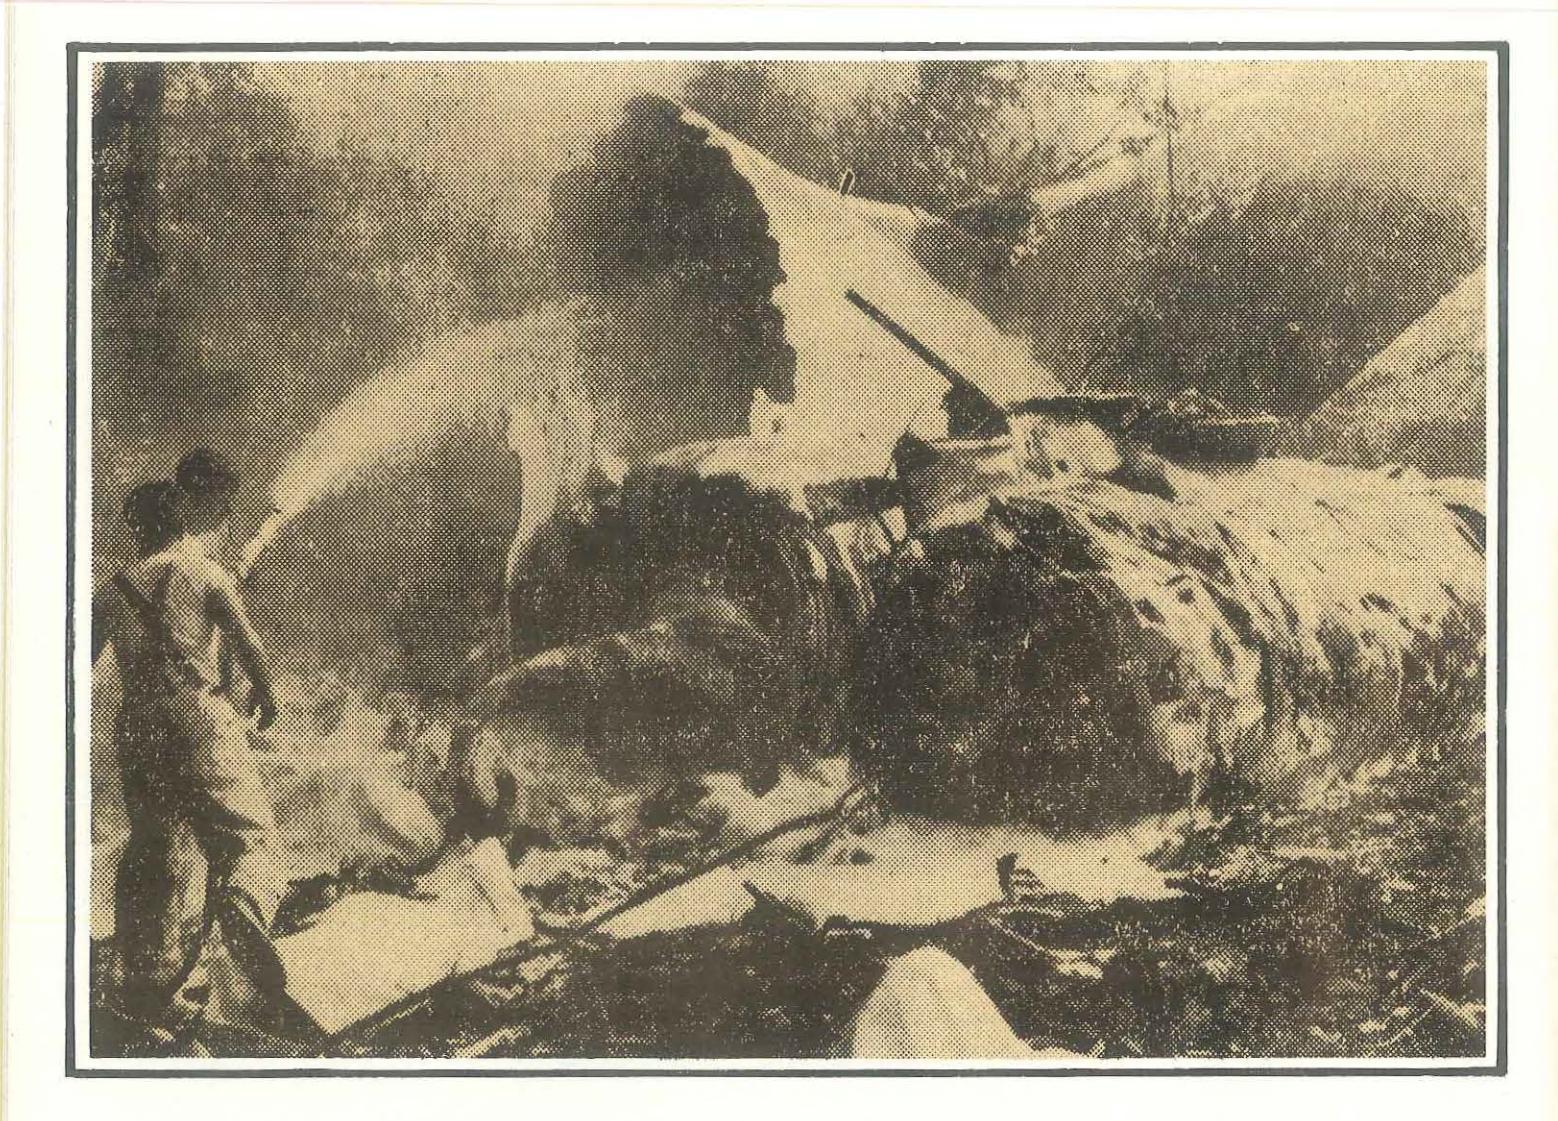
Above: Fireman hosing the still smouldering tail section of the aircraft. The engines can be seen in the foreground.

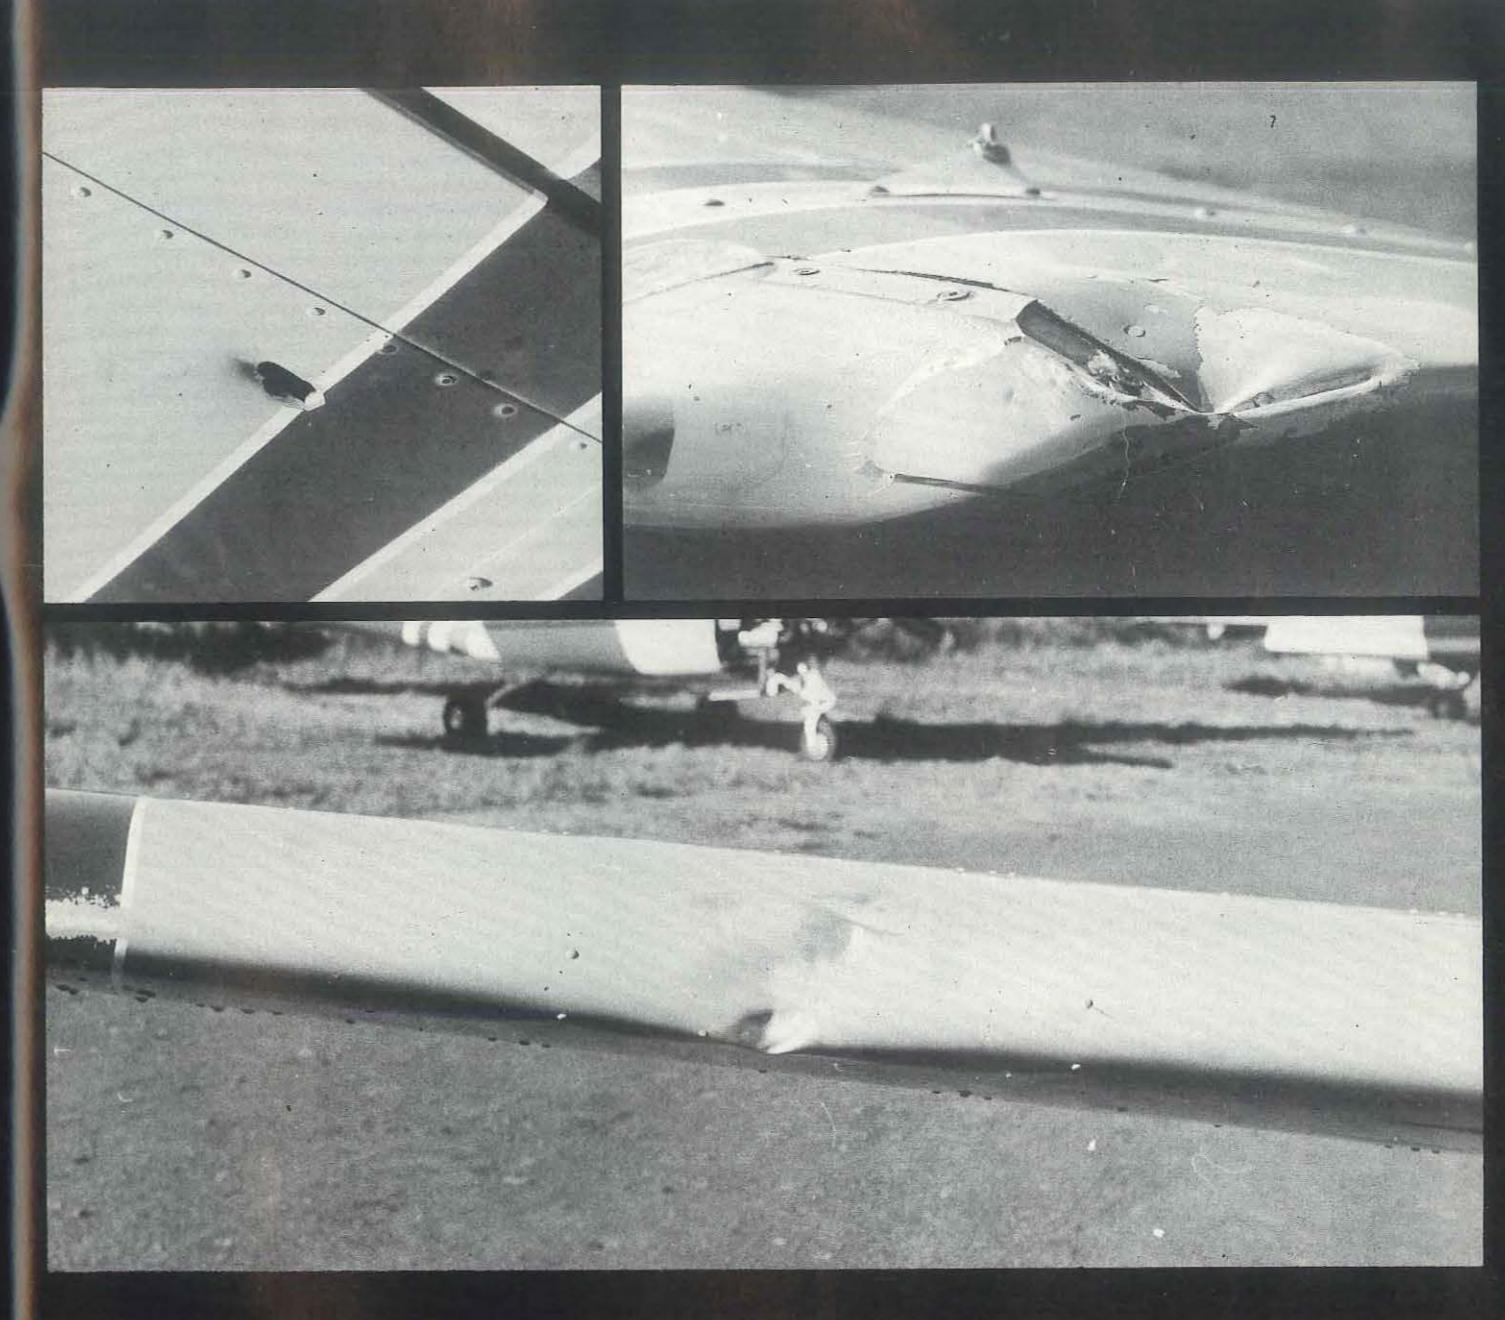
His flight to Bankstown was uneventful, but when the aircraft damage was examined in the morning, pieces of dead timber were found embedded in the buckled wing tip. This left no doubt that the aircraft had struck trees, apparently somewhere on a ridge top, during its

Above: Close-ups showing detail of damage sustained by the Bonanza. It is apparent the aircraft had struck the upper-most branches of a dead tree. From the nature and extent of the damage, it is not difficult to envisage the very narrow margin by which a major accident was averted.
