AUSTRALIAN DEPARTMENT OF TRANSPORT

Number 95 1976

Number 95 1976 CONTENTS

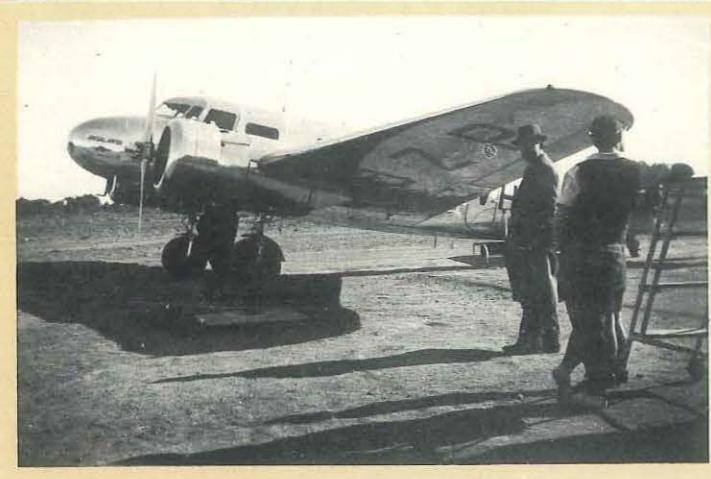
the Lockheed's starboard engine. torn from its mountings during the impact. Damage to the propeller shows that the engine was developing considerable power at the time of the crash.
