Contents

Aviation Safety Digest 112 / 3

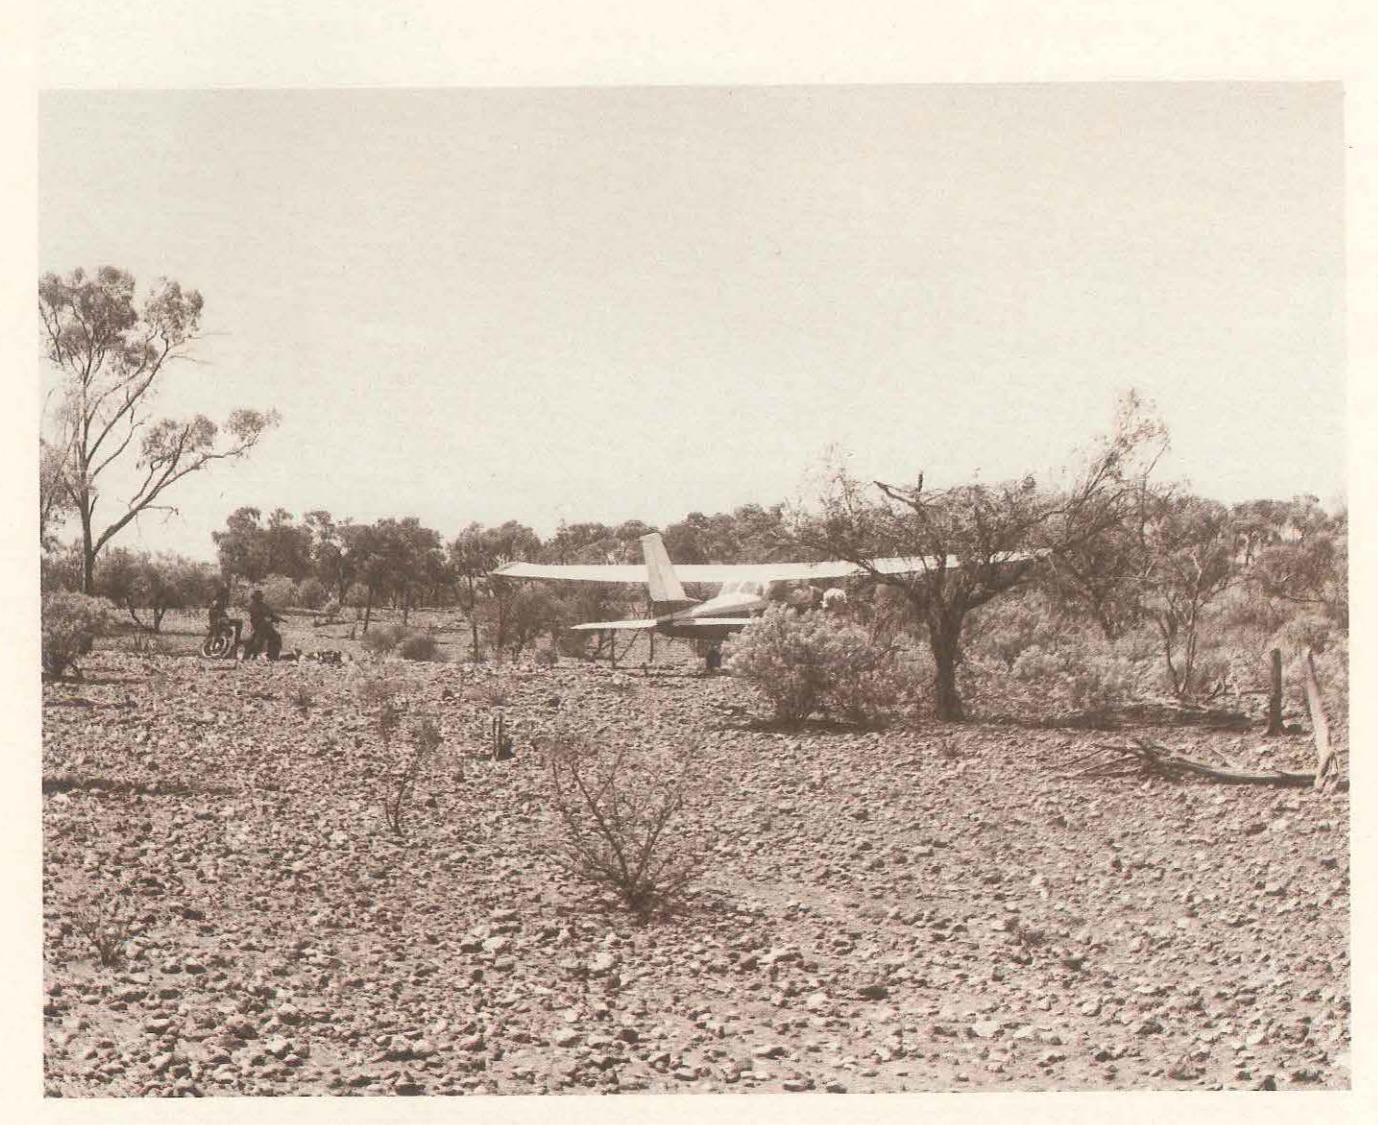
The pilot was flying his own aircraft on a sheep mustering task when he was faced with a forced landing on unsuitable terrain. He was unable to regain power after closing the throttle. The engine was running at idle but operation of the throttle, which felt 'sloppy', had no effect on RPM. At that time the aircraft was at 500 feet above undulating terrain and the most suitable area for landing was a rough rocky upslope sparsely covered with trees and saplings. During the landing roll the aircraft was substantially damaged by the rough terrain and from impact with trees. The pilot and his passenger escaped injury.

Investigation showed that the throttle arm had separated from the drive shaft on the carburettor because the lock screw which clamps the arm to the shaft had worked loose. The lock wire had not been effective in preventing movement of the screw and had eventually broken due to working as the throttle arm rotated around the drive shaft.

Although he had been aware of slackness in the throttle control for some 20 hours, he made no attempt to identify the cause.

Pilots must be alert for the appearance of abnormalities of operation in their aircraft. Early recognition and investigation of a developing fault may well prevent a disastrous failure

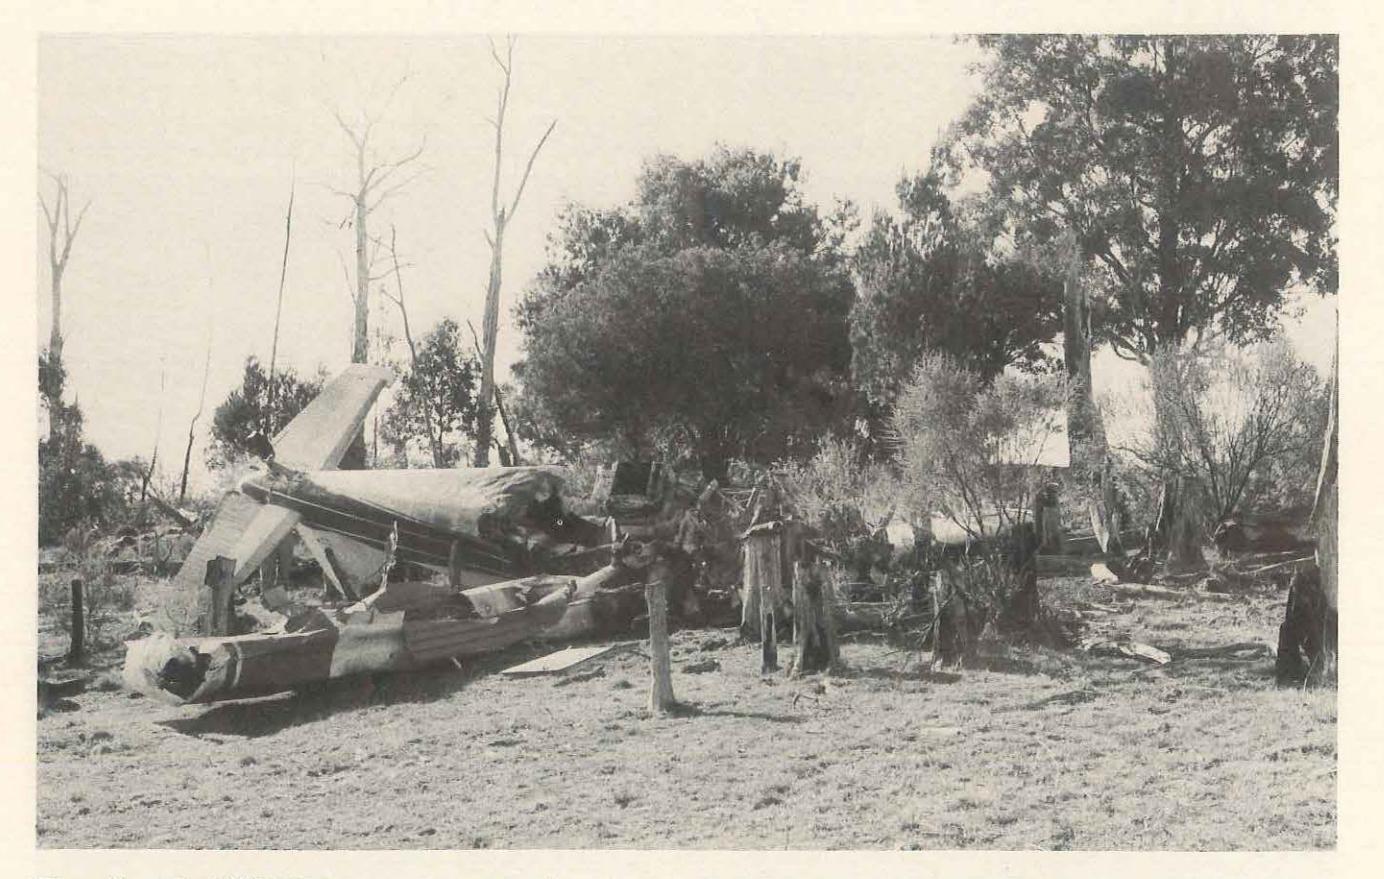
Brake effectiveness was reduced by the frosty grass surface and the pilot could see that he would not stop in the remaining distance. He briefly considered trying to swing the aircraft, but decided against this course of action as the sloping ground around the strip was covered with trees to one side and stumps and logs to the other. The complete load of 916 kilograms of superphosphate had been dumped by the time the aircraft had reached the end of the strip.

The aircraft continued off the strip and through a wire fence. After rolling 30 metres beyond the fence down a five per cent slope, speed had been reduced to walking pace. At this point fallen logs caused the aircraft to very slowly nose over on to

its back. Several tree stumps penetrated the starboard wing as the aircraft nosed over, and the top of the rudder was bent. Other damage was minor.

The cause of the engine malfunction was failure of number one cylinder head resulting in a partial power loss. The pilot briefly considered the possibility of dumping the load and flying a circuit; however, he discarded that option and decided to abandon the take-off because of the nature of the surrounding terrain. (If the surface of the strip had not been frosty the aircraft might have been stopped in the remaining distance without damage). Had he hesitated in rejecting the take-off, or elected to continue, a far more serious accident could well have resulted.

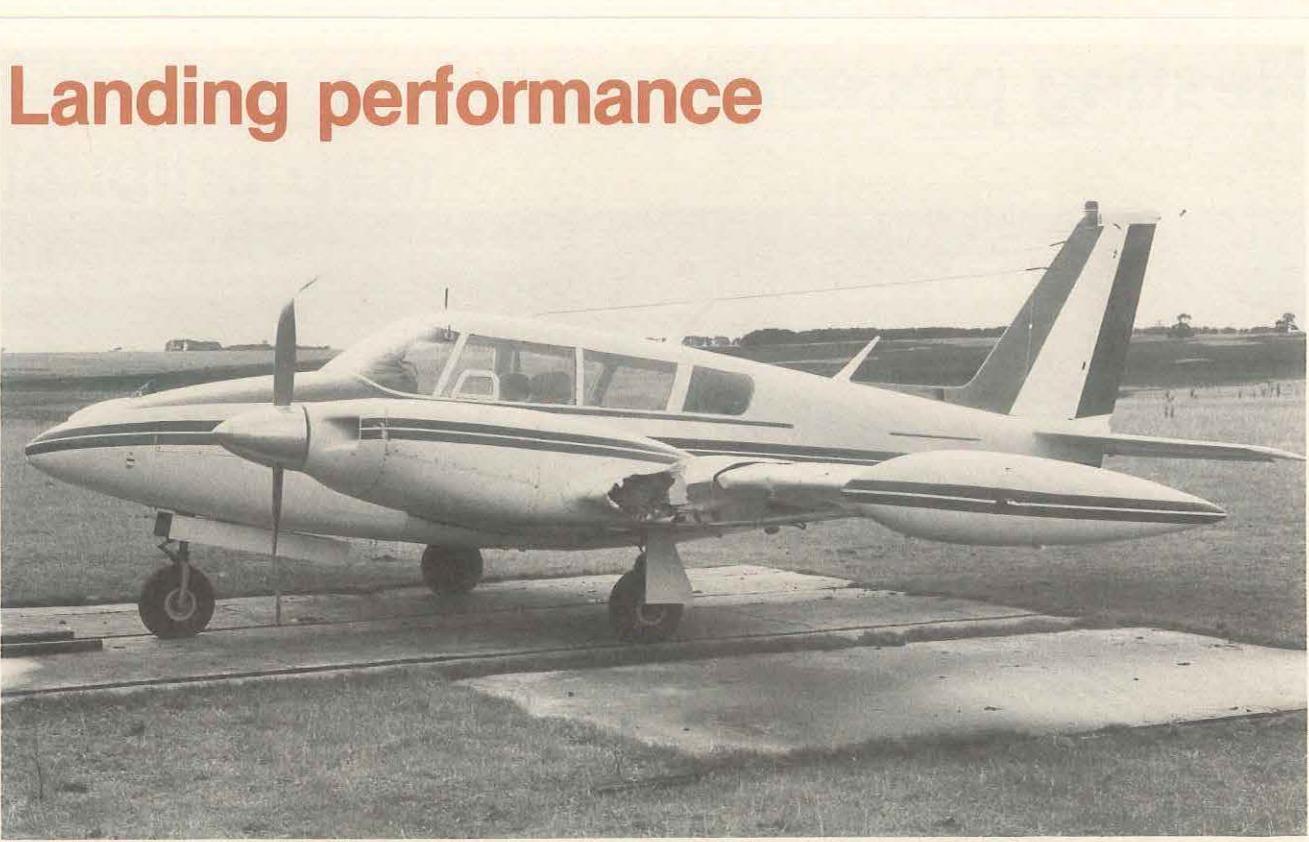
The aircraft crossed the fence at 80 knots with full flap down and the pilot added a little power to pass over the sheep. Touchdown was made at the intersection of the strips which left 369 metres available for the landing run. The pilot braked hard and the recently replaced brake pads did their job well. The wheels locked up and skidded along the wet grass surface which was very soft and 'greasy' from the 75 millimetres of rain which had fallen during the previous eight days. When it became obvious that the aircraft would not stop, the pilot applied power to the left engine to try and induce a ground loop. The aircraft veered off the strip to the right, struck a boundary fence and suffered substantial damage.

A check of the landing weight chart from the aircraft flight manual revealed that, for a landing in the prevailing meteorological conditions on a

level surface, the distance required was 488 metres. This is the distance required to bring the aeroplane to rest on a level, short-dry-grass runway from a height of 50 feet above the threshold following a steady approach to land, at a speed of 73 knots, with the aircraft in the landing configuration and maximum braking applied immediately after touchdown. The ground roll, under ideal conditions, could

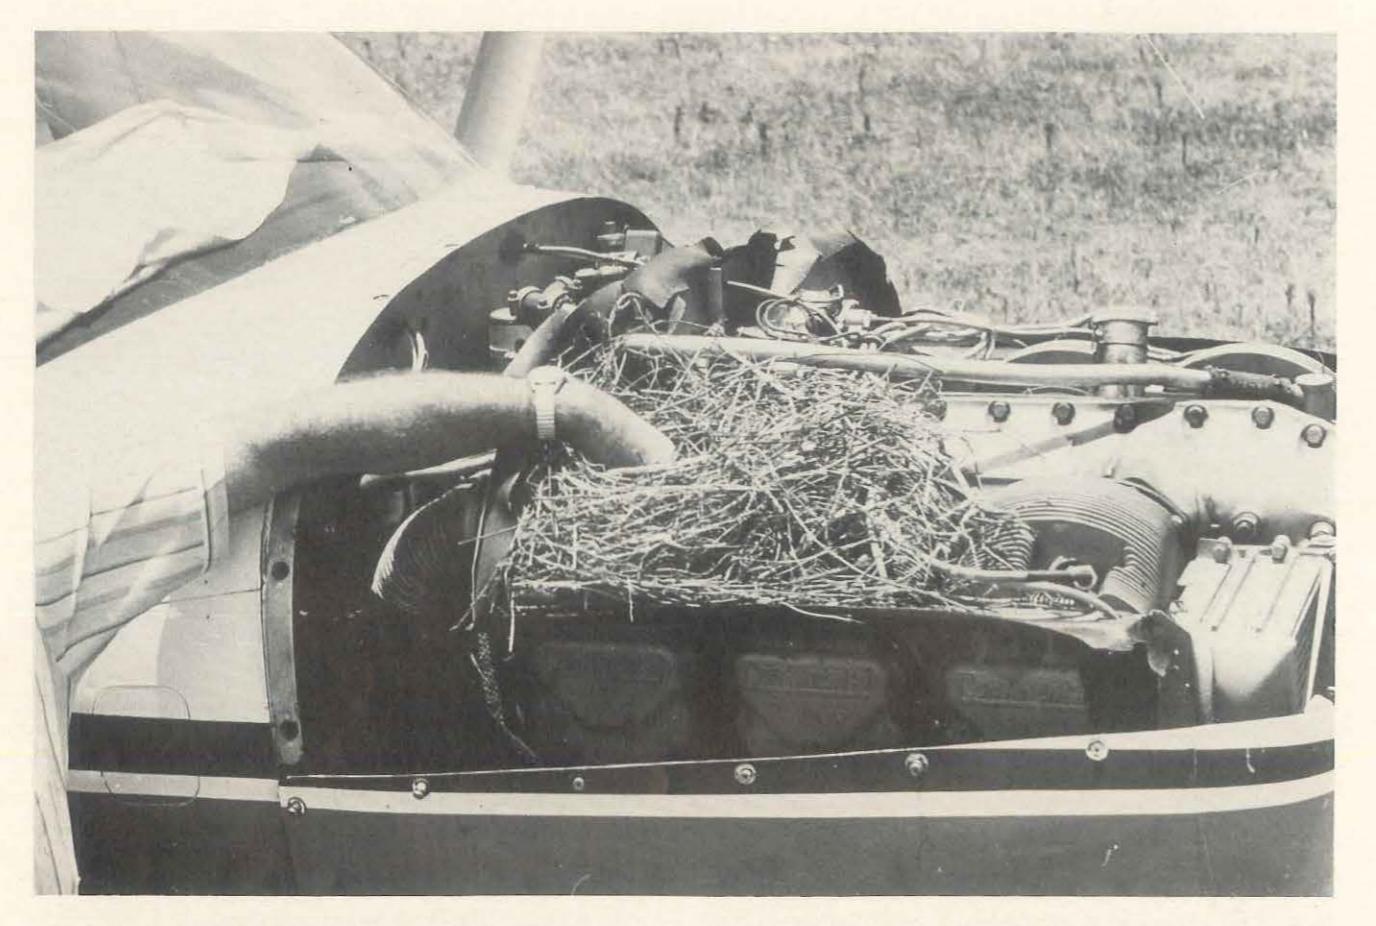
'Having left my plane, a Cessna 182-H, parked one Friday afternoon, I returned at noon on Sunday to find a note tucked under the door handle. It said: "Check your engine for myna birds. Found a nest in the 150 this morning." And written obviously later was the addendum, "3.15 pm, there is a nest in this engine."

'On peering into the ventilation opening beside the spinner, I could see the remains of a nest which our unknown friend had removed for us. There seemed to be more grass and sticks still remaining, enough to start a fire, so I pulled the top cowl off to get rid of the remains, and found yet another large nest on the same side back near the firewall; a mass of small sticks and grass. Prime fuel for a fire in flight!

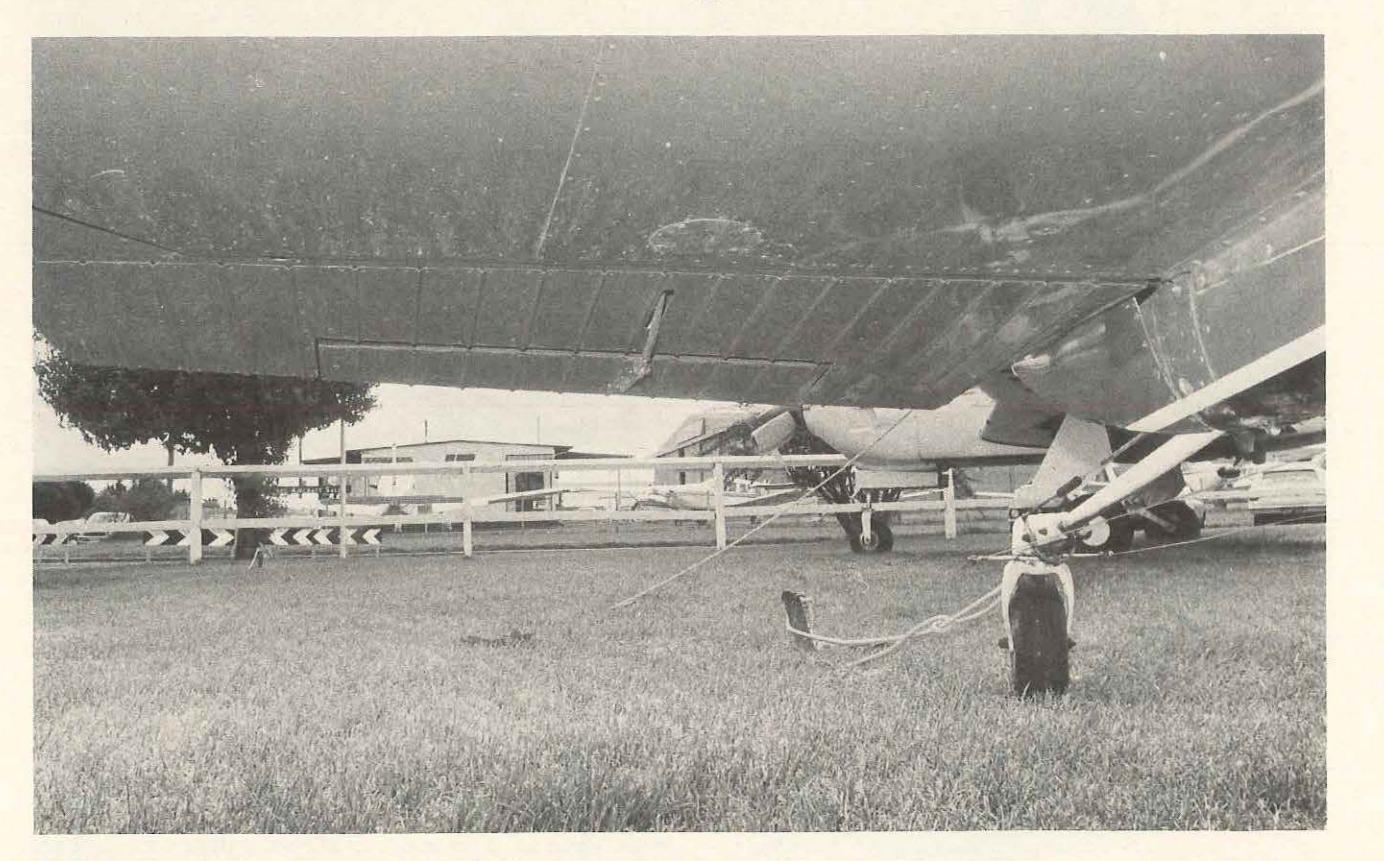
The lower surface of the elevator trim tab is close to the ground and may be awkward to inspect.

The lower surface of the elevator trim tab of the Cessna Agwagon and other tailwheel aircraft is close to the ground and may be rather awkward to inspect. But remember, trouble does not come only from the easily accessible areas of an aircraft.

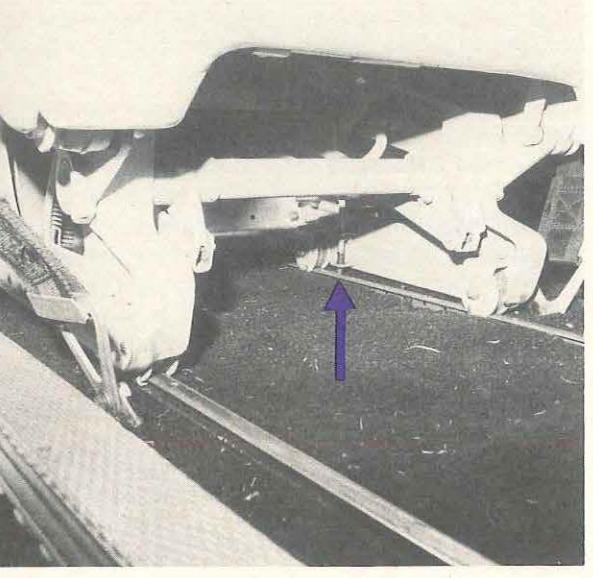
Opposite page and above. Typical light aircraft seat adjustment mechanisms. In both examples the seat is unlocked.

• The floor-mounted rails - make certain they are tight to the floor and tracking true; the rail stops should be clear and not distorted, and the end stops solid.
