BUREAU OF AIR SAFETY INVESTIGATION

tion Safety Digest

122/1984

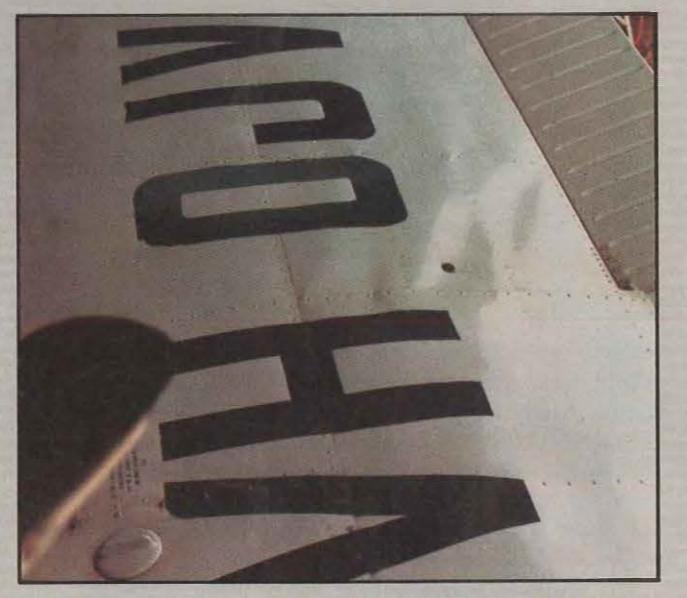
It was subsequently found on return to base that the aircraft had been substantially damaged. Bulkheads had crumpled and the right wheel had been pushed back, while the right wing had buckled ribs and wrinkled skin. There were also popped rivets in various places.

As the photograph shows, the wrinkled skin on the right wing is quite obvious. The wrinkling is indicative that something has happened to the structure beneath the skin, and that the structural integrity of the aircraft may be at risk.

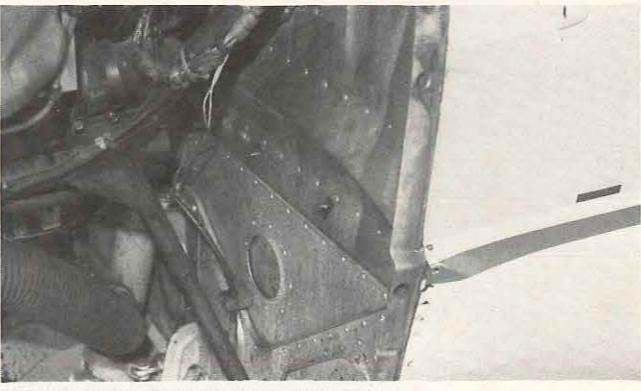
- The firewall was compressed and buckled.
- The nose wheel outer left-hand rim had a flat spot.
- Both propeller blades were bent back and abraded.
- There was buckling on the left-hand side of the forward fuselage.
- The nose wheel strut seals had ruptured, allowing the strut to gradually deflate.

Compression deformation of firewall.

There have been several instances in the past where Australian GA aircraft have had their flight control systems adversely affected by heavy landings. In this instance, the buckling of the firewall could well have deprived the pilot of elevator control by displacing elevator control pulleys. The propeller damage also may have led to a catastrophic failure.

It is vital that pilots report any heavy landing so that the aircraft concerned can be inspected for possible hidden damage before it is flown again. The consequences of a heavy landing can be far reaching.

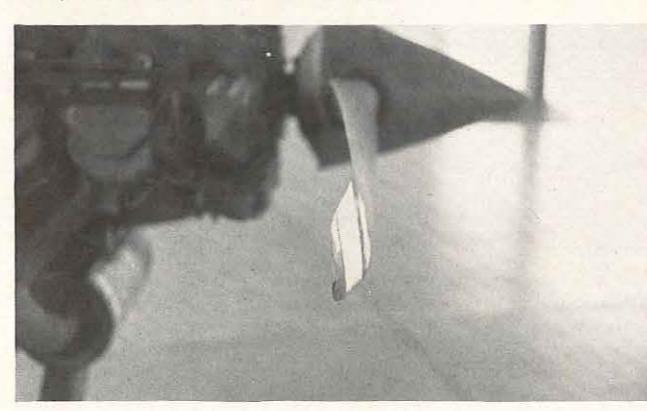
Propeller blade damage not noticed by pilot.
