# Aviation Safety Digest

ASD 130 SPRING 1986

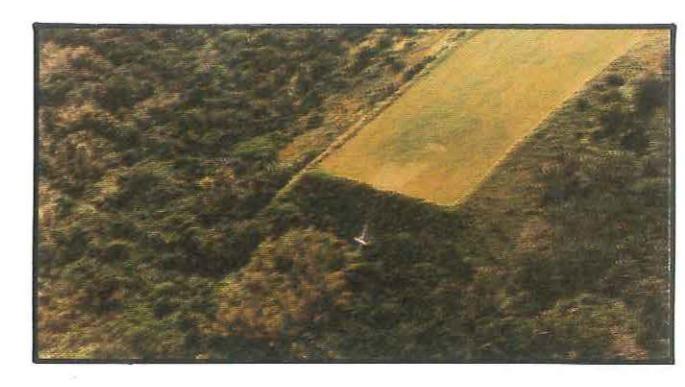
During the approach she found the aircraft's flight path descending below the level of the runway (the threshold was elevated above the surrounding terrain). Power was applied and while correcting the flight path, it also led to an excessive threshold speed. The aircraft touched down some 10 metres in from the threshold and bounced. The next touchdown was about 140 metres farther in. Full braking was applied but it became obvious the aircraft could not be stopped in the remaining runway distance. The pilot tried to ground loop but the aircraft slid sideways off the end of the strip, down a 40 degree embankment and came to rest against the trees some 8 metres below. There were no injuries.

So we have an apparently misjudged and overcorrected landing approach. Under the circumstances, the pilot deserves an award for diplomacy and for resolve in controlling the events as well as she did. However, it would have been valuable to 'switch off' al extraneous thoughts when the 'downwind' checks were carried out. In this way the pilot could have devoted her undivided attention to the final approach - the most critical phase of flight.

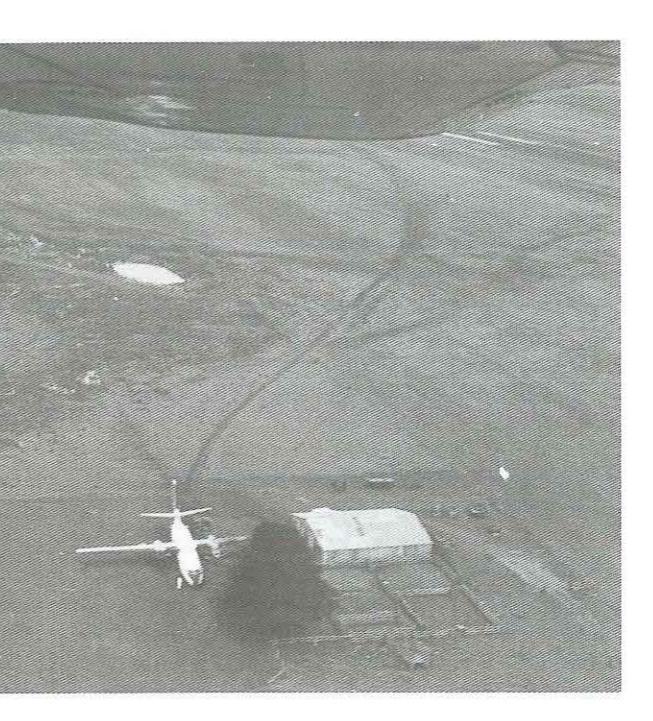
A classic case involving this phenomenon occurred at Bathurst, New South Wales, in May 1974. An F27 engaged on a Regular Public Transport service entered the circuit area in generally fine conditions, with the surface wind reported as 5 knots from the north-east. Some rain was evident over the eastern sector of the aerodrome associated with a nearby active cumulus cell. and after descending through 300 feet above terrain the aircraft encountered heavy rain. A headwind component of 30 knots rapidly developed, the aircraft drifted well off the centreline, and with a wheel height of 50 feet a go-around was initiated. By this time the F27 had left the headwind and entered an area of rapidly increasing tailwind. Coincident with the change in wind direction the aircraft was also probably affected by a downdraught of at least 2.5 metres per second, and the F27 crashed 48 metres from the runway centreline (see photograph).

The BASI Inspector (Air Safety) in charge of the accident investigation was the first person in the world to perceive that this largely unknown phenomenon could be an accident cause, and it was later that the terms downburst and microburst became more widely known. The unpredicted behaviour of the air during the go-around at Bathurst had adversely affected the climb performance of the aircraft at a height too low to effect recovery, and the accident report gives this as the cause.

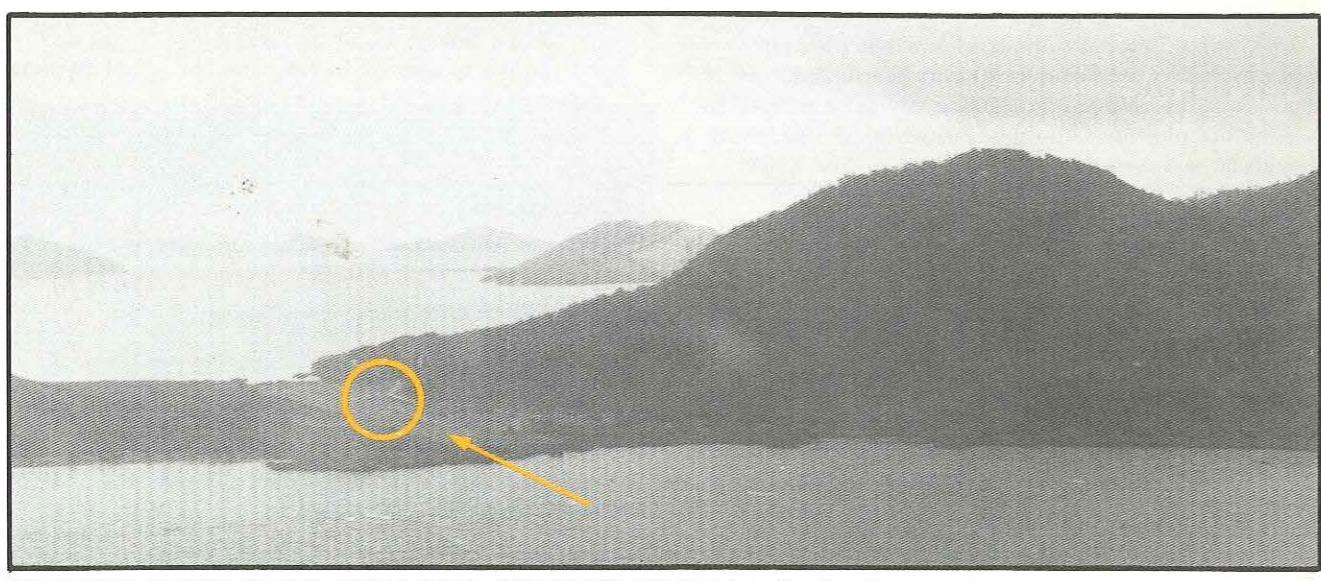
A TAF was not obtained by the pilot before the flight. The forecast wind for the strip in fact was 110/16, which would predict a tailwind component of 14 knots on runway 32. Of course, a forecast can be one thing and actual conditions another; nevertheless, a knowledge of the overall pattern is helpful in making assessments of the weather and trends. In this case, the rainshowers in the area were expected to influence landing conditions. Not only was there a forecast possibility of water on the grass strip but also substantial variations in wind speed and direction were likely to be associated with the squalls.

The forecast was an accurate warning of the expected conditions and in light of this warning, the pilot's inspection of the runway and assessment of the wind seems a little cursory

Airstrip from position at which pilot checked windsock (circled). Landing direction is arrowed.

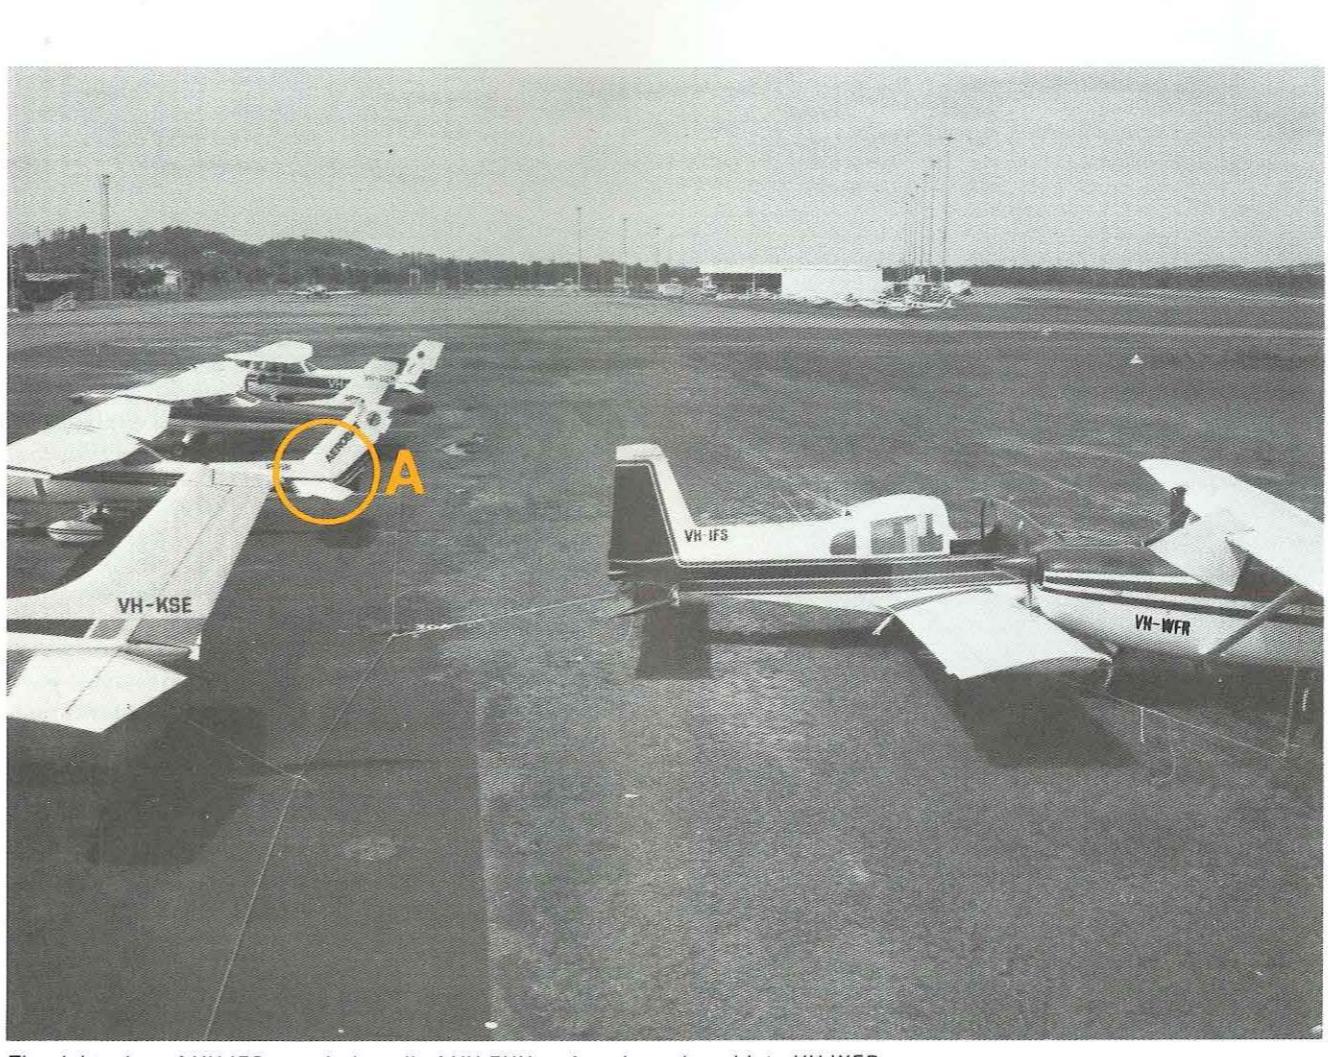
Leaving the propeller area, the pilot started to run around the right wing to return to the cockpit so that he could throttle the engine back. Just as he reached the wingtip, the right tie-down rope snapped and the aircraft began to move. The pilot managed to clamber onto the wing near the cockpit, but before he could take any action to retrieve the situation he was thrown off balance when the AA5's right wingtip struck the tail of a Cessna Aerobat.

The right wing of VH-IFS struck the tail of VH-FUH at A and continued into VH-WFR.

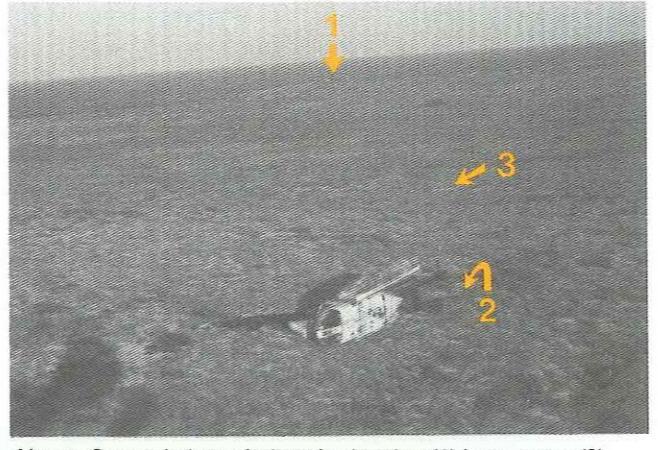
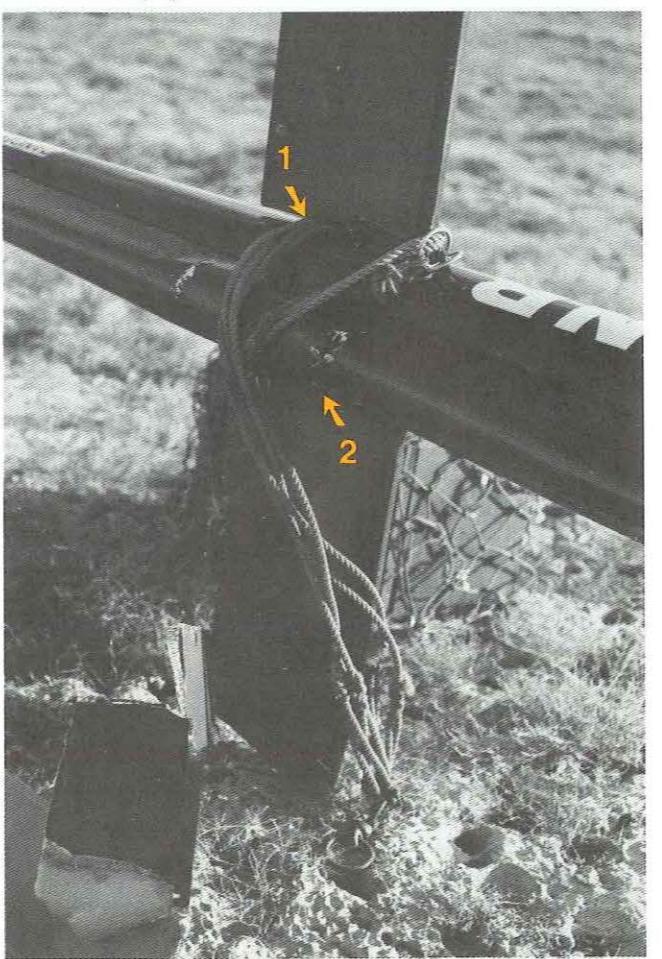
During the investigation it emerged that the box in the sling may have had a defective latch. It was postulated

Above. General view of aircraft showing (1) base camp (2) final resting place of box and (3) approximate position of tailrotor wreckage

Below. View of horizontal stabilizer showing (1) rope securely attached and (2) point of tailrotor shaft breakage.

that this may have allowed the box's lid to come open once the load was airborne, thus creating extra drag and causing the load to become unstable. There was reason for some concern in the fact that the loader had not received any formal training, and could not remember if he had closed the latch properly. He was aware that one of the boxes being used had a defective (bent) latch but could not remember if it was the one used on this particular flight. [Continued opposite.]

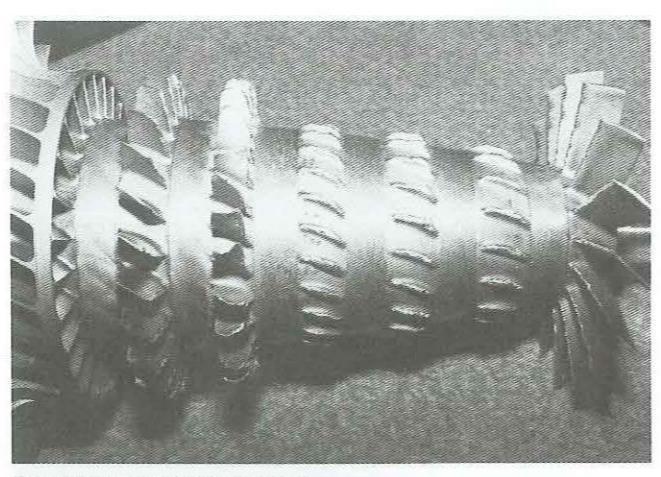
Damage to compressor rotor.

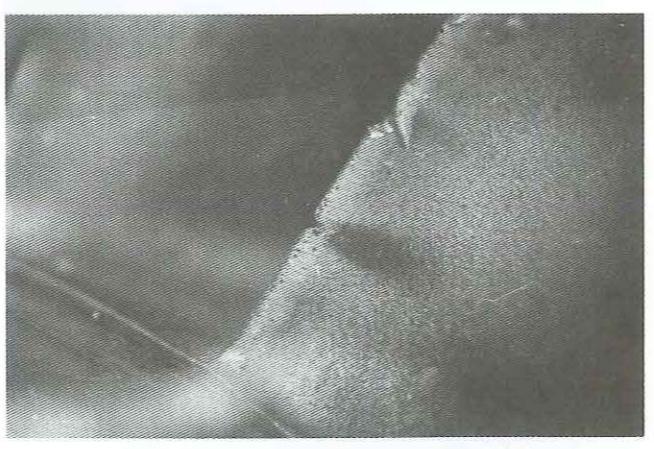
Pitting, FOD damage and streaking on a sixth-stage rotor blade.

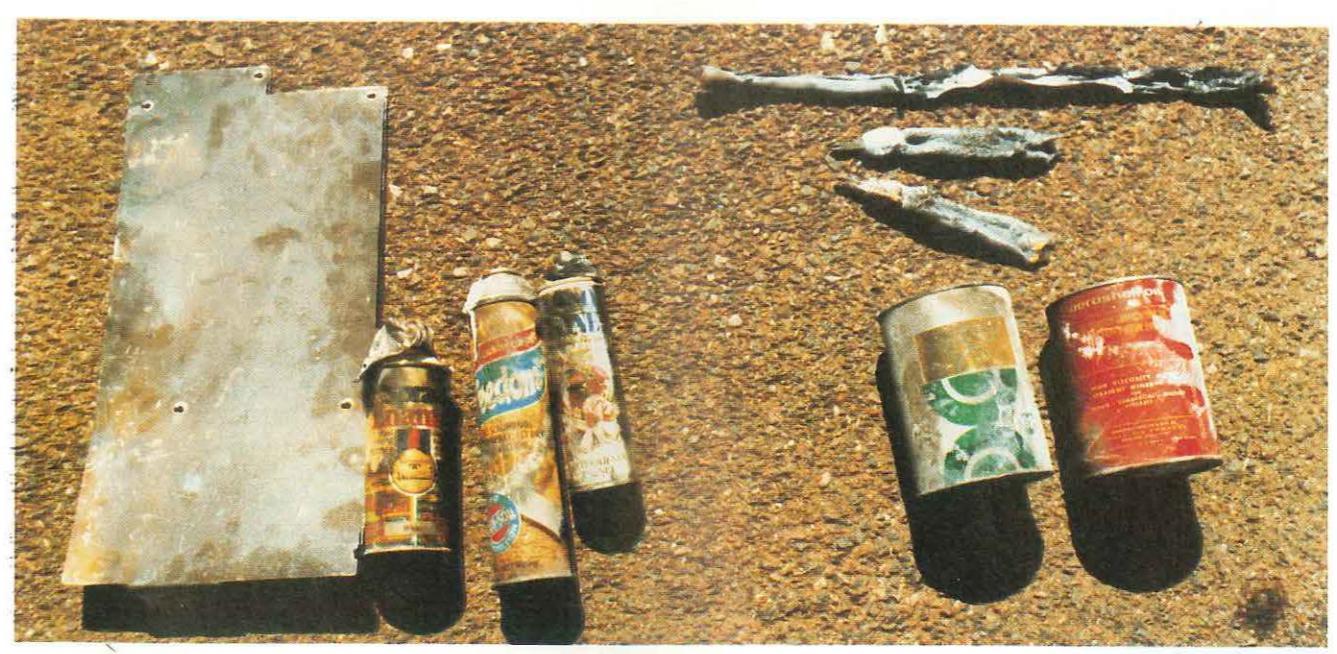
A Beech 58 on a charter flight from Laverton to Kalgoorlie was 10 miles from destination when the pilot noticed black smoke entering the cockpit from the base of the forward bulkhead. Alternators and unnecessary equipment were switched off, and after advising Kalgoorlie FSU of a cabin fire, VHF Comm and the battery were also switched off. The black smoke thickened rapidly, and in an effort to make the cockpit environment bearable the pilot opened the main cabin door with the assistance of his sole passenger. The battery was switched on prior to gear and flap extension, FS was advised the aircraft was on a right base for RW28, and the battery then switched off again.
