Hydraulic system failure involving Boeing 757, VH-TCA

Auckland International Airport, New Zealand | 5 February 2018

Aviation Occurrence Investigation AO-2018-014 Final – 1 May 2019 Released in accordance with section 25 of the Transport Safety Investigation Act 2003

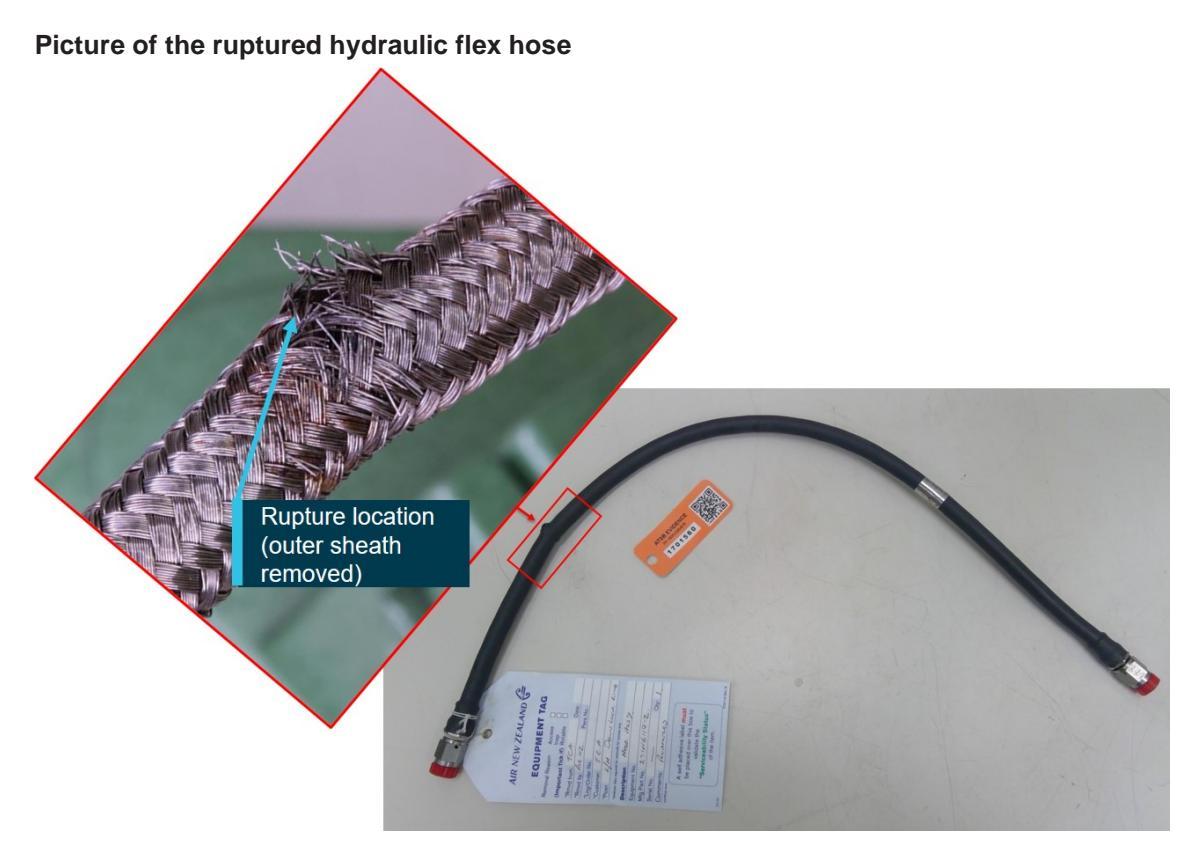
Rupture location (outer sheath removed)

After the occurrence, the operator conducted an examination of the aircraft and discovered that the left main landing gear (MLG) downlock actuator retract flexible (flex) hose was ruptured. No faults were detected during an operational check of the right system and the power transfer unit (PTU) (see the section titled *Boeing 757 Hydraulic System*). The required components were replaced as per the aircraft maintenance manual (AMM) and the aircraft was returned to service.

The sequence of events leading to the dual hydraulic system failure commenced with rupture of the left main landing gear downlock actuator retract flex hose under pressure (during landing gear retraction). This resulted in the depletion of the hydraulic fluid in the left side and, subsequently, low pressure in the left system. The exact mechanism of the rupture could not be determined due to extensive corrosion on the fracture surfaces. However the hose did not exhibit any physical damage that would have made the hose more susceptible to failure.

Following the occurrence, the operator conducted preventative maintenance on the aircraft, replacing all of the main landing gear flex hoses as well as updating the PTU pressure switch to conform to the published service bulletin. In addition, the operator revised the aircraft maintenance plan to introduce improved inspections and a time-limited life on the flex hoses.

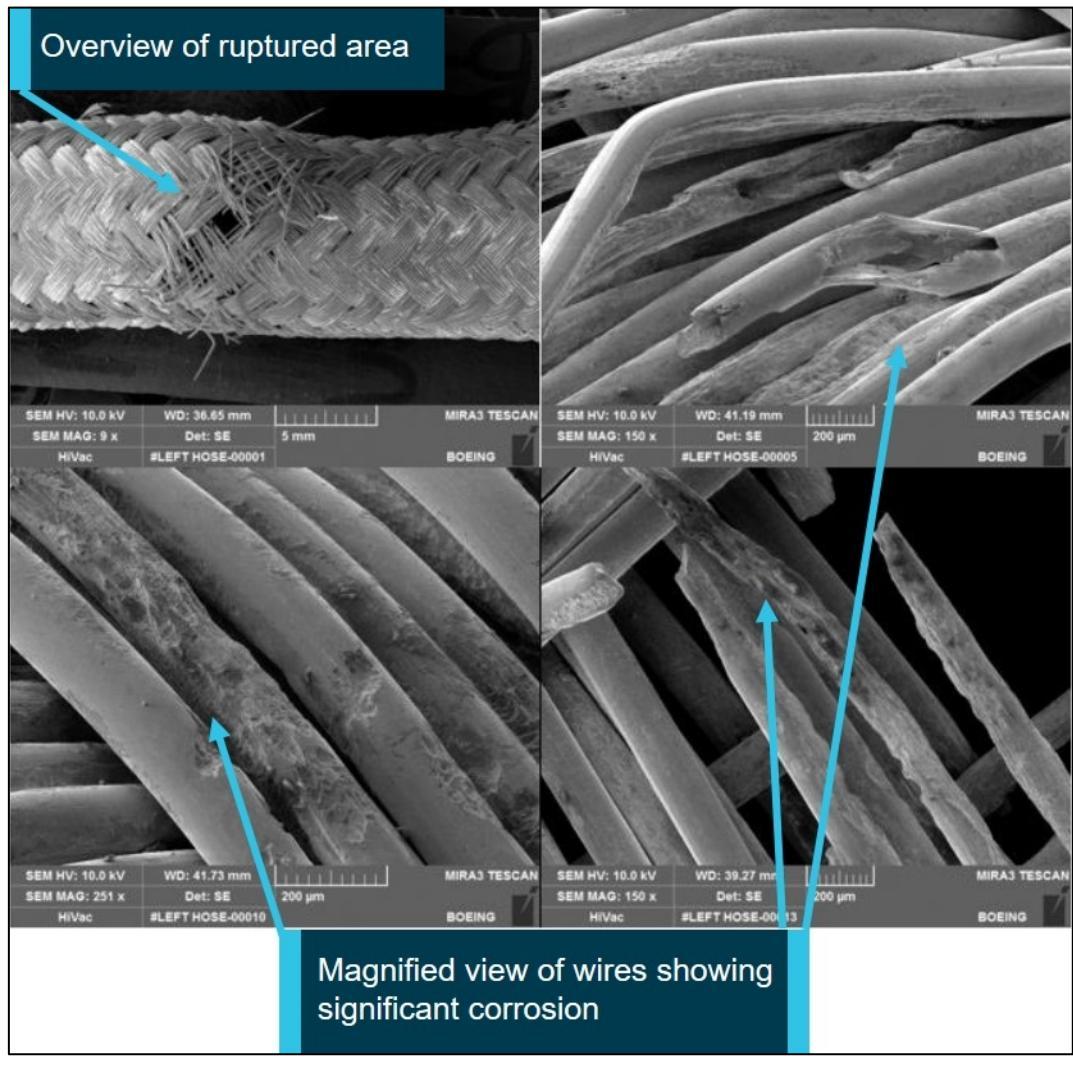
Figure 4: Scanning electron microscope images of the ruptured area on the left hose

- the chemical composition of the braid material fell within the required specifications
- the direction of the failed wires indicated that the braided hose failed under burst pressure
- the location of the rupture was not coincident with the maximum bend location on the hose, indicating the failure was not due to bending fatigue
- corrosion was limited to the rupture location, indicating that it was likely the wires corroded after the rupture (Figure 4)
- there was some evidence of ductile overstress on the individual wire filaments, but significant corrosion on the fracture surfaces made determination of the failure mode impossible
- no wear, cuts, abrasion or pinching on any of the layers of the hose was evident
- there was no evidence of manufacturing anomalies or kinking/twisting of the hose to indicate improper installation.

- A 6-year soft life on all main landing gear flex hoses (replacement of hoses after 6 years rather than just on condition replacement) was introduced.

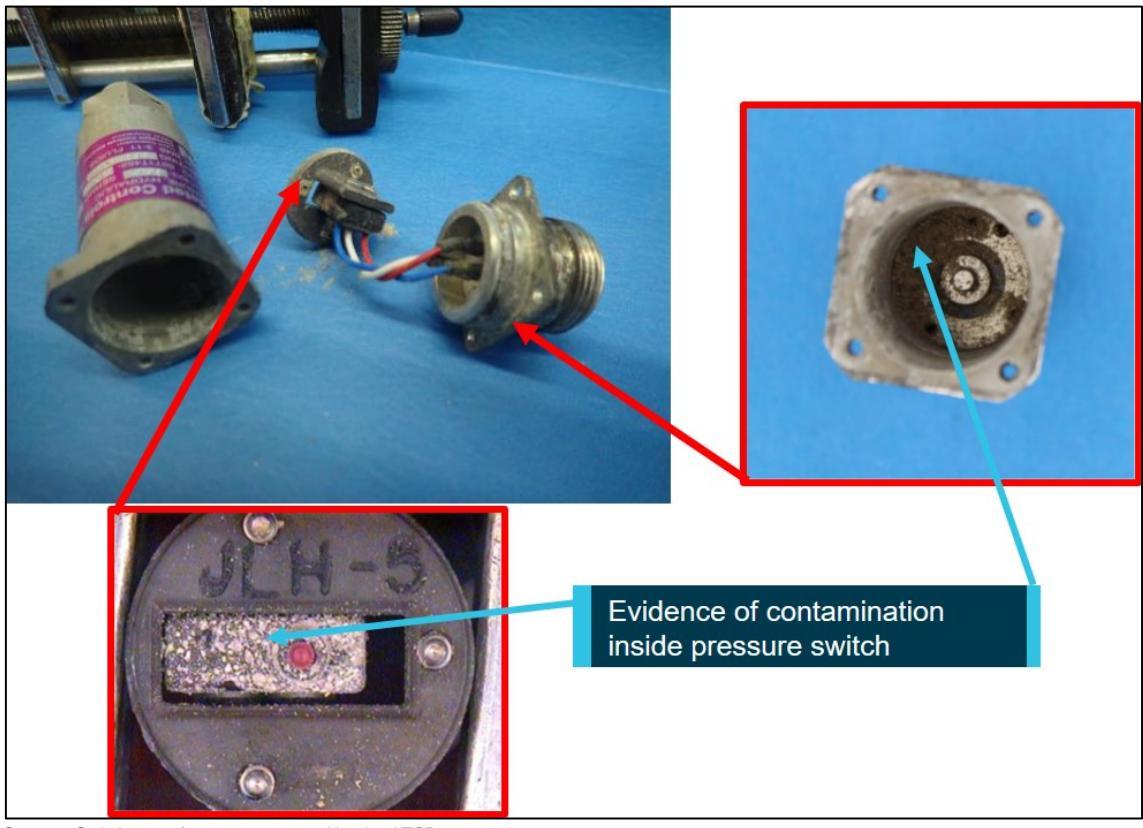
Figure 5: PTU pressure switch installed on VH-TCA

The examination of the PTU pressure switch revealed that the electrical switch contacts were stuck in the 'normally open' state due to an excessive amount of contamination on and around the electrical switch button. The contamination prevented the switch from returning to the 'normally closed' (unpressurised) condition. The visual appearance of the contamination was consistent with corrosion, as identified in the 2010 SB (SB 29-09-05-02).

Visual examination revealed a large amount foreign object debris (FOD) throughout the entire unit. Indications were that the FOD entered the unit past the O-ring seal between the receptacle and the unit housing (Figure 5).

After the crew shut down the left system, the right hydraulic system overheated due to the power transfer unit (PTU) pressure switch being stuck in the open position and the associated pump running continuously without hydraulic fluid in the left hydraulic system. These events were consistent with the failure sequence reported in the 2001 and 2010 service bulletins. The non-mandatory 2010 service bulletin to modify the susceptible PTU switch had not been actioned, which probably resulted in the failure of the pressure switch due to contamination/corrosion.

- Nose landing gear and main landing gear hydraulic flex hoses were all replaced.
- The 2010 SB for the power transfer unit pressure switch was incorporated.
