# Flap and landing gear overspeed during go-around involving Airbus A320, VH-VQL

9 km south of Sydney Airport, NSW, on 9 May 2018

ATSB Transport Safety Report Aviation Occurrence Investigation AO-2018-034 Final – 7 May 2019 Released in accordance with section 25 of the Transport Safety Investigation Act 2003

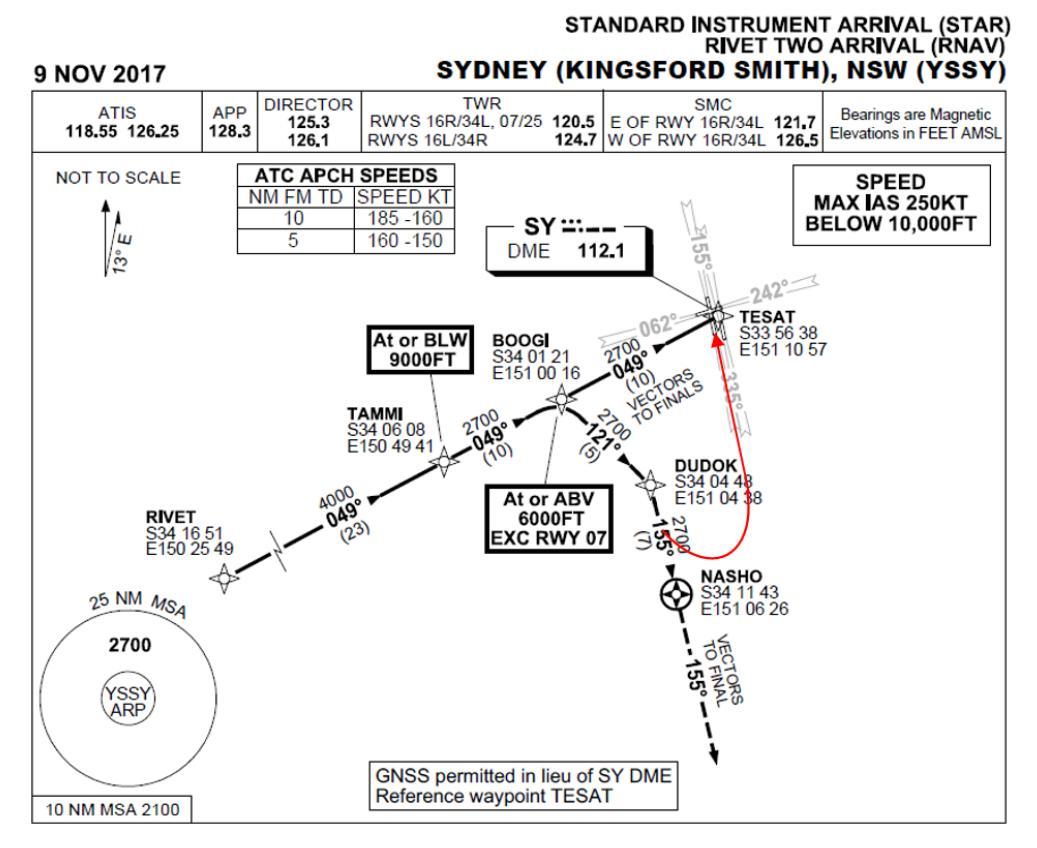
#### Figure 1: Departure and approach chart – Sydney Airport

Source: Airservices Australia, modified by ATSB. After passing DUDOK, ATC provided clearance to conduct the runway 34L<sup>4</sup> Independent Visual Approach (IVA) and provided radar vectors for a final approach intercept (Figure 2 and red line on Figure 1). Crossing the coast, the aircraft was about 2,000 ft high on profile compared with other similar approaches (see the section titled *Approach profiles*) Figure 1.

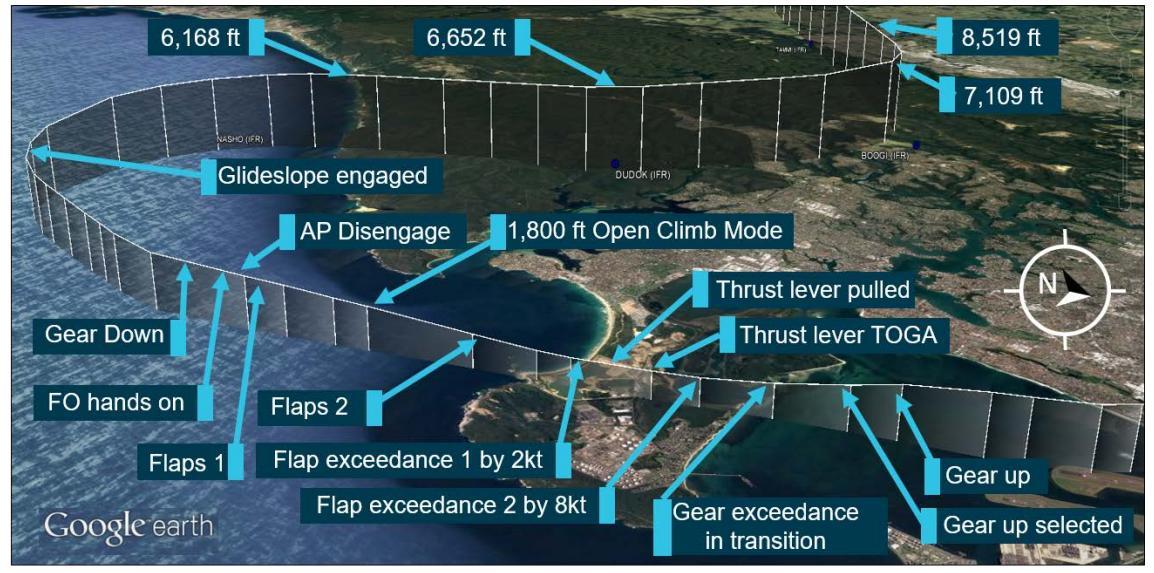
After intercepting the final approach course, the flight crew selected landing gear down and disengaged the autopilot. The FO reported manually flying the aircraft to intercept the glideslope from above. At about 2,850 ft, which was 300 ft above glideslope, the flight crew selected the first flap setting for landing.

Prior to configuring for 'flaps 2', the flight crew selected the missed approach altitude of 3,000 ft in the altitude window of the flight control unit (FCU). The recorded data indicated that the altitude selector was also pulled, which changed the aircraft's vertical flight mode from open descent to open climb. In response to the mode change, the auto-thrust system, which was active at the time, increased thrust to climb the aircraft to 3,000 ft. Unaware of the thrust increase, the flight crew continued configuring for the approach by selecting 'flaps 2'.

The increase in thrust increased the aircraft's airspeed. This led to the FO reducing the aircraft's descent rate in an attempt to manage the acceleration and prevent flap overspeed. Despite this, the aircraft's airspeed continued to increase, leading to a 2 kt flap overspeed. Reducing the rate of descent also resulted in the aircraft diverging further from the approach glide path.

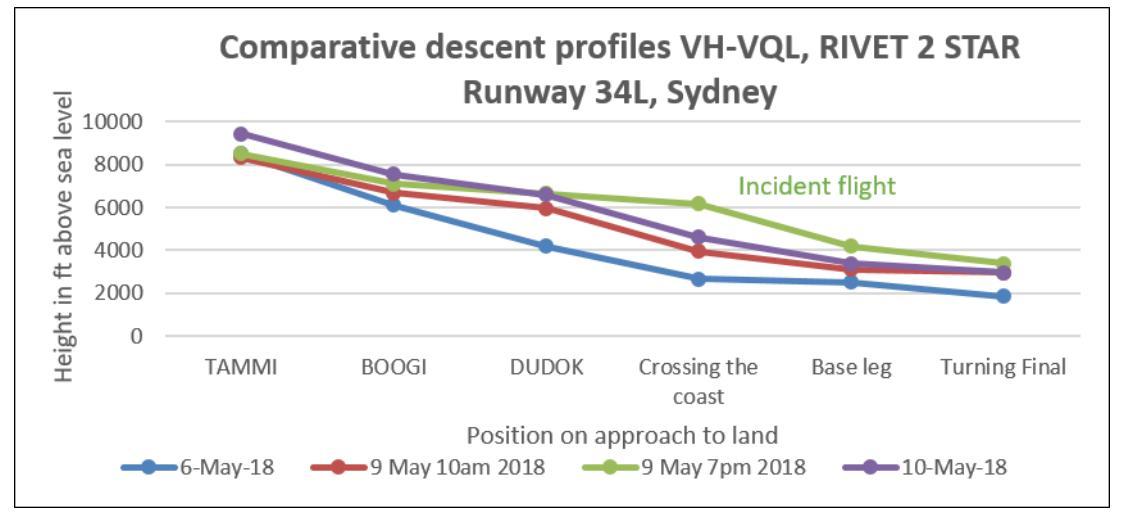
Table 1: Comparative descent profiles for VH-VQL on the RIVET 2 STAR, Sydney

The approach profile for VH-VQL, between DUDOK and final approach to runway 34L, was comparably higher and faster than previous flights (Table 1 and Figure 3).

Despite being cleared for a high speed descent during the initial phase of the arrival, the aircraft was recorded to have arrived at BOOGI slightly high on profile, with an airspeed reduced to 250 kt, which was required by the standard operating procedures (SOP). However, between DUDOK and NASHO the aircraft's descent shallowed until crossing the coast prior to NASHO. This positioned the aircraft about 2,000 ft high on profile in comparison to other flights that were flown in the same aircraft type by different flight crews.

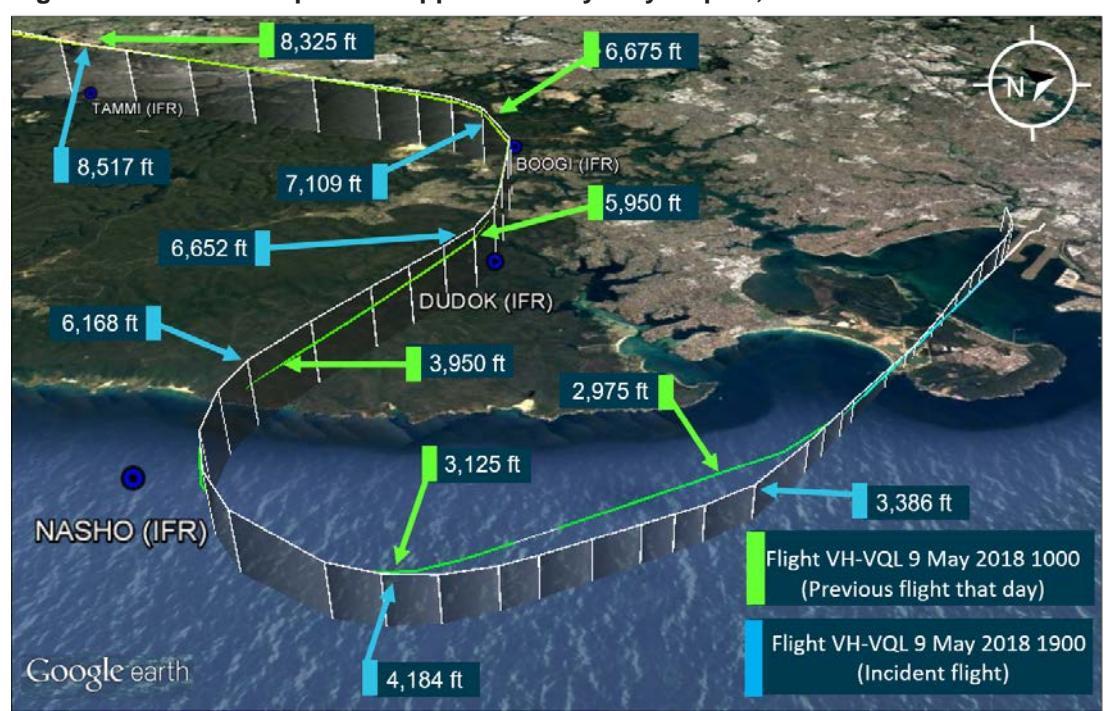
Figure 3: VH-VQL comparative approach to Sydney Airport, RIVET TWO STAR 34L

Recorded data indicated that the descent rate of the aircraft increased after crossing the coast, which corresponded to the ATC clearance for the commencement of the IVA. Further, the data showed the aircraft's selected speed target remained set at 250 kt prior to intercepting the final approach track. The flight crew continued to use various speed targets for the remainder of the approach in an attempt to slow/configure the aircraft and capture the glideslope profile.

The data also indicated that the aircraft turned onto final approach at about 9.8 NM from the runway threshold, at about 3,400 ft. The aircraft's speed turning final was about 223 kt. This resulted in delays with aircraft configuration and achieving a stabilised approach.
