# Runway excursion involving Boeing 737, VH-VUI

Darwin Airport, Northern Territory | 6 December 2016

**ATSB Transport Safety Report**

Aviation Occurrence Investigation AO-2016-166 Final – 15 May 2019 Cover photo: Source: ATSB

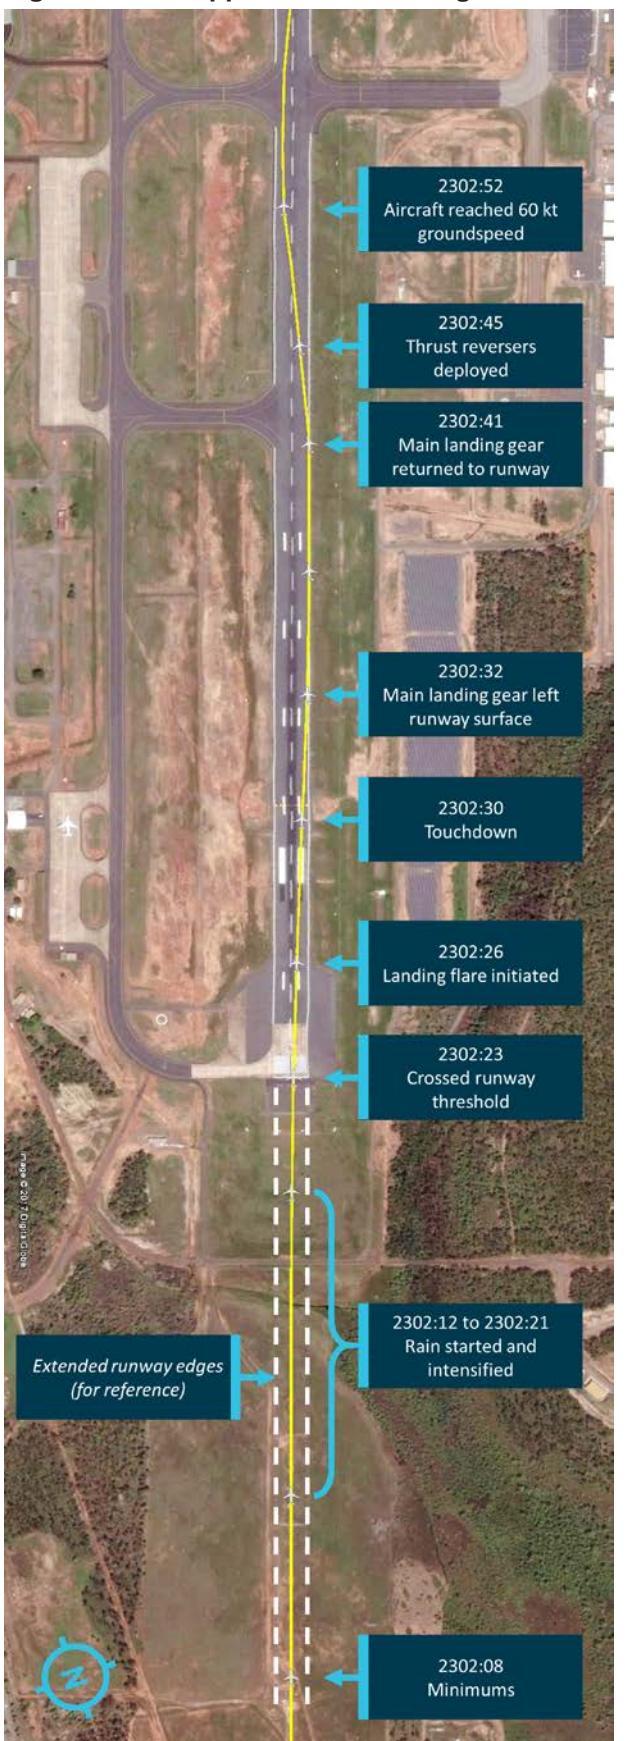
At 2302:33, 4 seconds after landing, the right main landing gear departed the right side of the runway. The captain recalled hearing a repeated, light thudding noise. He asked the first officer if they had hit the runway lights and the first officer responded that that they were just missing the lights. The aircraft's nose was oriented to the left of the direction of travel, placing the flight crew and nose gear over the sealed surface and inside the painted runway edge markings. The first officer later reported feeling a shudder, as though the wheels were skidding. Both flight crew recalled that the physical sensation and noise were not as strong as they would have expected from the wheels departing the runway.

Figure 1: Final approach and landing roll of VH-VUI

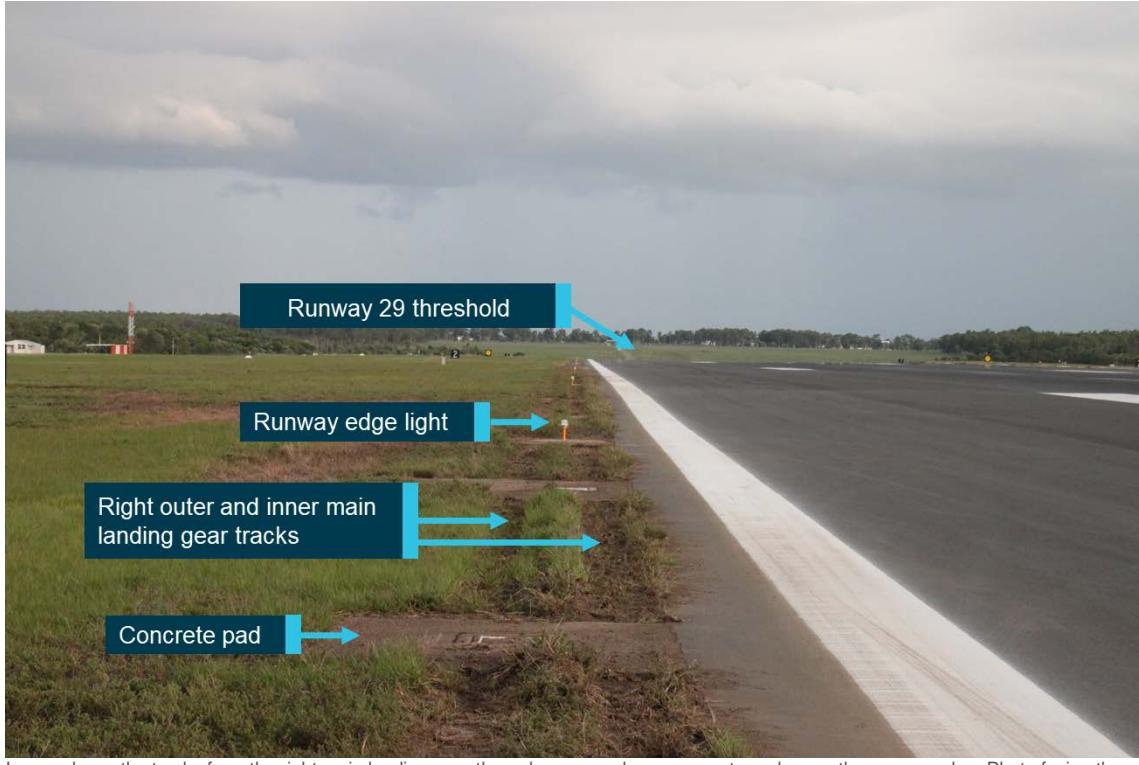
The aircraft landed 21 m to the right of the runway centreline and, shortly after touchdown, the right landing gear departed the sealed surface of the runway, destroying six runway lights before the aircraft returned to the runway. The aircraft incurred minor damage from ground debris and there were no injuries.

Figure 2: Wheel tracks where VH-VUI departed the runway 29 sealed surface and destroyed runway edge lights<sup>11</sup>

<sup>&</sup>lt;sup>11</sup> The photograph was taken after displayed high intensity runway lights that were damaged by impact were replaced.

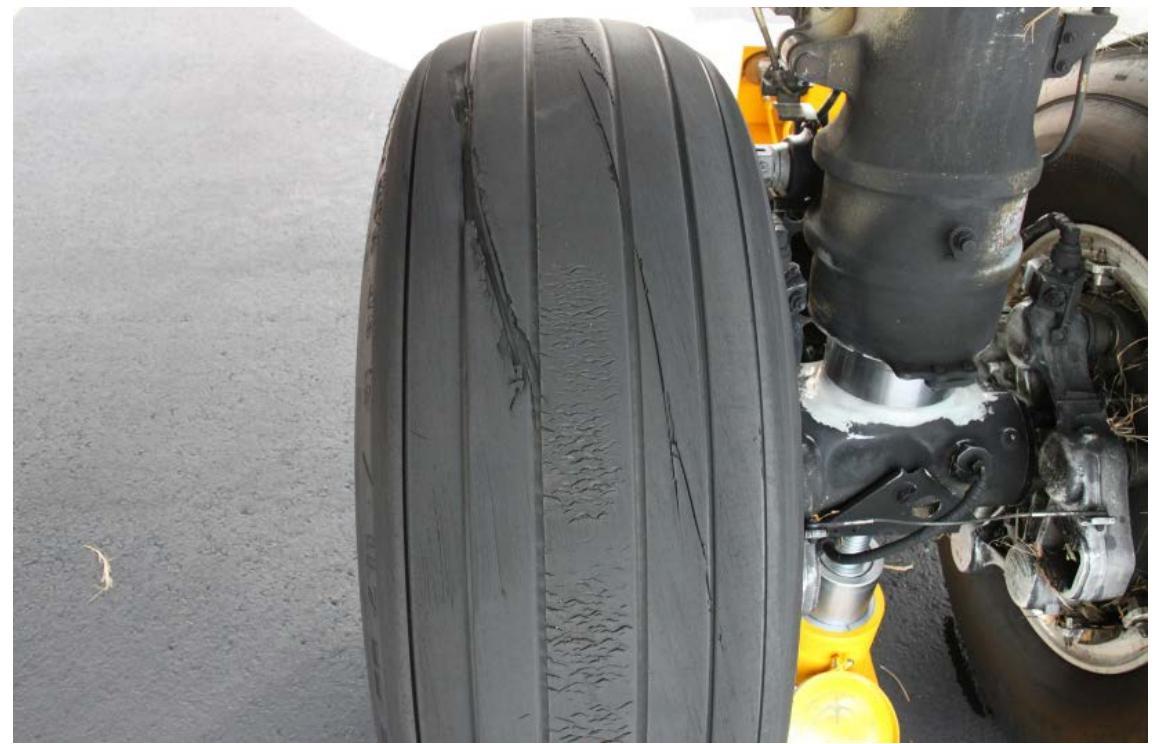
#### Figure 3: VH-VUI tyre damage

Image shows cut damage to the right main landing gear outboard tyre. The chevrons in the centre of the tread are normal. Source: ATSB

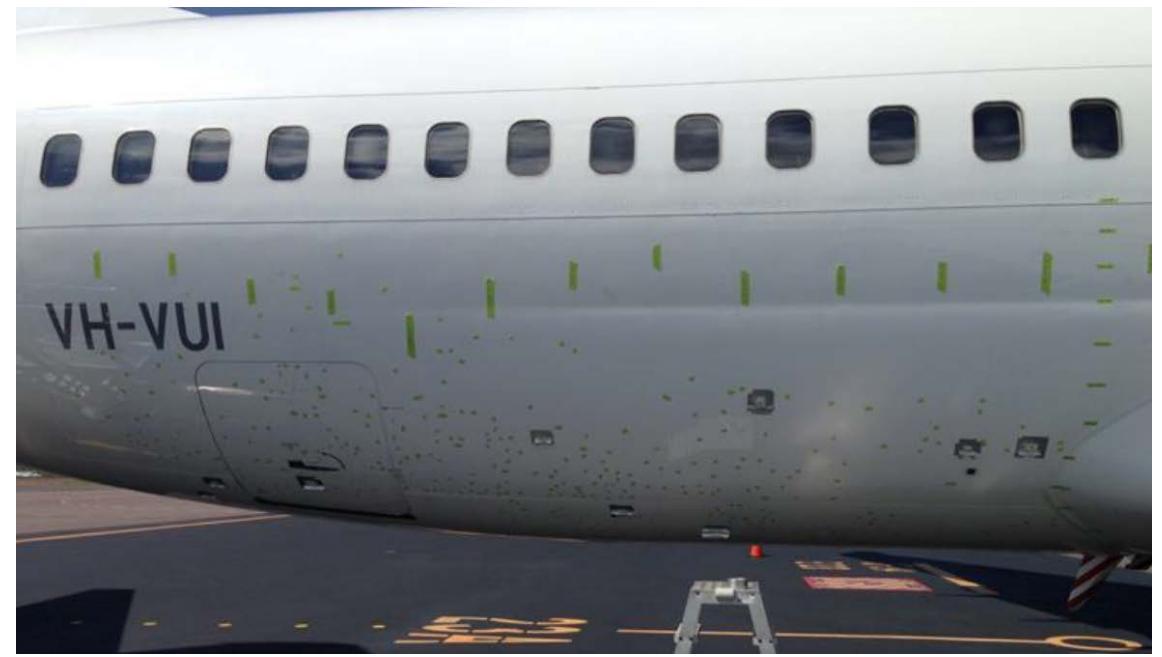
Debris impacted the aircraft resulting in minor damage to areas of the right aft fuselage and right horizontal stabiliser (Figure 4). A large quantity of grass accumulated in the vicinity of the right wheel well, landing gear and wing flaps.

Figure 4: VH-VUI fuselage damage, marked with green tape

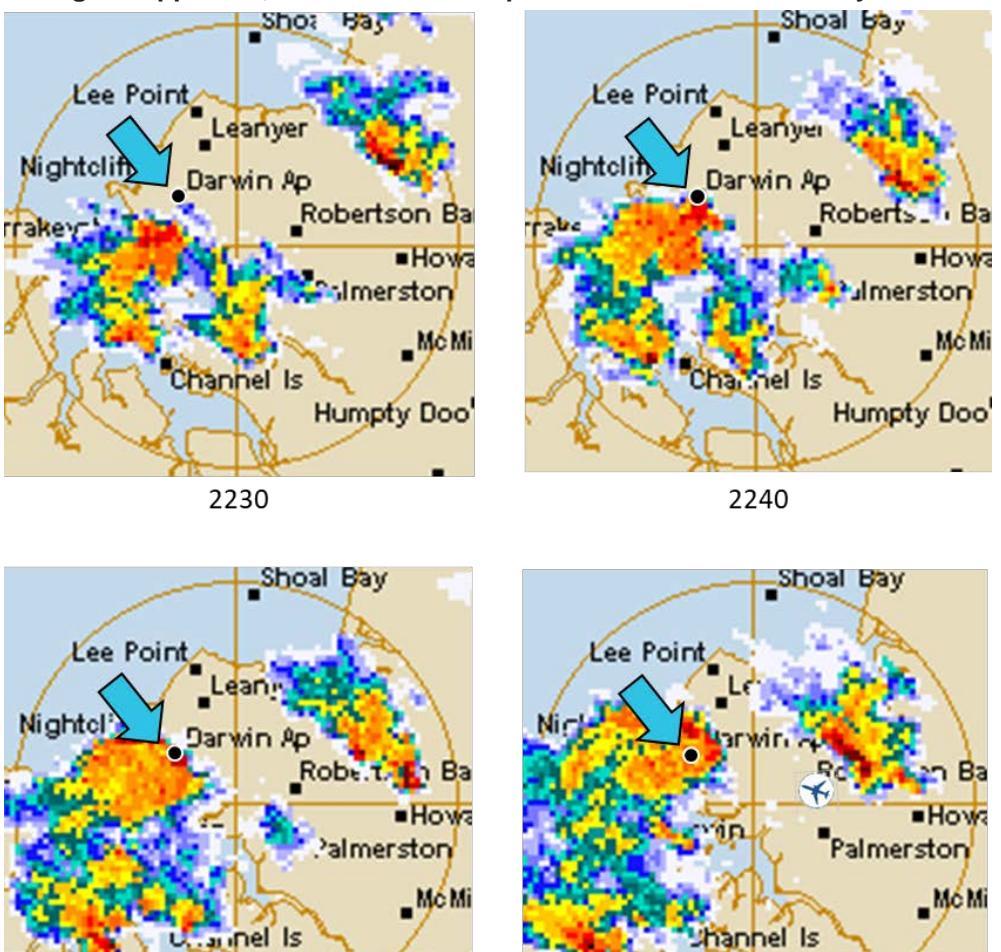
Closed-circuit security video showed rain at the terminal (2 km north-west of the runway 29 threshold) starting and increasing from about 2250, and becoming heavy by 2302. Over this period, the video showed four brief, bright flashes consistent with lightning strikes.

Recorded lightning strike data showed significant activity in the area. In the 5 minutes before VH-VUI landed (at 2302), there were several lightning strikes within 5 NM of the airport and two within 5 NM of the aircraft. Some of these may not have been visible to the flight crew due to them potentially being obscured by cloud.

Figure 5: Ground-based radar images showing rainfall near Darwin Airport (blue arrow) during the approach, with the aircraft's position at 2300 indicated by an aircraft symbol

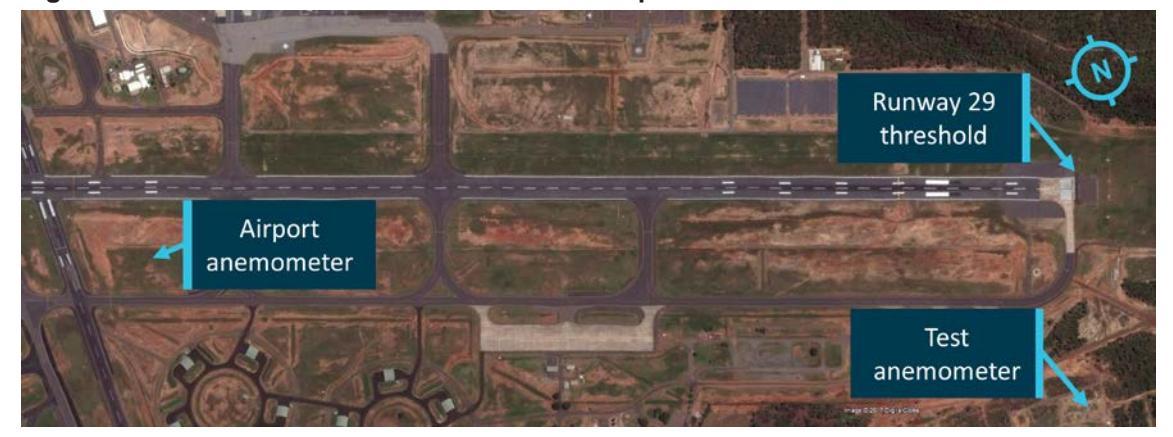
Figure 6: Location of anemometers at Darwin Airport

Due to a failure attributed to a lightning strike,<sup>14</sup> the airport anemometer was unserviceable at the time of the occurrence and no wind information was being displayed in the control tower. Darwin tower controllers obtained wind information from windsocks located at the airport, and through BoM observers via telephone for information from a second, test anemometer about 550 m south of the runway 29 threshold. Wind data from this anemometer was relayed to the tower controllers by a trained BoM observer.

According to fault records, the primary anemometer was unavailable or exhibited faults on 32 occasions from February 2013 to December 2016, including 21 occasions in the wet season (November to April). The median time to repair was about 2.5 hours and the average was 14.5 hours. On four occasions, the repair took longer than 24 hours.

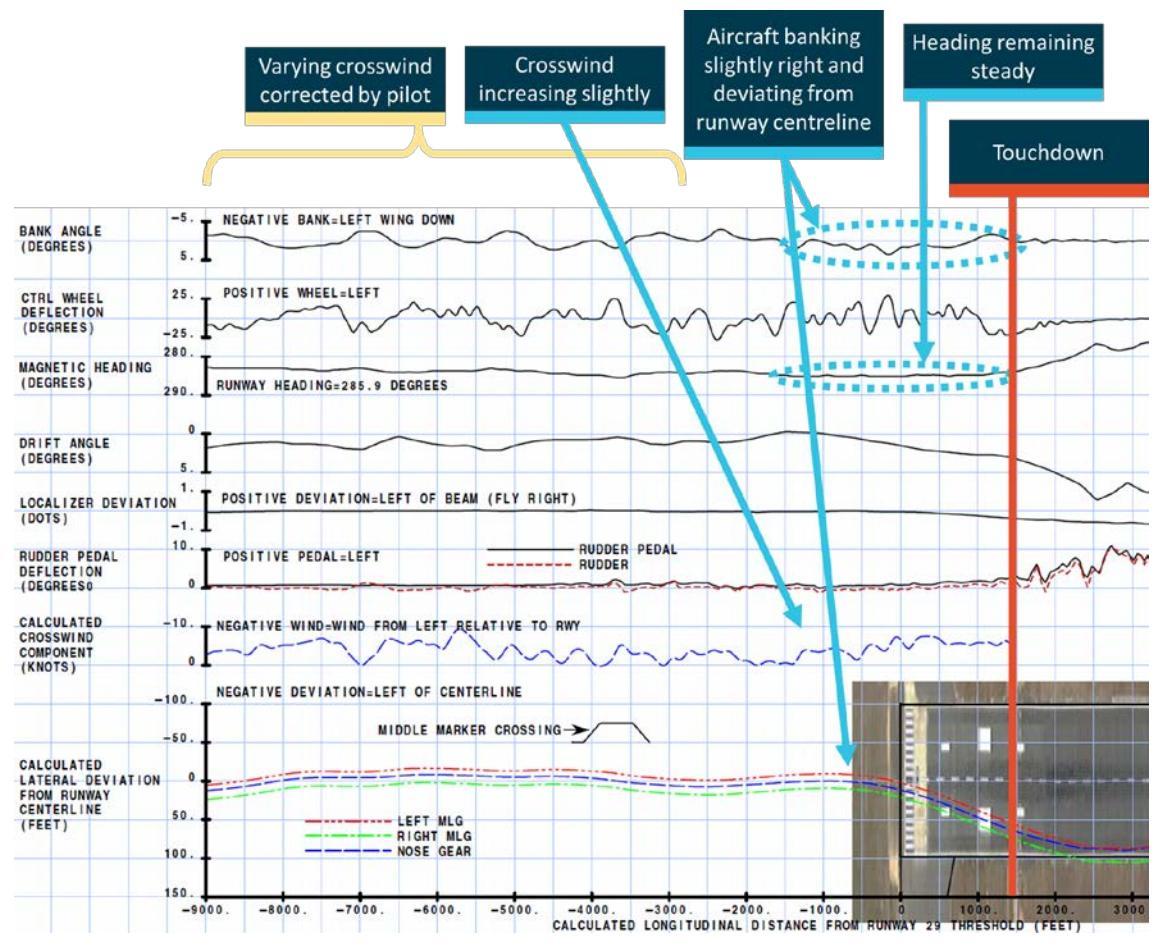
The kinematic analysis indicated that in the few seconds before crossing the threshold (2303:23), the crosswind varied but it was not significantly more than it had been previously (Figure 7). However, in a gradually increasing crosswind from about 140 ft, about 5 seconds before crossing the threshold, the aircraft banked slightly right and began drifting right, without correction. A combination of momentum and continuing crosswind meant that the drift to the right continued until touchdown.

## Figure 7: Recorded data showing the aircraft's drift from centreline. The runway width is exaggerated and the markings are different to those at the time of the occurrence.

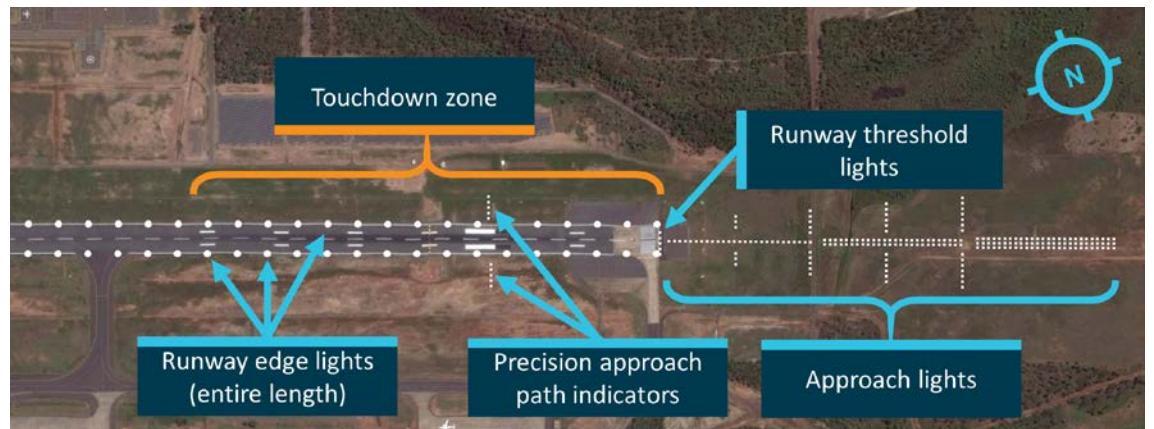
Runway 29 was 3,354 m long and 60 m wide, and the centre 45 m was grooved to aid water displacement and had a retractable arrestor cable in the touchdown zone for military use. The runway was equipped with an instrument landing system (ILS) that allowed for precision approaches in operations to category I minima (without autoland).

The runway had white markings along the centreline, an aim point starting 342 m from the threshold, and five touchdown zone markings from the threshold to 900 m. The runway had high intensity approach lights, runway threshold lights, and runway edge lights spaced at 60 m intervals.<sup>17</sup> There were also precision approach path indicator lights each side of the aim point (Figure 8).

Figure 8: General arrangement of runway lighting at Darwin Airport runway 29
