# Wirestrike involving a Robinson R44, VH-ZWK

20 km from Naracoorte, South Australia, on 13 March 2019

ATSB Transport Safety Report Aviation Occurrence Investigation AO-2019-011 Final – 28 June 2019 Released in accordance with section 25 of the Transport Safety Investigation Act 2003

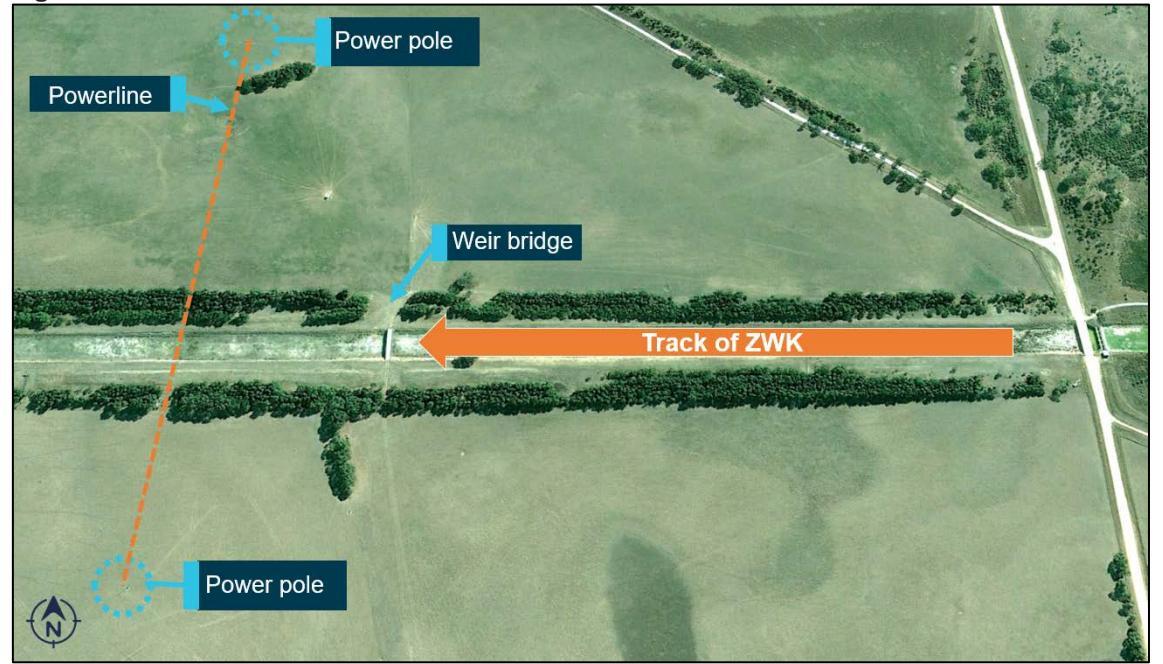
#### Figure 1: Accident location

The pilot commenced another spray flight at around 1430. The pilot started the spray run from a public road at the eastern end of the drain section, flying west towards the weir bridge and the powerline (Figure 1). The pilot recalled that, as he commenced this run, he reminded himself of the presence of the powerline further along the drain. The pilot turned on the spray nozzles, then looked at the nozzles and spray pressure gauge to confirm the spraying equipment was functioning as expected.

Shortly after passing the weir bridge, ZWK struck the powerline. The helicopter's ground speed was around 60 kt at the time of impact.

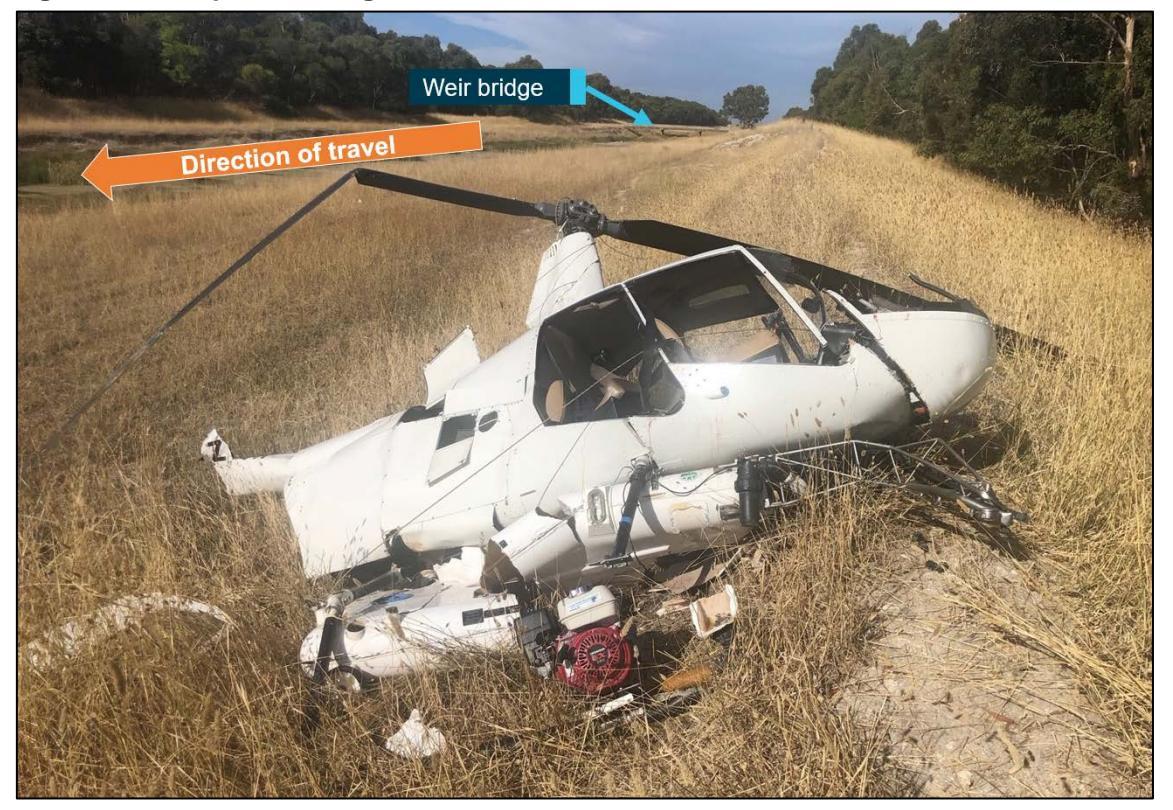
#### Figure 2: Helicopter wreckage

The initial impact occurred around the centre of the front windscreen, just above the helicopter's headlights. The powerline wire then cut into the helicopter, slowing its forward movement. The wire cut up into the helicopter cabin and the control instruments.

The pilot reported that that he retained some control of the aircraft following the impact, and was able to partially cushion the landing. However, the helicopter landed hard on the bank of the drain. The pilot exited the helicopter with minor injuries. There was no fire, but the helicopter was destroyed (Figure 2).

Although the helicopter in this accident collided with terrain and was destroyed, there was no post impact fire. The helicopter had been fitted with a bladder-type fuel tank, and there was no indication of a fuel leak. The bladder-type fuel tank probably reduced the likelihood of a fuel leak and post-impact fire following the collision.

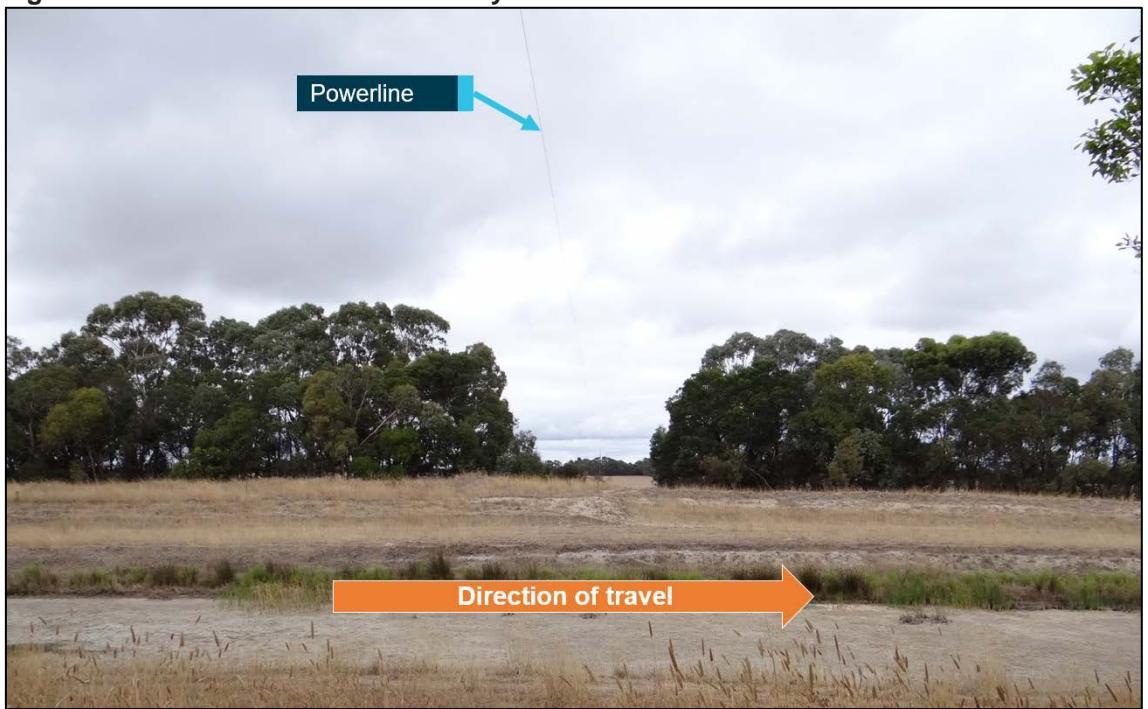
Figure 3: Powerline and drain boundary

The powerline struck by ZWK was a single-wire earth return (SWER) line, which consisted of a single line of intertwined narrow-gauge steel wires. The powerline spanned 244 m, and the approximate point of contact was 60 m from the nearest power pole. At the approximate point of contact, the powerline was about 8.9 m high, above the edge of the drain bank. There were no markers or other devices installed on the powerline to enhance its visibility, nor was there any requirement to install such devices.

The drainage channel was about 30 m wide, with a further 10-15 m clear bank on each side before a tree-lined boundary. This tree-lined boundary obscured visibility of the power poles from

within the drainage channel (Figure 3). It is likely that this reduced the ability of the pilot to use the power poles as visual cues for the position of the powerline.

Native vegetation near the power poles obscured additional visual cues for the presence of the powerline. The powerline was narrow-gauge and had no markings. Due to the limits of the human eye, powerlines can be very difficult to see, particularly in low level flight.<sup>3</sup>

- Discussing the accident in team meetings, in order to increase focus on key hazards and risks.
- Providing pilots conducting future spraying operations at the Bool Lagoon with georeferenced maps of the area.
- Introducing additional company documentation for drain spraying to further document sitespecific hazards prior to the start of each job.
- Making human factors training mandatory for pilots conducting aerial application. This training intends to increase pilot awareness in the wire and low-level environment.
