In-flight fire involving Kavanagh B-350 hot air balloon, VH-ZYO

near Coldstream, Victoria on 26 December 2018

ATSB Transport Safety Report Aviation Occurrence Investigation AO-2019-001 Final – 28 June 2019 Released in accordance with section 25 of the Transport Safety Investigation Act 2003

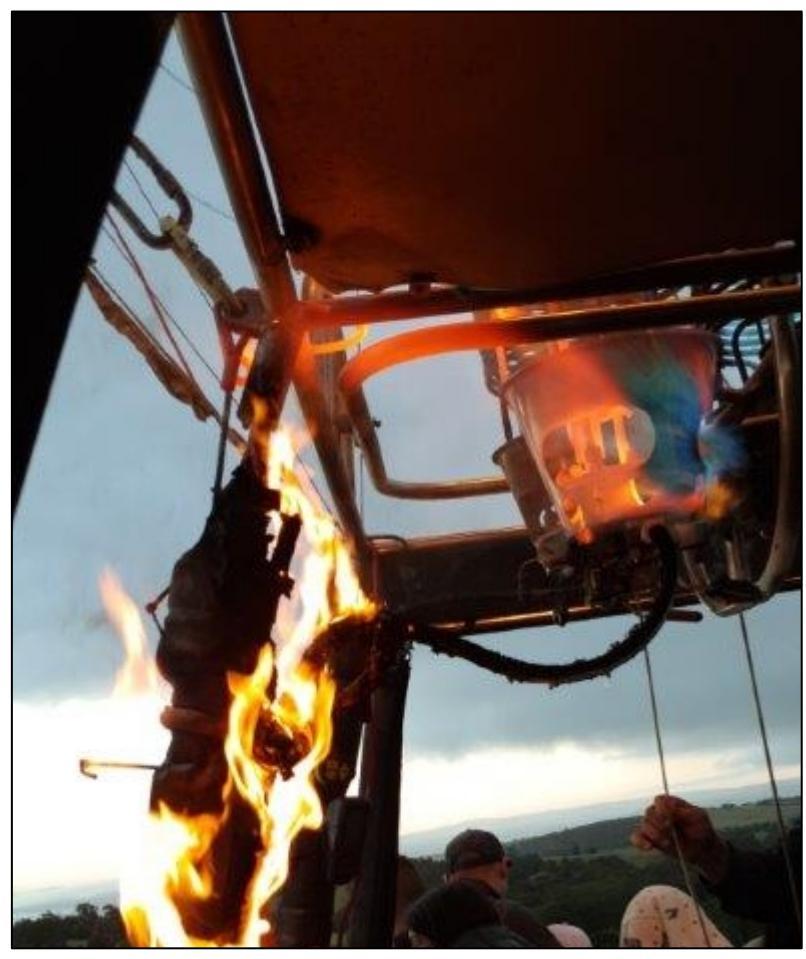
After 20 minutes in flight, and while operating at an altitude of about 800 ft, the pilot recalled hearing a small explosion from the front left burner and observed that a small fire had started on the outside of the burner. The pilot switched off the vapour valve at the fuel tanks to the front two burners and disconnected the hoses.

About a minute later, the pilot attempted to put out the fire using one of two on-board extinguishers, but the fire re-ignited almost immediately. After a further minute, the pilot discharged the second fire extinguisher, but again the fire re-ignited.

On-board view of in-flight fire involving VH-ZYO

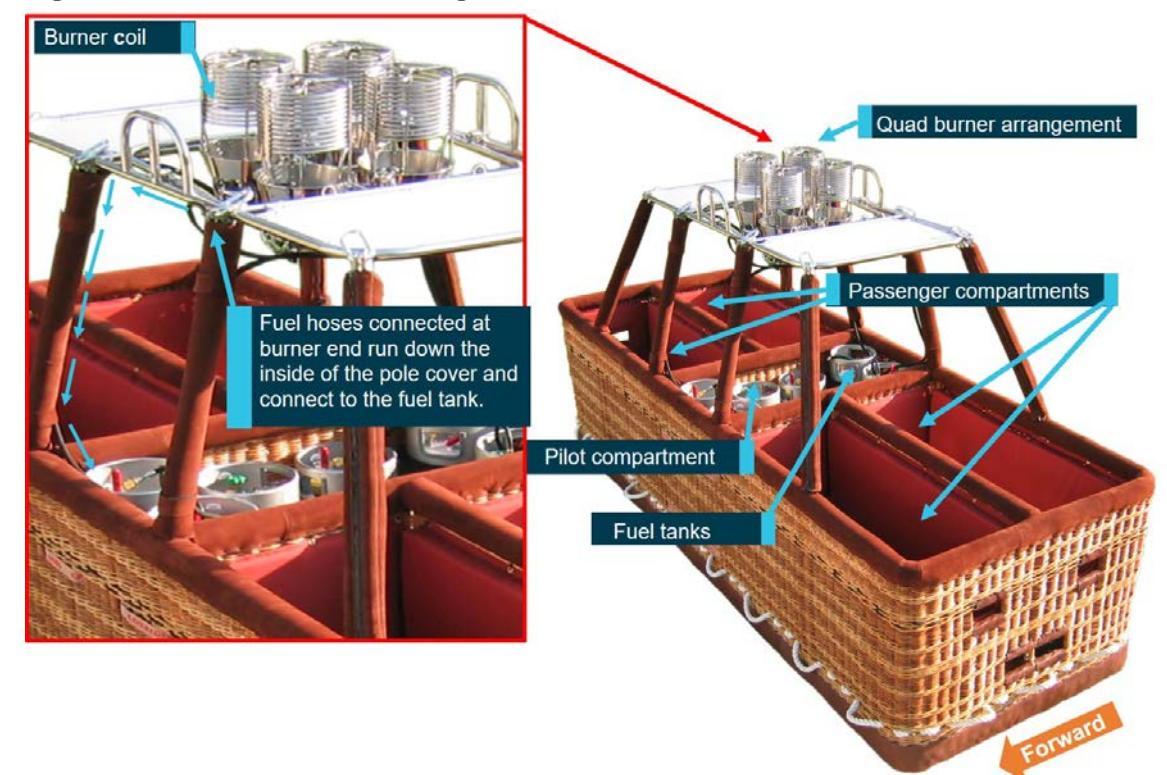
Figure 1: Basket and burner arrangement similar to VH-ZYO

A Kavanagh series 3, quad burner system was installed on the aircraft. The burner unit consisted of four high-pressure propane burners. Each of the burner units had two connections to the fuel tank: a vapour hose (connected to the pilot burner) and a liquid hose, which connected into the burner coil (Figure 1). A standard feature of the system included a secondary burner, known as 'liquid fire'. This system bypassed the heat exchanger coil and fed liquid propane directly into the burner. The vapour hose drew gaseous propane from the top of the fuel tank and the liquid hose drew liquid propane from the bottom of the fuel tank. The fuel tanks on VH-ZYO had hand-wheel shut-off valves installed at the connections for both the liquid and vapour hoses. The alternative certified configuration was a 90-degree valve. Both valve configurations are shown in Figure 3.

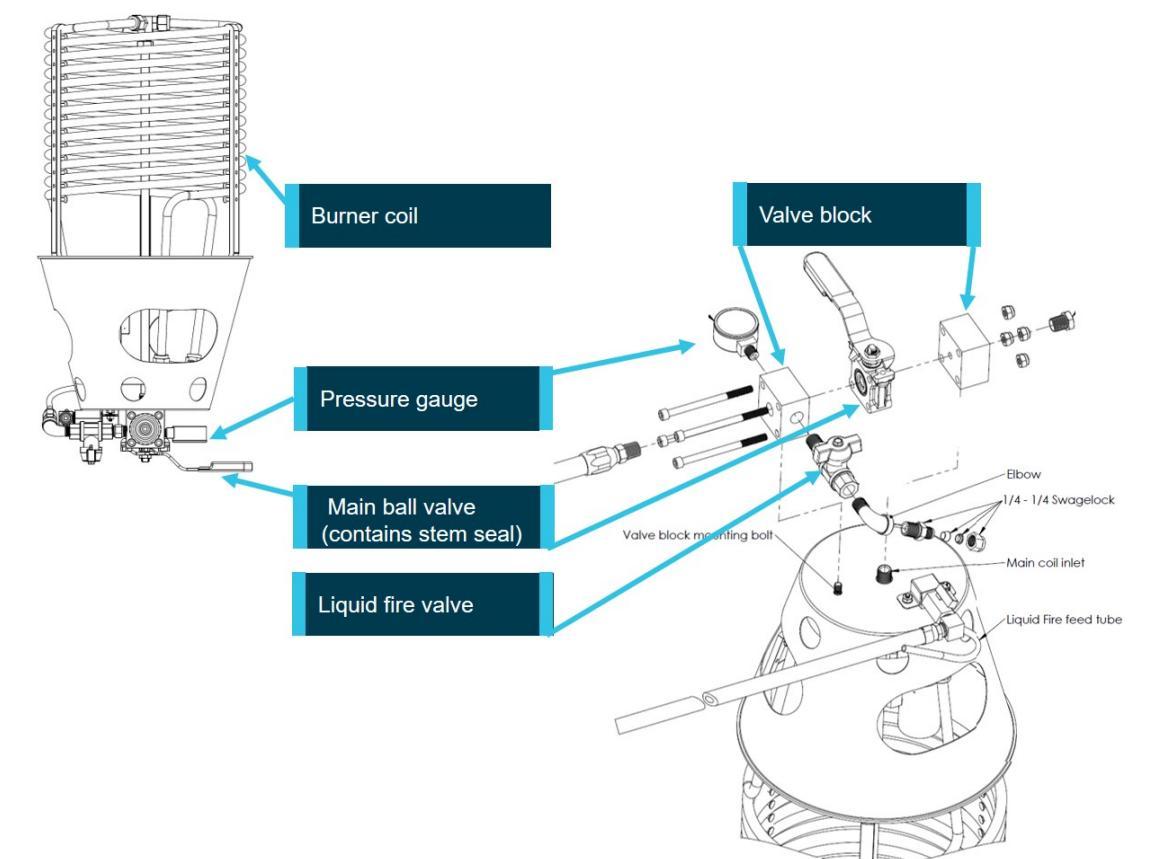
An illustrated diagram of a burner unit is shown in Figure 2 below. Figure 2: Illustrated diagram of the burner system on VH-ZYO

The main valve block (Figure 2) was an assembly of two solid pieces of aluminium, fastened either side of the main ball valve with four bolt and nut combinations. The liquid fire valve, liquid fuel hose, pressure gauge and cross flow plug each screw into a threaded hole in the main valve block.

- threaded connection between the liquid fire valve and main valve block
- liquid fire valve
- main ball valve.

The direction of the flame (towards the front of the balloon) was in line with the connection of the liquid fire valve into the main valve block. On installation, over-torquing or cross-threading the connection could result in damage to the aluminium valve block. Stresses from pressurisation and thermal cycling over time can cause the damage to develop into a crack, resulting in a fuel leak. However, as this joint did not require frequent adjustment, the likelihood of damage due to installation error or handling was reduced.

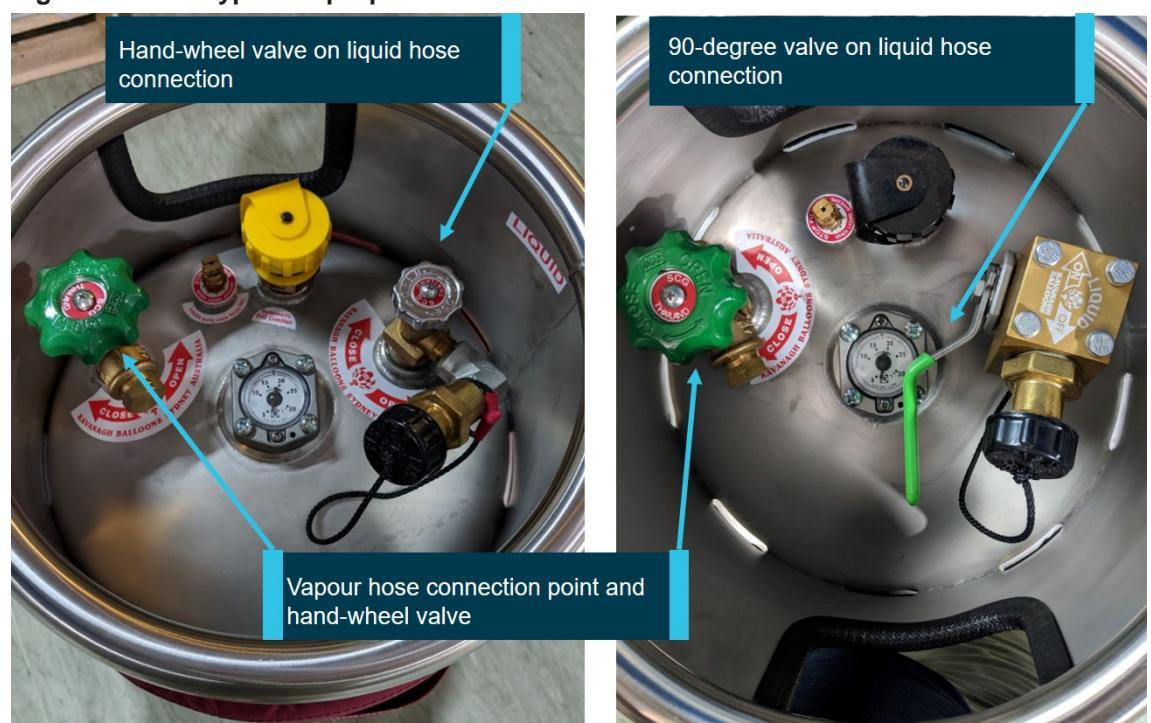
Figure 3: Valve types on propane tank

The hand-wheel valve on the liquid outlet of the fuel tank and the pilot burners were not shut-off, which resulted in the pilot being unable to control the fire. Installation of a 90-degree valve on the liquid fuel outlet may have assisted the pilot to recognise that the liquid fuel valve was not shut-off.

The European Aviation Safety Authority (EASA) has previously published a safety information bulletin (<u>SIB 2018-14</u>) highlighting the advantages of using 90-degree valves over the hand-wheel valves. EASA recommends operators of hot air balloons use the 90-degree valves for propane fuel cylinders as they had been found to improve the survivability outcome in the event of fire due to their easy and quick actuation.

In addition, Go Wild Ballooning has advised the ATSB that they have replaced all hand-wheel valves with 90-degree valves on all fuel tanks and reviewed the company policy on protective clothing.

- upgraded one basket to the new Kavanagh Quad Burner system and is considering phasing out the older Kavanagh series 3 systems
- replaced hand-wheel valves with 90-degree valves on all fuel tanks
- reviewed the company policy on protective clothing, and are researching new fire-proof gloves.

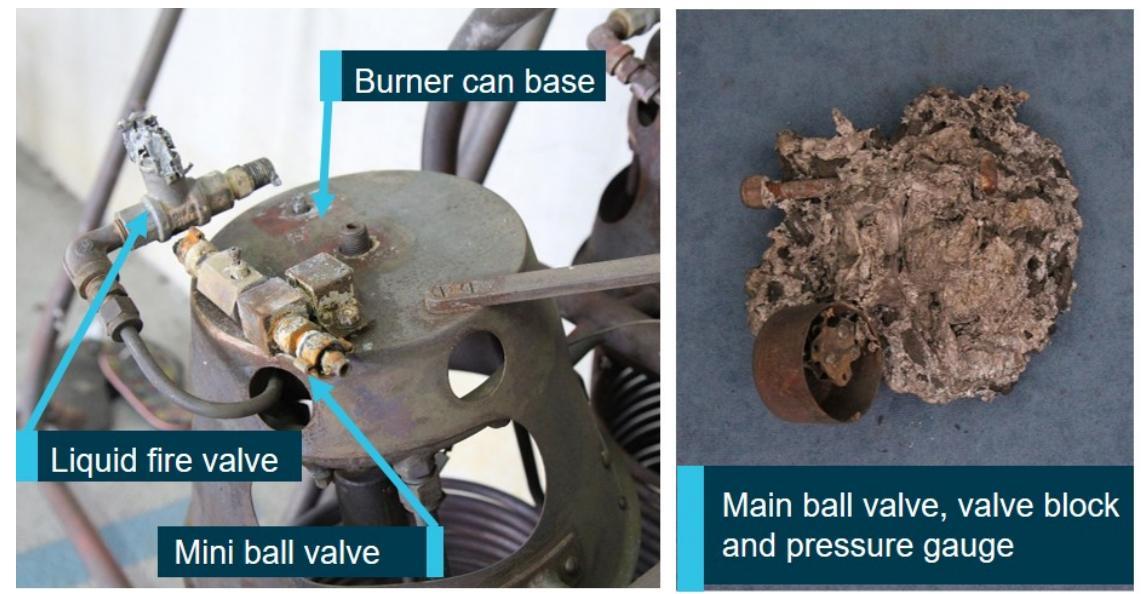
Figure 4: Underside of burner and main ball valve - fire location

- the burner from which the fire was emanating still had the liquid fire valve, the mini ball valve (vapour pilot burner) and the burner coil attached (Figure 4)
- the main ball valve was not attached to the coil (Figure 4)
- in-flight photographs showed that the main ball valve was shut during the fire
- all of the main valve block assembly bolts (with nuts attached) and cross-flow plugs were found intact in the wreckage
- examination of the components did not identify any possible sources of a leak or failure that may have contributed to the in-flight fire
- determination of the integrity of the main ball valve and liquid fire valve could not be established as the internal structures were completely disrupted by the fire.

The pilot first observed the fire coming from the front left burner. Physical examination of the components did not identify any possible sources of a leak or failure that may have contributed to the in-flight fire. However, the location of the fire (front left burner) eliminated any of the connections at the fuel tanks as a source of the leak. With the main valve switched off and the liquid fuel remaining on at the tank, only the pressurised components in between could have been the source of the initial leak. The most likely were considered to be the:

The flames emanated from a location near the main ball valve and the liquid fire valve. The valves (moving components) were prone to wear and therefore at higher risk of leaking than static components. The valves were oriented vertically with a handle on the base. It can be expected that any leaking fluid would spray downwards, into the handle, making it unlikely to see the directional flame pointing outwards from the basket. However, given the fire continued for an extended length of time, it is likely that the initial fire heated the surrounding structure causing failure of seals and joint sealant in other components, leading to further leaks and a larger fire. In that context, images and accounts of the flames directed outwards from the basket may be the result of subsequent failures.

- Inspect the condition and operation of the fuel pressure gauge, stem seal and liquid fire valve.
- Review the fuel system pressurisation limitations. Pressurisation of the fuel gauge beyond the maximum reading may cause catastrophic failure of the pressure gauge.
- Use 90-degree (quick shut-off) valves for the fuel tank liquid outlets.
- Review and rehearse all emergency procedures including in-flight fire and burner malfunctions.
- Both the liquid and vapour valves must be closed on any tanks connected to the burner with a leak or malfunction before any effective firefighting methods can be performed.
- Minimum industry standard protective clothing should be worn, which includes fire-resistant gloves, long-sleeved cotton shirt and sturdy, enclosed footwear
- Carry fire blankets of a size of at least 1.5 m x 2 m.
