# In-flight upset involving Boeing 747-438, VH-OJU

# 110 km SE of Hong Kong Airport | 7 April 2017

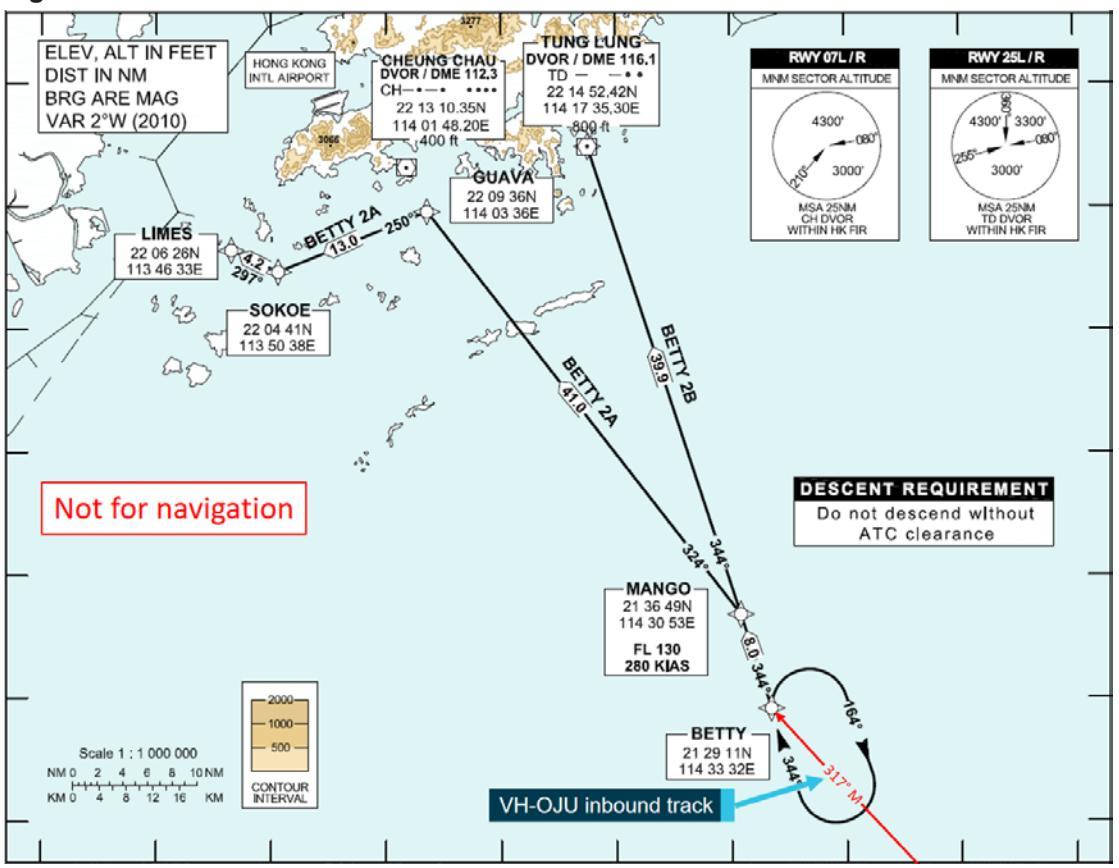
#### Figure 1: BETTY 2A standard arrival route chart extract

At about 1745 Hong Kong Time (HKT),<sup>2</sup> in daylight, the aircraft descended toward waypoint<sup>3</sup> BETTY (Figure 1) with the autopilot engaged in lateral navigation (LNAV) and vertical navigation (VNAV) modes,<sup>4</sup> and the autothrottle engaged. As the aircraft descended from flight level (FL) 300,<sup>5</sup> the customer service manager (CSM) (following direction from the flight crew) advised the passengers to prepare for landing and fasten seatbelts, however, at this time, the fasten seatbelt sign was not illuminated.

The figure shows the position of the BETTY hold along with the inbound track of VH-OJU. Source: Hong Kong CAD, annotated by ATSB

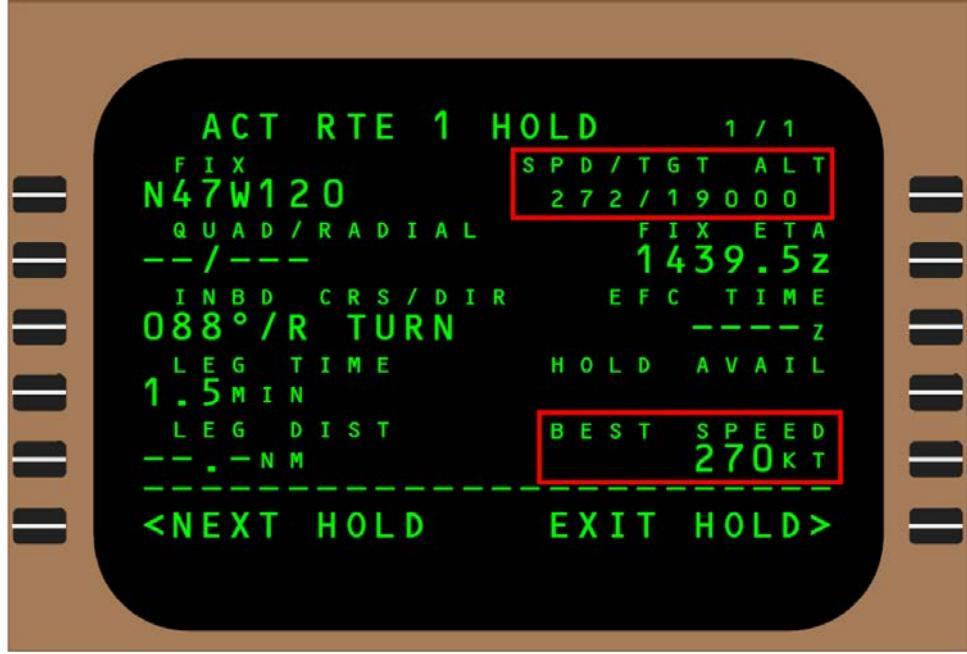
The flight crew anticipated that air traffic control (ATC) would direct them to hold at waypoint BETTY, at about FL 150 to FL 160, and they used the aircraft flight management computer (FMC) to plan for the hold. The FMC provided a calculated target hold speed (Figure 2) of 223 kt at FL156, which was the FMC-calculated crossing level at waypoint BETTY. The crew verified this calculated speed by comparing it to the flaps-up manoeuvring speed (see *Hold speed* below) using a heuristic of adding 80 kt to the flaps-30 landing reference speed of 143 kt, resulting in 223 kt.<sup>6</sup> The captain asked the first officer to input 225 kt above FL 150 as the target hold speed.

The FMC route hold page, showing the best speed indication (representative and not indicating incident data). Source: Operator, annotated by ATSB

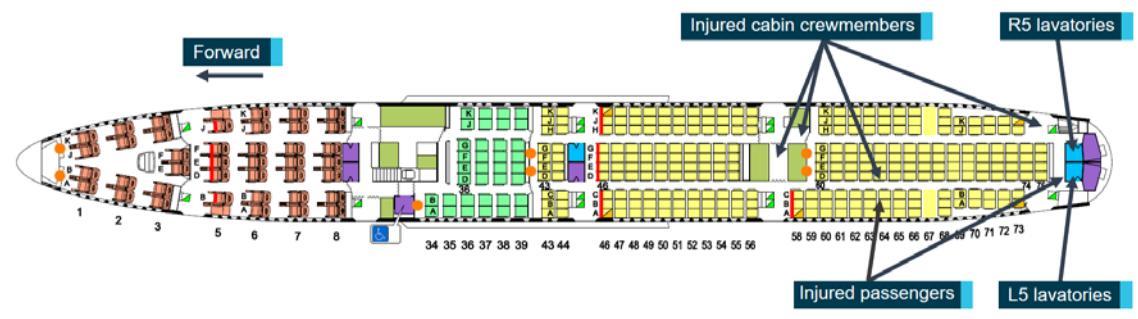
#### Figure 3: VH-OJU main deck layout

During the pilot-induced oscillations, the CSM, who was standing in the left aisle in the vicinity of rows 63 and 64 (Figure 3), struck the cabin ceiling before falling on a seat armrest, sustaining injuries. Five other cabin crewmembers also struck the ceiling, with three sustaining injuries. A passenger located in an L5 lavatory struck the cabin ceiling landing on the lavatory seat, resulting in minor injuries and damage to the lavatory fittings. A passenger in seat 63C who did not have her seatbelt fastened, was also injured.

The figure shows the aircraft main deck layout. The locations of the injured cabin crewmembers, injured passengers and L5 and R5 lavatories are identified. Source: Operator

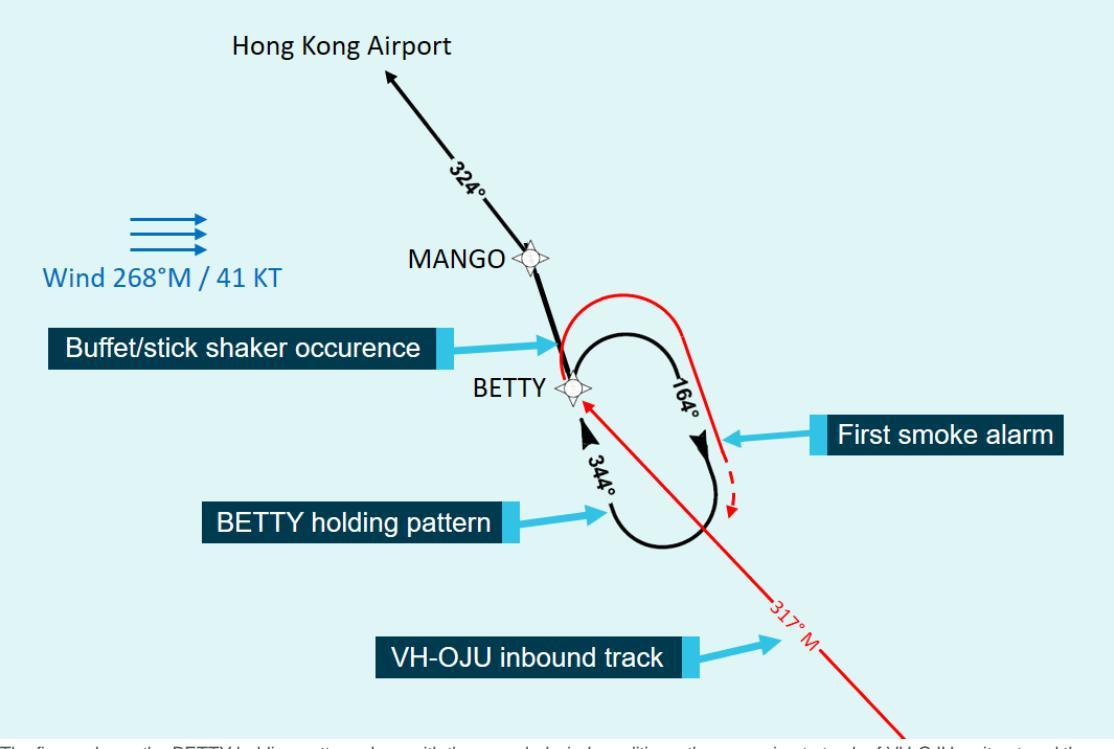
The aircraft tracked 317°M as it crossed BETTY (Figure 4) and began a right turn, through a total of 207°, to track 164°M for the outbound leg of the pattern.

As the aircraft turned, the wind direction moved to a relative position behind the aircraft, increasing the aircraft's ground speed. The increased ground speed required a greater bank angle to achieve the targeted turn radius and outbound track spacing. The first officer also later commented that when the holding entry required a turn in excess of 180°, the autopilot would initially command a bank greater than 30 degrees.

The figure shows the BETTY holding pattern along with the recorded wind conditions, the approximate track of VH-OJU as it entered the holding pattern and the locations of the buffet/stick shaker occurrence and first smoke alarm. Source: Hong Kong Civil Aviation Department, annotated by ATSB

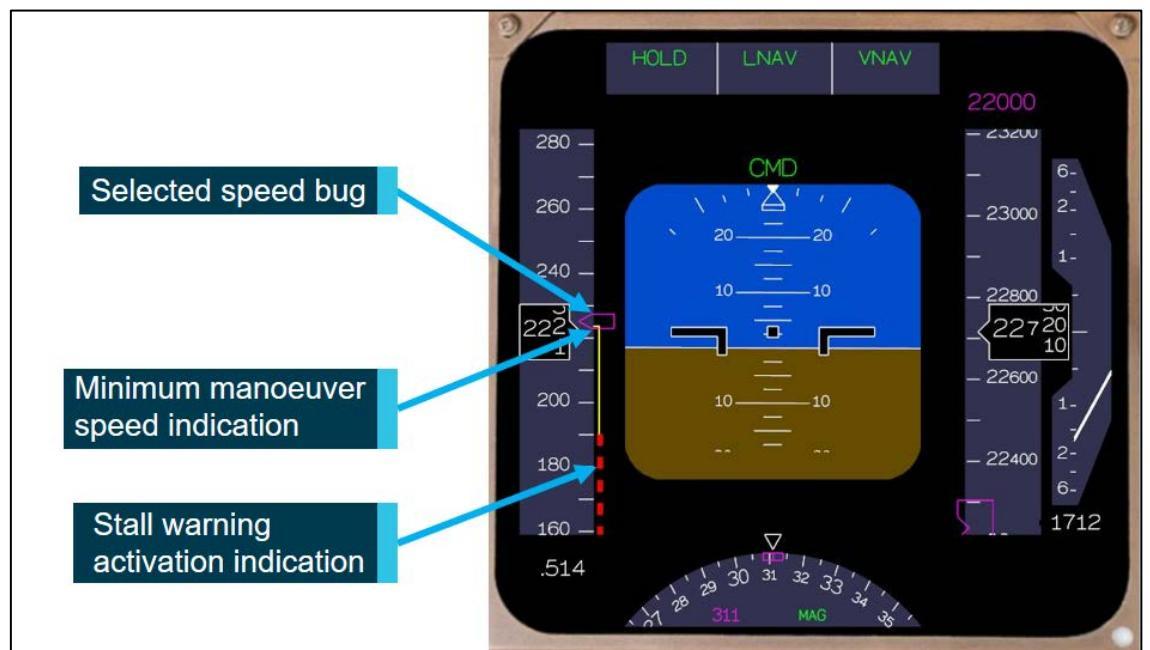
Figure 5: Representation of the primary flight display as the aircraft crossed BETTY

While descending towards BETTY, the aircraft's speed reduced below both the target speed of 225 kt and the minimum manoeuvring speed, which was indicated on the pilot's flight display (PFD) as the top of an amber band (see Figure 5 in *Operational information* below).

The minimum manoeuvre speed is indicated by the top of an amber band on the speed tape of the PFD (Figure 6: Figure 5). When operating at a speed within the amber band, reduced manoeuver capability exists.

This figure shows a representative presentation of the primary flight display as the aircraft crossed BETTY, derived from recorded flight data. The minimum manoeuver speed amber band and selected speed bug are annotated. Source: ATSB

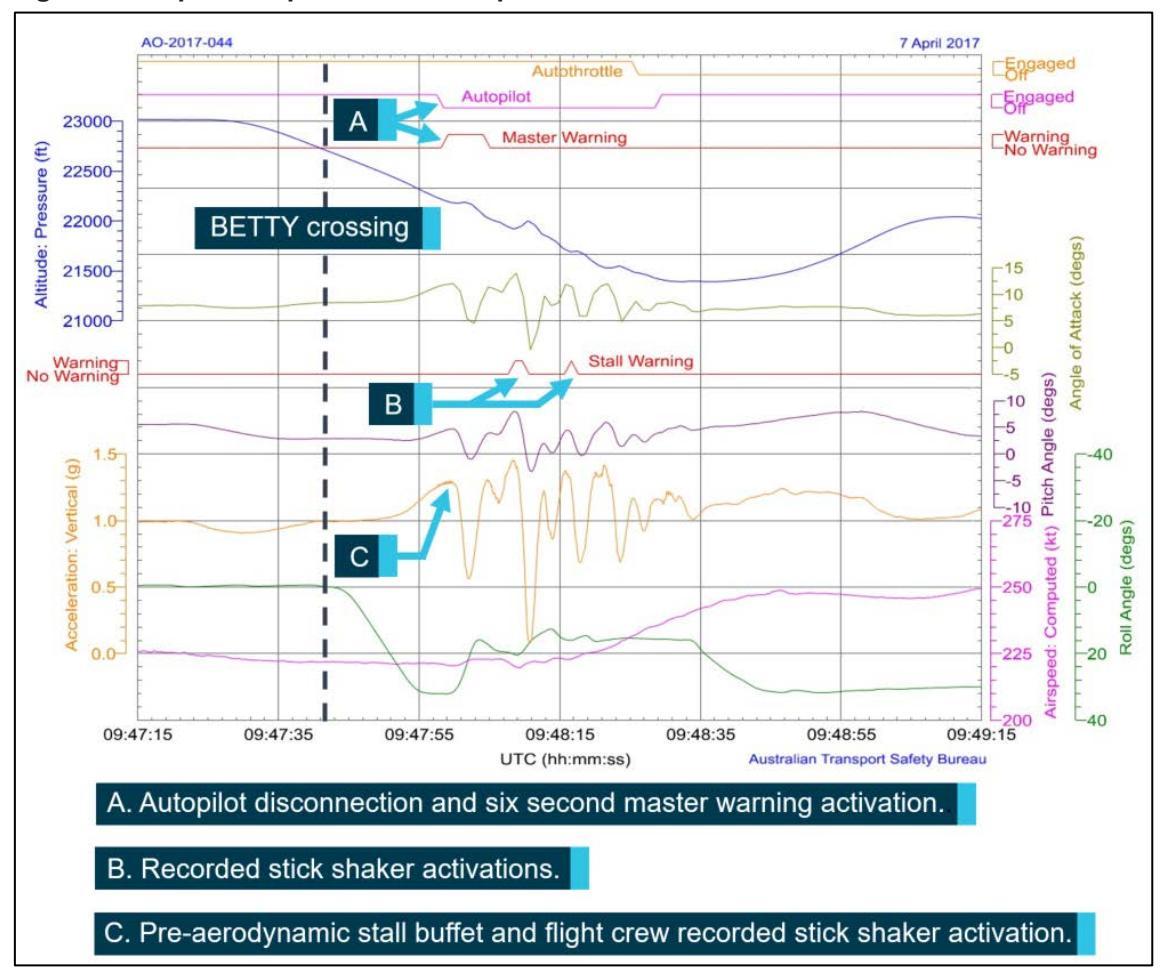
Figure 6: Graphical representation of quick access recorder data

The figure shows a graphical representation of recorded flight data from stick shaker incident significant points of the occurrence are annotated. Source: ATSB

For the 747-400, at the event flight condition, the estimated maximum vane angle of attack before stall is achieved would be approximately five degrees.<sup>15</sup> During this occurrence, the highest recorded vane angle of attack was approximately -0.5 degrees, resulting in significant margin to the estimated maximum vane angle of attack when stick shaker activated.
