Australian Government Australian Transport Safety Bureau

Collision with terrain involving an Insitu ScanEagle X200 unmanned aircraft system (UAS)

near Woleebee Creek, Queensland, on 9 January 2019

ATSB Transport Safety Report Aviation Occurrence Investigation AO-2019-004 Final – 15 August 2019 Released in accordance with section 25 of the Transport Safety Investigation Act 2003

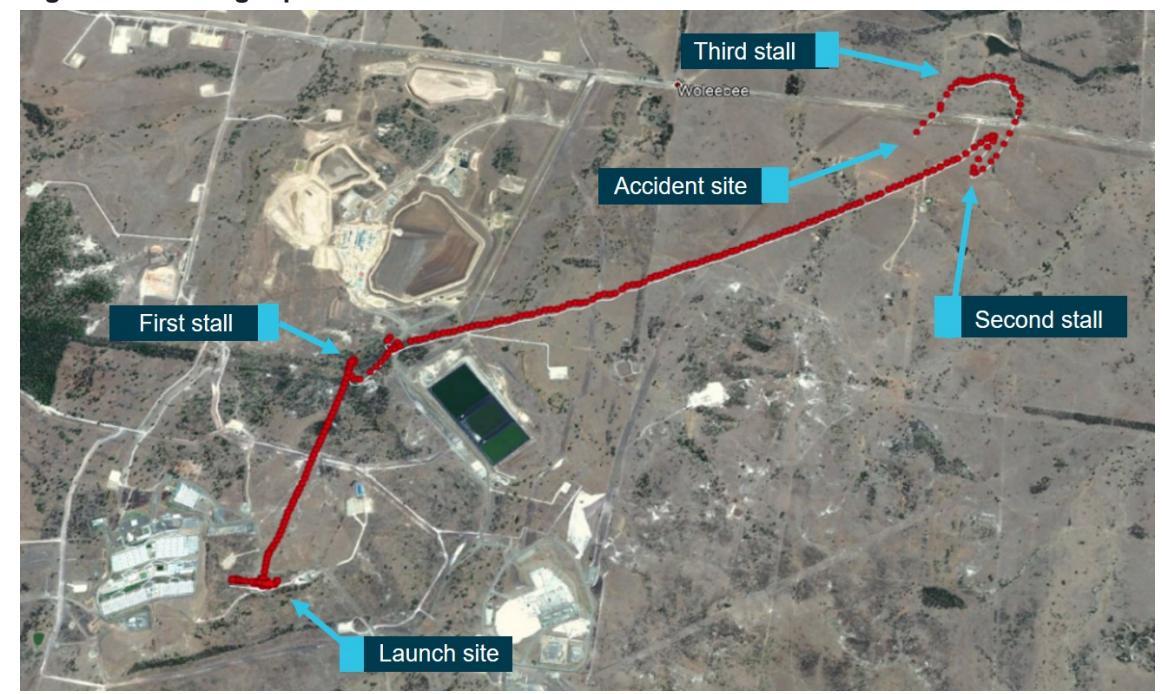
Figure 1: X200 flight path

Telemetry data showed that, about 90 seconds after the first stall, the X200 entered a second stall. The X200 self-recovered again, at about 150 ft above the ground, and commenced a climbing orbit. After about 30 seconds, the X200 entered a third stall and impacted the ground eight seconds later. The mission controller advised the ground crew that the X200 had been lost. Total flight time was less than four minutes and distance from the launch site to the collision with terrain location was about 4.75 km (Figures 1 and 2).

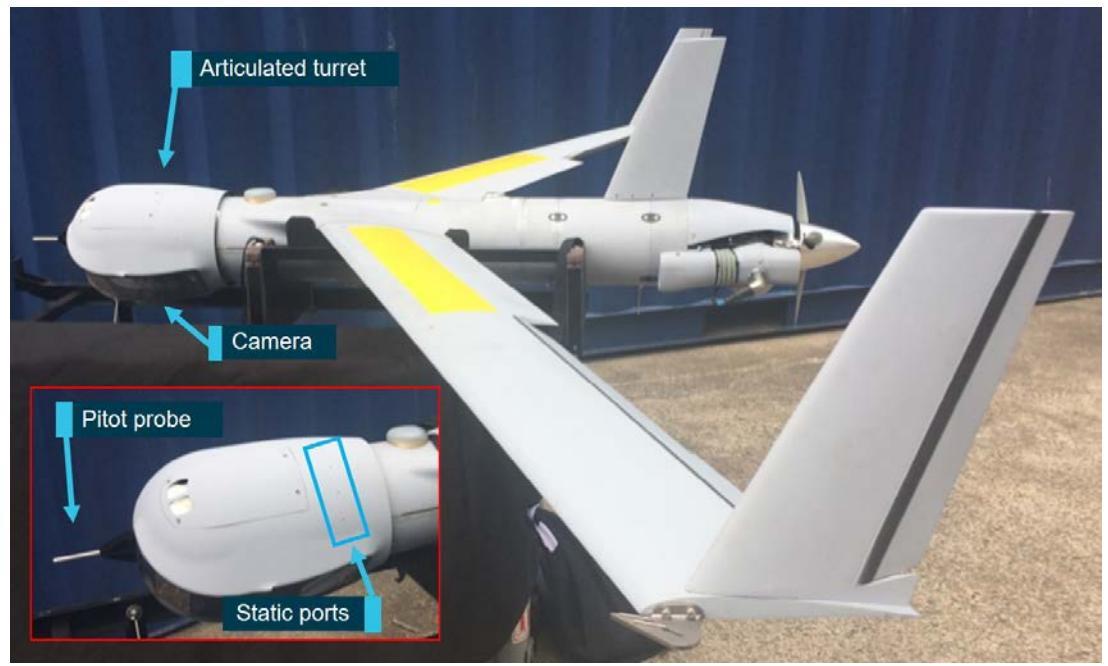
Figure 3: X200 with articulated turret

The pitot-static system senses ram air pressure through the pitot probe (on the forward face of the payload) and static air pressure through the static ports (on each side of the payload). The two pressures are used to calculate true airspeed (TAS) and barometric altitude (Alt). The autopilot uses this data to calculate the minimum and maximum airspeed in relation to the weight of the X200 and to maintain controlled flight.

The pitot and static tubes for the X200 were routed from the pitot probe and static port through the turret and connected to the pitot-static tubing in the fuselage. If not correctly oriented during assembly, the tubes could become pinched, blocked or damaged with turret operation. Obstructed pitot-static tubes have the potential to cause incorrect TAS and Alt calculations, affecting autopilot operation.⁹ In addition, the TAS and Alt indications to the pilots would also be unreliable. The manufacturer alerted X200 operators to this potential condition in November 2017, via both a service advisory and an operational advisory. Damage sustained to the X200 during this occurrence prevented testing for possible turret interference.

Further, the manufacturer revised their procedures for assembly of the turret and provided a reworked procedure to X200 operators to reduce the risk of in-service aircraft being affected by a pitot blockage.

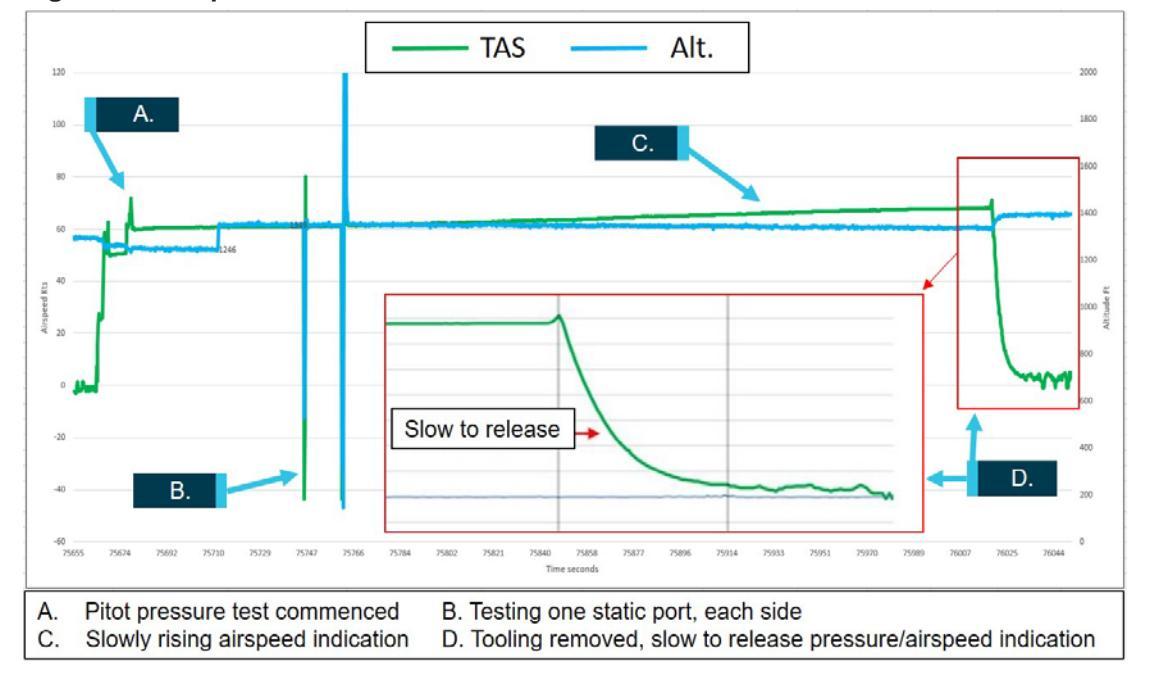
Figure 4: Pitot pressure test indications

During the test, a slow rise of about 10 kt TAS occurred, while the indicated altitude remained steady. The OA detailed that if the TAS 'increases slowly without turret movement or pressurisation of the pitot-static system', this was an indication of a blockage in the pitot-static system. As per the OA, turret movement had the potential to induce a restriction in the pitot system tubing, which could 'clear' with subsequent movement. The pitot system was pressurised and the turret was being operated for part of this test and as such, the rise in TAS as a possible indication of a blockage may have been difficult to identify. Following this occurrence, a revised OA amended the criteria for the slow increase in TAS to show 'at any time' during the procedure, removing any ambiguity surrounding pitot pressurisation and turret movement during the tests.

With no pitot system leak identified by the pilots, the tooling was removed. At this time, the pilot flying (PF) commented that the TAS was 'slow to release' (return to pre-check indication). The primary ground crew member reported that he heard this comment however, he took no action as he wasn't aware of the significance of this indication. The pilot pre-flight checklist identified that slow to release pressure was indicative of a blockage in the pitot system.

The pre-flight checks provided three opportunities for anomalies in the pitot static system to be detected. There was a slow rise in TAS, which was indicative of an anomaly in the pitot system. The pressurisation of the pitot system and movement in the turret during the pitot-static function test, however, may have meant that the slow rise in TAS and the physical blockage was not obvious. The slow reduction in TAS after the pressure test was an indication of a pitot system blockage. This was noted by some of the crew, however the significance of this indication was not recognised.

The X200 manufacturer published a revised Operational Advisory (OA) on 18 February 2019. One amendment in this revised publication was the inclusion of an image from the occurrence X200, showing the Ground Control Station indication for 'slow to release' pitot pressure. The criteria for the slow increase in TAS was also amended to 'at any time' during the procedure, removing any ambiguity surrounding pitot pressurisation and turret movement during the tests.

In addition, the revised OA included an additional caution (in red text) warning that the 'TAS error exceeds launch limit alarm is disabled for pre-flight pitot-static system checks. Therefore, it is critical to monitor the TAS-ALT-Tachometer plot throughout the on ground phase for any abnormal TAS or Alt signatures'. The operator reported that the X200 manufacturer advised a 'latching system alarm' would be incorporated into the next software release (scheduled for mid-2019) to alert the crew where the TAS has exceeded a threshold during on-ground checks.

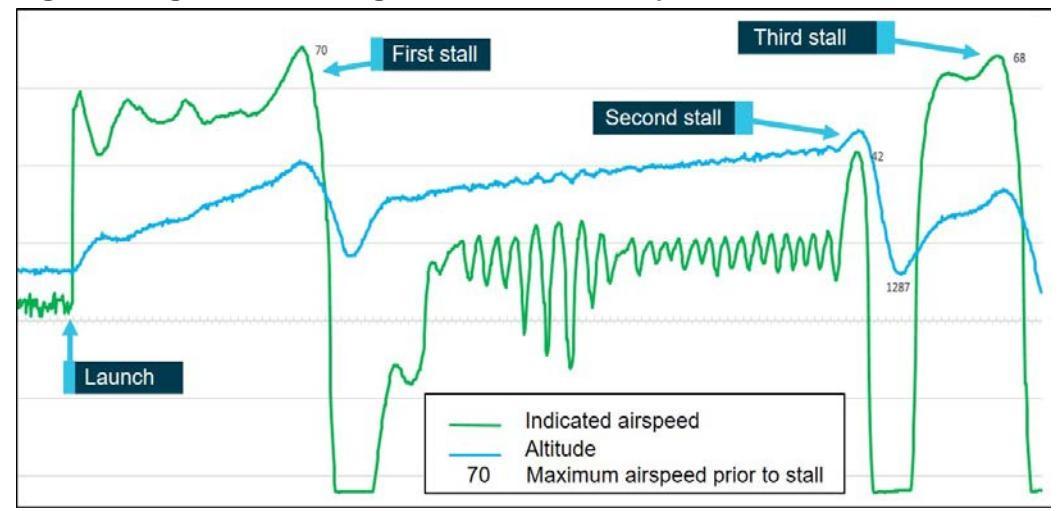
Figure 5: Flight data showing erratic indicated airspeed and altitude

Erratic TAS is one of the parameters that can lead to a stall-spin in the X200. Flight data showed that erratic TAS was present from launch, before the turret was unlocked and operated. This was consistent with a blockage of the pitot system, rather than turret interference.

The erratic TAS also resulted in the porpoising flight profile following the first stall and recovery. Following about 80 seconds of porpoising flight, the data showed another rapid increase in TAS. The autopilot likely commanded the X200 to increase pitch attitude, which again resulted in an aerodynamic stall and rapid reduction in height. Within 12 seconds, the X200 had again self-recovered from the stall, but at a much lower altitude than the first recovery. The second stall required 778 ft for self-recovery (at 64.83 ft/s rate of altitude loss).

This was followed by another extreme increase in TAS, leading to the third stall. This stall was at a similar rate to the second stall. Recovery was again initiated but only 591 ft was available and the X200 collided with terrain, about 9 seconds later (Figure 5).

Following recovery from the first stall, flight data showed the TAS was oscillating by up to 30 kt, resulting in the 'porpoising' flight profile, indicative of the autopilot trying to maintain controlled flight using unreliable airspeed data. A rapid 30 kt increase in TAS likely led to the autopilot increasing pitch attitude, resulting in the second aerodynamic stall. Again, the X200 self-recovered, however at a much lower altitude. A third rapid TAS increase followed shortly after, leading to the final stall, with insufficient height available for recovery.
