In-flight break-up involving Cicaré S.A. CH-7BT, VH-JEW

near Roy Hill Station, Western Australia | 28 July 2015

ATSB Transport Safety Report

Aviation Occurrence Investigation AO-2015-089 Final – 20 December 2019 Cover photo: Andrew Miles

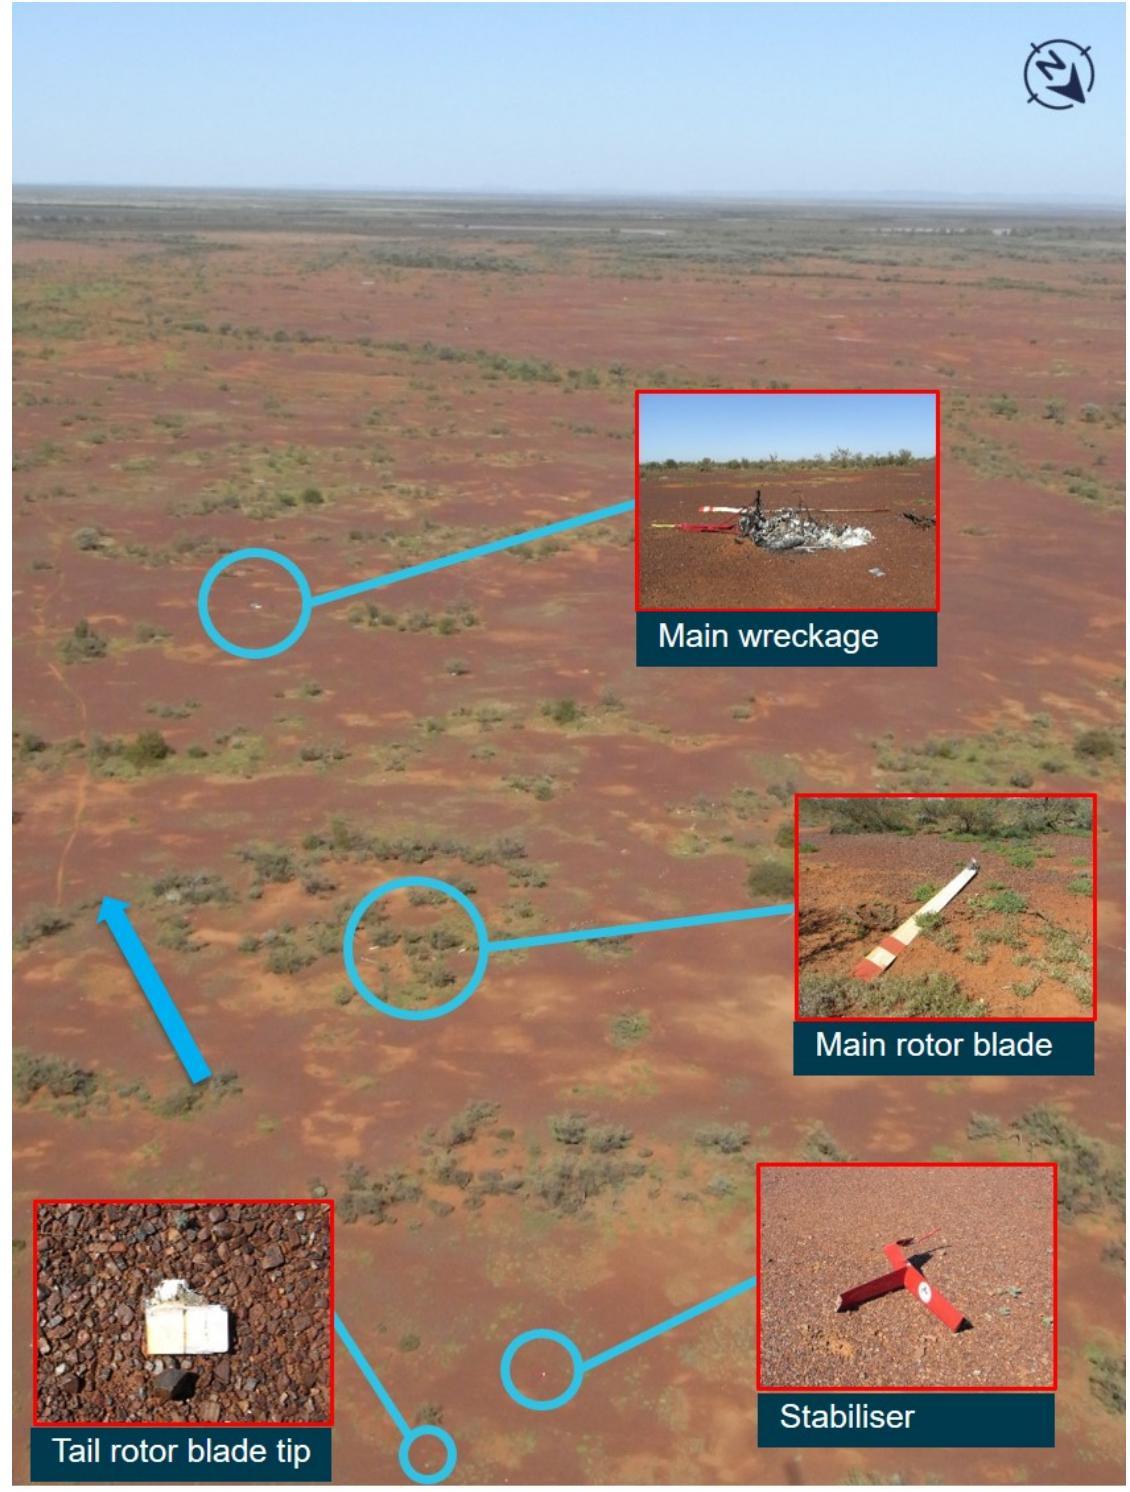
The helicopter was found in an open area, having broken into multiple fragments. The fuselage was subject to a post-impact fire, and the tail rotor stabiliser assembly was identified some distance away from the main wreckage (Figure 2).

Figure 2: Wreckage distribution showing main body and tail rotor stabiliser assembly, the blue arrow shows direction of travel

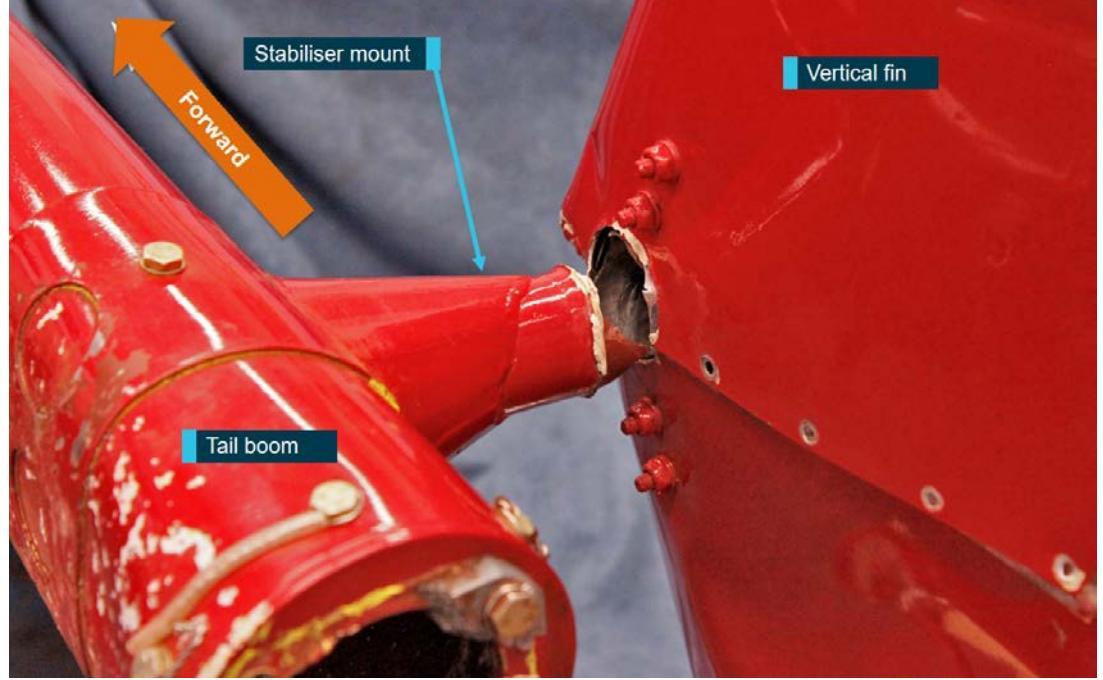
While it was outside the scope of the investigation to conduct an engineering assessment of the helicopter design, a detailed examination of the retained tail components was conducted at the ATSB's technical facilities in Canberra, with a focus on the fracture of the stabiliser support. That examination found that the failure had occurred adjacent to the welded region of the support. The location of the cracking was also coincident with the point at which the upper and lower vertical stabiliser fairings met the mount (Figure 4).

Figure 4: Location of the stabiliser failure adjacent to the welded region

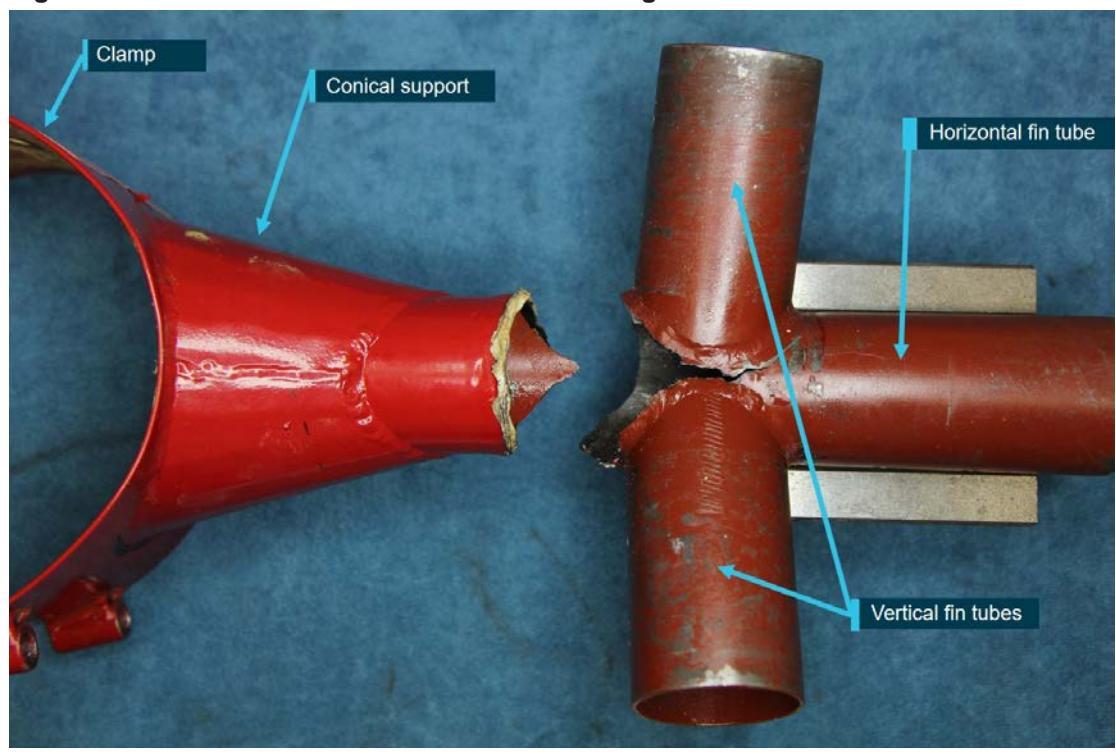
The stabiliser fins were removed from the stabiliser assembly in order to completely expose both portions of the fractured stabiliser mount (Figure 5). The stabiliser mount was comprised of three main sections; a clamp for attaching to the tail boom, conical support, and three oval-shaped, thin-walled seamless metal tubes that were used to locate and secure the fins into position (Figure 5). During manufacture at the factory, the three tubes had been cut to fit and then welded together at the conical support.

Figure 5: Location of the stabiliser failure following removal of the fins

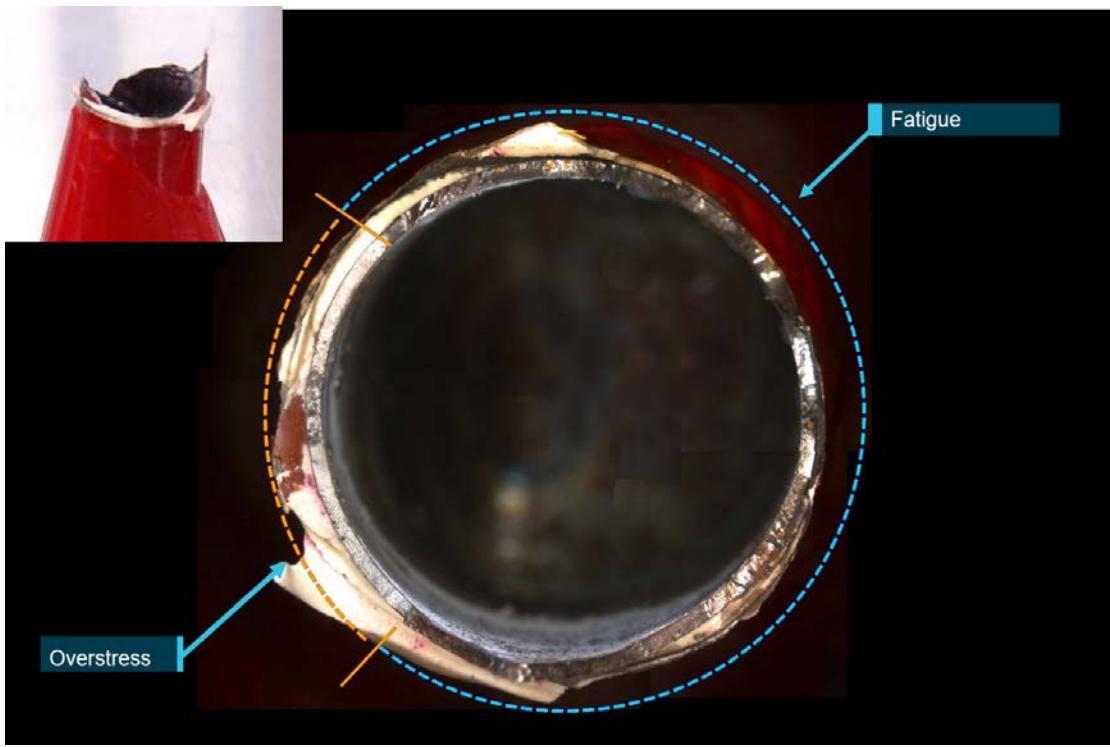
Detailed microscopic examination of the stabiliser mount fracture surfaces was accomplished using a binocular microscope. The examination revealed that the fracture path primarily followed the welded portions of the tube junction. A large portion of the fracture surface was discoloured, and exhibited fretting and corrosion product along with the presence of a series of finely spaced continuous progression marks. Such features were consistent with a fatigue crack growth mechanism as a result of in-service cyclic stresses and suggested that the crack had been present for some period of time prior to final fracture.

The fatigue crack had propagated in a circumferential manner through about 75 per cent of the structure prior to the failure (Figure 6). Once a significant portion of the cross section had fractured, the remaining section could no longer sustain in-flight loads and the stabiliser failed due to overstress. The origin of the fatigue cracking could not be clearly identified due to post-accident damage. No obvious defects or anomalies were observed in the welded regions that might have otherwise contributed to the growth of the fatigue cracking.

Figure 6: Stabiliser fracture surface showing fatigue and overstress areas

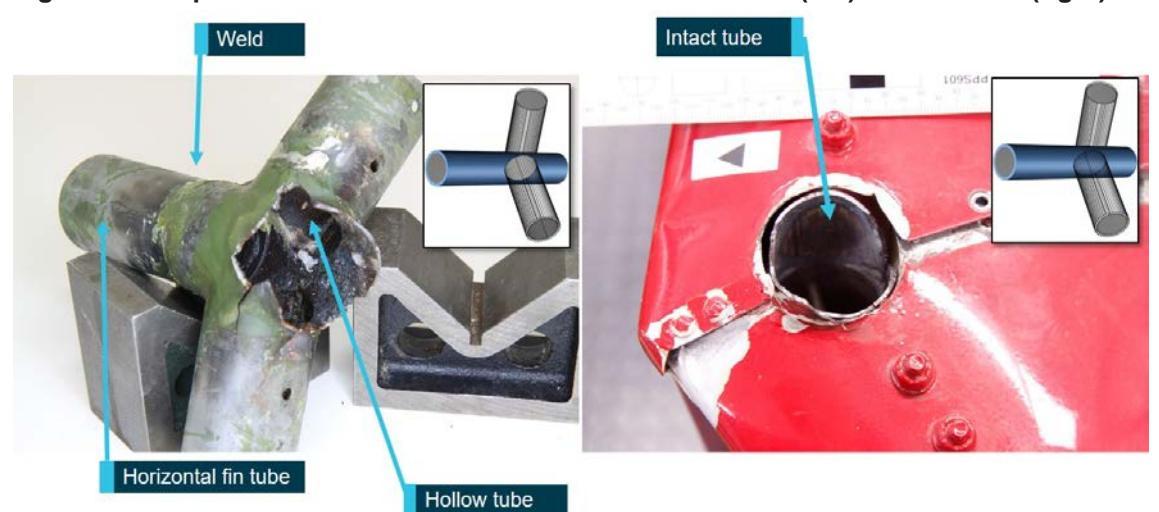
The two stabilisers had failed in a similar location, however, three differences were observed between the construction of the stabiliser mount of VH-JEW and VH-SWQ⁹ including:

Figure 7: Comparison between stabiliser fracture on VH-SWQ (left) and VH-JEW (right)

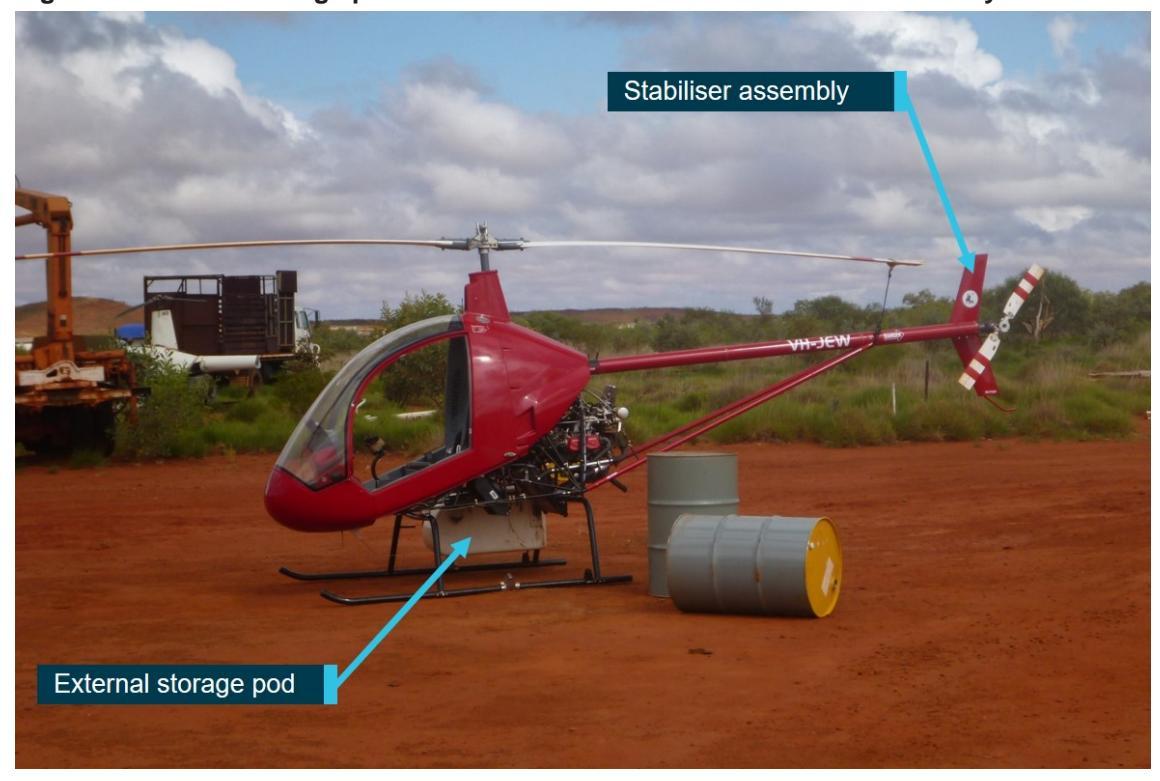
The helicopter had been modified with an external storage pod, attached to the rear strut of the right skid-landing gear (Figure 8). The storage pod was not included on the weight and balance documents provided as part of the special certificate of airworthiness approval process. It was reported that this pod was fitted for the flight from Queensland to Western Australia. However, as the helicopter logbooks were not located, the ATSB was unable to establish if the storage pod remained fitted for the life of the helicopter, or if any authorisations¹⁸ had been received.

Figure 8: External storage pod as fitted to VH-JEW at Indee Station on 23 July 2015

However, correspondence from the kit manufacturer advised that the helicopter was not designed to carry external loads, and had not been tested under asymmetrical load conditions. The kit manufacturer was of the opinion that the difference between the two helicopters with cracked stabilisers and the rest of the Cicaré fleet with unaffected stabilisers was the addition of accessories (the storage pod in the case of VH-JEW and a heli-basket and larger fuel tanks for VH-SWQ), 'making it very hard to ignore that this [sic] accessories could be related to the premature wear of the stabilizer'.

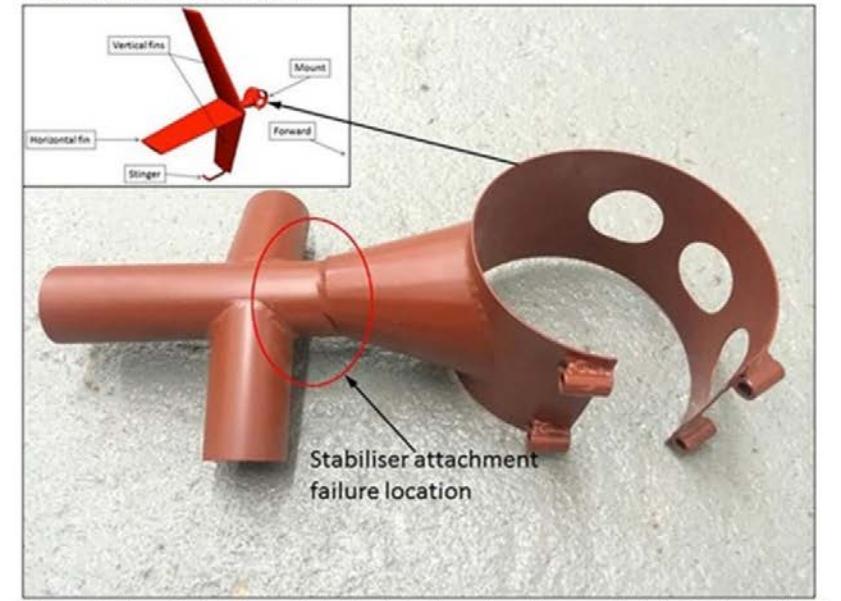
Stabiliser attachment failure location

The examination showed cracking in the stabiliser attachment outboard of the tail boom, coincident with the welded intersection of the conical and tubular sections of the attachment. The location of the cracking in the attachment cannot be easily inspected as they are obscured by the upper and lower vertical stabiliser fairings.

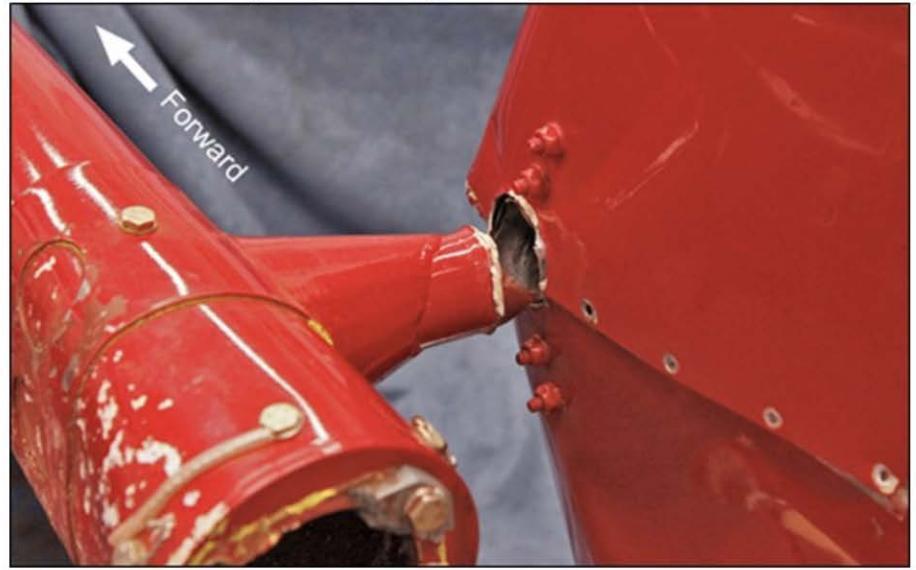
The cracking is unlikely to be easily visible during inspection. However, black dust in the vicinity of the attachment bracket, and working rivets are indicative of increasing stabiliser movement as the crack develops.

CH-7Bt tail section showing the location of fatigue fracture on the stabiliser attachment

Fractured stabiliser attachment bracket with black dust outlined in white (in two places)

The ATSB recommends that owners of CH-7B series helicopters ensure the integrity of the stabiliser prior to further operation and on an ongoing basis. While the ATSB is working to establish the factors leading to the two failures, owners are advised to exercise extreme caution in the operation of their helicopters.
