Loss of control and collision with terrain involving Cessna T310R, VH-JMW

40 km south-south-west of Port Macquarie, NSW | 28 October 2017

ATSB Transport Safety Report

Aviation Occurrence Investigation AO-2017-105 Final – 29 January 2020 Cover: Source: Flightaware.com

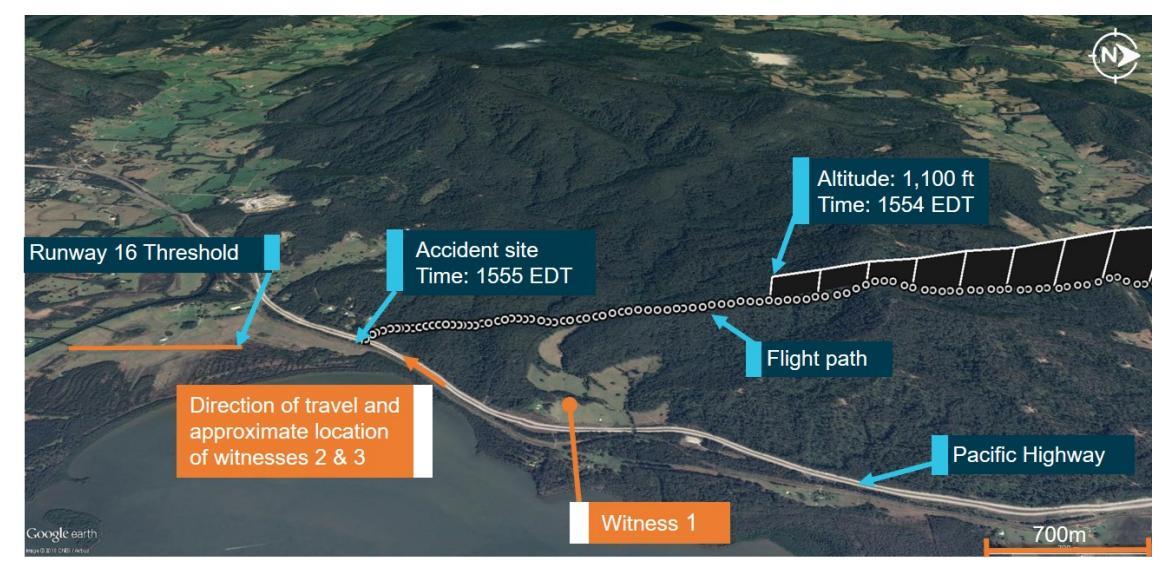
Figure 1: Flight path of VH-JMW

At about 1554, a witness located close to JMW's track heard a low-flying aircraft to the west of his position travelling south (Figure 1, 'Witness 1'). He described the aircraft as sounding like a single-engine aircraft and recalled hearing the engine 'cough' and then stop as the aircraft flew past him.

A minute later, two other witnesses, both driving south along the Pacific Highway, saw JMW to the west of the highway at low altitude (Figure 1, 'witnesses 2 & 3'). One witness recalled the aircraft was descending slowly at first with the landing gear extended. Soon after, the witness saw the aircraft 'jerk' then roll to the left, pitch down and descend rapidly to the ground.

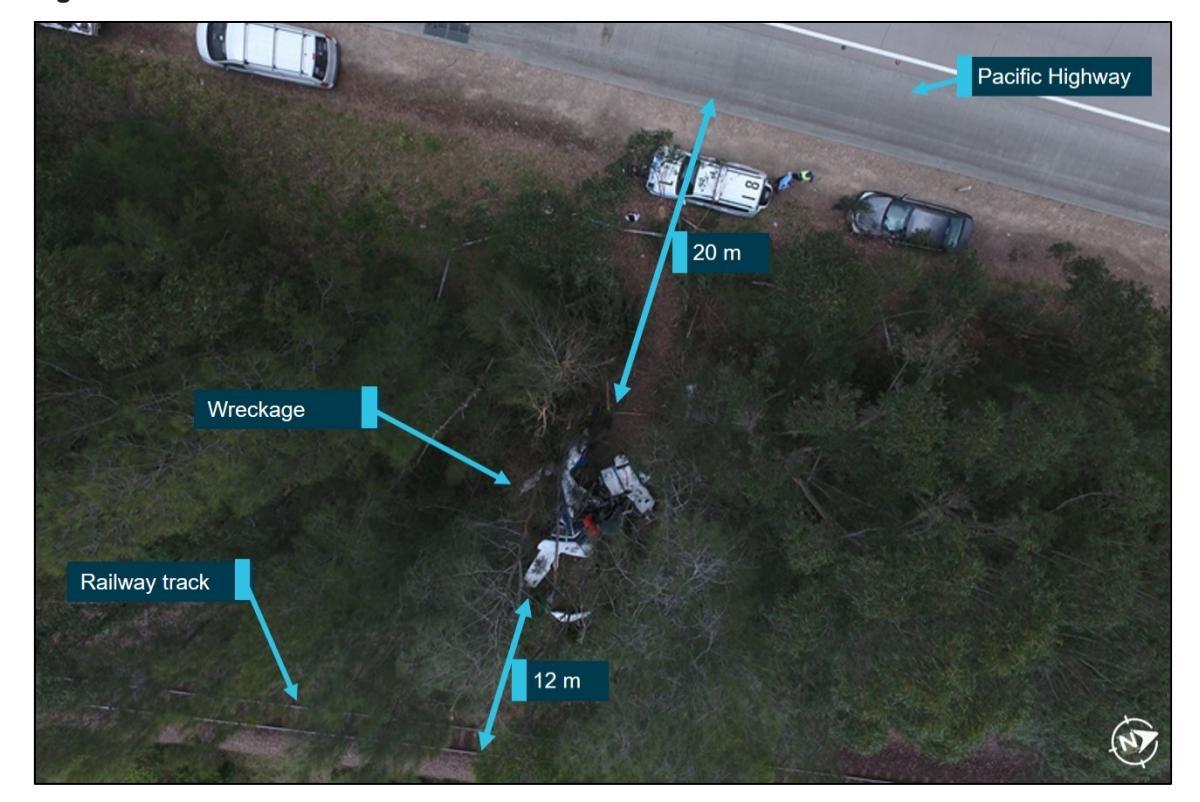
Figure 2: Accident site

At about 1555, JMW impacted trees and then collided with terrain. The aircraft came to rest in a narrow wooded strip of land between the highway and the main northern railway line (Figure 2). The wreckage was about 800 m (0.4 NM) from The Lakes runway 16 threshold.

The ATSB's examination of the accident site confirmed that the aircraft was in a left-wing, nose-down attitude when it collided with terrain. It came to rest between a railway line and the Pacific Highway in a thicket of gumtrees and coastal scrub. The distribution of the wreckage and the damage to the trees indicated that the aircraft had little forward momentum on impact (Figure 2). The impact forces from the collision destroyed the aircraft.

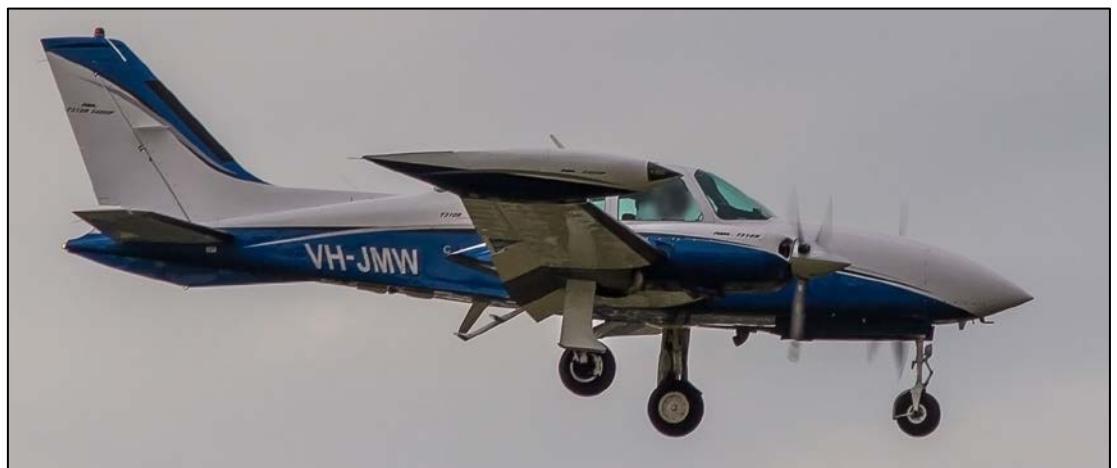
The Cessna Aircraft Company T310R is a low-wing, twin-engine aircraft equipped with retractable landing gear. In 1988, VH-JMW was modified under supplementary type certificates to replace the original Continental IO-520-MB engines with turbocharged engines (TSIO-520-NB) and fit new three-bladed propellers (Figure 3).

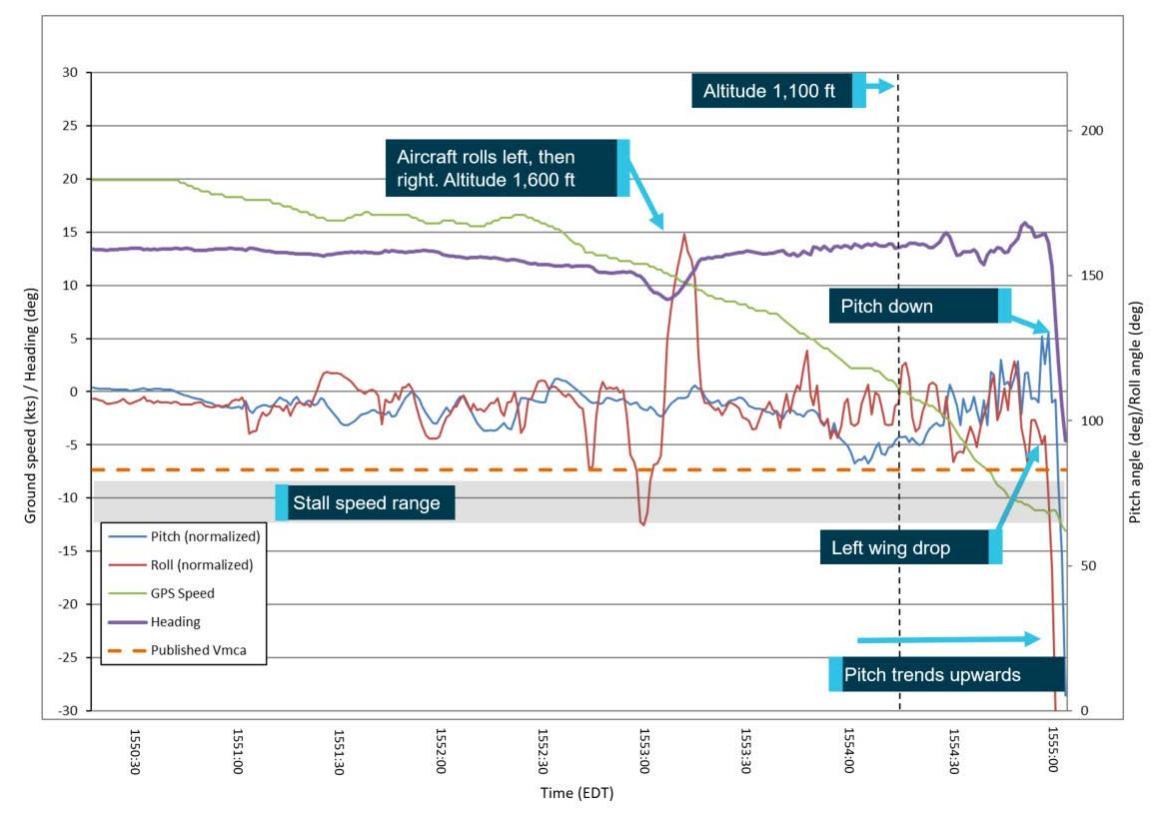
Figure 4: Last 280 seconds of recorded flight data

- Over the last 30 seconds of the flight, the rate of speed decay increased with the aircraft's speed reducing to below the published (and likely actual) V_{mca}, and into the stall speed range (68–74 kt).¹² Constant variations in pitch and roll were evident throughout this stage of the flight, with a continual upward trend in pitch (Figure 4).

- Just before 1555, the aircraft's speed decayed to 67 kt¹³ (ground speed). The nose continued to pitch up, attaining a maximum pitch of about 6.5 degrees. Shortly after, the left wing dropped and the nose pitched towards the ground.
