Australian Government  
Australian Transport Safety Bureau

# Loss of containers overboard from *YM Efficiency*

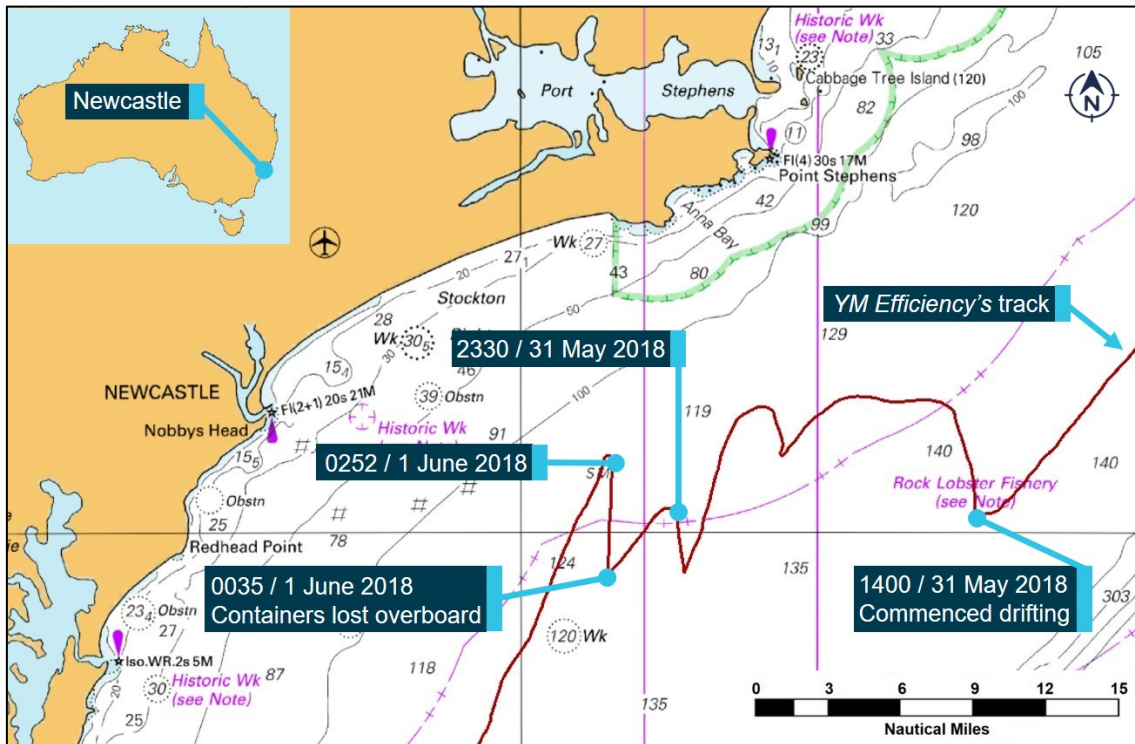
Source: Australian Hydrographic Office, annotated by the ATSB

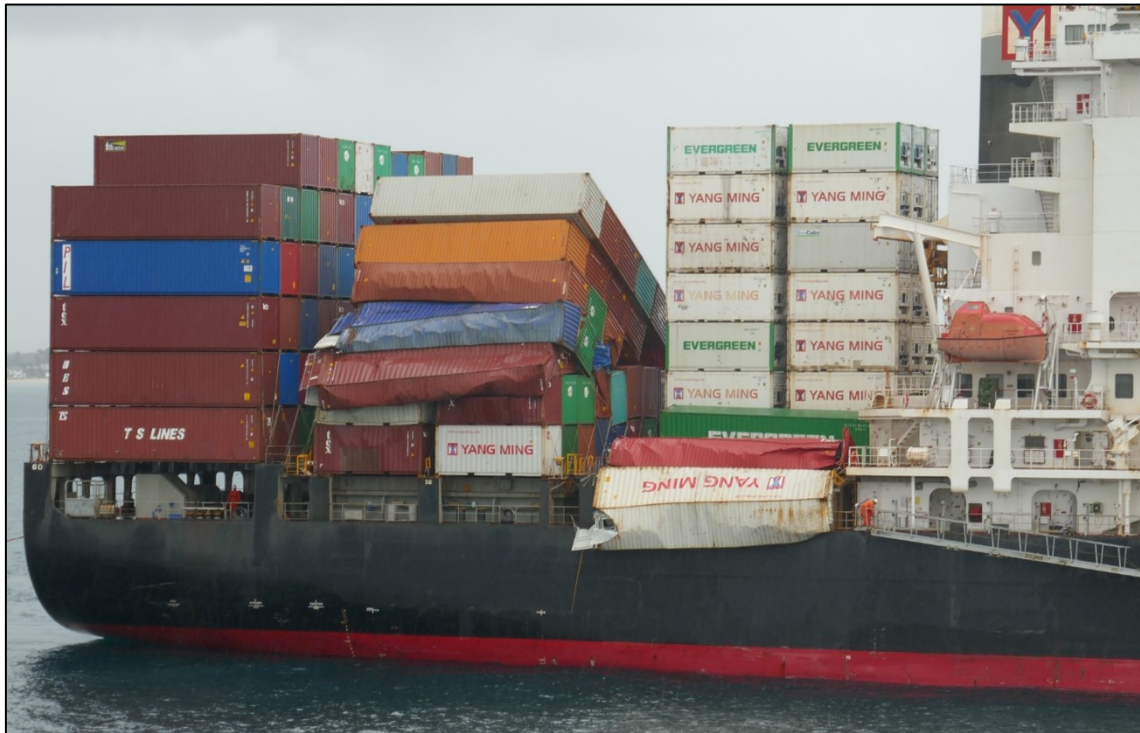
**Figure 3: Damaged containers in bays 52 and 56**

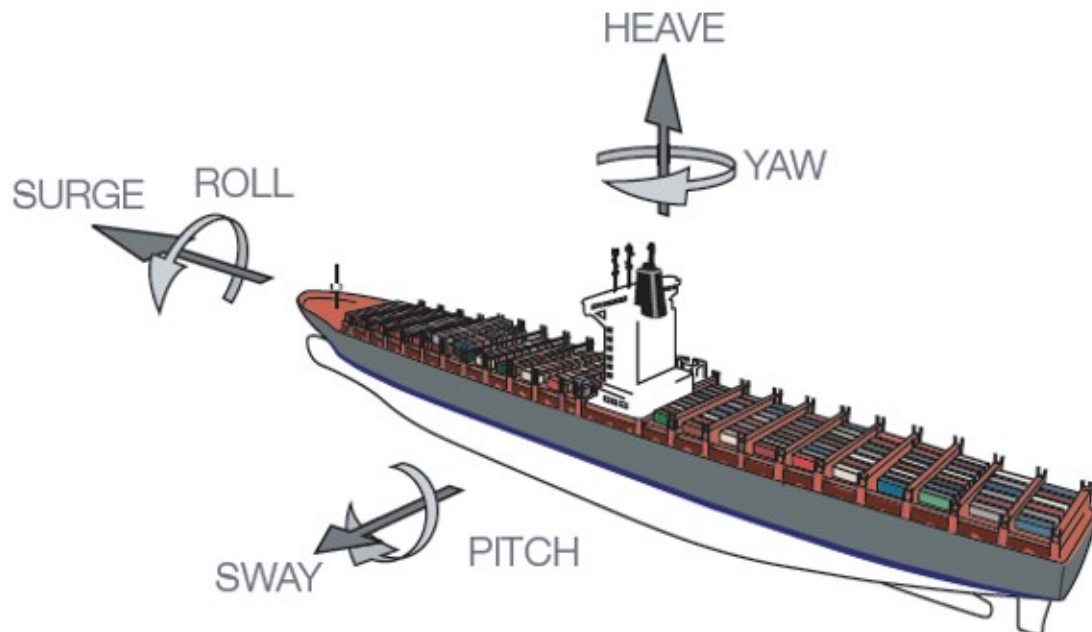
Source: MacGregor Container Securing Systems product catalogue, modified by the ATSB

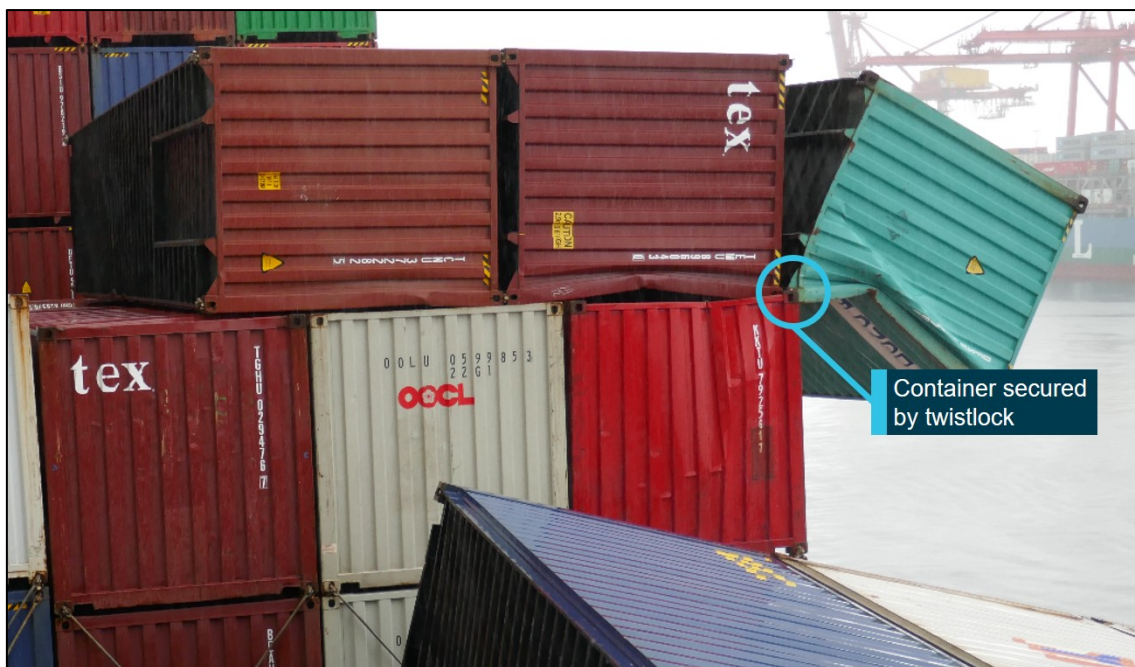
**Figure 11: Dislodged containers six days after the accident**

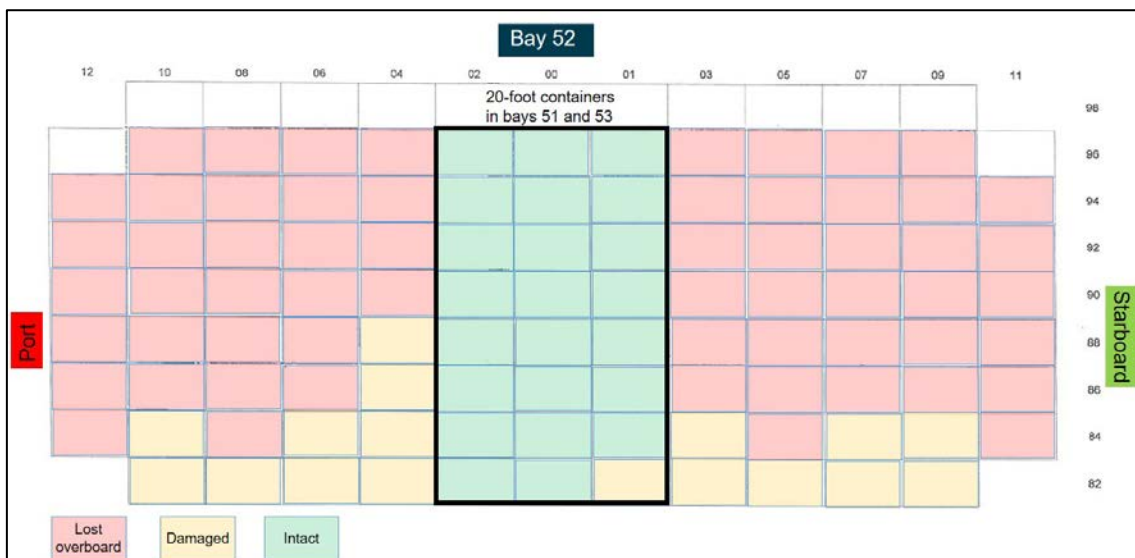
Source: Yang Ming, modified and annotated by the ATSB

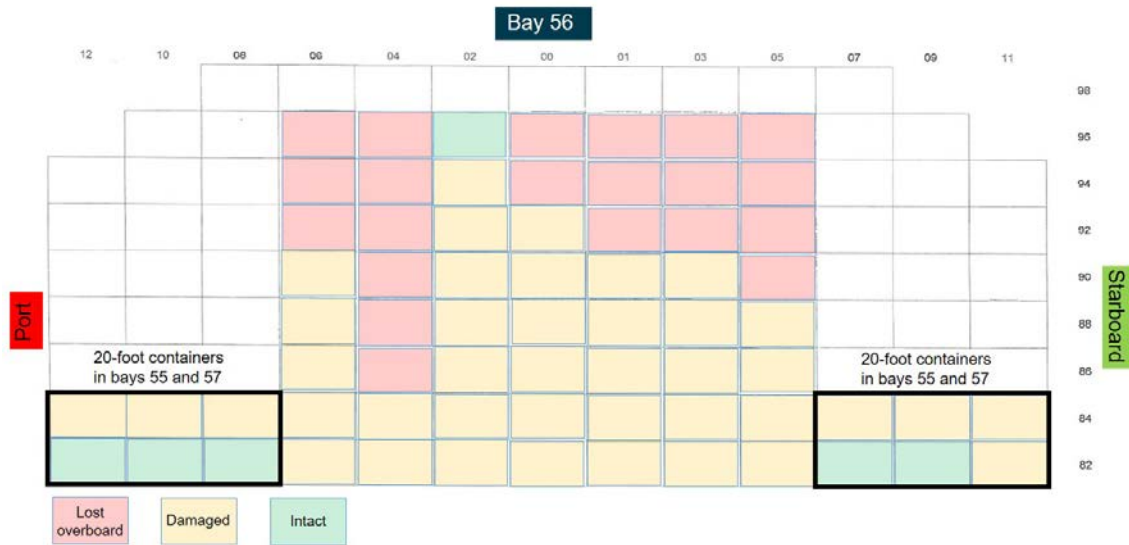
### **Cargo securing**

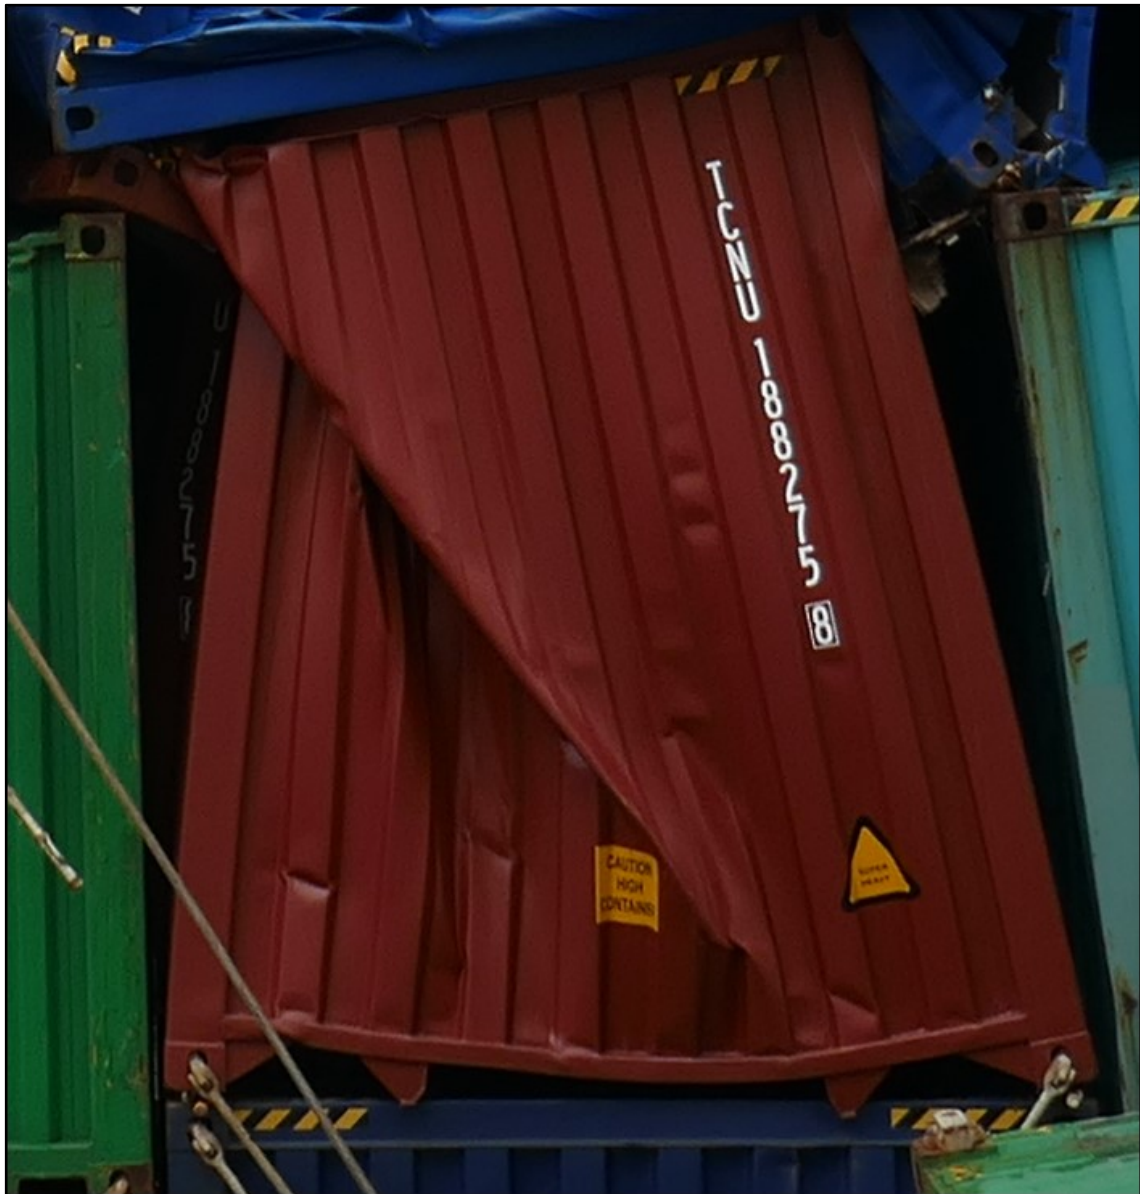
**Figure 21: Image showing container corner post collapse**

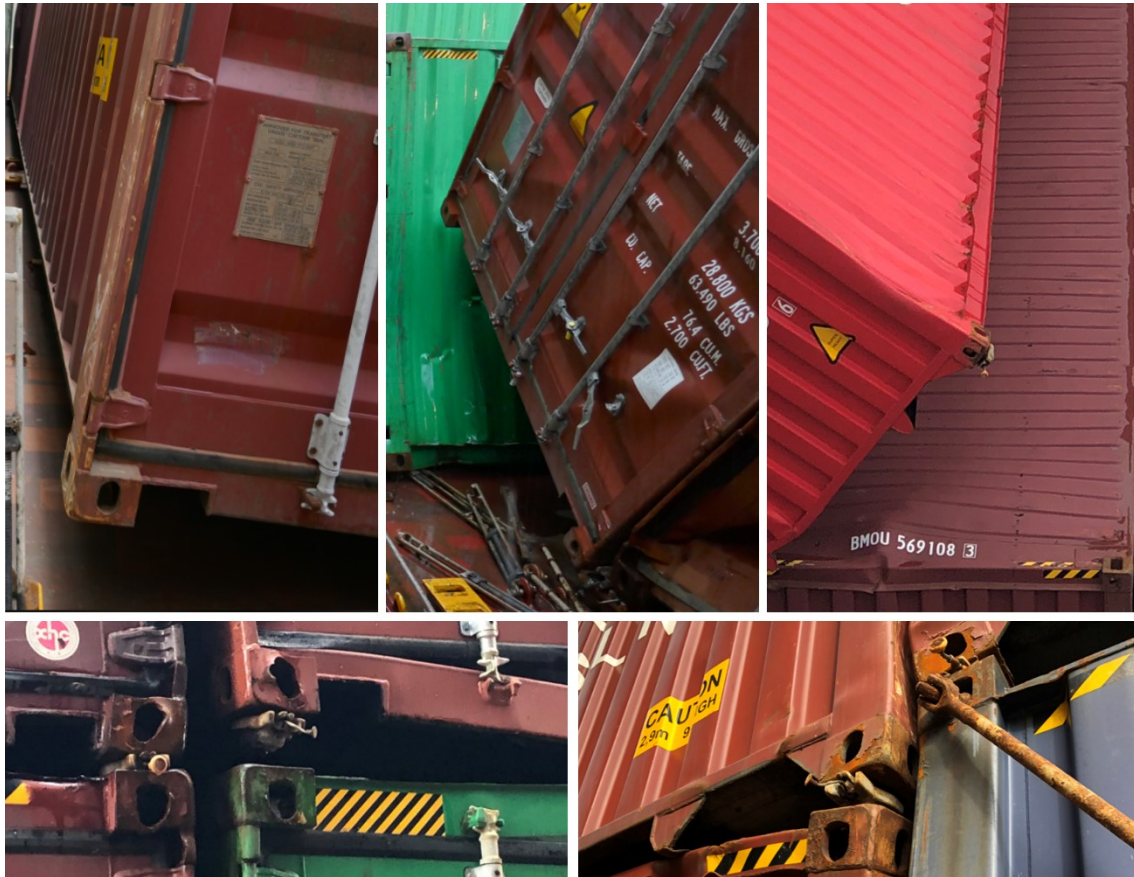
**Figure 22: Examples of lifting force exceedances**
