Uncontrolled flight into water involving Cessna 208B, VH-FAY

260 km north-east of Narita International Airport, Japan, on 27 September 2018

ATSB Transport Safety Report Aviation Occurrence Investigation AO-2018-065 Final – 18 March 2020 Released in accordance with section 25 of the Transport Safety Investigation Act 2003

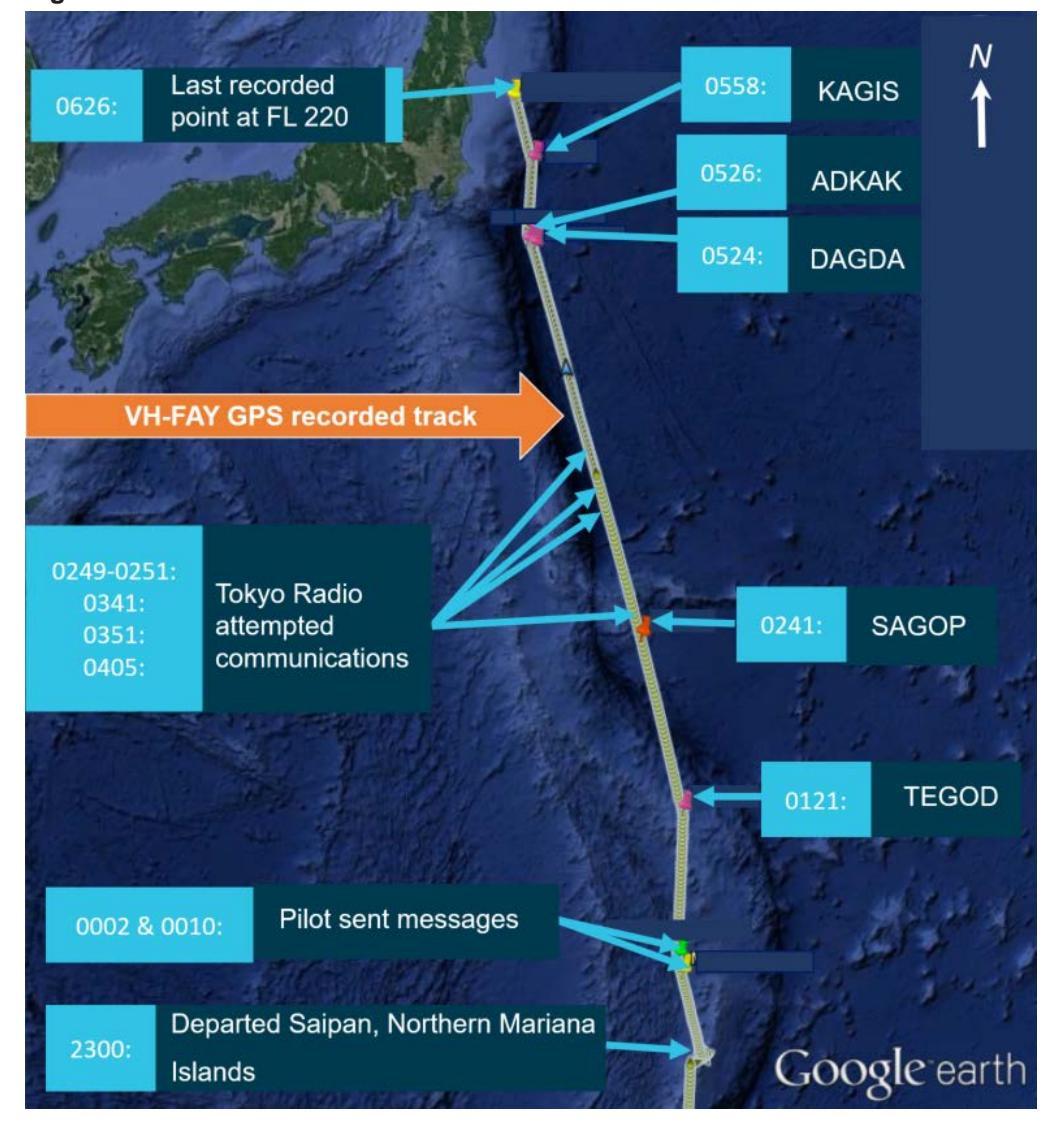
Figure 2: VH-FAY GPS recorded track

The pilot sent several messages from the Garmin device after departing Saipan and before the aircraft reached reporting point TEGOD. The last position recorded by the Spidertracks and Garmin devices was at 0626 UTC at FL 220. The aircraft took less than 2 minutes to descend from FL 220 to the ocean and there were no GPS recorded points below that altitude.

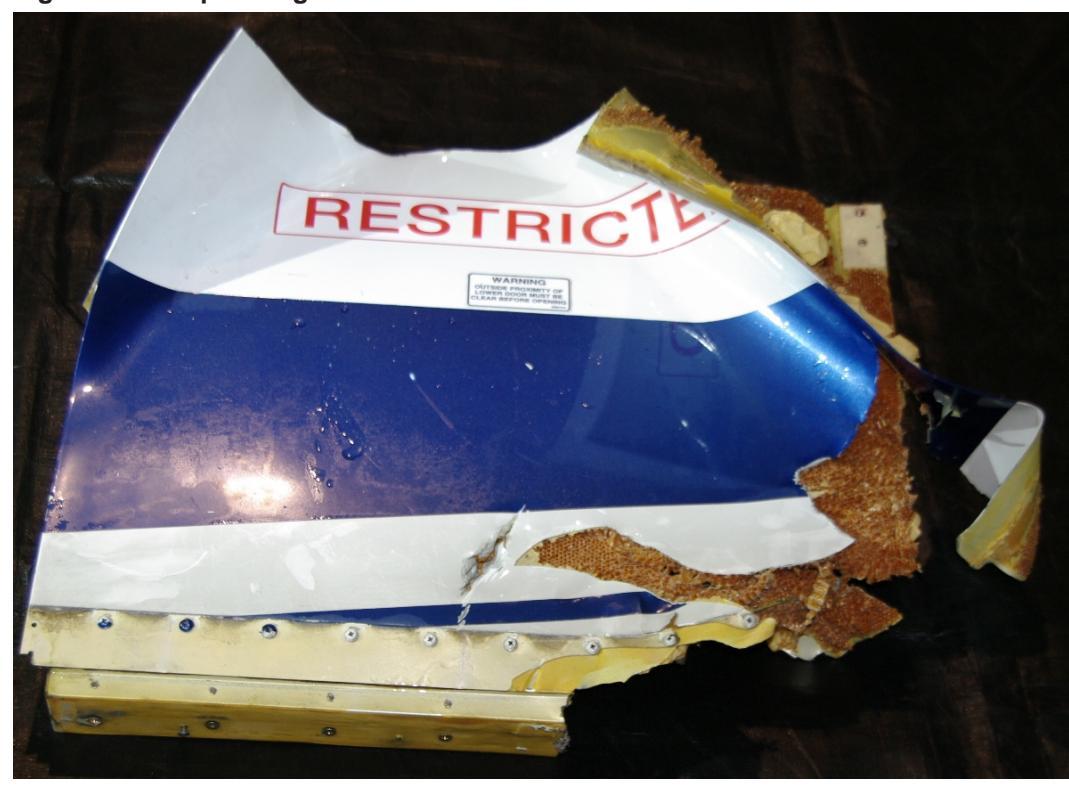
Figure 3: Rear passenger door

After about 30 minutes, the JASDF pilots observed FAY descend into cloud. The aircraft descended rapidly and disappeared from radar less than 2 minutes later. Within 2 hours, search and rescue personnel located the aircraft's rear passenger door. No other aircraft parts were located and the pilot was not found.

At 0626 UTC, the aircraft's GPS tracker stopped reporting, with the last recorded position at FL 220, about 100 km off the Japanese coast and 589 km (318 NM) short of the destination airport. Radar data showed that the aircraft descended rapidly from this point and collided with water approximately 2 minutes later. The Japanese authorities launched a search and rescue mission and, within 2 hours, searchers found the aircraft's rear passenger door (Figure 3). The search continued until the next day, when a typhoon passed through the area and the search was suspended for two days. After resuming, the search continued until 27 October with no further parts of the aircraft found. The pilot was not located.

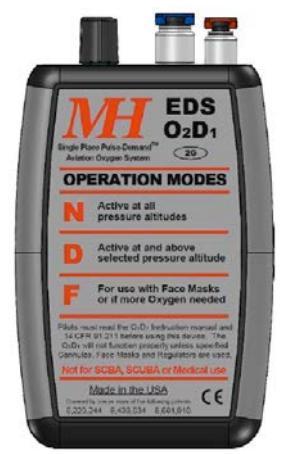
Figure 5: Mountain High Pulse-Demand Electronic Delivery System O2D1

The pilot had a battery-operated Mountain High (MH) Pulse-Demand[™] Electronic Delivery System (EDS) O2D1 (single-person) model (Figure 5). The EDS unit supplied a measured pulse of oxygen at the beginning of each inhalation and was oxygen-compensating (increasing flow with altitude). The unit had audible and illuminating flow fault and apnoea alarms. A representative from Mountain High advised that although the ceiling of the MH EDS is 25,000 ft, at 22,000 ft it is at the maximum flow rate requirement for oxygen.

The pilot had also indicated his intention to connect the EDS to the aircraft system without the inline regulator that was required to ensure the EDS operated within its limits. At FL 220, this had the potential for the pilot to receive inadequate oxygen supply or for the EDS to be rendered inoperative, resulting in higher oxygen consumption than anticipated. However, it is noted that the pilot had the Cessna mask available which, if used with the aircraft system, would have mitigated this risk.

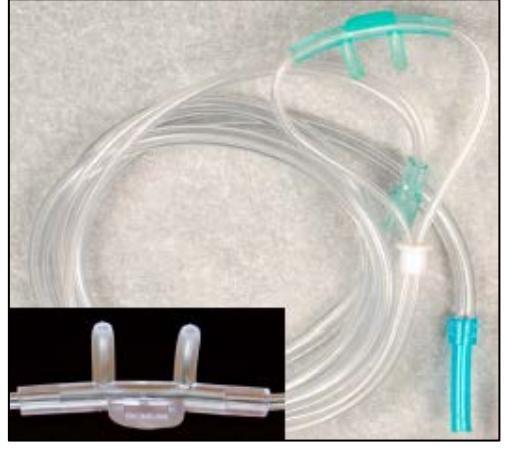
Figure 6: Mountain High nasal cannula

The ATSB could not establish the cannula model used for the ferry, however the MH EDS manual stated 'Use only the supplied MH EDS cannula, as other cannulas may not work properly with the EDS.' The standard MH nasal cannula (Figure 6) differed from the Oxymizer specified in CAO 108.26, which had a reservoir that stored oxygen during the exhalation then added it to the delivery during inhalation to increase oxygenation. Mountain High advised that the risks of wearing a cannula are:

- it is ineffective if the pilot has nasal congestion, is eating, talking or mouth-breathing
- it can come away from the nose, which would also trigger the apnoea alert.

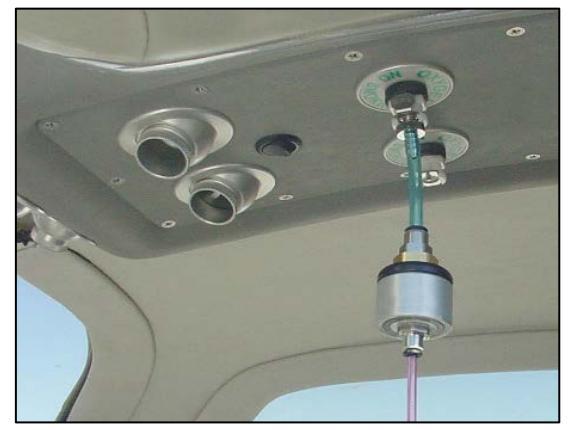
Figure 7: In-line regulator to connect EDS to aircraft oxygen outlet

The EDS was required to be operated with an oxygen inlet pressure between 16 and 20 PSI, which could be achieved with an in-line regulator (Figure 7). The MH EDS manual indicated that the flow of oxygen would be unnecessarily high between 20-30 PSI. The manual also included the warning that higher pressure 'will not only compromise the performance of the EDS, but is likely to damage the internal breathing sensor, rendering your EDS unit inoperable.' MH advised that pressures above 30 PSI would cause the valve to open up and result in the EDS working like a constant flow system. In this situation, the apnoea alert would sound out constantly until the oxygen supply was nearly depleted.

The pilot did not have an in-line regulator for the flight. At altitudes above 17,000 ft, the aircraft's system provided oxygen at 21.55 \pm 2.5 PSI, which was higher than the EDS inlet pressure range. At 20,000 ft, this increased 24.45 \pm 2.5 PSI. There was no data for the output pressure at 22,000 ft.
