Main rotor blade crack and precautionary landing involving Robinson R22 Beta, VH-HPH

12 km south-west of Labelle Downs Station, Northern Territory, on 16 December 2016

ATSB Transport Safety Report Aviation Occurrence Investigation AO-2016-174 Final – 5 May 2020 Released in accordance with section 25 of the Transport Safety Investigation Act 2003

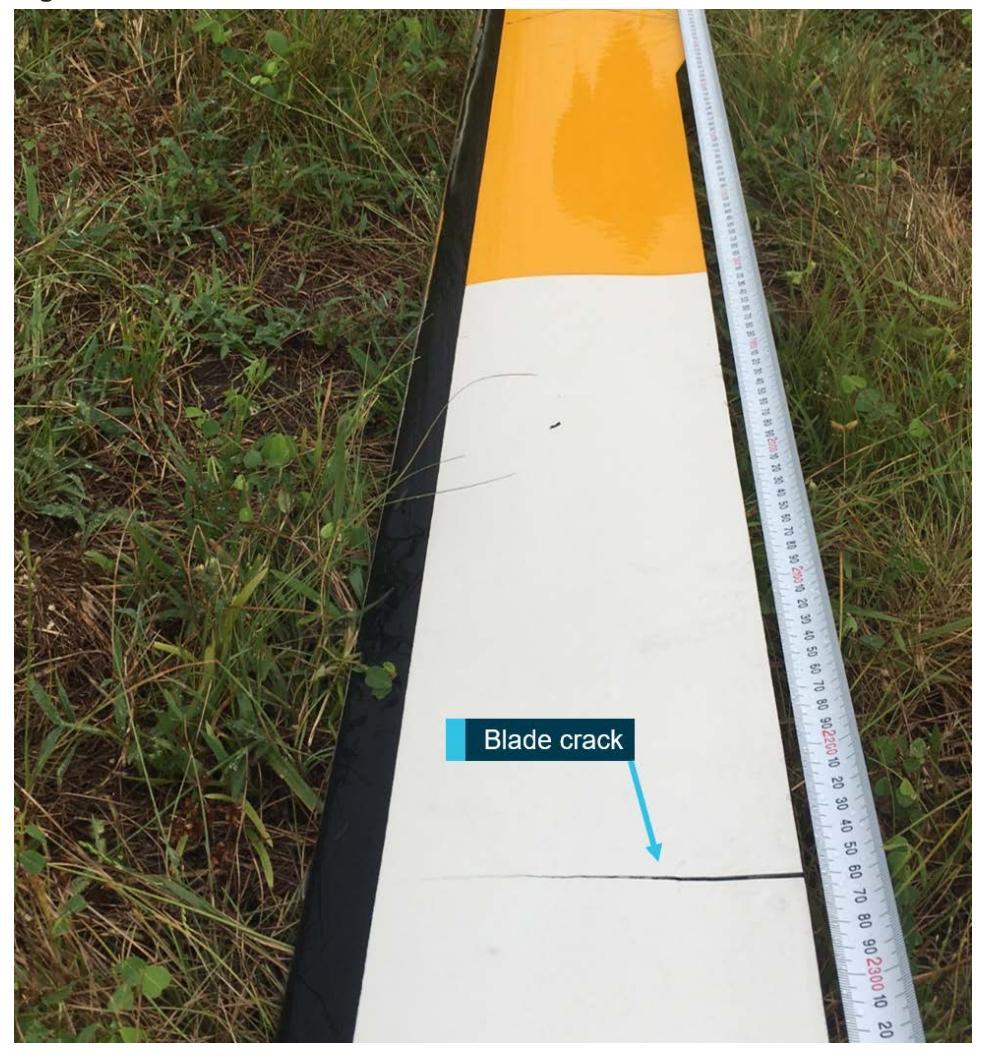
Figure 1: The main rotor blade crack is identified near rotor station 61

The measurement scale positioned along the trailing edge is from the blade tip. Source: North Australian Helicopters, annotated by ATSB

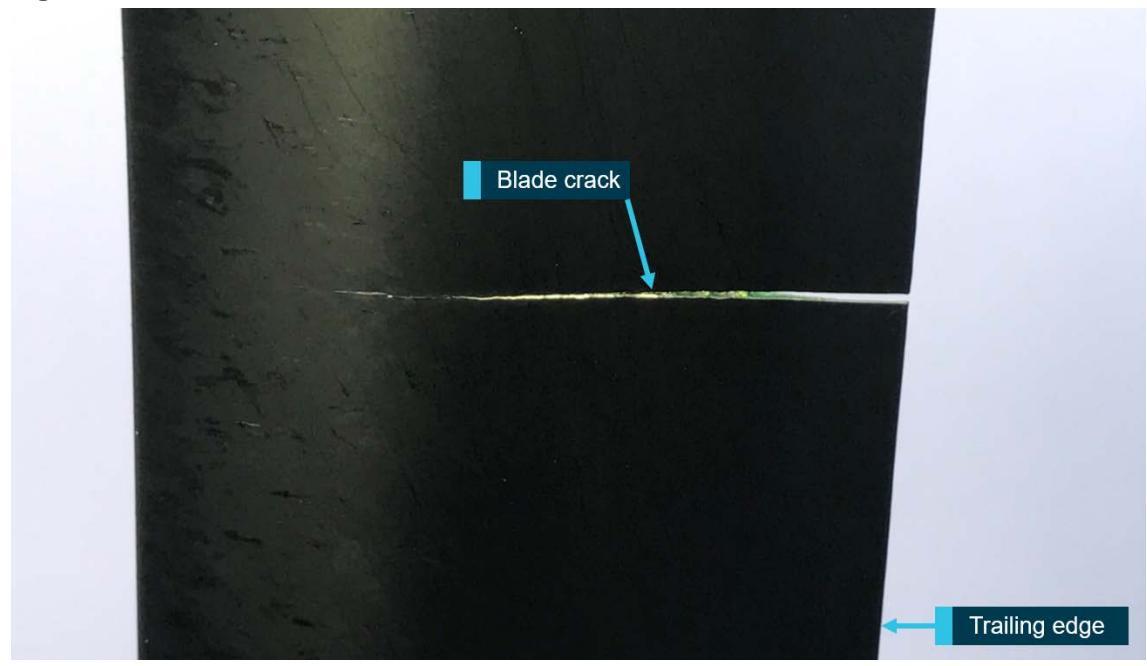
Figure 2: Closer view of the cracked main rotor blade from the lower surface
