Engine flameouts on descent involving GIE Avions De Transport Regional ATR72-212A, VH-FVN

near Canberra Airport, Canberra, ACT, on 13 December 2018

ATSB Transport Safety Report Aviation Occurrence Investigation AO-2018-081 Final – 5 May 2020 Released in accordance with section 26 of the Transport Safety Investigation Act 2003

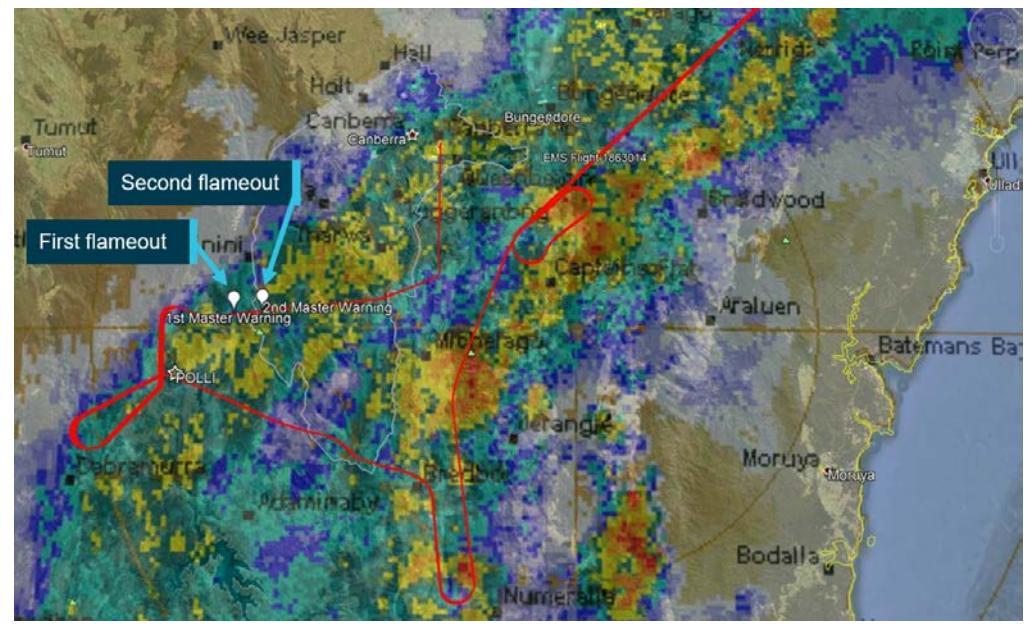
Figure 1: Radar image at time of flameouts

The crew stated that the aircraft was in heavy rain at the time of the flameouts but they did not notice any significant icing at the time. Figure 1 depicts the rainfall recorded by radar at about the time of the first flameout.

The radar image at 1854, about the time of the first flameout. Areas of yellow depict moderate rainfall with red depicting heavy rainfall. Source: PWC annotated by ATSB.

The crew recalled that the aircraft was in heavy rain and Bureau of Metrology (BOM) radar imagery indicates moderate rain at the time. Although the engines passed certification requirements for water ingestion, numerous flameout occurrences have previously been associated with moderate or heavy rain conditions. Testing takes place in a controlled environment but does not account for engine installation and other variables of actual flight conditions. There was insufficient evidence to determine if rain did or did not contribute to the flameouts.

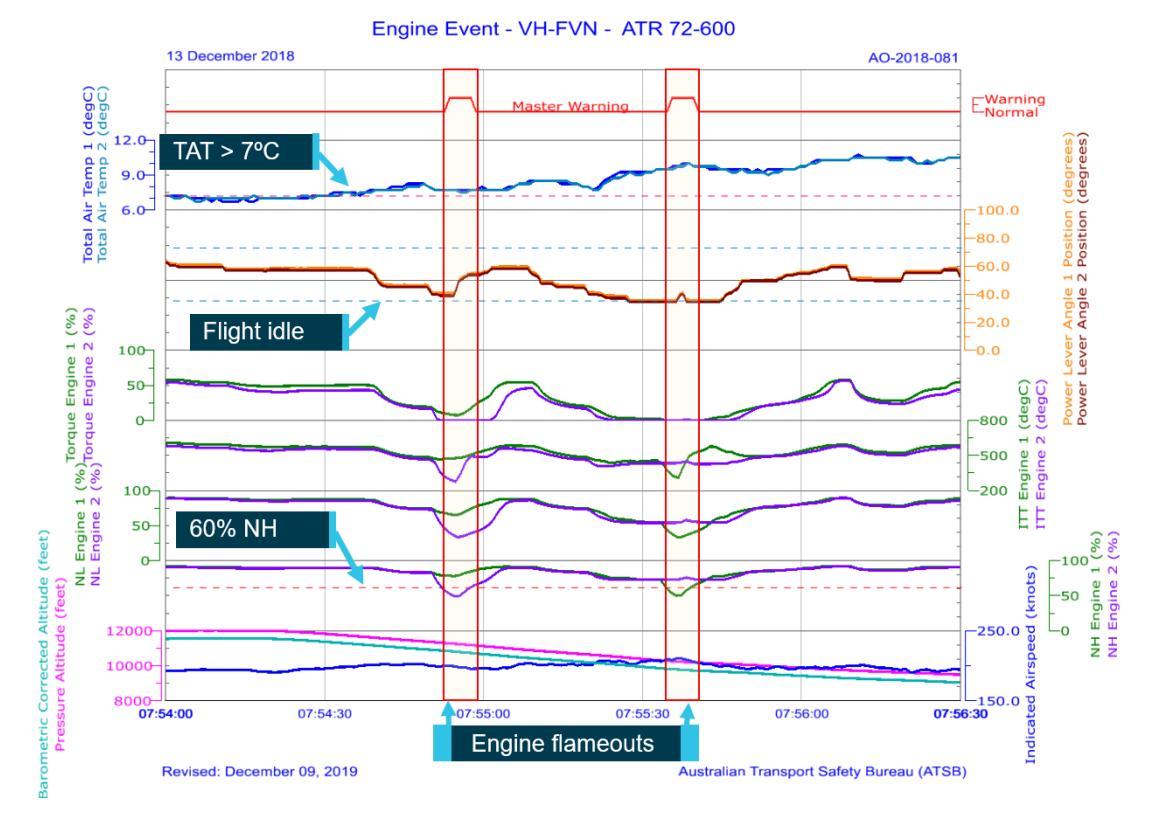
Figure 2: Recorded flight data

The ATSB downloaded and analysed the data from the aircraft flight data recorder. Figure 2 below presents the key recorded aircraft and engine parameters at the time of the flameouts. During both flameouts, the master warning was active for 5 seconds. This included the time from flameout, initiation of automatic ignition and full recovery.

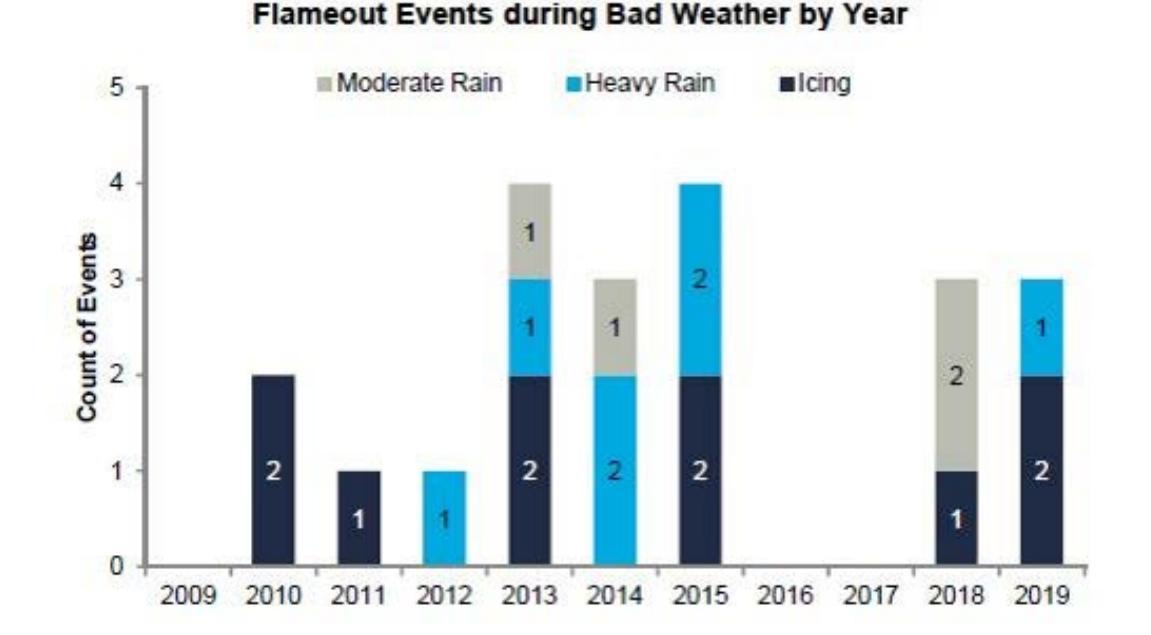
Figure 3: Flameout events during bad weather by year

- ten were in icing conditions
- seven were in heavy rain
- four were in moderate rain.

The earlier related occurrences prompted a water ingestion test in 2016 by PWC of the PW127M engine. As previously discussed, the engine performed in excess of the certification requirements, satisfying both PWC and ATR that the engines were capable of operating in significant adverse environmental conditions.
