# Engine failure involving Airbus A330, 9M-XXE

Near Carnarvon, Western Australia, on 25 June 2017

### ATSB Transport Safety Report Aviation Occurrence Investigation AO-2017-066 Final – 30 June 2020

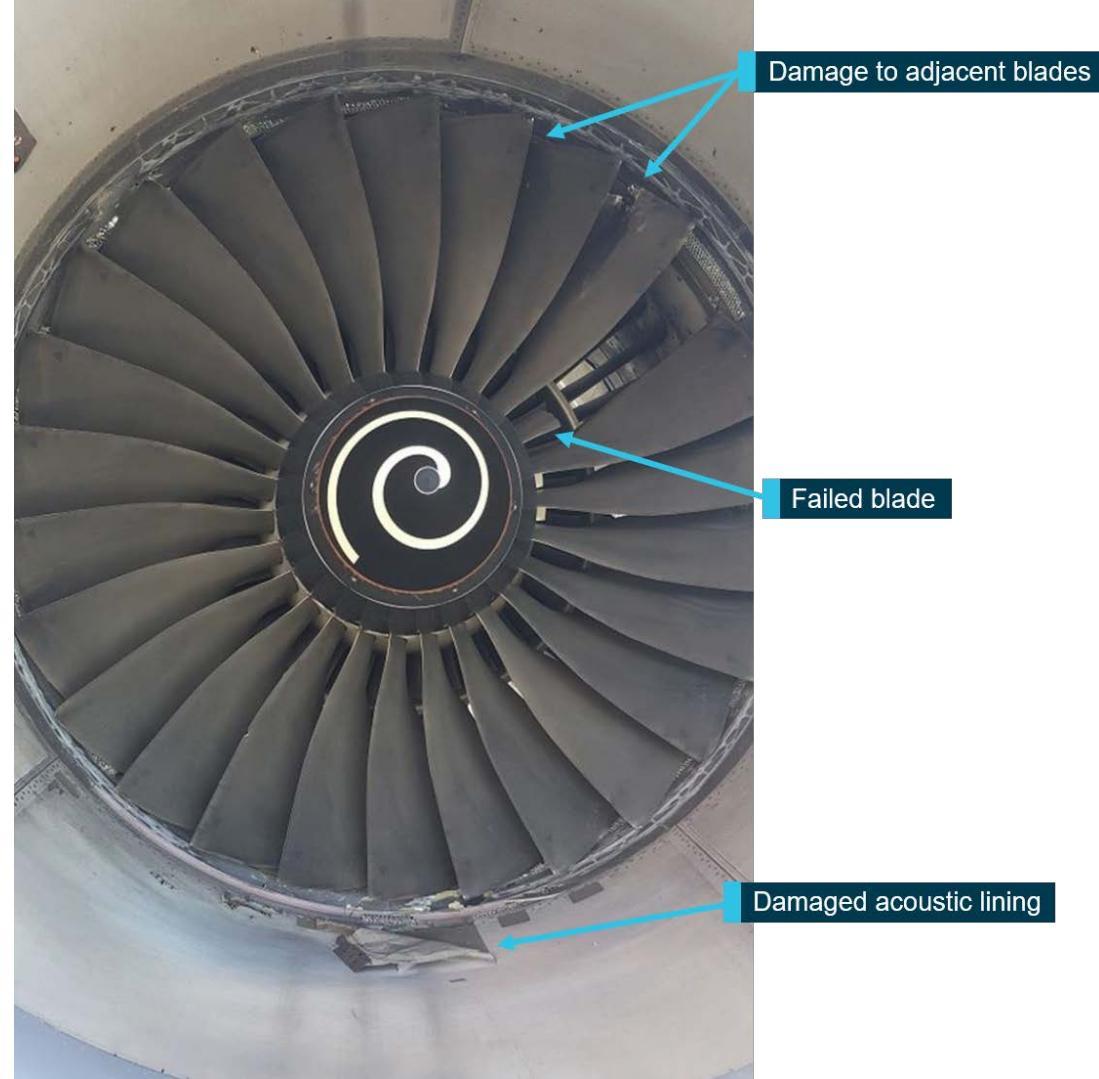
The aircraft landed at Perth at 0957. A post-flight inspection revealed that approximately three quarters of one fan blade (serial number RGF35538) aerofoil was missing on the left engine (Figure 2). No damage to the airframe was identified.

Figure 2: Left engine failed fan blade, with adjacent damaged blades

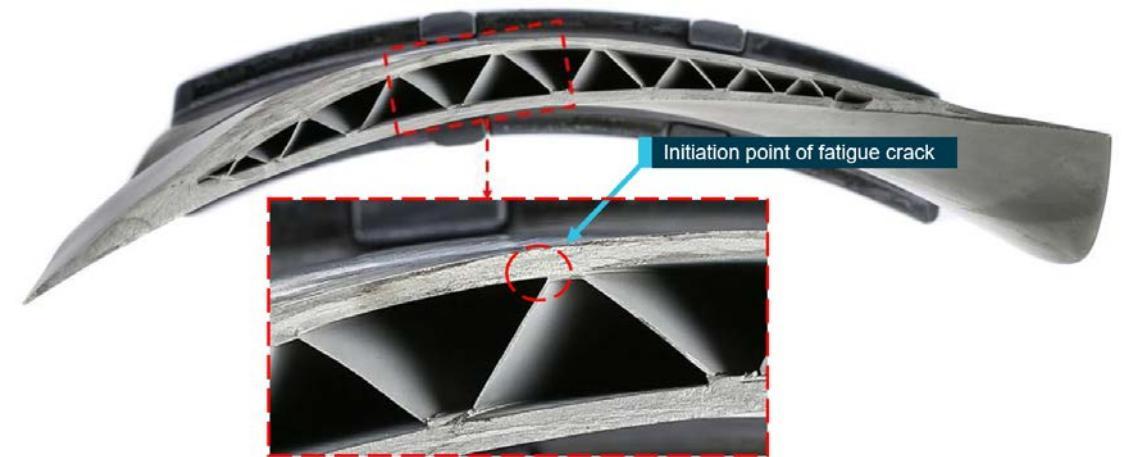
Optical and electron microscope inspection identified a region of fatigue cracking on the inner surface of the convex panel of the fan blade, about mid-chord from the blade leading edge. The fatigue appeared to have initiated on the inner surface of the panel at the acute corner of a membrane-to-panel bond (Figure 4).

Figure 4: Overview of fracture surface showing the initiation point of the fatigue crack on the inner surface of the convex panel

Photograph of the remaining section of the failed blade identifies the initiation point of the stress crack that led to the blade failure. Source: Rolls-Royce and ATSB.
