Engine malfunction involving De Havilland Aircraft of Canada DHC-8-315, VH-XKJ

near Perth Airport, Western Australia on 23 April 2019

ATSB Transport Safety Report Aviation Occurrence Investigation AO-2019-020 Final – 23 July 2020 Released in accordance with section 25 of the Transport Safety Investigation Act 2003

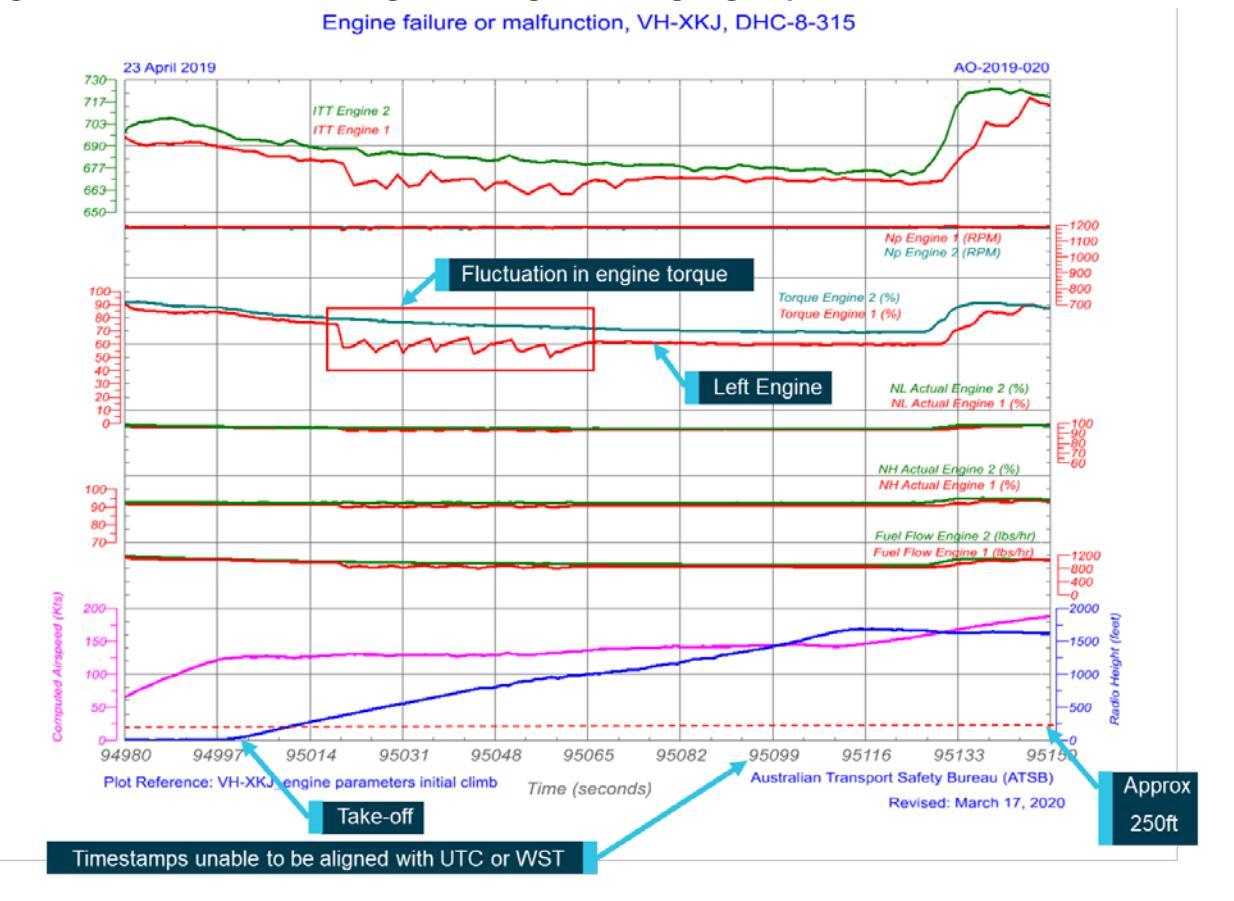
The aircraft's flight data recorder (FDR) was downloaded by the operator and a copy of the relevant data provided to the ATSB. The flight data showed a sharp reduction in left engine torque as the aircraft climbed through 250 ft (see Figure 1). This was followed by a period of torque fluctuations, which aligned with the time that the flight crew reported hearing the banging sound coming from the left engine. The torque fluctuation was also coincident with minor fluctuations in

the left engine inter turbine temperature (ITT), fuel flow, compressor (N_L) and turbine (N_H) percentages.

A slow reduction in right engine torque and ITT also occurred for the duration of the left engine power fluctuations, and until the torque increase on both engines was observed.
