# Loss of cyclic control and in-flight break-up involving Robinson R22 helicopter, VH-HGU

7 km north-north-west of Cloncurry Airport, Queensland, on 2 August 2017

ATSB Transport Safety Report Aviation Occurrence Investigation AO-2017-078 Final – 21 July 2020 Released in accordance with section 25 of the Transport Safety Investigation Act 2003

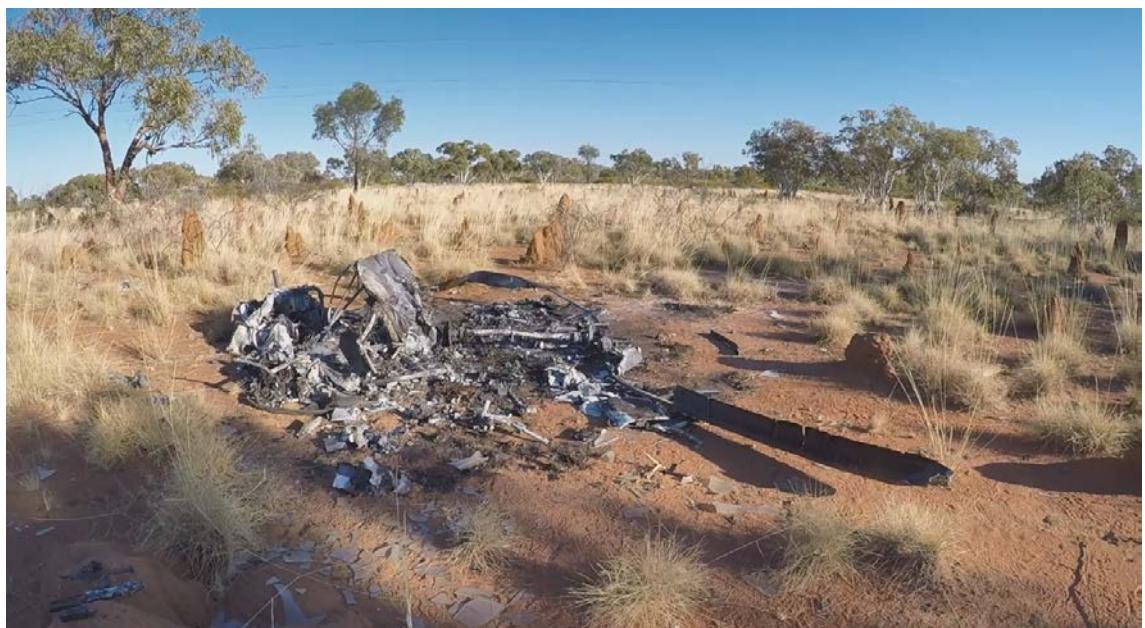
### Figure 1: VH-HGU accident site

The helicopter wreckage was located about 7 km north-north-west of Cloncurry Airport at about 0718 (Figure 1). The pilot was fatally injured and the on board global positioning system device indicated the accident occurred at about 0702.

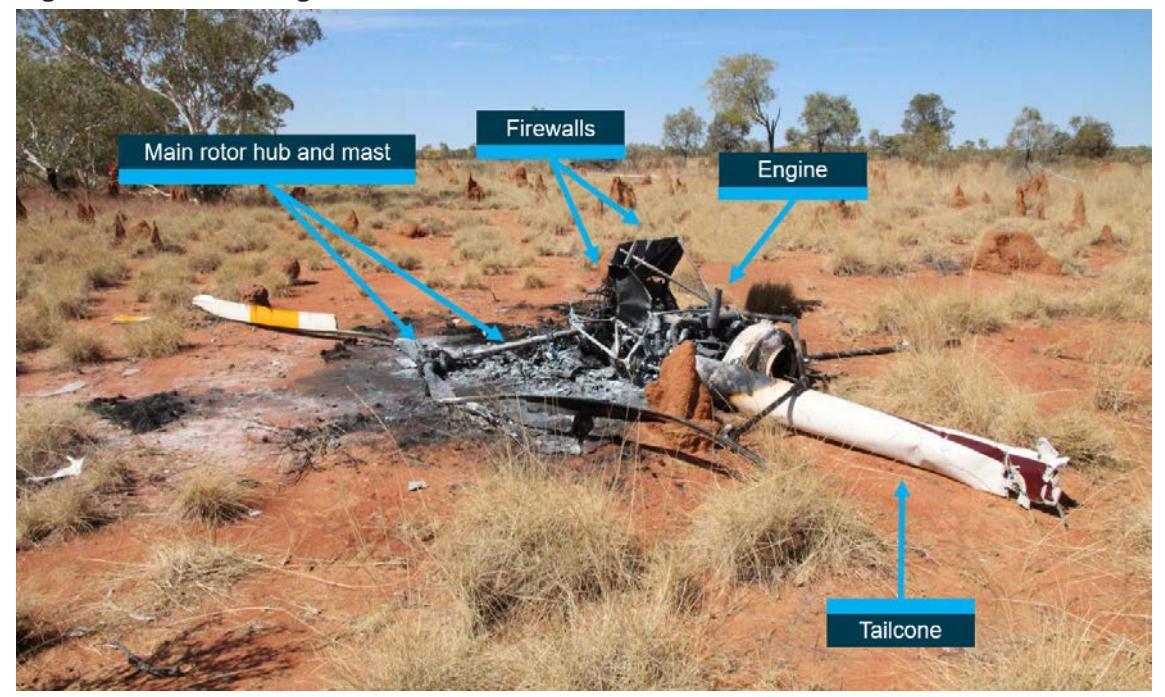
#### Figure 5: Main wreckage

The helicopter wreckage was located amongst termite mounds, in a sparsely treed area. The main wreckage had been subject to a significant post-impact fire, which had reduced the cabin area to ash, molten aluminium, and fibreglass mat. The airframe was oriented south-east on a heading of about 140°, which was in the opposite direction to the helicopter's recorded flight path. Small pieces of debris were scattered around the wreckage in a radius of about 20 m in most directions. The windscreen perspex was unburnt, shattered into small pieces and contained in an area of about 2 m<sup>2</sup> just forward of the cabin area. All the major components were identified within the debris field (Figure 5).

The airframe impacted the ground on the front left. Compression damage to the forward vertical firewall of the helicopter indicated that it impacted with a high rate of descent.

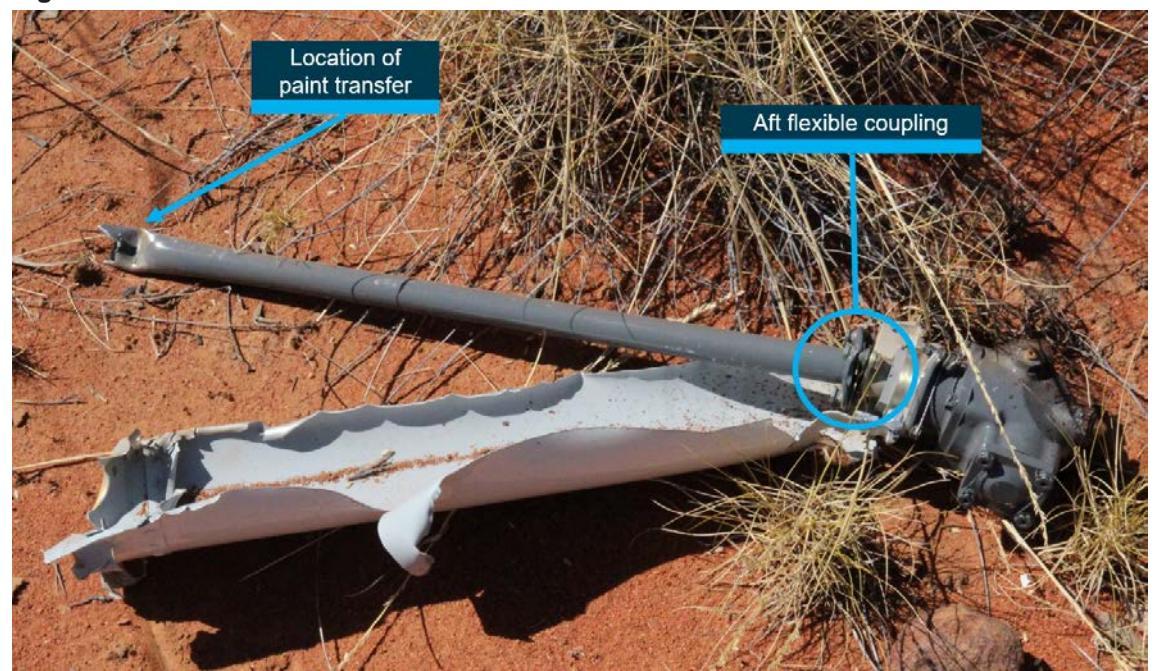
Figure 6: Severed tail rotor driveshaft

There was no evidence of any significant tension on the tail rotor driveshaft aft flexible coupling and little evidence of bending on the severed aft section of driveshaft (Figure 6). This indicated it was likely a power-on, high energy, main rotor strike to the tail.<sup>25</sup> The section of driveshaft forward of the severed section exhibited elongation and a bending overload, which indicated it was rotating during the break-up sequence. Therefore, the damage to the driveshaft was consistent with the main rotor disc striking the tail under normal engine power and rotor speed conditions.

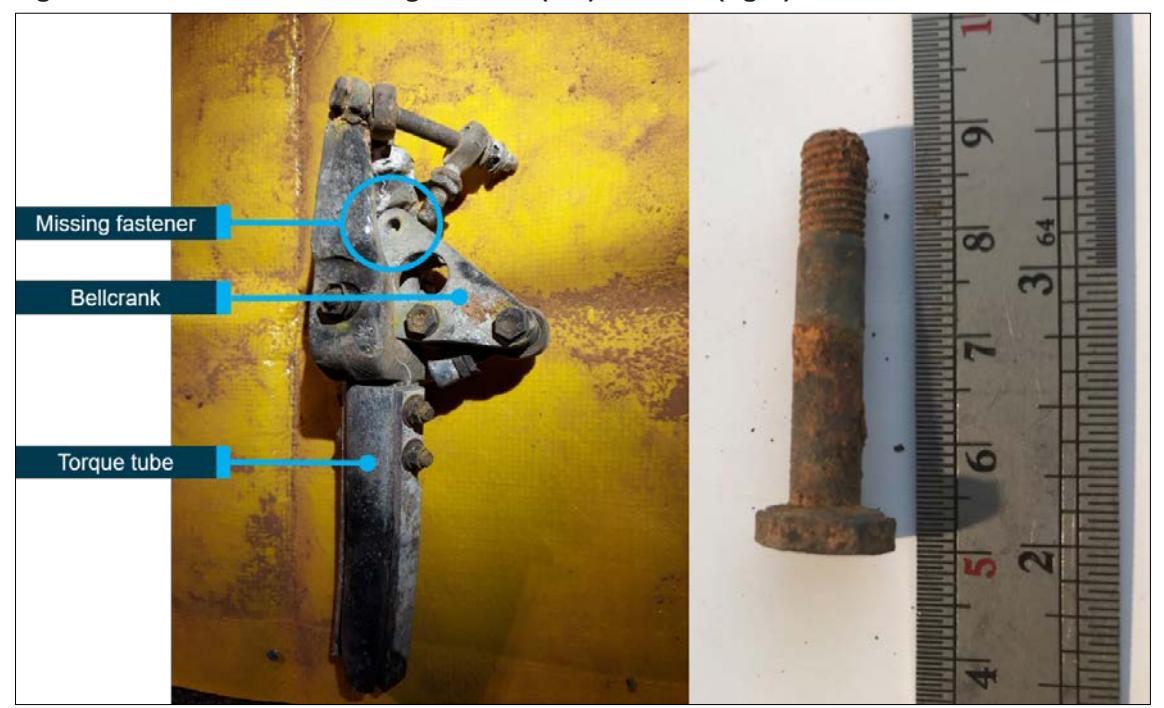
Figure 8: Bellcrank with missing fastener (left) and bolt (right)

During the photographic review of the wreckage after the initial on-site inspection, the ATSB noted an anomaly with a flight control bellcrank (part number A958-1) in the cyclic control assembly. The fastener,<sup>26</sup> which attached the horizontal push-pull tube (part number A121-1) to the bellcrank, was missing. The remaining bellcrank fasteners were all attached. The missing fastener was part of the longitudinal cyclic control, which controls the fore-aft tilt of the main rotor disc (Figure 7). The RHC R22 *Illustrated Parts Catalog* (IPC) showed that the flight controls should be secured at the bellcrank with a National Aerospace Standard (NAS) 6604-15 bolt and D210-4 self-locking nut.<sup>27</sup>

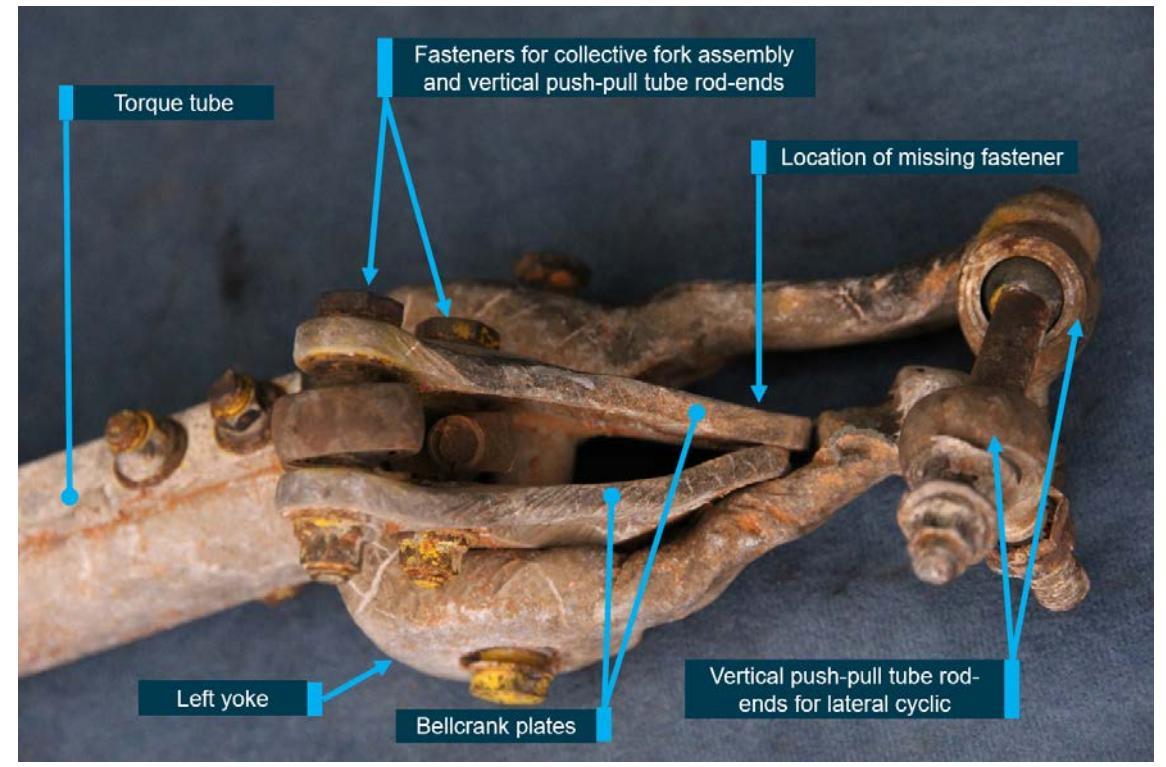
# Figure 9: Bellcrank showing deformation observed on the torque tube yoke assembly and bellcrank plates

The bellcrank and torque tube yoke assembly had been subject to significant mechanical damage such that the rod ends had fractured in overstress and the left side of the yoke assembly and bellcrank plate had significantly distorted. While the distortion of the plates was similar where the fasteners remained in position, the plates had been pushed together where the fastener was missing (Figure 9). The yoke assembly also exhibited heat damage in this area, with the left side moulding around the bellcrank plate. The combination of mechanical and heat damage meant that an exemplar bolt could not be reinserted through the bellcrank.

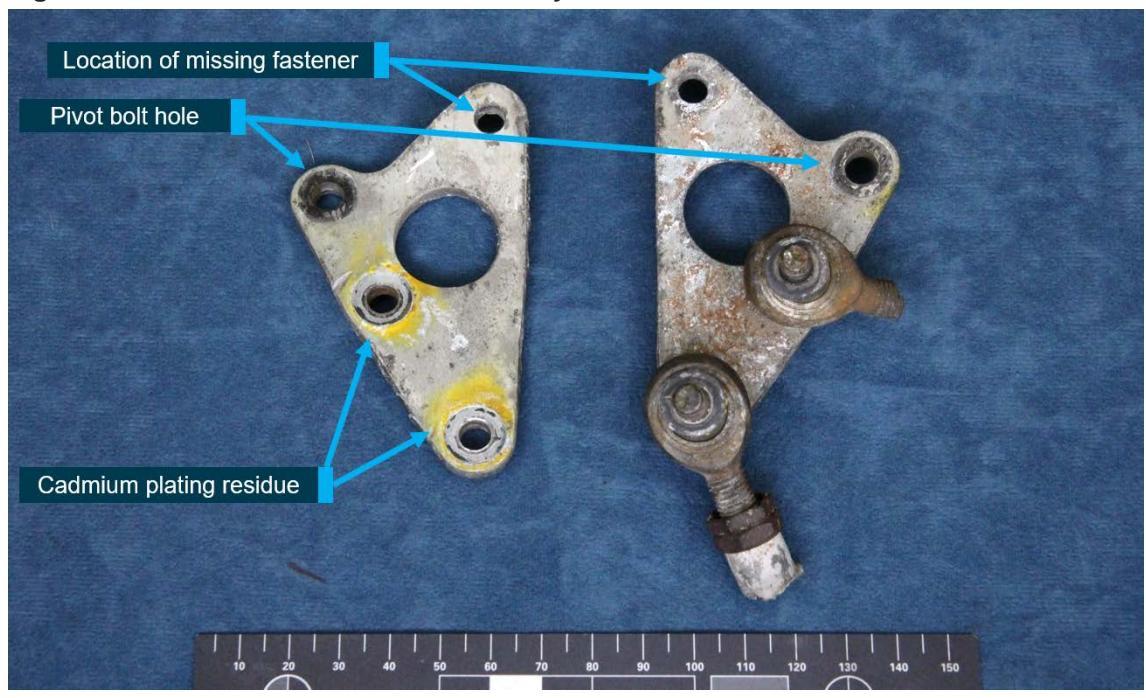
Figure 10: Bellcrank internal surfaces with yellow colouration

The bolt holes where the fastener was missing did not exhibit gross deformation or elongation of the holes to indicate that the fastener assembly had been forcibly removed during the accident sequence. Yellow colouration was observed around the other bolt holes where the fasteners had remained in position. While some yellow colouration was observed around the bolt hole of the missing fastener, it was much less than for the other holes, and none was observed around the internal surfaces of the hole (Figure 10).

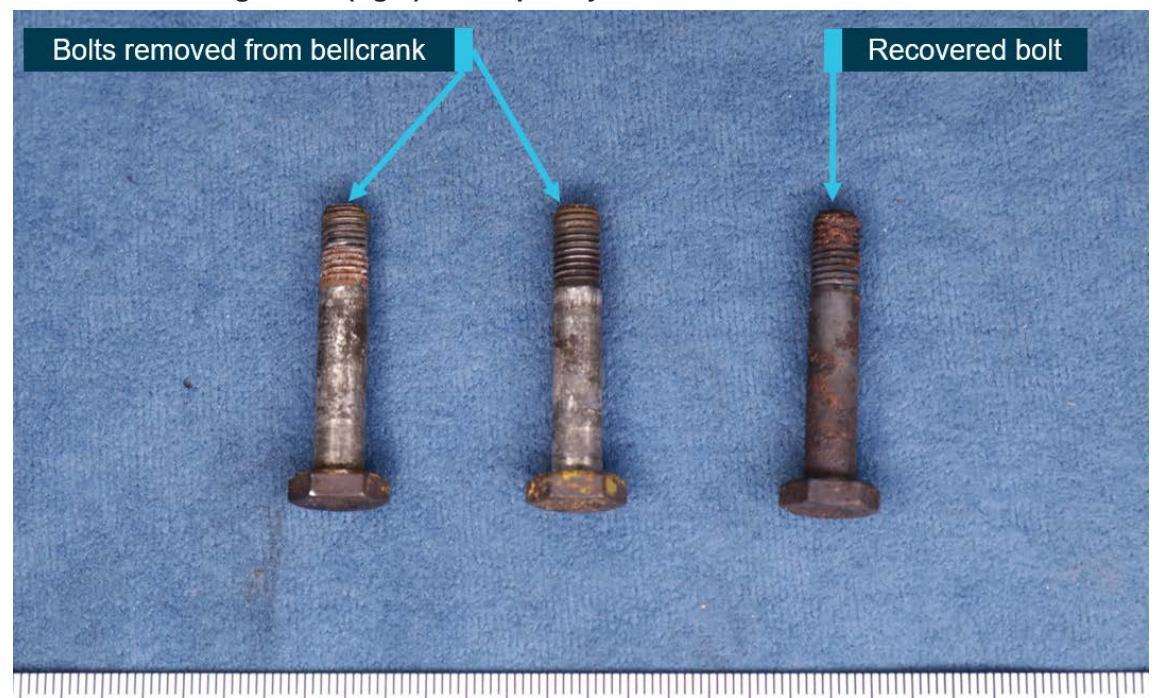
Figure 11: Comparison between the bolts removed from the bellcrank (left and centre) and the fire damaged bolt (right) subsequently recovered from the accident site

The solitary bolt found on 16 May 2018 by the next-of-kin was identified as a NAS6604-15 bolt. The bolt had the same manufacturer identification ('LFC') as the other two bolts fitted to the bellcrank, but exhibited greater fire damage (Figure 11).

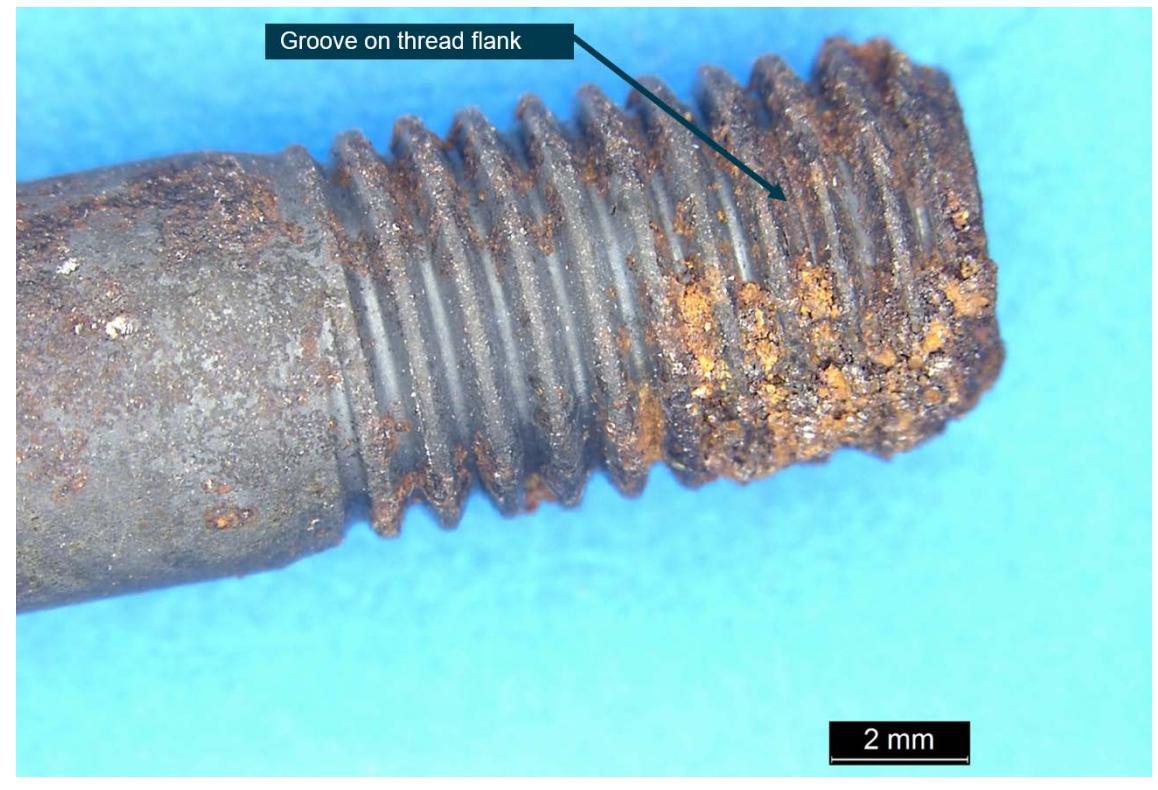
Figure 12: Magnified image of the bolt found 16 May 2018 showing thread groove

The recovered bolt was thermally damaged from the post-accident fire, but was otherwise in good condition with no evidence of distortion along its length or to the threads. A small groove was identified on the thread flank, which was likely from contact with a self-locking nut during installation (Figure 12).

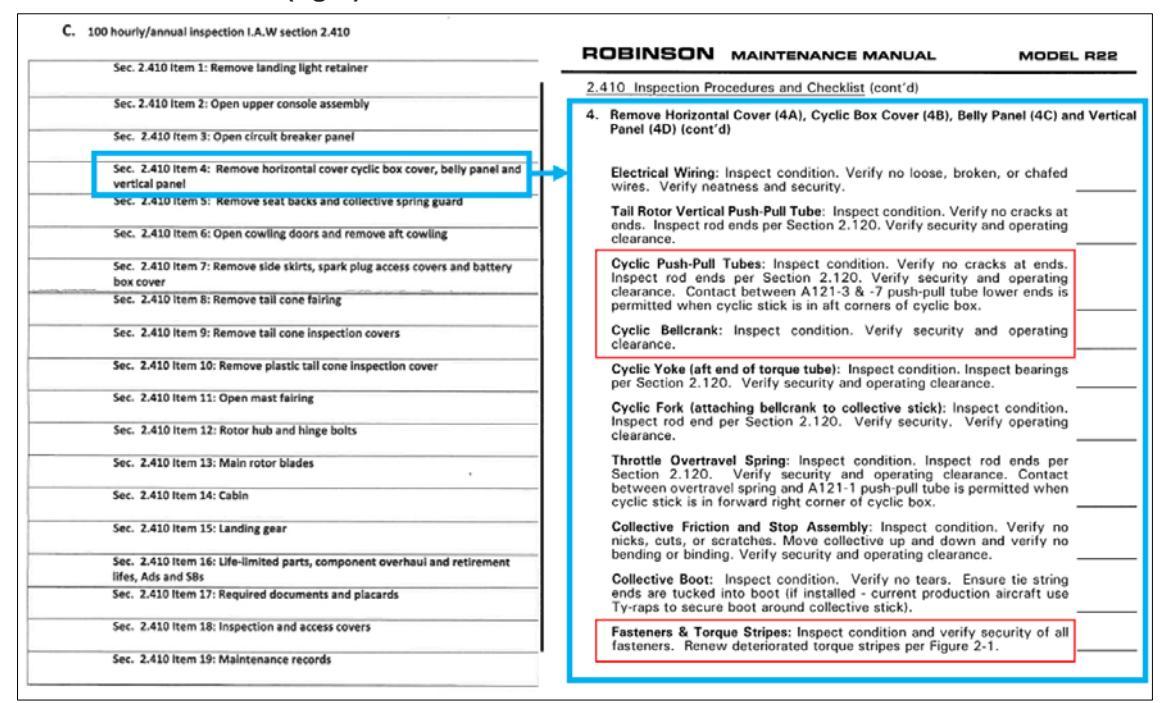
# Figure 14: Comparison of the CAM 100-hour inspection checklist (left) and the R22 maintenance manual (right)

Figure 14 shows a comparison of the CAM checklist item (left) with the RHC R22 maintenance manual (right) for the removal of the horizontal cover cyclic box cover, belly panel and vertical panel. The depiction below of the maintenance manual is one of three pages under the heading 4 task certifications. Inspection of the cyclic push-pull tubes, bellcrank and fasteners were items 19, 20 and 26. These items were covered as item 4 in the CAM abbreviated checklist.

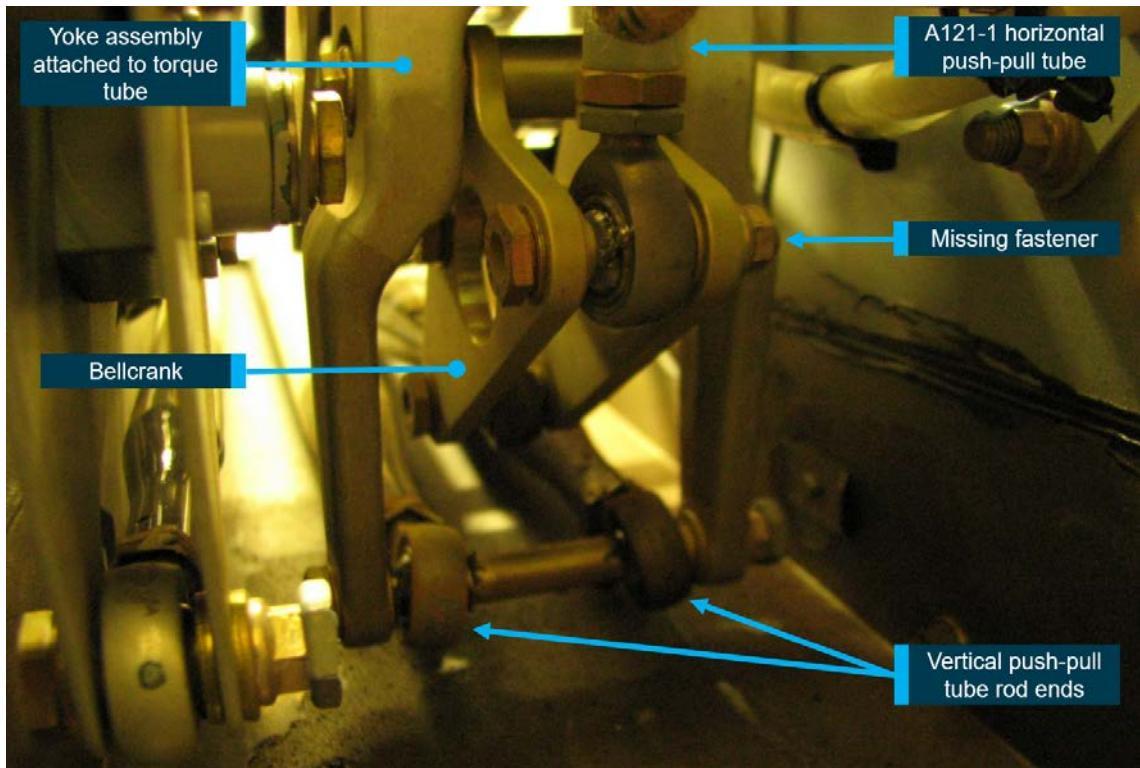
# Figure A1: View looking upwards of an exemplar R22 control system, showing the bellcrank and location of the missing fastener

The missing fastener was normally installed in the bellcrank, connecting through the rod end of the horizontal push-pull tube (Figure A1). Due to the criticality of this fastener in relation to the operation of the cyclic control and its absence predicating an in-flight loss of control, several items from the wreckage were recovered from the accident site. The retained items were examined in closer detail at the ATSB's technical facilities in Canberra. They included:

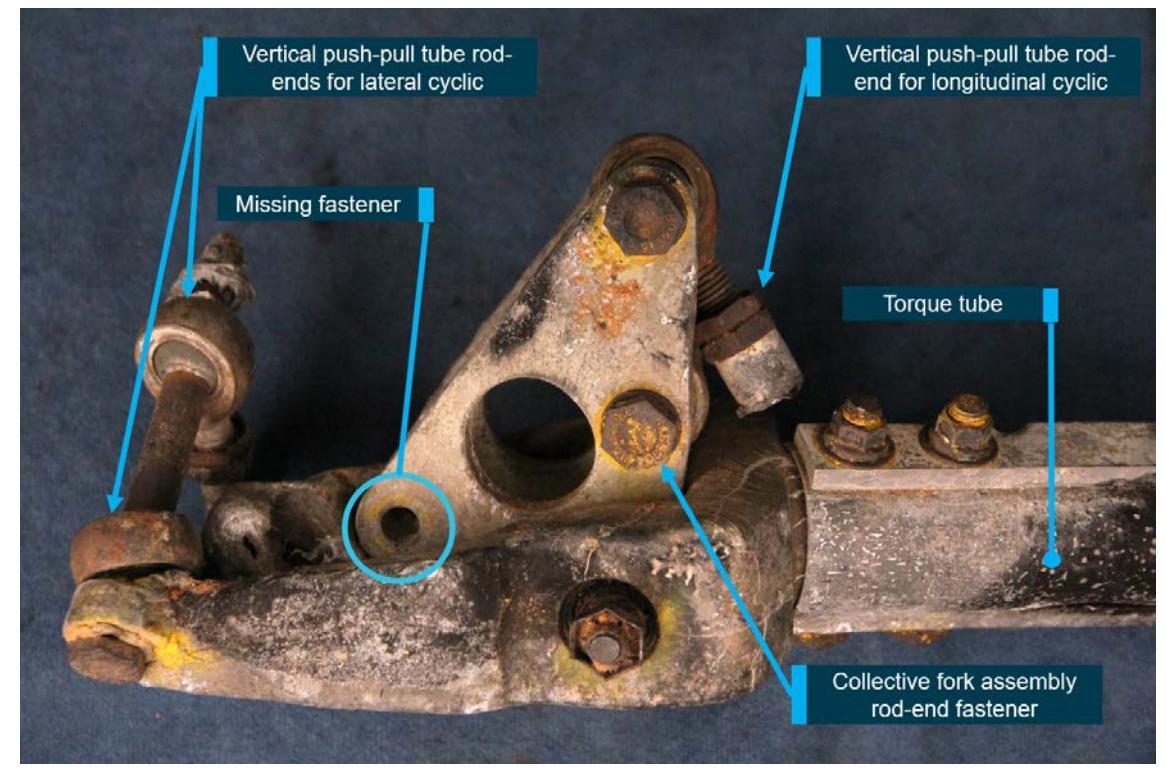
Figure A3: Side view of the bellcrank as received, location of missing fastener circled

The recovered bellcrank remained attached to the torque tube yoke assembly, which had fractured at the termination of the attached stiffening brackets. The submitted assembly exhibited significant damage as a result of mechanical and heat effects. All remaining rod ends, including those attached to the vertical push-pull tubes and collective fork assembly, had fractured in overstress (Figure A3).

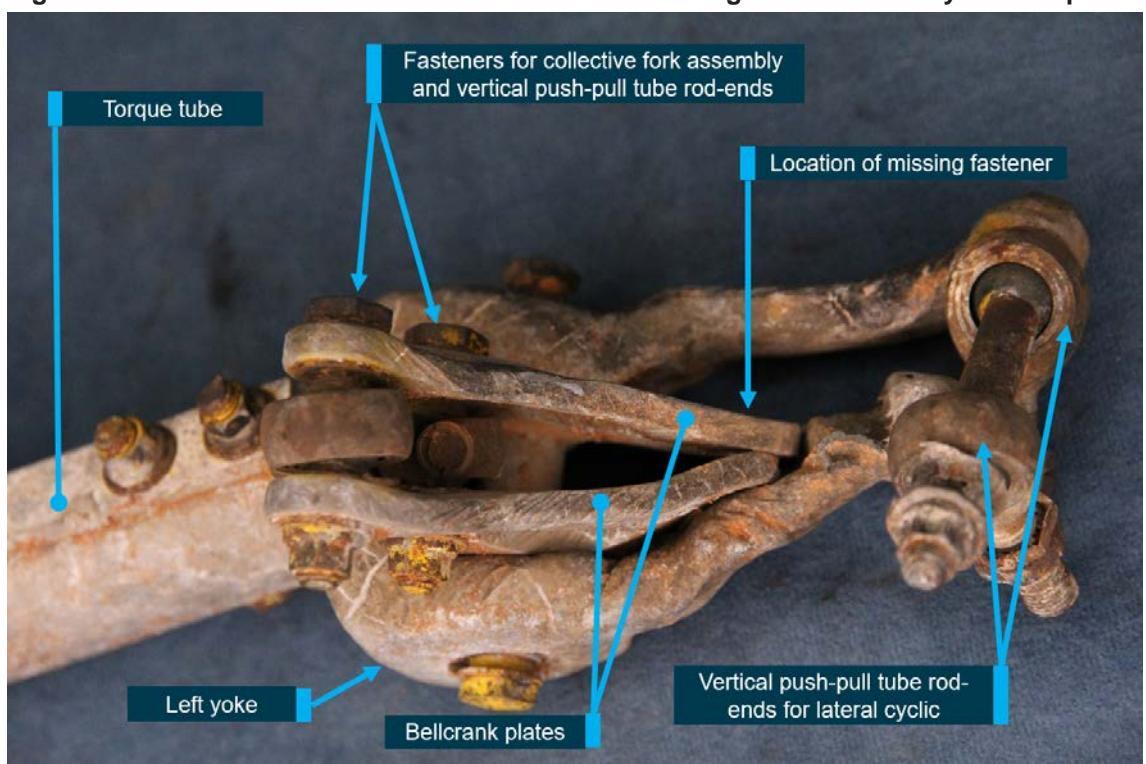
Figure A4: Side view of the bellcrank as received showing deformation of yoke and plate

The torque tube yoke assembly had separated from the bolt for the lateral cyclic vertical push-pull tube rod end on the left side, and was distorted from a combination of mechanical impact and heat. The left side of the yoke assembly exhibited significant distortion, and had been plastically deformed inward, towards the right side. The left bellcrank plate had been distorted in a similar way, causing the two plates to come together at the location of the missing fastener. The yoke assembly also exhibited heat damage in this area, with the left side moulding around the bellcrank plate (Figure A4).

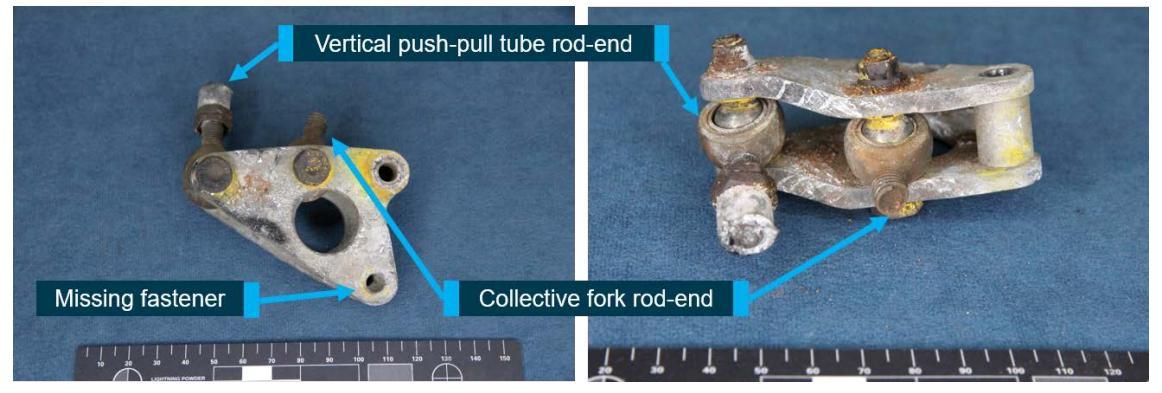
# Figure A5: Bellcrank following removal from the torque tube and showing parallel deformation of both plates

Following initial visual examination and photography, the bellcrank was removed from the torque tube yoke assembly for further examination. The bellcrank exhibited distortion from a combination of mechanical stress and heat effects. The two plates of the bellcrank had been deformed along the length between the vertical push-pull tube and torque tube attachment ends (Figure A5). Where the fasteners remained in position, the two plates had deformed in parallel. However, as above, where the fastener was missing, the two plates of the bellcrank had been pushed closer together.

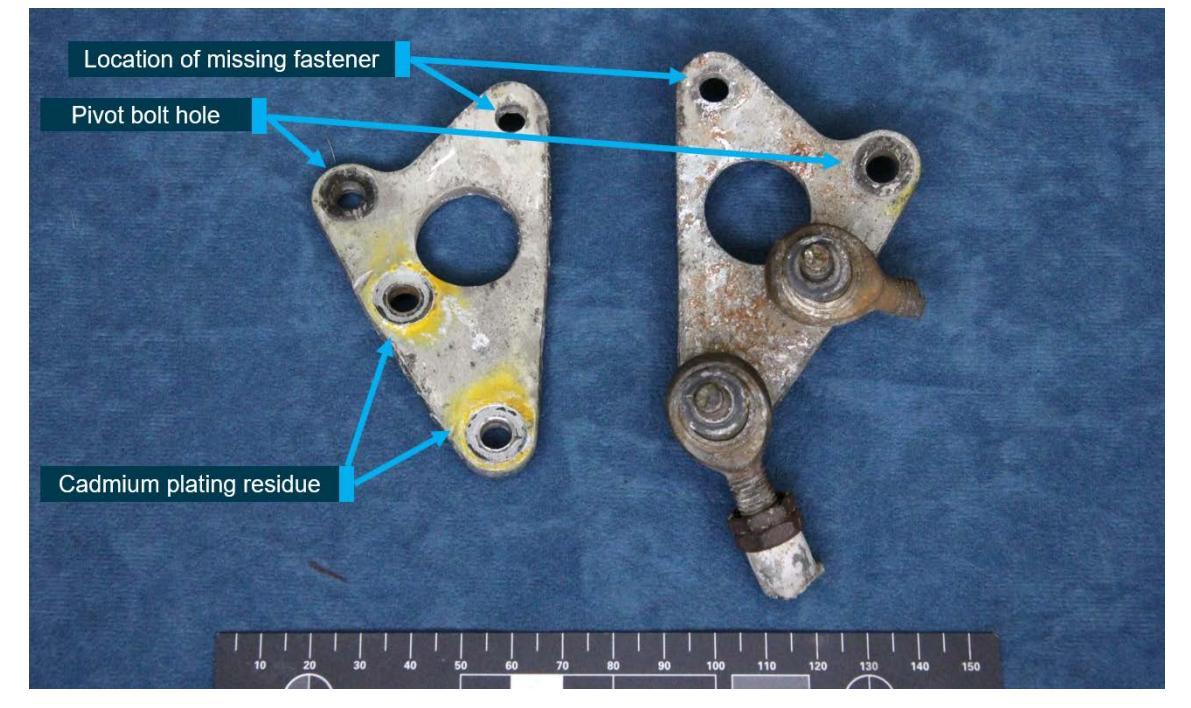
Figure A6: Bellcrank internal surfaces showing the cadmium plating residue

Closer examination of the bellcrank plates showed that a yellow residue had been deposited around the holes where the bolts had been in position. However, there was minimal residue around the hole where the fastener was missing (Figure A6). The manufacturer advised the residue was likely cadmium plating from components within the fastener assembly that had melted during the fire. They were also of the opinion that the minimal residue observed around the hole where the fastener was missing was likely from cadmium plating transfer from a previous installation. The presence of cadmium within the residue was confirmed by semi-quantitative chemical analysis using a scanning electron microscope (SEM) equipped with an Oxford energy dispersive x-ray spectrometer (EDS).

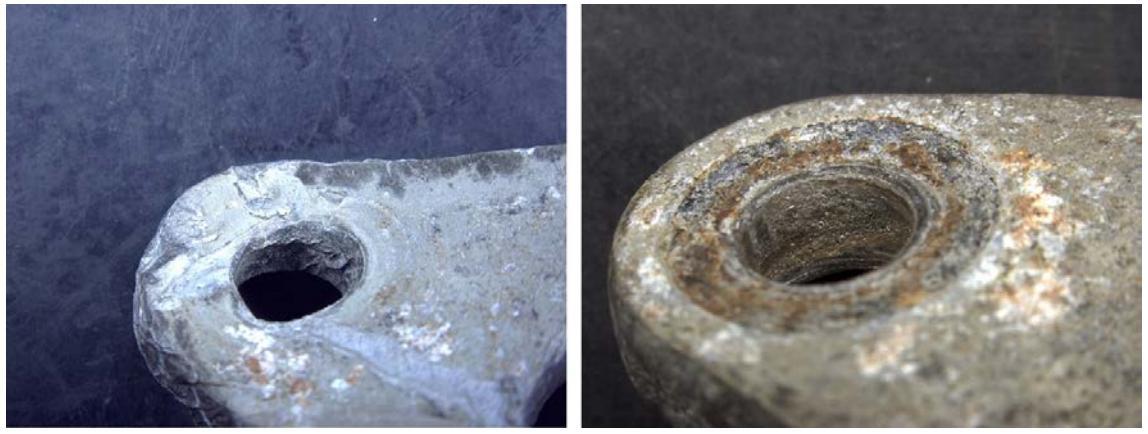
Figure A7: Comparison between the bolt hole where the fastener was missing (left) showing deformation due to heat and a bolt hole where a fastener remained in position (right)

There was no evidence of deformation or elongation of the bellcrank fastener hole to suggest that the nut and bolt had detached forcefully during the collision. The surface of the bellcrank in the region adjacent to the missing bolt, and the internal surface of the bolt hole, was rippled as a result of high temperatures associated with the fire. Minor damage in the form of scrapes and dents were observed in the region adjacent to the bolt hole of the missing fastener, coincident with where it had been in contact with the torque tube yoke assembly (Figure A7).

An exemplar bolt could not be inserted through the bellcrank bolt holes where the fastener was missing. This was due to a combination of misalignment of the two plates as a result of impact damage, and the heat damage observed on the internal surfaces of the holes.

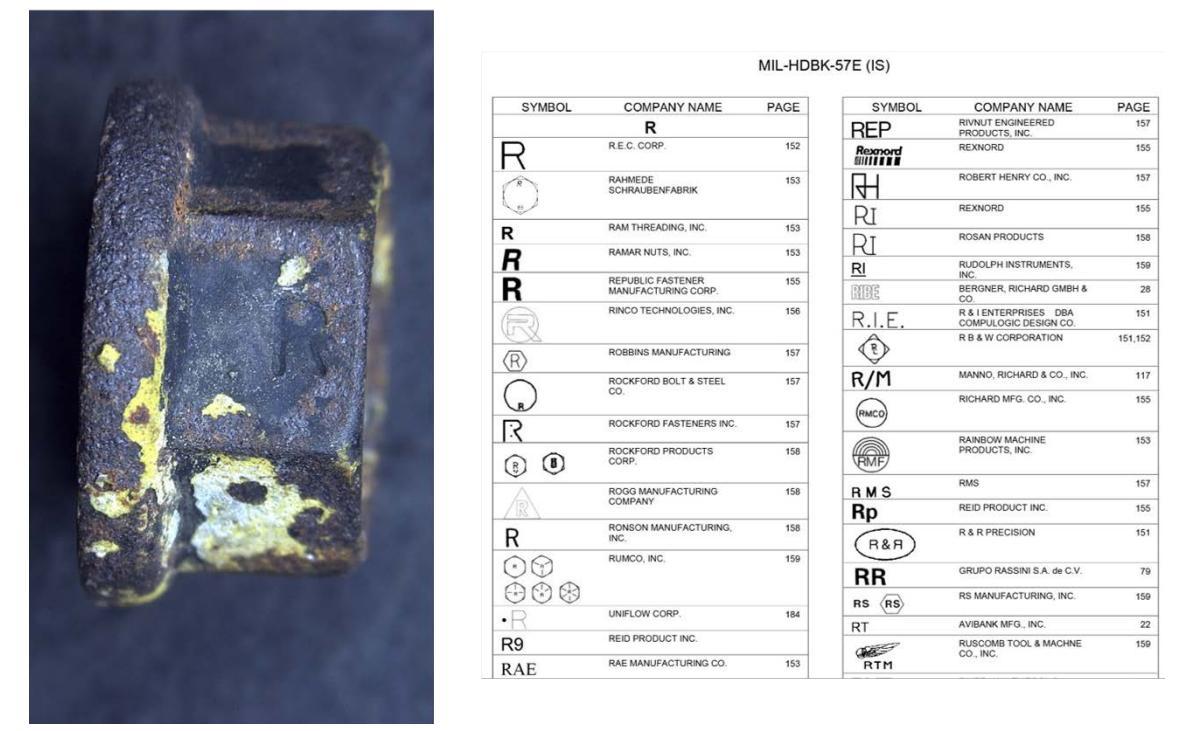
# Figure A9: Nut markings from one of the remaining fasteners (left) and relevant page from MIL-HDBK-57 showing manufacturers marks (right)

The nuts of the two remaining fasteners were stamped with an 'R' symbol on two of the hexagon flats on opposite sides. As per United States Department of Defence Handbook, MIL-HDBK-57E *Listing of Fastener Manufacturer's Identification Symbols,* the nuts were most likely manufactured by Ronson Manufacturing Inc. (Figure A9). The two remaining nuts were in relatively good condition, with no evidence of any cracking or damage observed. The chemical analysis results, provided in Table A3, confirmed the nuts were manufactured using 4037 alloy steel. Measurements and chemical analysis confirmed that they were consistent with MS21042-L4/NAS1291-series nuts.

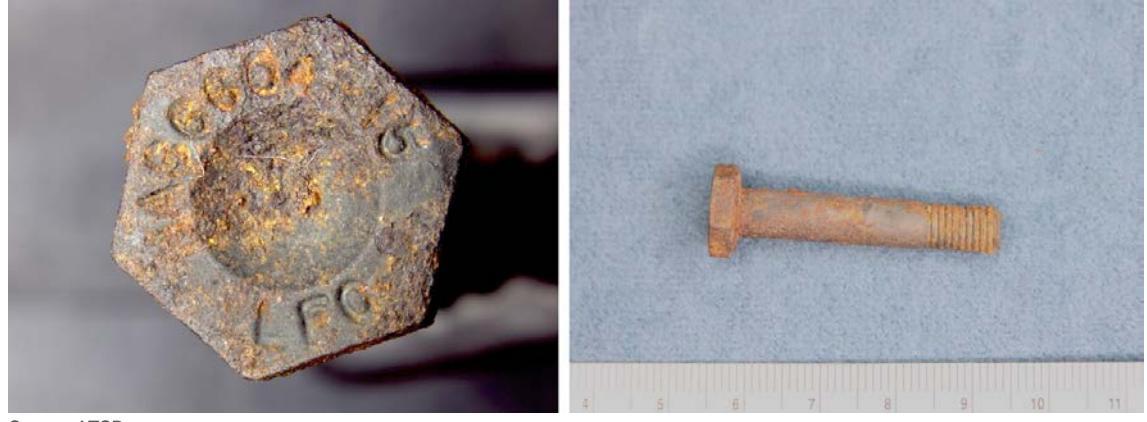
#### Figure A10: NAS6604-15 bolt found 16 May 2018

The bolt found on 16 May 2018 by the pilot's next-of-kin displayed the same markings as those that remained in position on the bellcrank (NAS6604-15 manufactured by LFC) (Figure A10). The surfaces of the bolt were severely heat affected, with areas of material loss and areas where additional material had adhered to the surface. Ultrasonic chemical cleaning of the bolt was unable to remove much of the adhered material. There was no damage observed to the head, shank or threads of the bolt. A dial indicator was used to check the bolt run-out, which confirmed it to be straight without significant distortion along the length.
