Controlled flight into terrain involving Kavanagh Balloons G-525, VH-HVW

Pokolbin, New South Wales, on 30 March 2018

ATSB Transport Safety Report Aviation Occurrence Investigation AO-2018-027 Final – 11 August 2020 Released in accordance with section 25 of the Transport Safety Investigation Act 2003

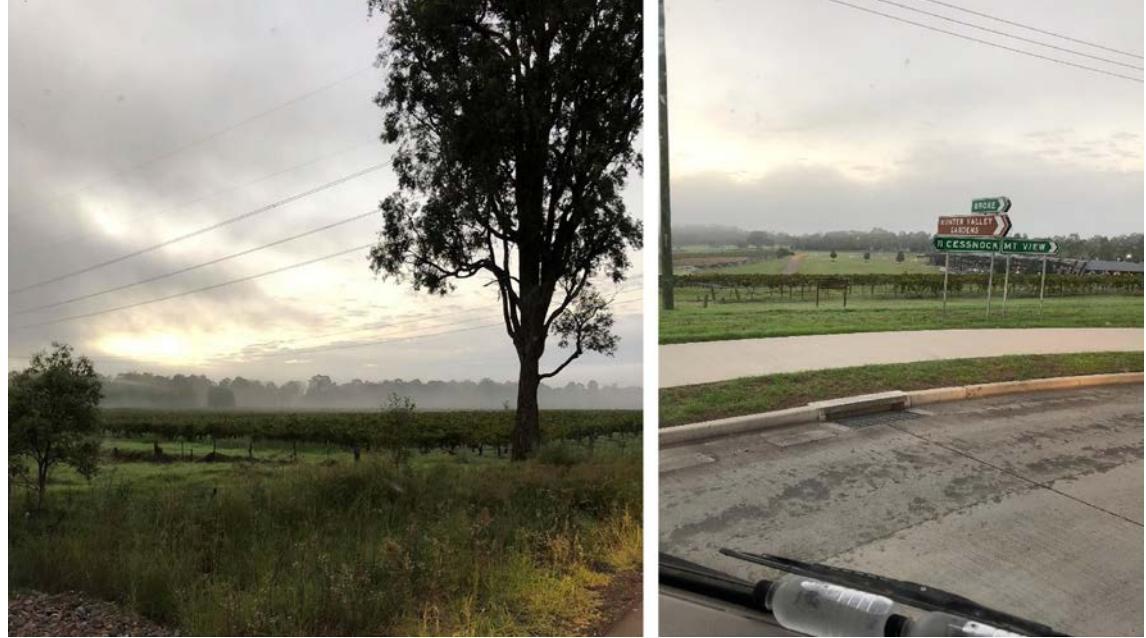
Figure 2: Photos taken by senior base pilot prior to launch

The pilots reported that the sky was still clear at Peppers Creek when they started to inflate the balloons, but that some light mist was rolling in. The senior base pilot drove to a location about 3.5 km to the north-west to assess the conditions in the area. He took a photo (Figure 2), which he sent to the other two pilots showing it was 'clear'. Following receipt of this, and on the senior base pilot's experience of the weather in the area, they elected to launch the three balloons from Peppers Creek.

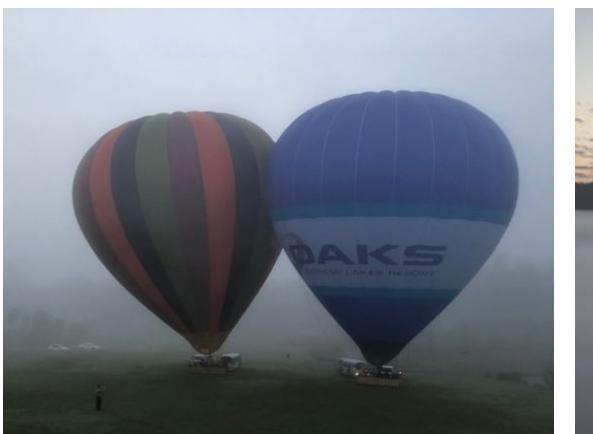
Figure 3a: View of company balloons from VH-HVW, airborne at about 0704

At about 0704, HVW lifted off and the other two balloons followed soon after. The pilot of HVW reported that there was a thin layer of low cloud but the visibility was adequate. Photos provided by the passengers showed fog in the area during and just after launch (Figures 3a and 3b).

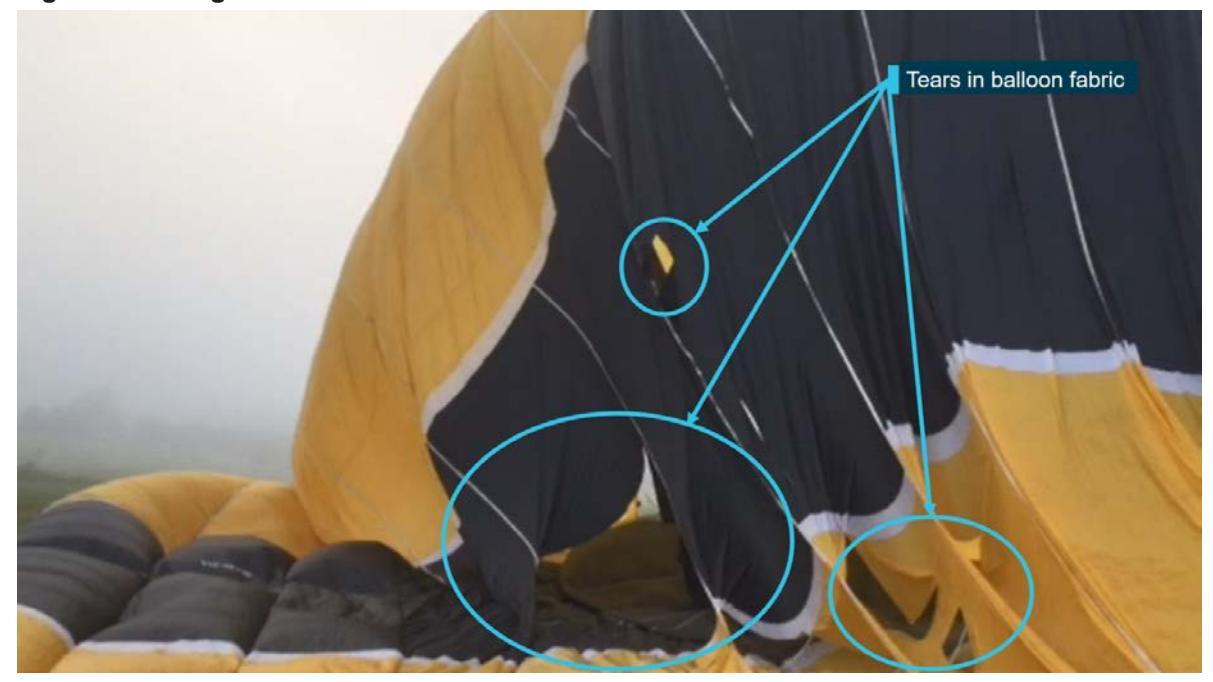
Figure 4: Damage to balloon VH-HVW

At about 50 ft above the ground, a number of passengers sighted a road and trees ahead and called out a warning to the pilot. The pilot saw the trees and reported activating full burners to try to climb above them, however he was unable to prevent a collision. The collision resulted in several large tears to multiple panels of the balloon fabric in the lower section of the balloon envelope. The impact with the trees also resulted in the basket rotating 180 degrees.

Sixteen passengers were injured in the landing, three of them seriously. The balloon was substantially damaged, requiring repairs to the fabric of the balloon envelope (Figure 4).

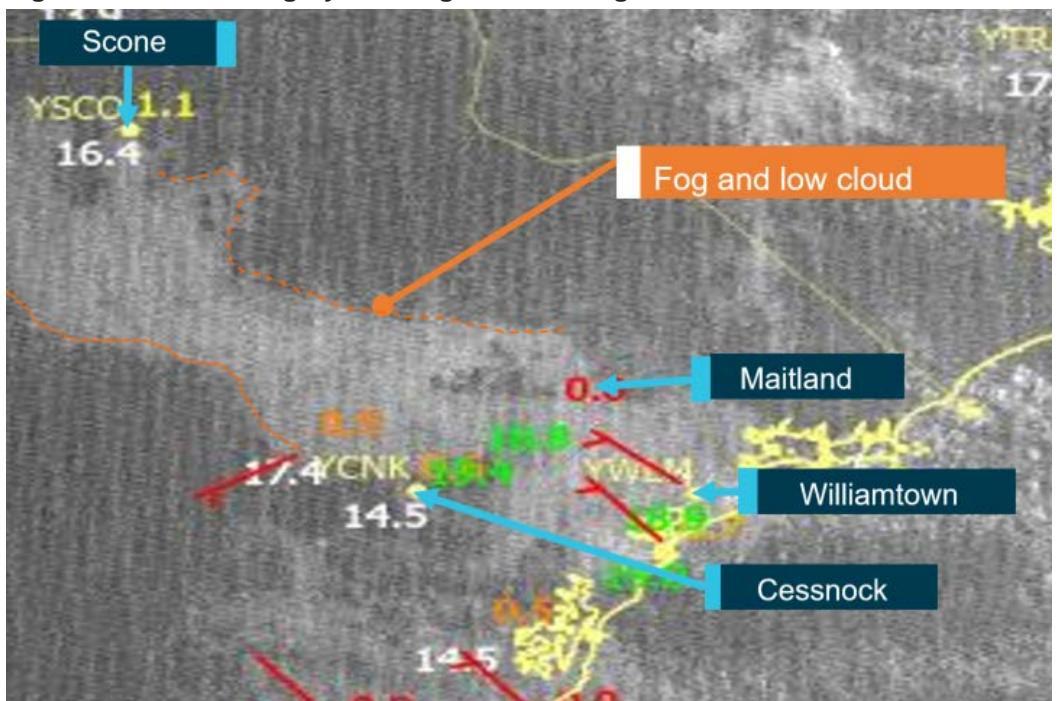
Figure 7: Satellite imagery showing a band of fog and low cloud at 0700

The Bureau of Meteorology graphical area forecast, issued at 0322 on 30 March and valid from 0400 to 1000, included visibility reducing to 500 m in scattered⁶ fog over land, and broken⁷ stratus clouds with bases at 1,500 ft above mean sea level (AMSL) and tops at 4,500 ft.
