Main rotor blade strike involving Leonardo Helicopters AW139, VH-EGK

21 km west-southwest of Caboolture Airport, Queensland on 20 June 2020

ATSB Transport Safety Report

Aviation Occurrence Investigation AO-2020-031 Preliminary – 12 August 2020 Released in accordance with section 25 of the Transport Safety Investigation Act 2003

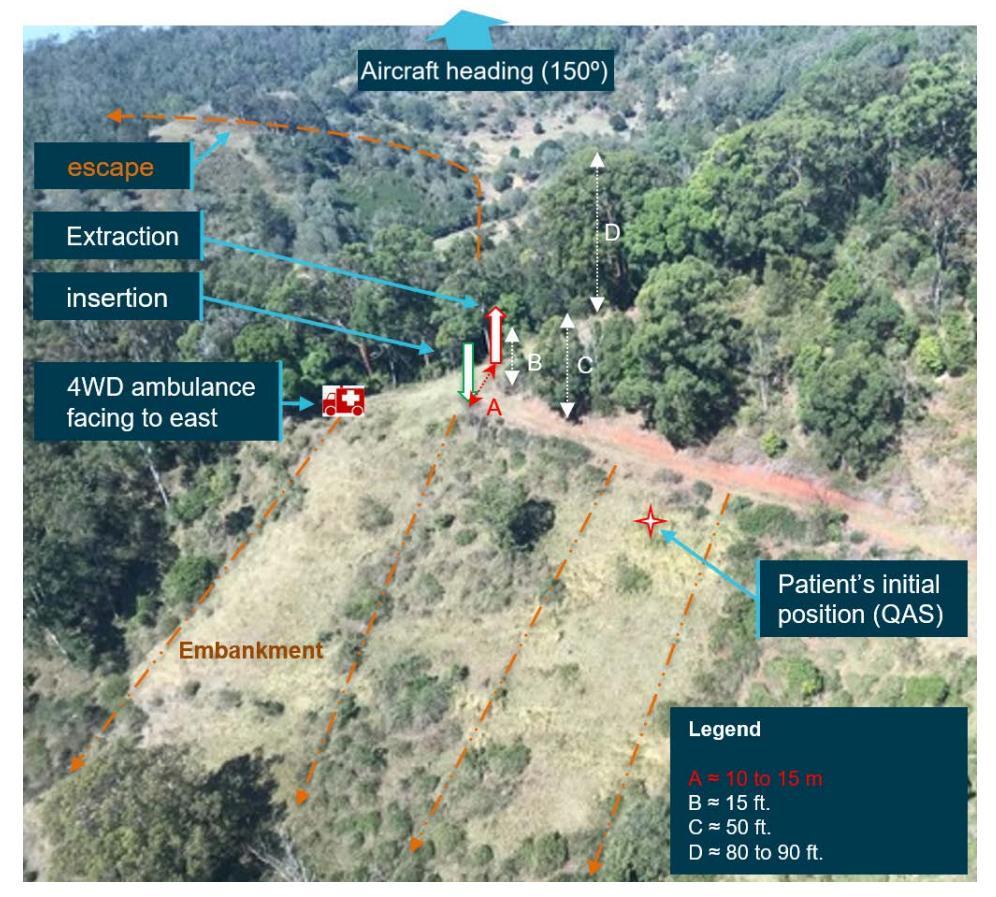
Rescue 500 arrived overhead Ocean View at about 1802 in very dark conditions (see *Meteorological and astronomical information* for light levels). For the purpose of reconnaissance, the helicopter commenced orbiting the ambulance which was located on the eastern edge of a confined area,⁶ situated on sloping ground surrounded by trees of varying height (Figure 3). After conducting several high and low level orbits at 1,000 ft and then at about 500 ft above ground level (AGL) respectively, the pilot manoeuvred the helicopter to an out-of-ground-effect (OGE)⁷ hover at a high reference datum,⁸ about 200 m north of the confined area at about 500 ft. The pilot and ACO then identified, discussed and agreed on a potential escape route in the event of an engine failure while operating in the vicinity of the confined area (Figure 3).

Figure 3: Aeromedical task - area of operations orientated south (by day)

The ACO then winched the RCO and flight paramedic down to the clearing about 10–15 m north of the patient and QAS ground paramedic (Figure 3). After reaching the patient, the flight

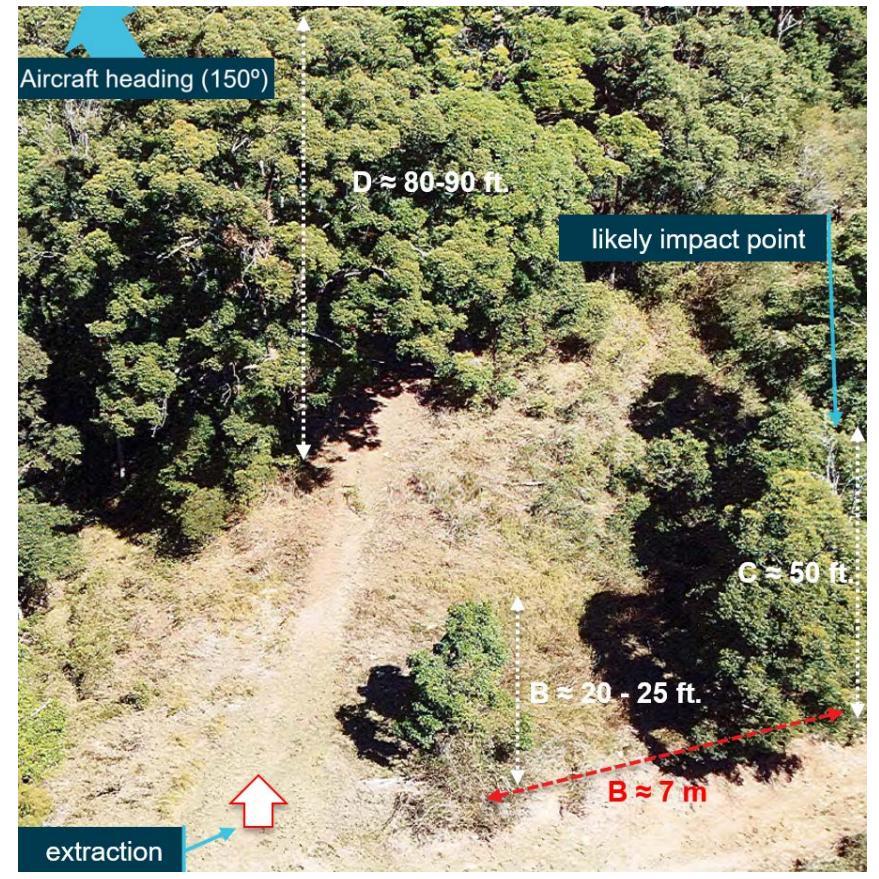
At about 1845, the helicopter returned to the site to facilitate the extraction winch (Figure 4). Once the helicopter was in the immediate vicinity of the confined area the RCO had the capability to communicate with the ACO and pilot via a Bluetooth³⁰ communications system (see *Aircraft information-AW139 crew communications*). During interview, the RCO recalled assessing the winching position shift as 'not significant', and therefore did not communicate the change to the ACO or pilot.

Figure 4: Confined area overview (looking south-southwest) and likely impact point

At 1851:13 as the RCO was being lifted for the second time, the helicopter's main rotor blades contacted trees around the rear right quadrant of the main rotor disc (Figure 5). Immediately following the impact, the ground paramedic reported seeing a branch fall through the trees. The estimated dimensions included; diameter of 10 cm and length of 1–1.5 m.

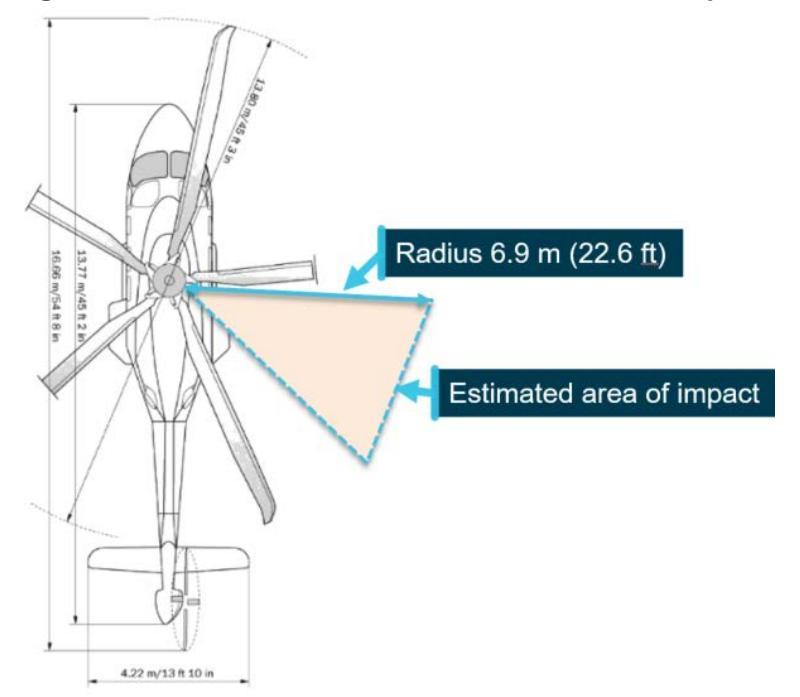
Figure 5: Estimated area of VH-EGK main rotor disc impact with trees

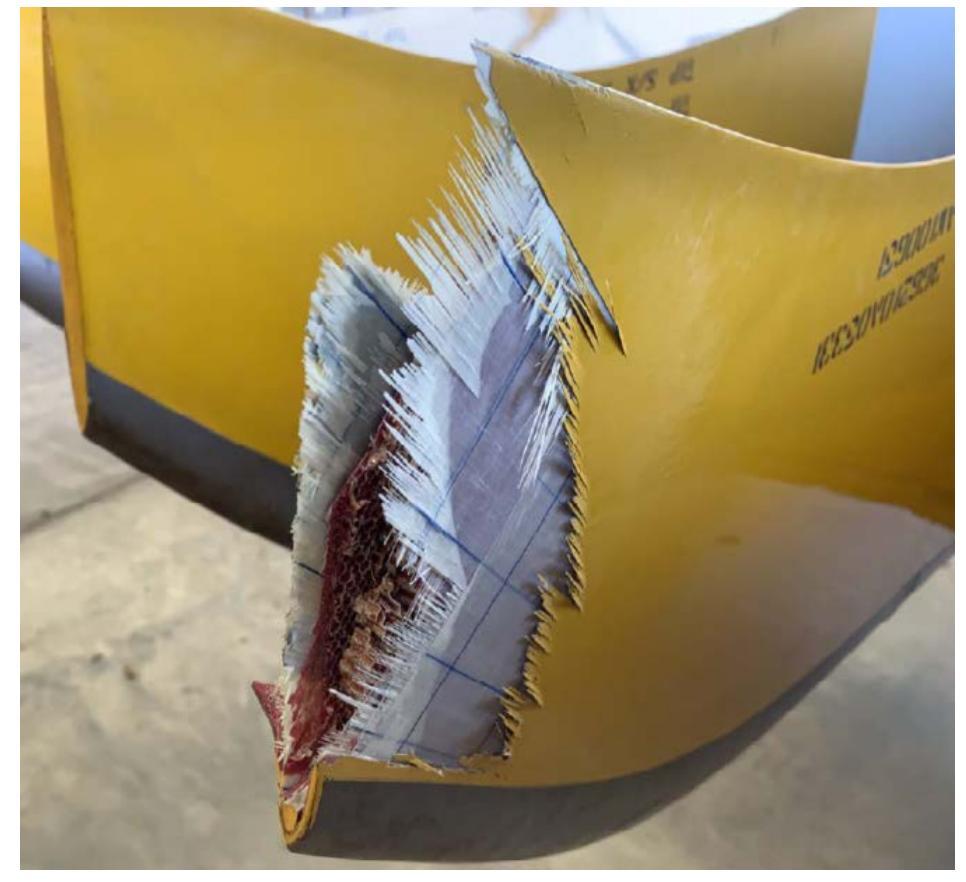
Damage was identified to at least three of the main rotor blades. One blade sustained significant damage to the tip cap and a small 2–3 cm skin puncture about 1 m from the blade tip (Figure 6).

Two more blades showed evidence of damage to the abrasion strip on the outer most edge of the tip cap. Three of the five main rotor blades were returned to Leonardo in Italy for detailed inspection and repair. At the time of finalising this preliminary report, Leonardo engineers estimated the weight missing from the most substantially damaged blade was about 50 grams (0.005 kg).

Figure 6: Substantial damage to VH-EGK main rotor blade S/N AW4447

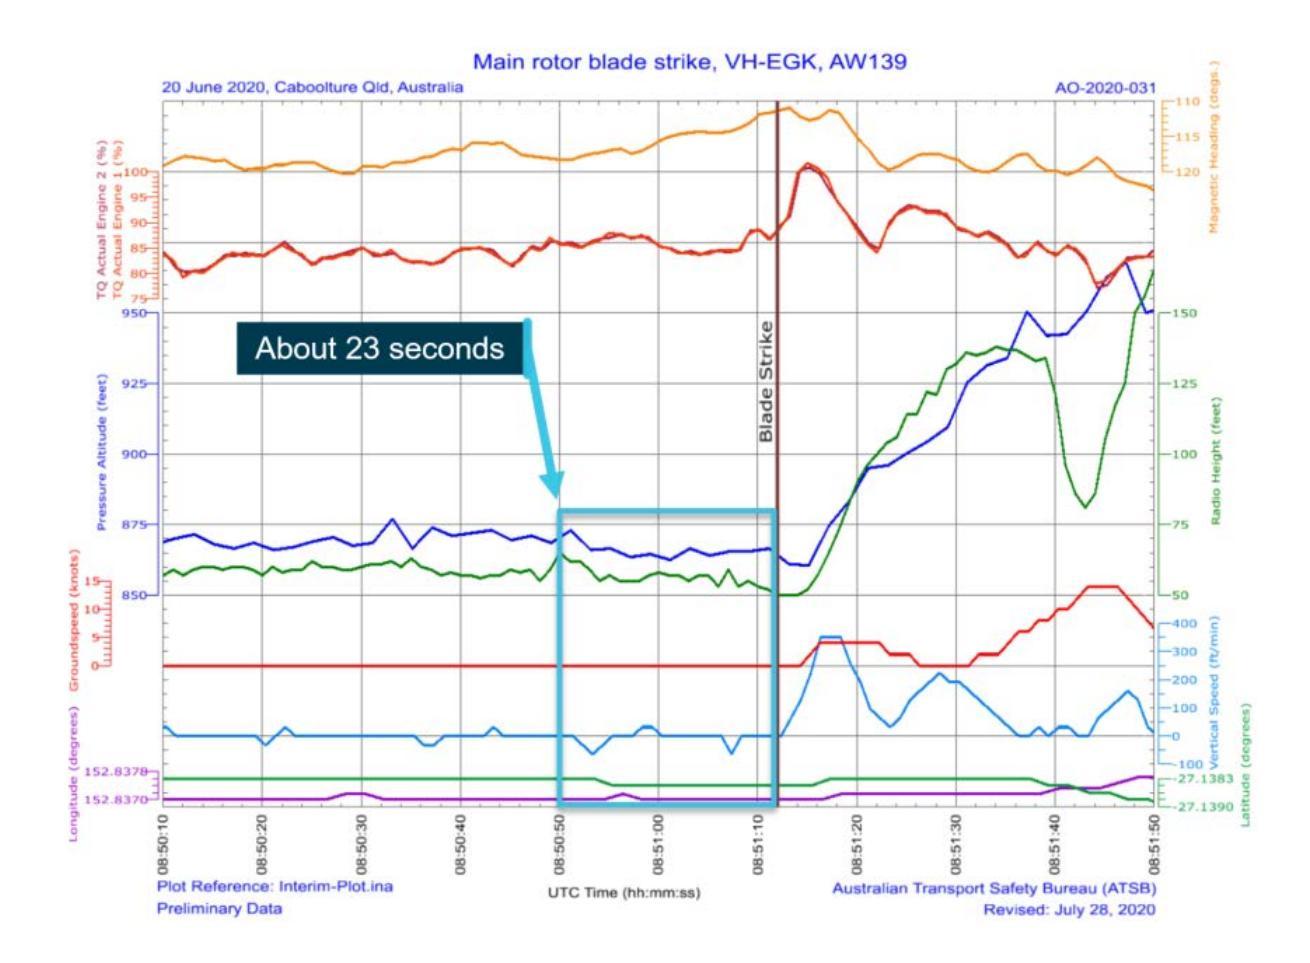
Preliminary flight data VH-EGK 20 June 2020

A preliminary examination of the flight data revealed that between 1850:49 and 1851:12, the helicopter's heading drifted left by about 10° and the hover position shifted forward towards the surrounding trees.¹⁵ Further, the flight data showed that during this time the helicopter descended from about 65 ft down to 50 ft AGL.¹⁶ The medical officer¹⁷ reported that at about this point, becoming concerned regarding the helicopter's proximity to the tree-line. However, in the limited time available, this concern was not communicated to the aircrew.
