Collision with terrain involving Cessna 172, VH-CBB

31 km west of Mittagong, New South Wales, on 22 March 2020

ATSB Transport Safety Report Aviation Occurrence Investigation (Short) AO-2020-020 Final – 11 November 2020 Released in accordance with section 25 of the Transport Safety Investigation Act 2003

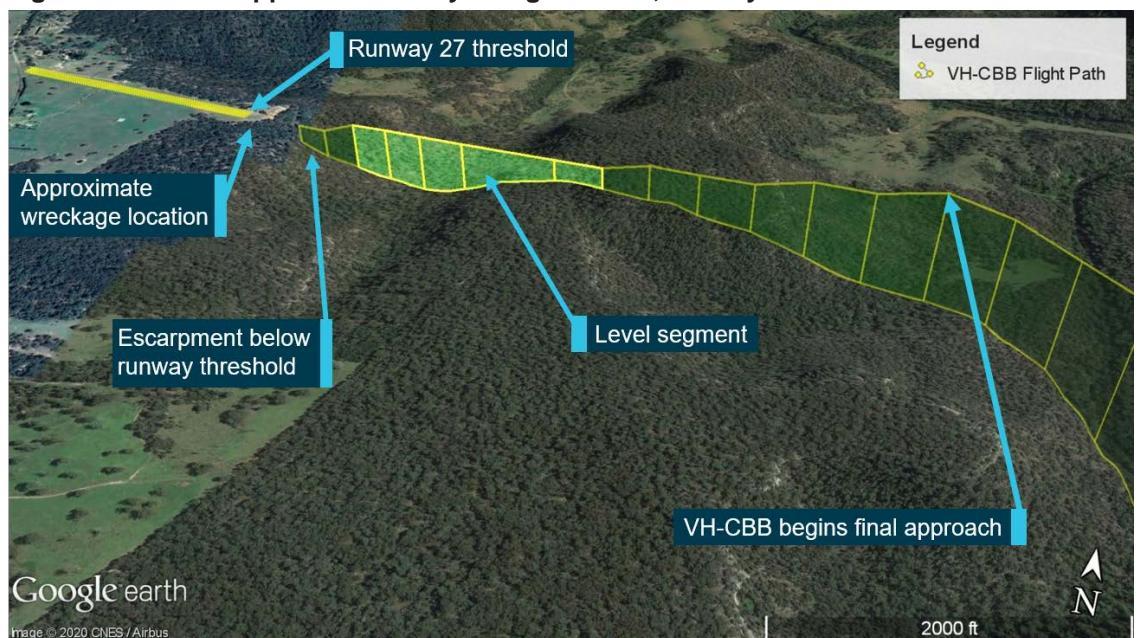
Figure 1: VH-CBB approach to Canyonleigh airfield, runway 27

OzRunways² information for the flight was obtained, with the final approach shown in Figure 1. A review of the flight data identified that during the second half of the approach, the aircraft's altitude remained relatively level (highlighted segment), but the terrain beneath falls away into a deep gully then climbs towards the airfield.

The recorded data rounded the aircraft's altitude down to 100 ft increments, giving a low approximation of VH-CBB's actual approach. Due to sudden changes in attitude and altitude, the last few data points were considered unreliable and were therefore not included in the image
