Derailment of coal train TM94

Moss Vale, New South Wales, on 28 June 2019

ATSB Transport Safety Report Rail Occurrence Investigation RO-2019-013 Final – 24 November 2020 Cover photo: Office of Transport Safety Investigations (OTSI)

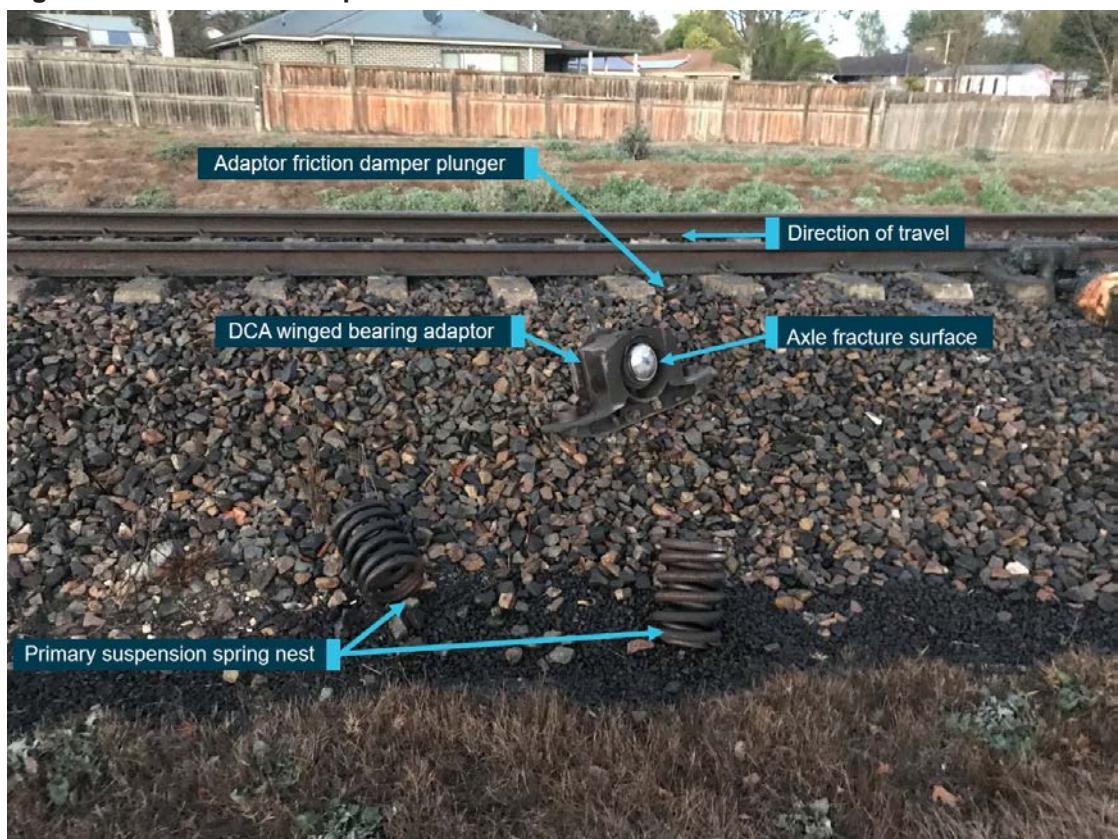
Figure 3: Parts found on Up side of track near derailment location

At 0041, the 14th wagon in the train's consist (NHSH 42774Q) passed the 128A catchpoints, and the L1 axle journal separated from the rest of the axle. This created unloading of the R2 wheel, which resulted in the R2 wheel climbing the Down rail and the L2 wheel moving into the four foot⁴ and derailing. The train continued with the broken axle and the No. 2 wheelset derailed, there was no loss of brake pipe pressure. Approximately 80 m past the point of derailment, at 150.067 km, the axle box and suspension elements were found later on the Up side of the track (Figure 3).

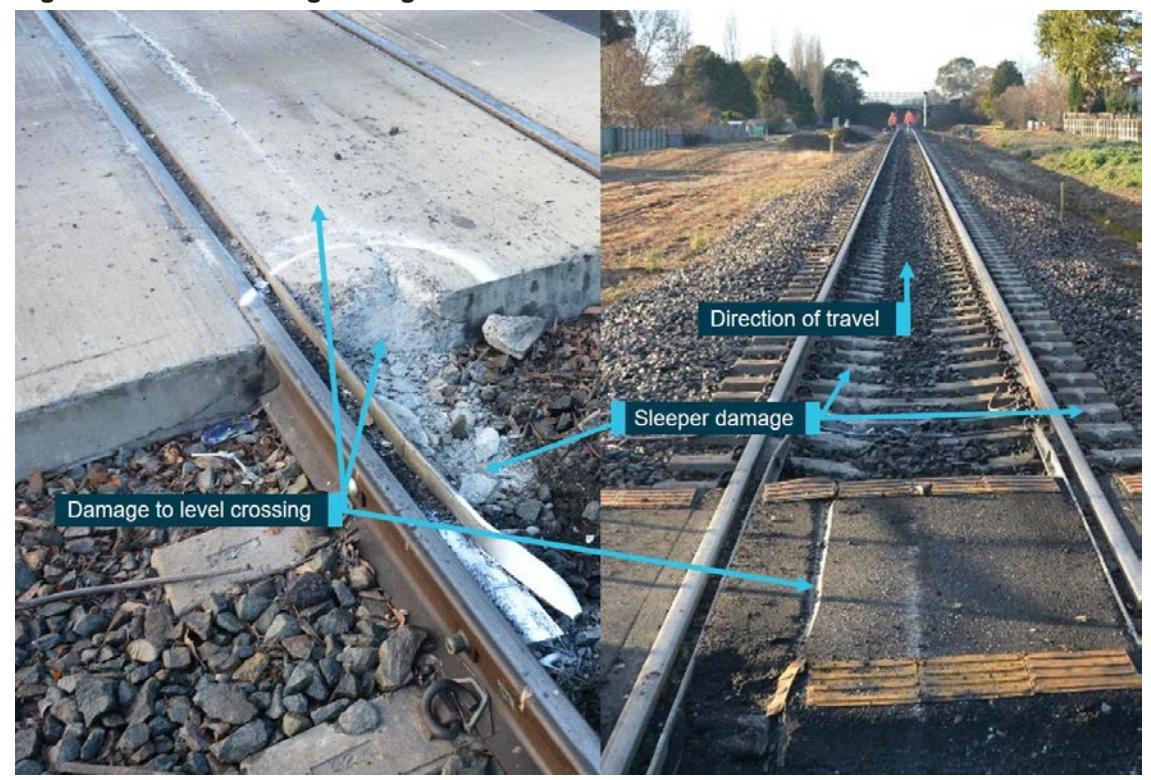
Figure 6: Level crossing damage

Following the derailment, investigators from ARTC, OTSI and Pacific National attended the site. On-site evidence identified the location of the derailment at 150.152 km. The likely point of dropoff was identified from a mark on the Up Rail gauge face and the start of sleeper damage. The track sustained damage beyond this point for approximately 2.6 km. Following the incident, 4,350 concrete sleepers were replaced. The 128B turnout had damage to multiple areas, which required repair and replacement. There was also damage to the concrete pad at the Suttor Road level crossing (Figure 6). The significant damage to the concrete pad at the level crossing was almost entirely on the Down side, having been caused by the L2 wheel. The R2 wheel caused minimal damage to the concrete pad.

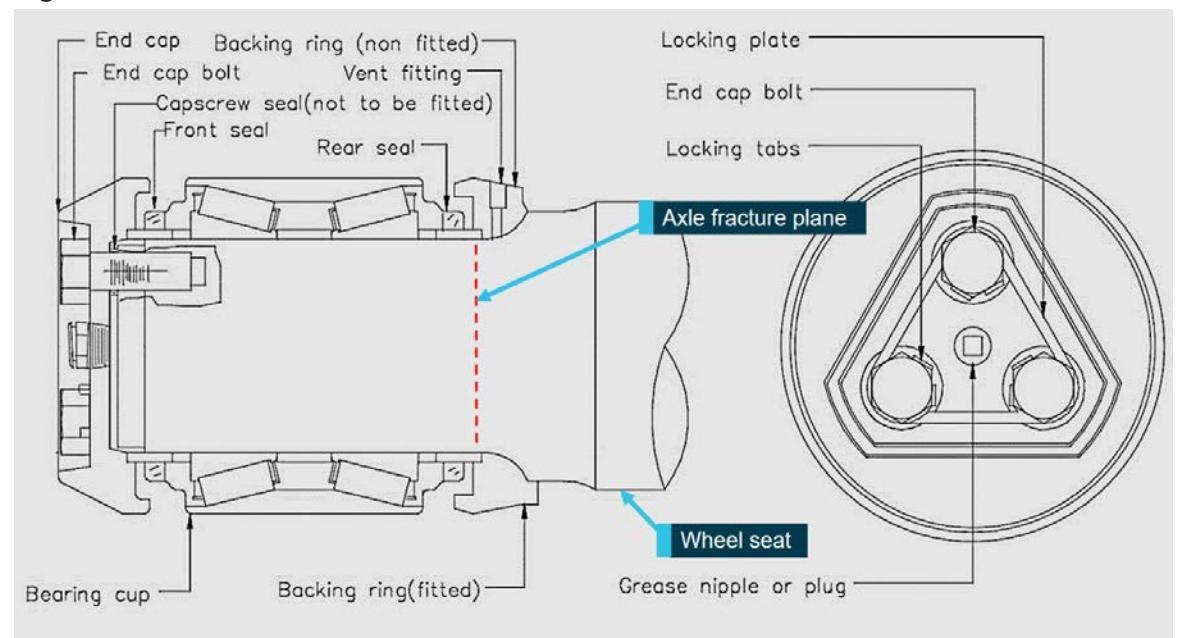
The metallurgical report concluded that the position of the fracture face was approximately 250 mm from the end of the axle. This was at the start of a radius transition where the axle diameter increased from the 144.5 mm to 177.8 mm (Figure 9).

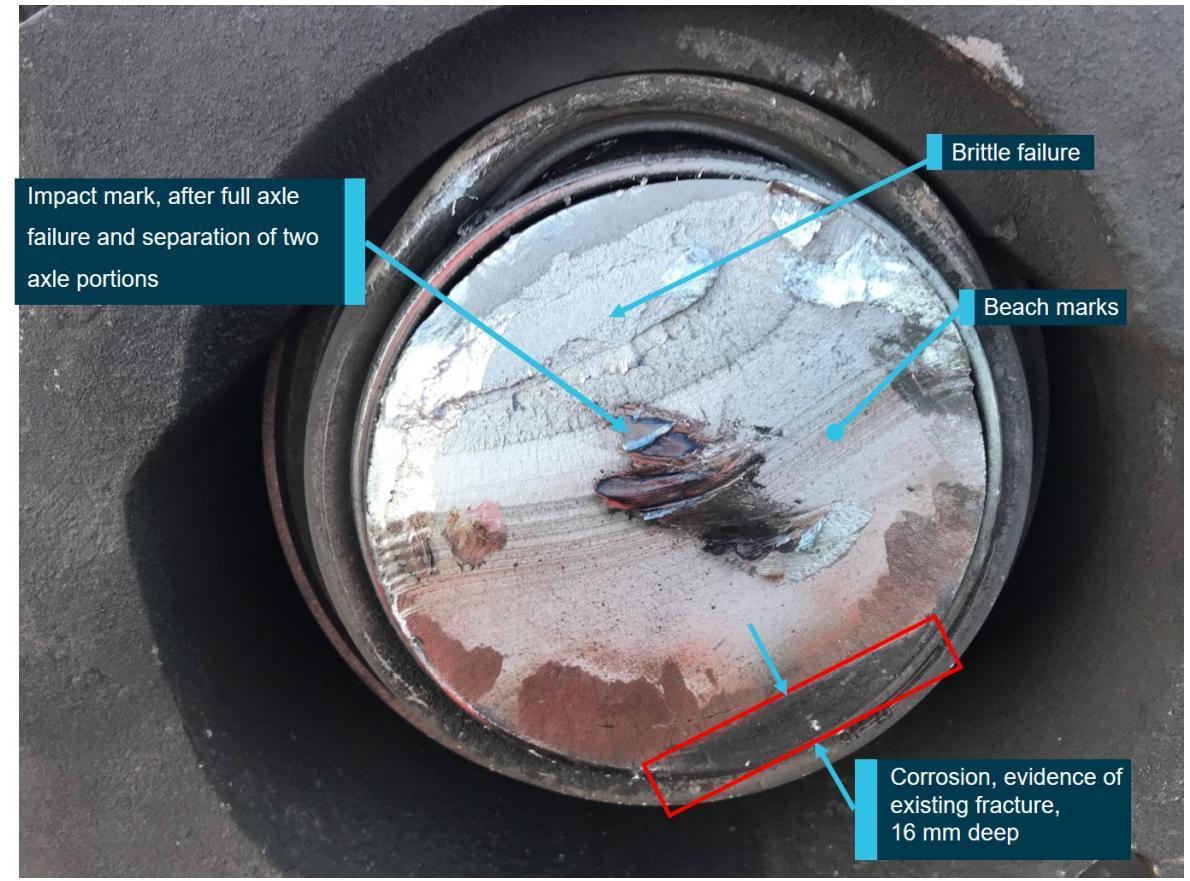
Figure 10: Fracture surface face of axle remaining within bogie

After examination of the fracture face, Bureau Veritas metallurgists concluded that the axle failure was the result of the propagation of a fatigue crack that extended over 60% of the axle cross section. Although no clear initiation point was visible, a discoloured area, which extended 16 mm into the section, likely represented the position of the initiation of the fatigue crack (Figure 10). There was a line of surface corrosion pits next to the fracture face that was likely to have provided the stress concentration for fatigue initiation (Figure 11).

Analysis conducted on the crack propagation found it likely that the axle was defect-free in November 2010, when the wheel change maintenance activity took place. The period between this event and the fracture was 8.5 years. It is likely that the fatigue crack was present at the January and November 2016 wheel maintenance events where wheel bearings were replaced, but was undetected.

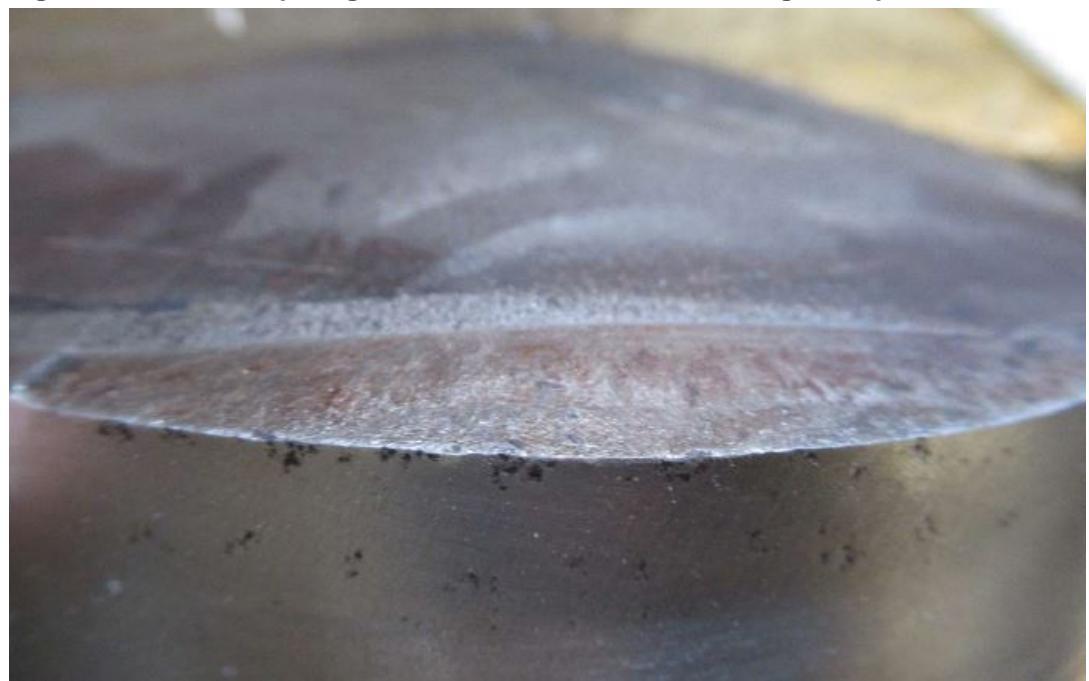
Figure 11: Corrosion pitting on axle surface next to fracture ignition point

- The axle failed due to the initiation and propagation of a crack at the beginning of a radius transition curve at the end of the bearing journal. There were a series of surface corrosion pits next to the fracture face that may have provided the stress concentration for fatigue initiation. A discoloured area which extended 16 mm into the section likely represented the position of the initiation of the fatigue crack; this had progressed approximately across 60% of the axle cross-section before brittle failure occurred.

Pacific National commenced and completed a program of non-destructive testing of axles in-situ to ensure that no axles pose an immediate risk of failure. This included all 7E5S axles and involved ultrasonic testing. During wheel shop maintenance activities, Pacific National requires the removal of bearings from axles at workshops to allow magnetic particle testing, with the exception of K and G Class which do not necessarily require removal. This allows more accurate detection of initial indications of cracking in the radius transition area of the axle.

A Rolling Stock Notice (RSN) was also issued, to reinforce to Pacific National's wheel set overhaul contractors of the requirement. Pacific National have included a new check to the wheel shop audit checklist, requiring confirmation that the specified corrosion inhibition is being applied to the axle.¹³

Pacific National have implemented a process with some wheel shops to machine the fillet radius of axles in order to restore the fillet radius to a defect-free state. Pacific National have also purchased a quantity of new axles to replace any found to have cracking or corrosion pitting.
