Australian Government Australian Transport Safety Bureau

Engine power loss involving Piper Aircraft Inc. PA-36, VH-TVU

Near Latrobe Valley Airport, Victoria, on 12 August 2019

ATSB Transport Safety Report Aviation Occurrence Investigation (Short) AO-2019-043 Final – 25 November 2020 Released in accordance with section 25 of the Transport Safety Investigation Act 2003

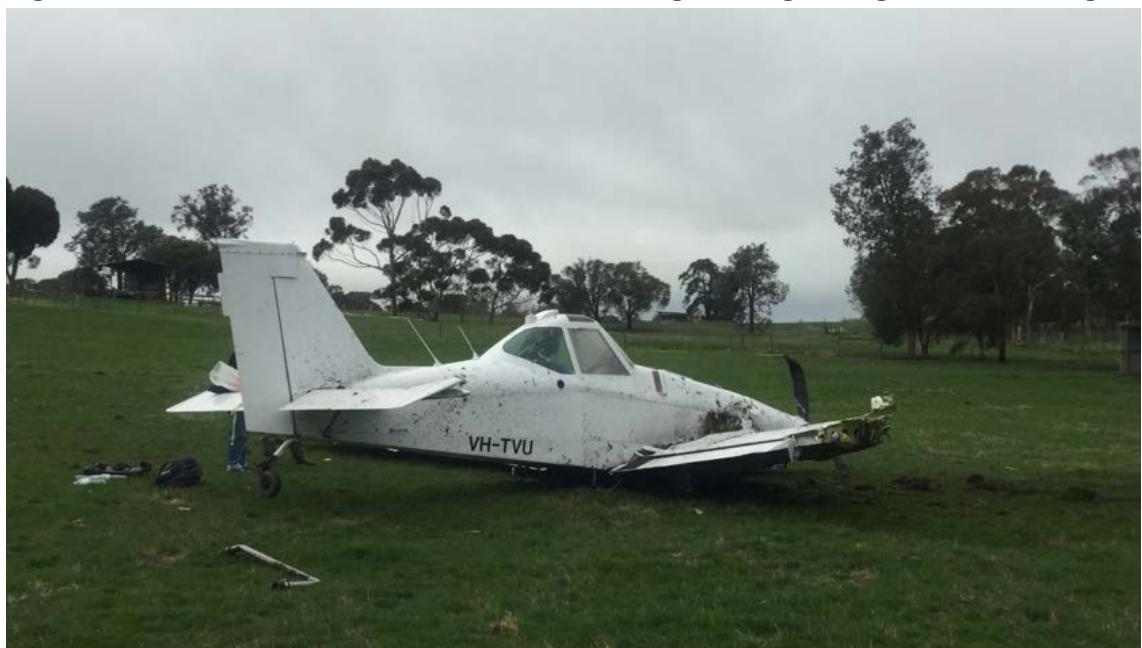
The selected paddock had a fence running down the middle. To ensure this was not struck while the aircraft was airborne, the pilot intentionally landed the aircraft hard before reaching the fence. The right wing struck one of the fence posts resulting in separation of the outboard wing section. A number of tree stumps in the paddock were also struck, removing the undercarriage legs (Figure 2).

Figure 2: VH-TVU after the accident with undercarriage and right wing section missing.

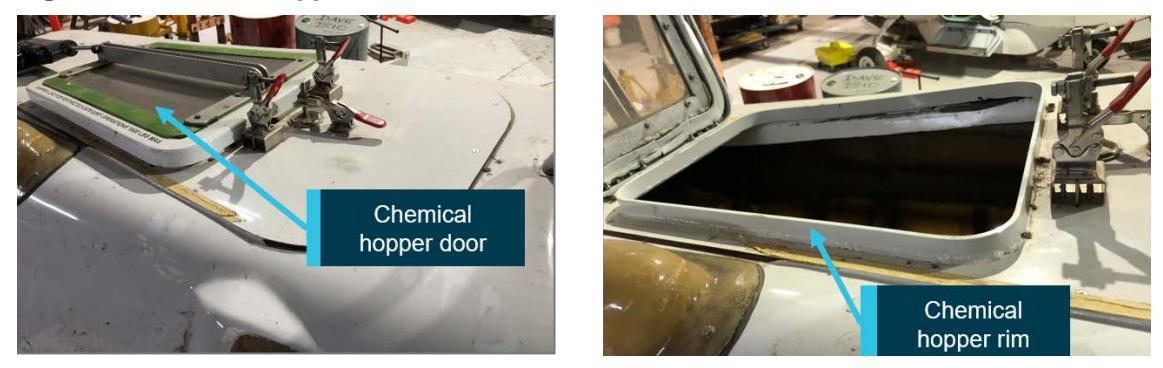
Figure 3: Chemical hopper

The aircraft had been configured to use the hopper as a ferry fuel tank. The door for the hopper hinged at the rear and sat over a raised rim that pressed into a seal (Figure 3).

The hopper fuel tank was selected ON using an ON/OFF tap in the cockpit. This connected to the main fuel system before the main fuel filter, ensuring the fuel passed through two filters before it entered the fuel system. No approved technical data could be provided to show how the system was installed in the aircraft.

The chemical hopper is not designed for the storage of fuel; therefore, the use of the hopper as a spare fuel tank is not recommended.

Finally, the use of the chemical hopper as a ferry tank was contrary the manufacturer's advice and no approved technical data was available for the modification. Using approved and documented engineering processes to make changes to a safety-critical aircraft system is important, as it ensures the design complies with applicable airworthiness standards or an equivalent level of safety.

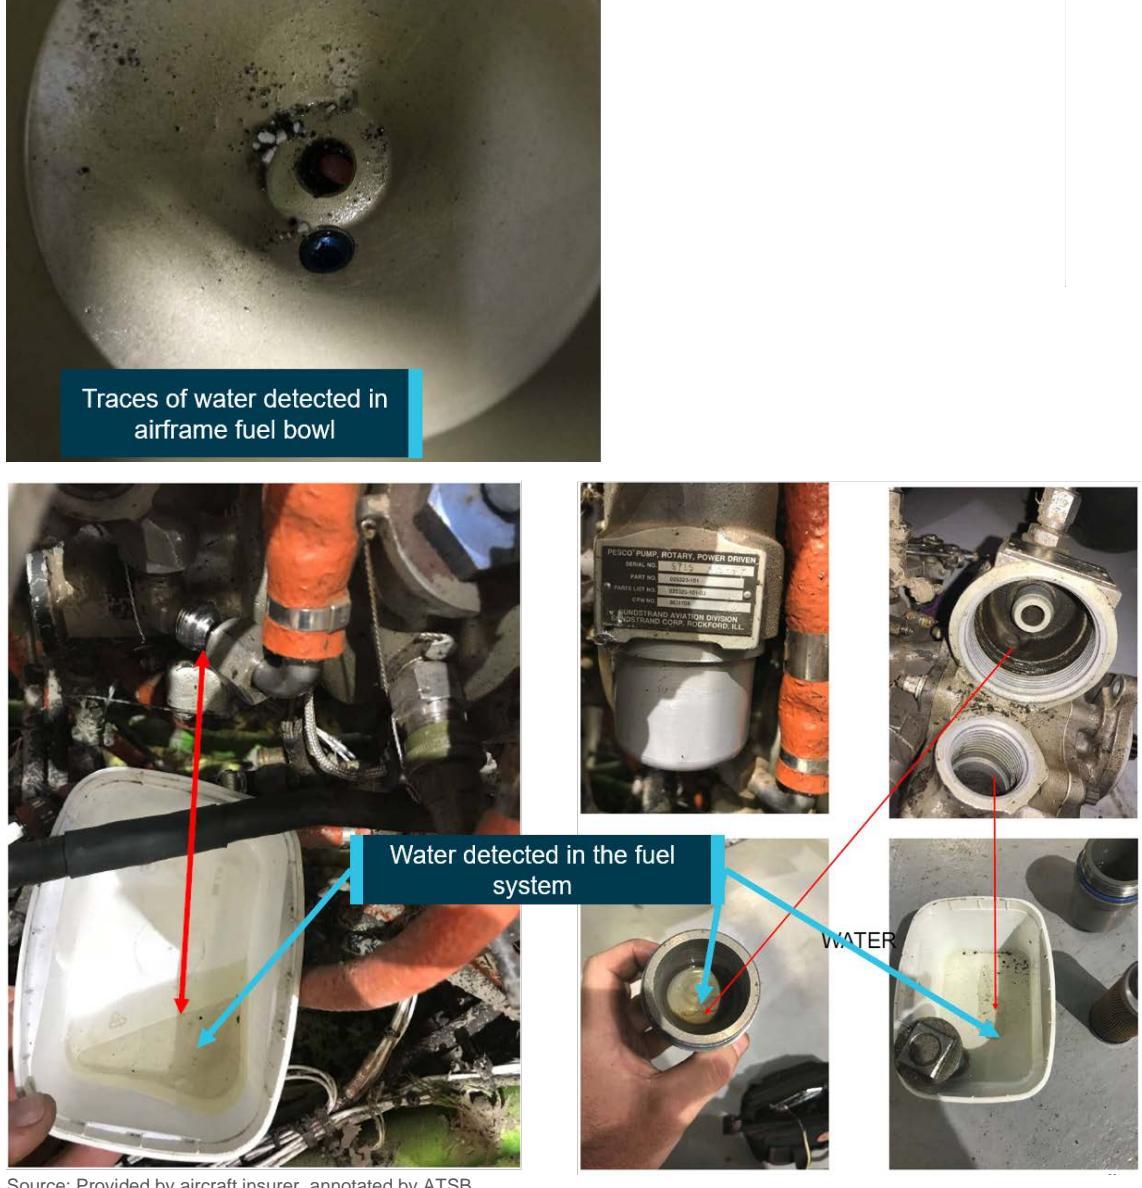
An inspection of the engine, conducted 7 weeks after the accident, did not find any defect or degradation that would have contributed to the engine power loss. However, the inspection identified a significant quantity of water in the fuel system, including in the airframe fuel bowl, fuel pump, and the fuel control unit (drained at the flow divider) (Figure 4).

Figure 4: Photographs of water detected in the fuel system

Based on the significant quantity of water identified in the aircraft fuel system components after the accident, and the absence of any other engine defect, the ATSB concluded that the engine power loss was probably the result of water contamination. The water detected in the hopper during the aircraft inspection on the day before the accident indicated that, despite the seal and lip, water could enter the chemical hopper. Therefore, it was considered a possible source of water contamination to the fuel system. However, as the ferry fuel system was reportedly not used during the accident flight, there was no obvious mechanism for such contamination to enter the aircraft's fuel system. It is also possible that the water entered the wing tanks while the aircraft was exposed to rain in the days leading up to the accident, as the fuel tanks were only partially filled.

The methods used to check for water in the fuel—opaque sampling containers/fuel sight and smell were not in accordance with the Civil Aviation Safety Authority and United States Federal Aviation Authority guidance for pre-flight fuel testing and did not assure that there was no suspended water droplets—a particular risk with turbine fuel. Nor did they ensure that the fuel drain conducted on the morning of the flight, was free of water.

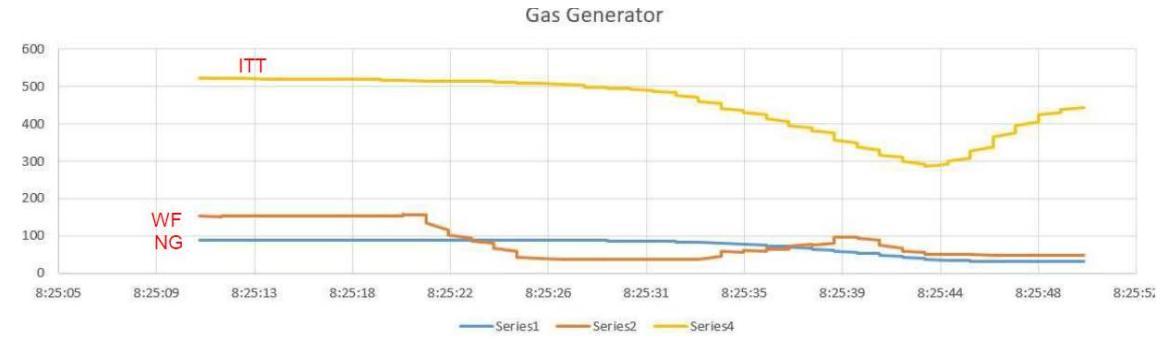
Figure 5: Engine data

Based on engine data (Figure 5), there was no indication of an engine surge that caused the power reduction. Unexplained variation of fuel flow was recorded prior the power reduction. Pratt and Whitney Canada reviewed the data and consider the fuel flow recording is inaccurate.

However, the engine data showed that the engine did not surge when the power loss occurred. This could indicate that the water droplets had stayed in suspension and resulted in the engine not producing enough power to maintain flight. The time between the accident and the engine inspection would have allowed any water droplets to separate out of suspension from the fuel, as found during the examination.

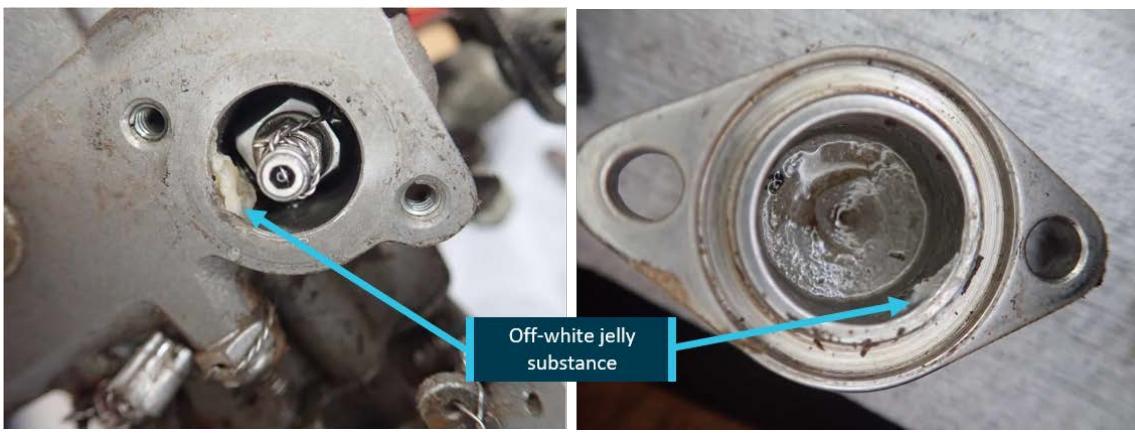
Figure 6: Contamination within the fuel control unit

The fuel control unit (FCU) was sent to a specialist PT6 engine accessory overhaul facility for detailed technical examination. That investigation determined that there was contamination (an off-white jelly substance that could be the result of incorrectly mixed anti-icing additive) in the fuel section of the FCU, which may have hindered or resulted in abnormal fuel flow (Figure 6). The pilot advised that they did not use anti-ice additives. Evidence of blue grease was present at the drive shaft bearing retaining plate. This was indicative of a previous fuel or oil leak with the potential to damage the FCU bearing due to insufficient lubrication. No further detail was available at the time of writing.

The photograph on the left shows the off-white jelly substance detected within the fuel section of the torsion shaft. The photograph on the right shows the same substance detected in the ratio lever cap. Source: Provided by the aircraft insurer, annotated by ATSB

In addition to the water found in the fuel, the examination of the fuel control unit showed additional contamination and grease washout, which may have also hindered the fuel flow to the engine. However, there was insufficient available information to determine if that occurred.
