# Runway incursion and take-off commenced on incorrect runway involving GIE Avions de Transport Régional ATR72, VH-VPJ

Canberra Airport, Australian Capital Territory, on 25 September 2019

ATSB Transport Safety Report Aviation Occurrence Investigation (Defined) AO-2019-055 Final — 11 December 2020 Cover photo: Darren Crick

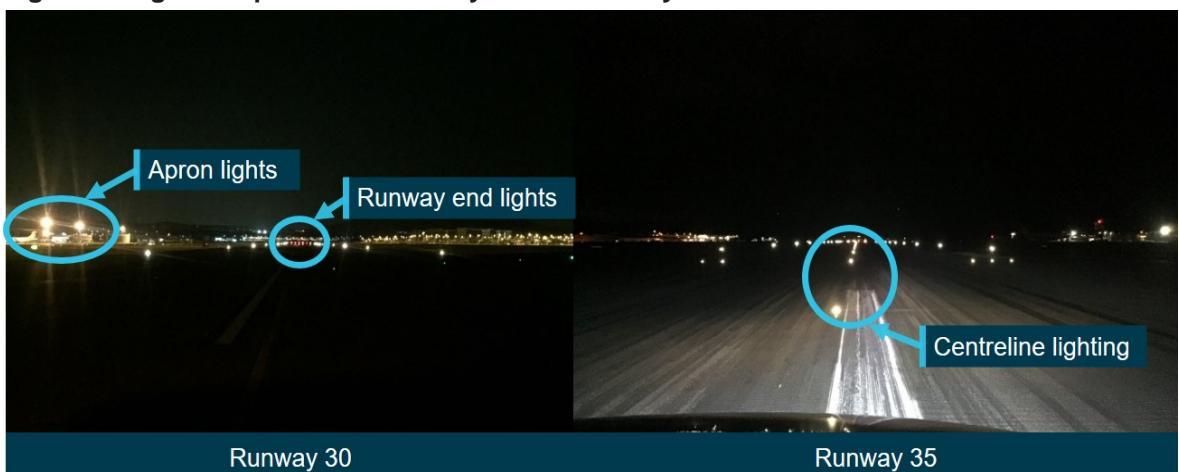
At about 1859, ATC instructed the flight crew to line-up on runway 35 and about a minute later, they were cleared for take-off, with both instructions read back correctly by the FO. After the stop bar was deactivated by ATC, the aircraft crossed the holding point and the captain commenced turning through the intersection, inadvertently aligning with the centreline of runway 30.

During the turn, the FO was completing the final *Before take-off* checks and therefore, only looked up after the aircraft was lined-up on the runway. The captain recalled focusing on taxiing the aircraft to follow the lead-on lights (refer to section titled *Airport lighting*) and trying not to go too far into the intersection. Both flight crew recalled 'the picture didn't look right' when they were lined-up on what they thought was the departure runway (runway 35). They also reported the runway (runway 30) appeared shorter than expected and that there was no centreline lighting (Figure 1). Neither of the flight crew could recall if they cross-checked the aircraft's heading or position by available means as per the operator's *Before take-off* procedure when they were in the lined-up position.

Figure 1: Night comparison of runway 30 and runway 35 from intersection Golf

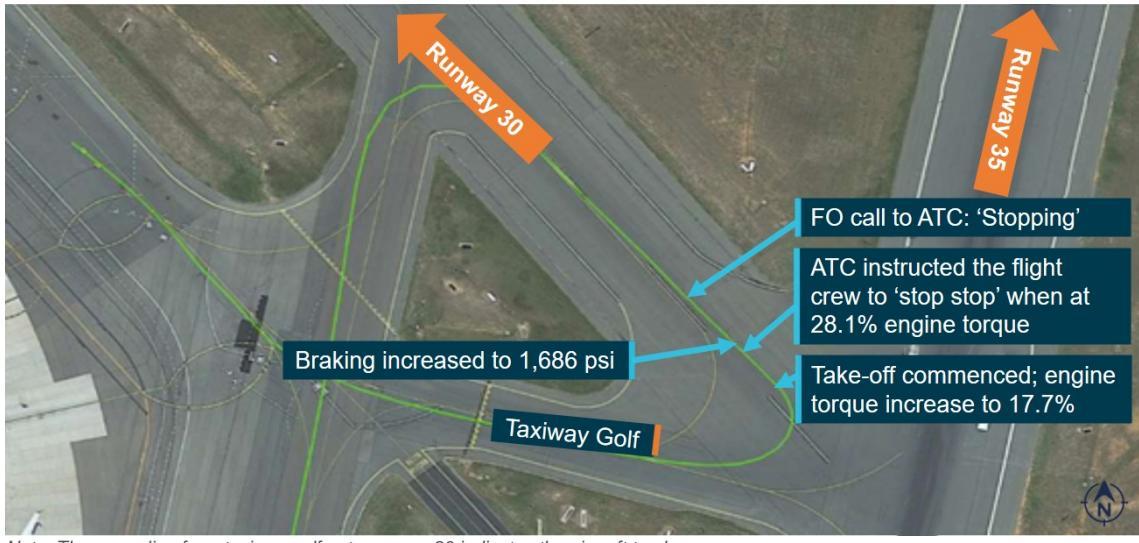
Air traffic control reported noticing the aircraft moving on runway 30 and immediately instructed the flight crew to 'stop stop' as they 'seemed to be taking off on [runway] 30'. About 6 seconds later, the FO advised ATC they were 'stopping'. The flight crew reported that take-off power<sup>2</sup> had not been applied, nor the take-off roll commenced, and no braking was required. However, recorded flight data showed an immediate increase in torque for both engines from 4-6 per cent during taxi to 17.7 per cent, as well as a decrease in brake pressure to 16 pounds per square inch (psi) after the turn onto runway 30 (Figure 2). About 4 seconds later, the engine torque reached 28.1 per cent, indicating the power levers had been advanced to commence the take-off. At about this time, ATC instructed the flight crew to stop, after which, the data showed a decrease in the power lever positions to flight idle and an increase in brake pressure to 1,686 psi.

The flight data was consistent with airport closed-circuit television footage. This footage showed the aircraft cross the holding point and line-up on runway 30, followed by a brief pause, then a short acceleration before a sudden braking. The aircraft then remained stationary on the runway for a few seconds before it was taxied forward along the runway and vacated at the next exit.

Figure 2: Flight data showing the aircraft's turn onto runway 30 with key events

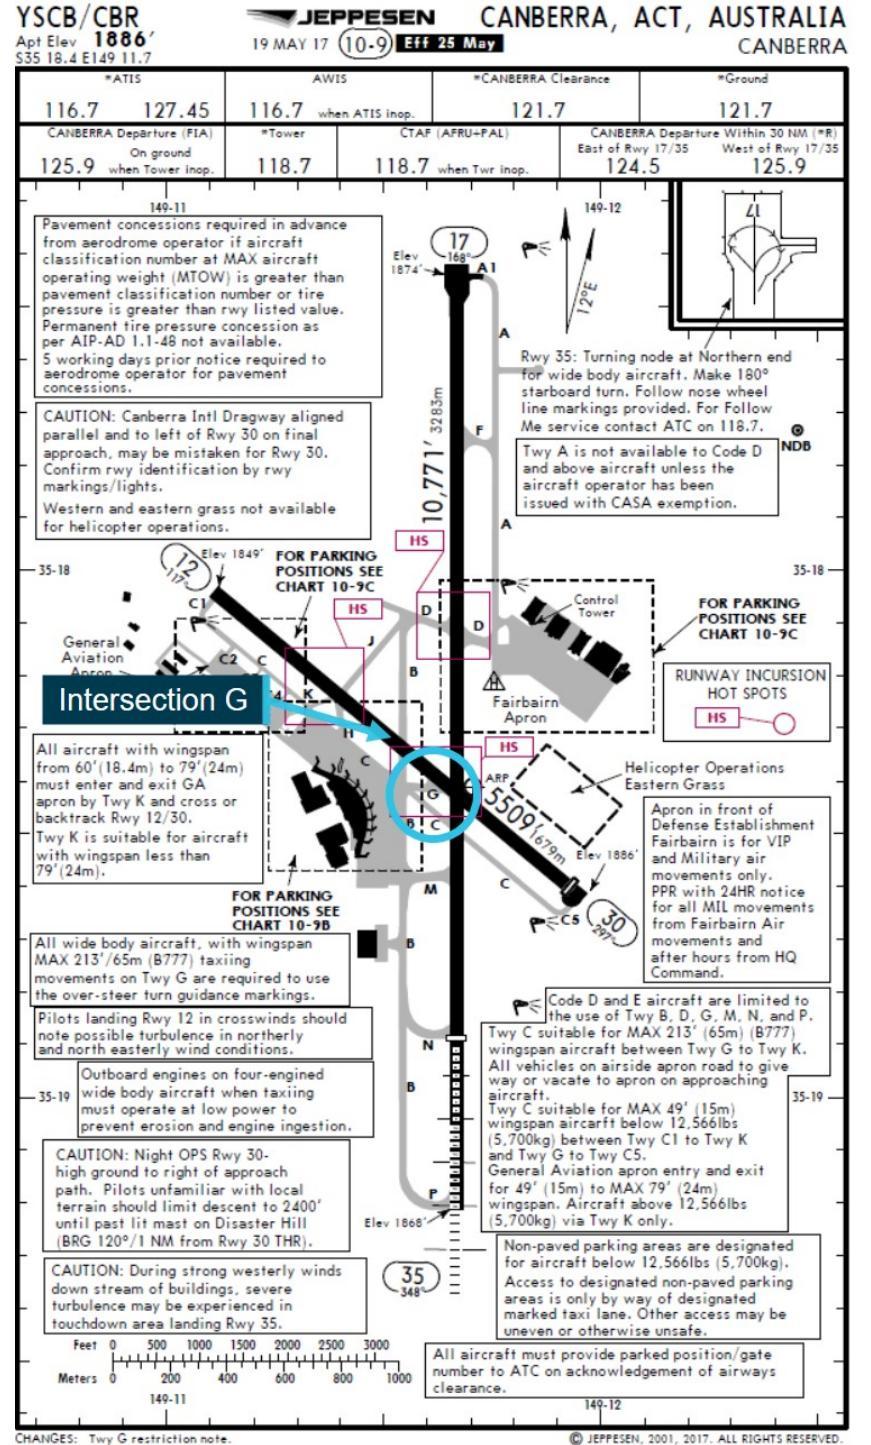
#### Figure 3: Canberra Airport chart

The intersection departures available for runway 35 were from taxiways 'Golf' (G), 'Mike', 'Papa', and 'November' (Figure 3). Taxiway G leads to the intersection of the two runways 17/35 and 12/30 and is listed as a runway incursion hotspot due to this complex layout (refer to section titled *Runway incursions*). There are few airports in Australia where a taxiway led to the intersection of two runways.

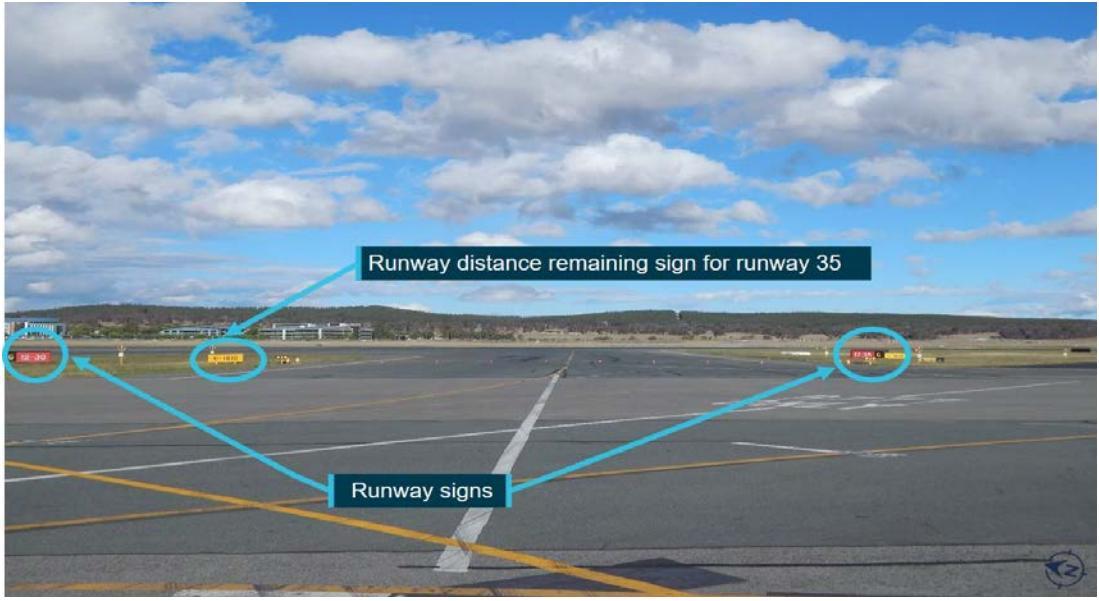
Canberra Airport had runway and taxiway signs as per the Civil Aviation Safety Authority's *Part 139 Manual of Standards for Aerodromes* and International Civil Aviation Organization's *Annex 14: Aerodromes.* However, these documents do not include standards for signs at taxiways that lead to the intersection of two runways. Intersection G had a red runway sign for 12/30 on the left and a runway sign for 17/35 on the right of the taxiway when viewed from the cockpit (Figure 4). Adjacent to the holding point lights on the left side of the taxiway was the yellow runway distance remaining board for runway 35.

Figure 4: View of intersection G at Canberra Airport

While intersection G was a complex layout, the runway signs were consistent with the applicable standards. Although other signs could be used at taxiways that lead to the intersection of two runways, such as those shown above, there were no other incidents reported for Canberra Airport where an aircraft had been inadvertently taxied onto the wrong runway from intersection G.

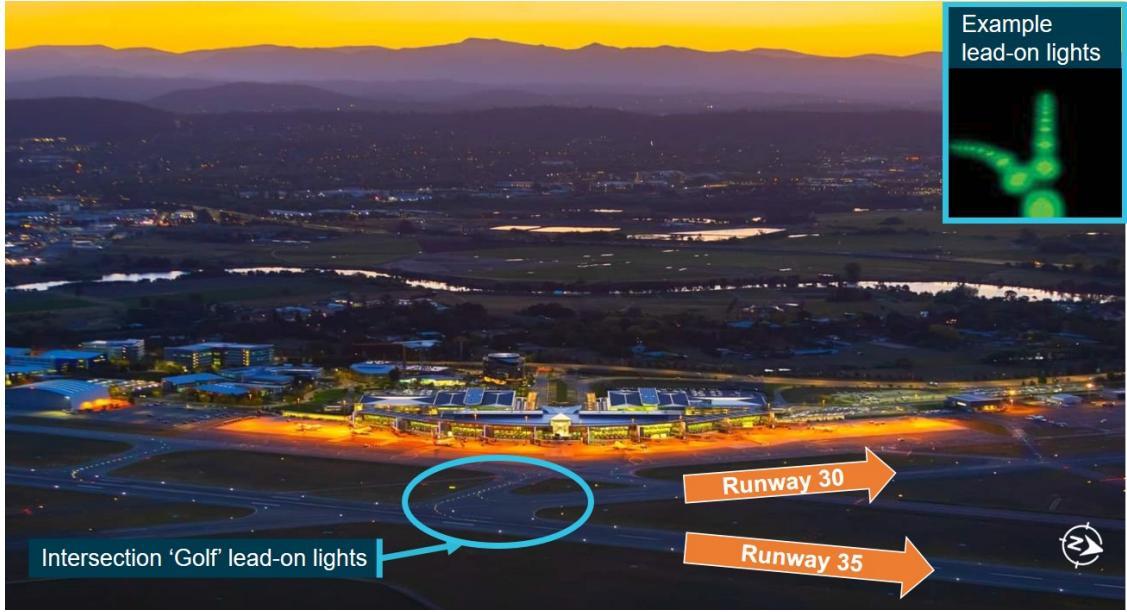
The lighting system at Canberra Airport included runway lighting and taxiway lighting (Figure 6). Runway lighting consisted of white lights on the edges of the runway, and green and red lights positioned at the ends of the runway landing and departure thresholds respectively. Taxiway lighting consisted of green centreline lighting. There were also red stop bar lights at all the holding points for both runways. Only runway 17/35 had white centreline lighting.

the stop bar so that when the stop bar was deactivated by ATC, the green centreline lighting beyond the stop bar activated. The lead-on lights for runway 30 were on the same circuit as the taxiway lighting, and therefore already active irrespective of the state of the stop bar. Therefore, it was possible for the lead-on lights to both runway 30 and 35 to be illuminated at the same time.

Figure 6: Canberra Airport lighting

- When the runway holding point stop bar at intersection Golf was turned off, the lead-on lights to both runway 30 and 35 were illuminated. This increased the risk of an aircraft being manoeuvred onto the incorrect runway, particularly at night and/or in low visibility conditions.
