Track obstruction due to loss of freight involving train 6WM2 and subsequent impact of passenger train 8615 with track obstruction

near Winton, Victoria, on 30 March 2018

Rail Occurrence Investigation RO-2018-008 Final – 10 December 2020 Cover photo: Pacific National

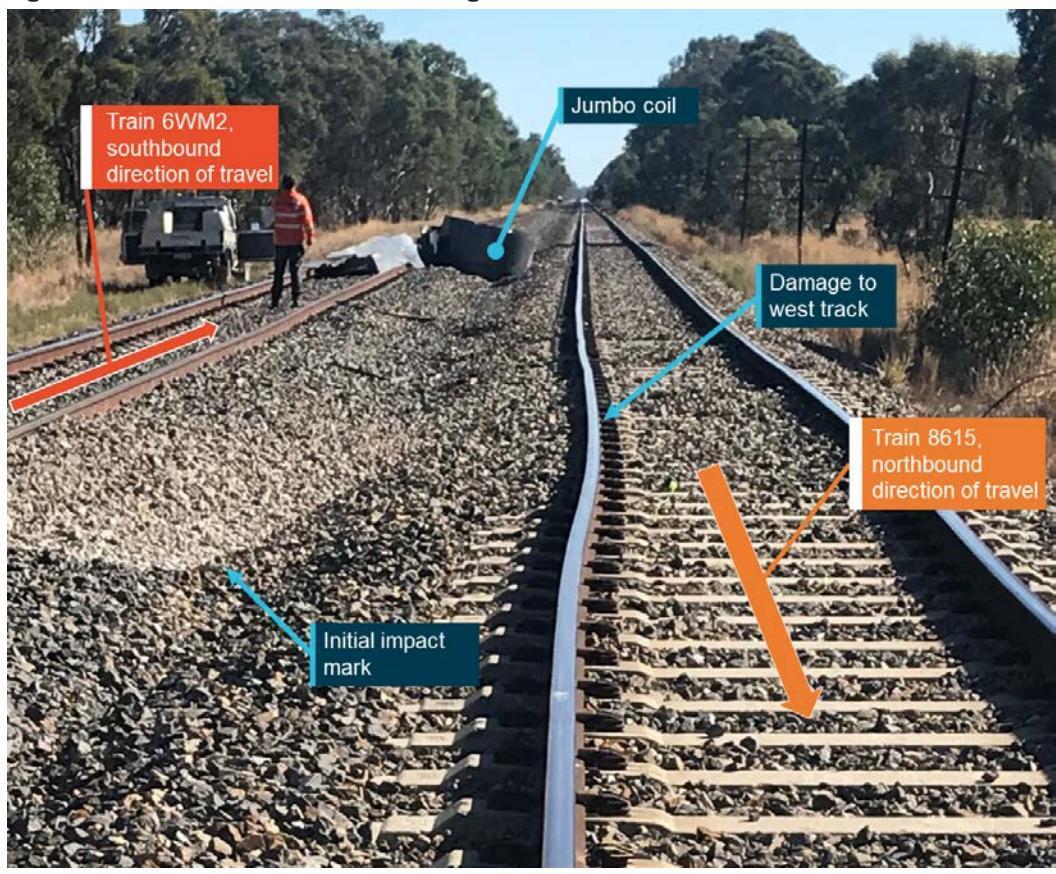
At about 1450, the driver of train 8615 saw a jumbo coil obstructing the track ahead and made an emergency brake application. Train 8615 subsequently struck the unravelled tail of the coil and associated damage to the west track (Figure 2) at about 110 km/h, but it did not derail. After traversing the damaged track, the train travelled over the Seven Mile Creek Bridge, which was less than 100 m beyond the steel coil and damaged west track, as shown in Figure 3.

Figure 2: Jumbo coil and track damage at location 204.5 km

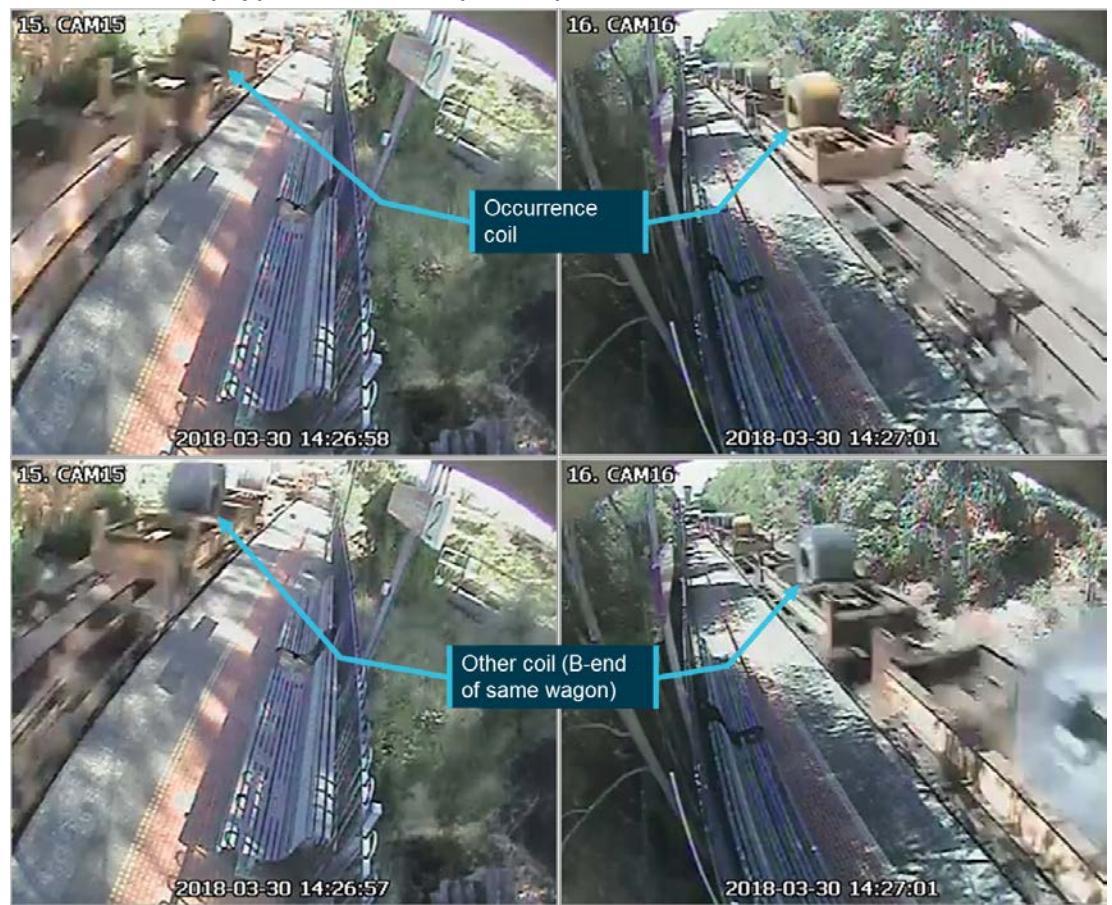
Figure 8: Comparison of closed-circuit television footage at Wangaratta Station - occurrence coil (top) and other coil (bottom)

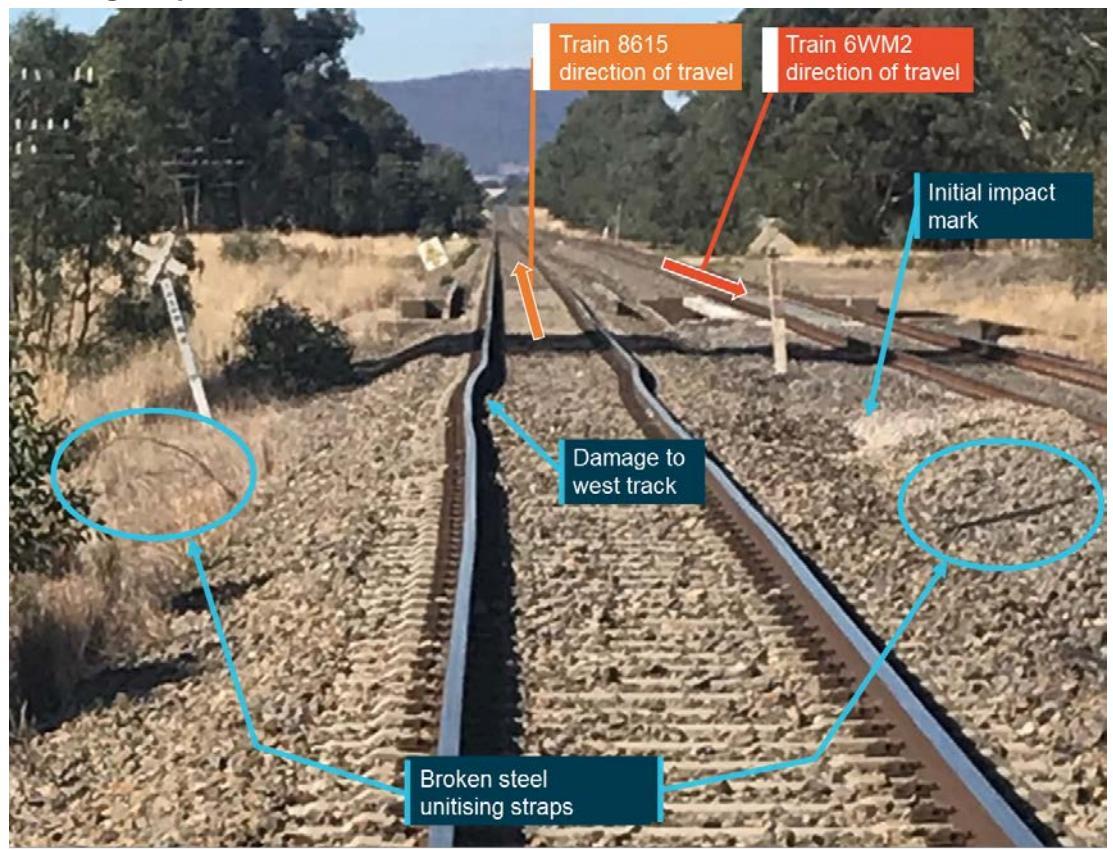
While the ATSB did not attend the occurrence location, ARTC and PN representatives provided information, including photographs of the site and the coil. Impact marks were present indicating that the coil had significantly impacted the ballast between the two tracks at least twice. The initial impact to the ballast between the tracks was sufficient to shift the rails and sleepers of the west track, resulting in the misalignment that is visible in Figure 9 below. The force of the second impact dug through the ballast layer and exposed the formation below while also displacing the rails and sleepers on the east track. The coil came to rest immediately next to the second impact location (Figure 10). The steel unitising straps were not present with the coil though two were observed in close proximity. A broken steel strap was also found on the ballast between the two tracks about 1 km before this location at 205.5 km. However, it could not be determined if this strap had been fitted to the occurrence coil.

Figure 9: The initial impact location, track damage, and location of the broken steel unitising straps

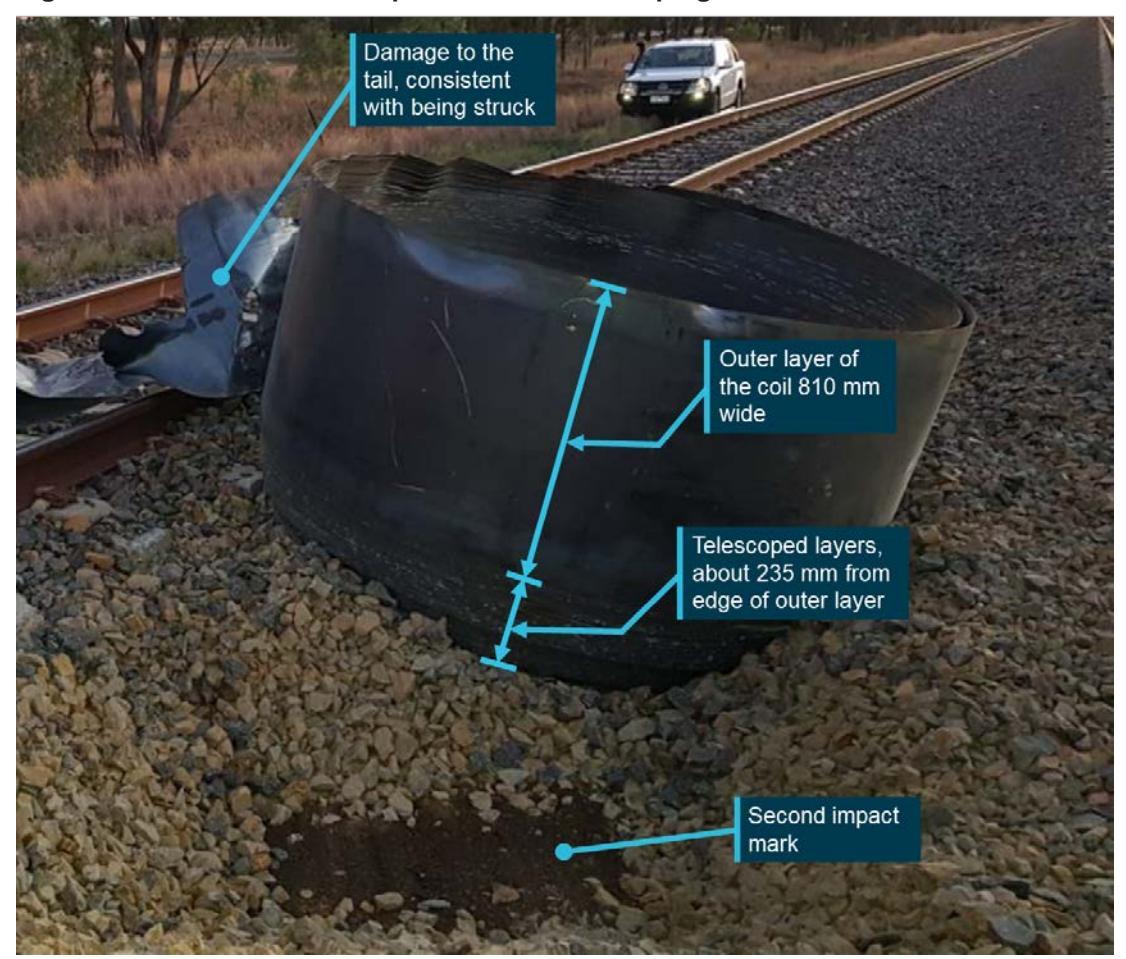
The outer layers (the tail) of the coiled steel had unrolled and was observed in a final position on top of the east track (Figure 2). The unrolled section showed significant damage consistent with the reported impacts with the trailing wagons of train 6WM2. The tail's position on the east track was consistent with it having been struck by the locomotive of train 8615 on the west track and pushed across. There was no evidence to suggest that train 8615 struck the main body of the coil. The rest of the layers remained coiled, however, the centre of the coil (the eye) had moved relative to the outer layers (telescoped) by about 235 mm. In Figure 10, the layers of the coil are clearly visible at the top and bottom, with the centre of the coil having moved downward relative to the outside. This is effectively the same as a coil, in its normal orientation, having telescoped sideways.

Figure 10: The coil in its final position with telescoping evident

The ATSB also repeated the calculation for a telescoped coil approximating the condition of the coil as it was observed post-occurrence. An estimate of 235 mm telescoping over the outer 30 layers of the coil was derived by scaling Figure 10 against the known coil width (810 mm). This allowed the mass distribution of the telescoped coil to be estimated and the lateral acceleration required to topple the coil to be recalculated. The result was an acceleration of about 0.30 g required to topple the coil toward the side that had telescoped, a 46 per cent reduction in stability compared with the unitised coil.

Pictures of the coil in its final position showed that all four straps were missing and that the outer layers of coiled steel were telescoped by about 235 mm. Two broken straps were found near the initial impact location and another broken strap was on the ground about 1 km prior to the occurrence location. As the broken straps were not recovered, the mechanisms of failure could not be determined.

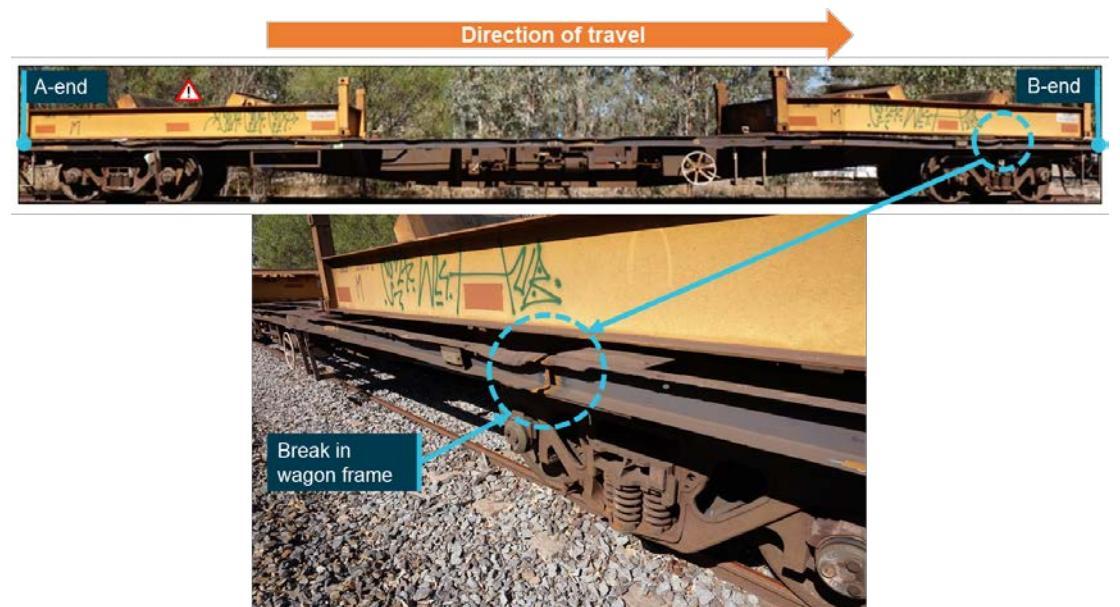
An inspection of wagon NQJF-21574 was conducted by ARTC on 4 April 2018 (4 days after the occurrence) and a further inspection was performed by the ATSB at PN's West Melbourne Yard on 22 May 2018. Those inspections identified a break in a portion of the frame (Figure 11). The break was in a piece of U-section steel on the outside of the frame under the B-end cradle.

Figure 11: Inspection of wagon NQJF-21574 showing location of break in wagon frame

ATSB photographic analysis of the break from the ARTC inspection indicated that it was a brittle fracture¹⁶ at a previous weld repair. However, the fracture surface showed significant rust and no conclusion could be made about the age of the fracture due to the four days that had elapsed since the occurrence, providing time for surface oxidation to form.

The wagon's orientation within the train meant that the B-end was leading the A-end during this journey. As such, the break in the wagon frame could not have been a result of impact from the coil that fell from the A-end cradle. Pacific National reported that maintenance of the wagon occurred on 22 February 2018. The maintenance record indicated this was a 'minor repair' to a 'broken or cracked' part of the frame. However, it could not be confirmed if this was the same location as the break that was present after the occurrence.

The broken part was not part of the main structure of the wagon frame that transmitted load from one bogie to the other, and was between the attachment points for the B-end cradle. As such, the break location did not affect retention of the A-end cradle nor was it likely to have significantly affected the torsional stiffness of the wagon frame. Due to these factors, no link between the break and the loss of the coil from the A-end cradle could be established.

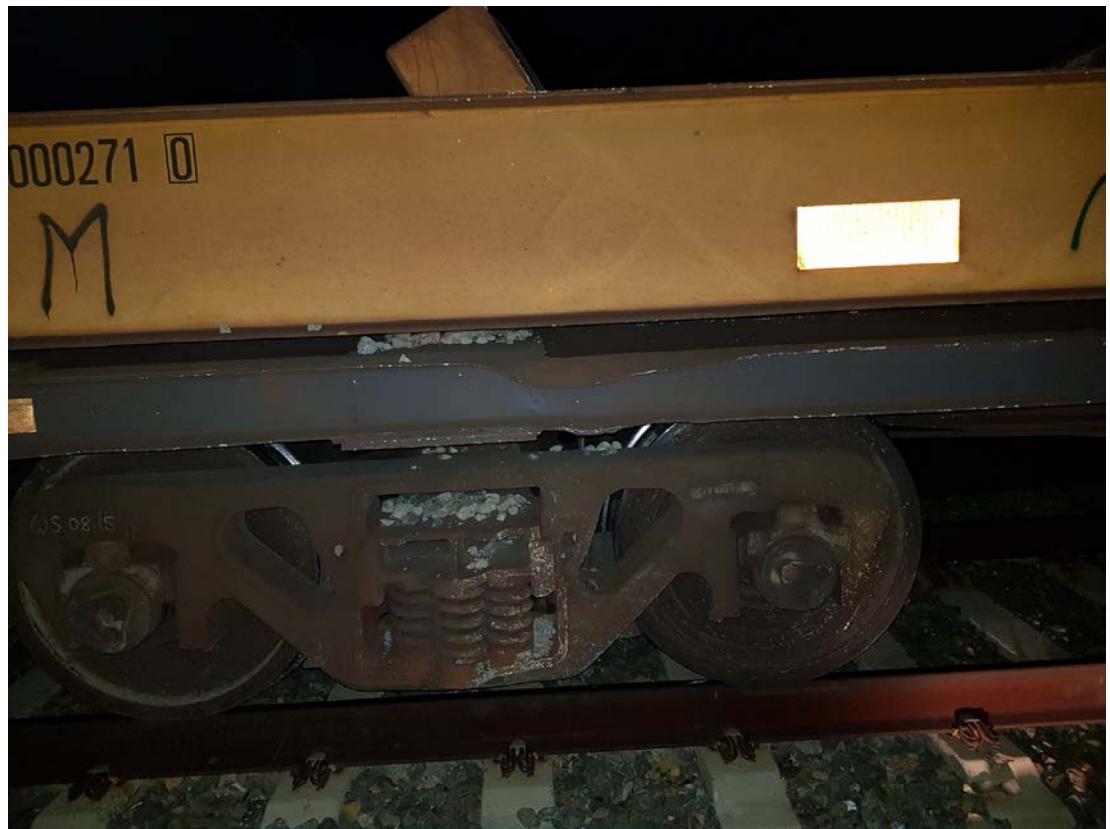
Figure 12 shows ballast observed on the right side-frame (in direction of travel) and bolster of the A-end bogie, which was consistent with ballast being sprayed on the wagon from the coil striking the ground immediately beside it.

Figure 12: Residual ballast rocks on the A-end bogie

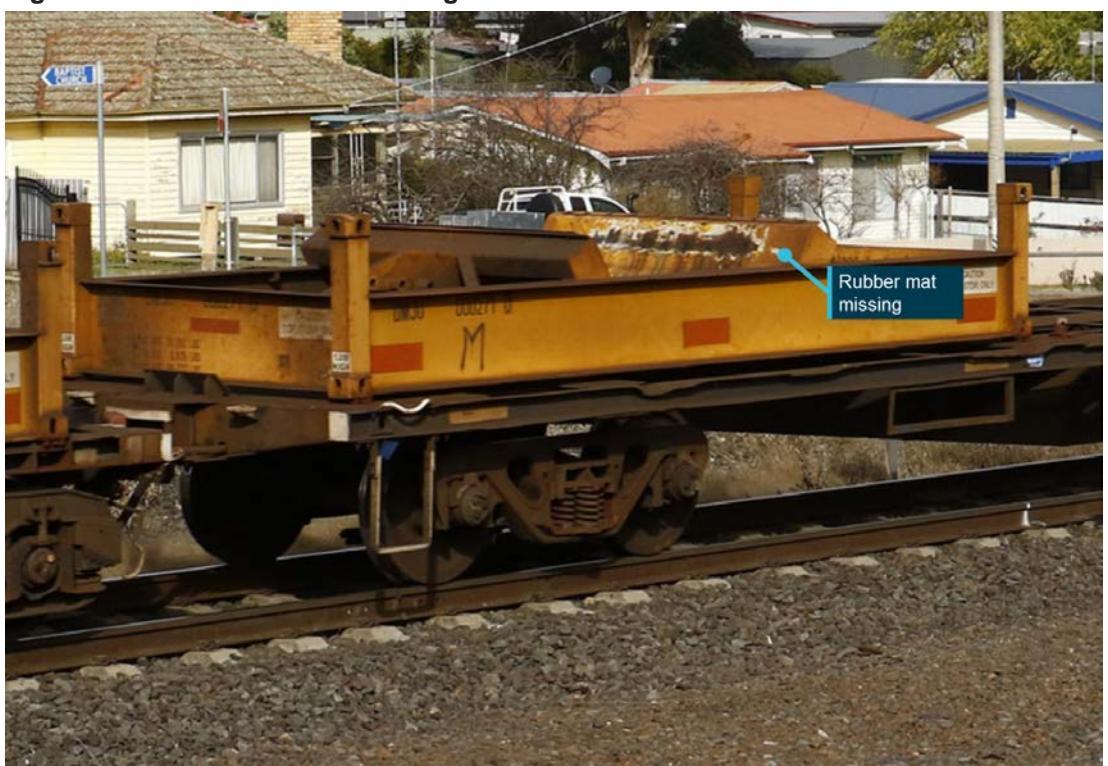
The inspections of the wagon conducted by ARTC and the ATSB also assessed the jumbo coil cradles. They identified that a rubber mat was missing from one face of the A-end cradle. The mat had dislodged from its mounts and fallen to the floor of the cradle (see Figure 14 below).

A photograph (Figure 13) obtained from a member of public, taken in June 2017, showed that the rubber mat was also dislodged at that time. This was eight months prior to maintenance conducted on the wagon in February 2018. The maintenance record did not note the condition of, or indicate that any maintenance to the mat had been performed. This suggested the mat had not been replaced since at least June 2017 and was likely to have been missing for this entire 9-month period of operation.

Figure 13: Rubber load mat missing from the cradle face in June 2017

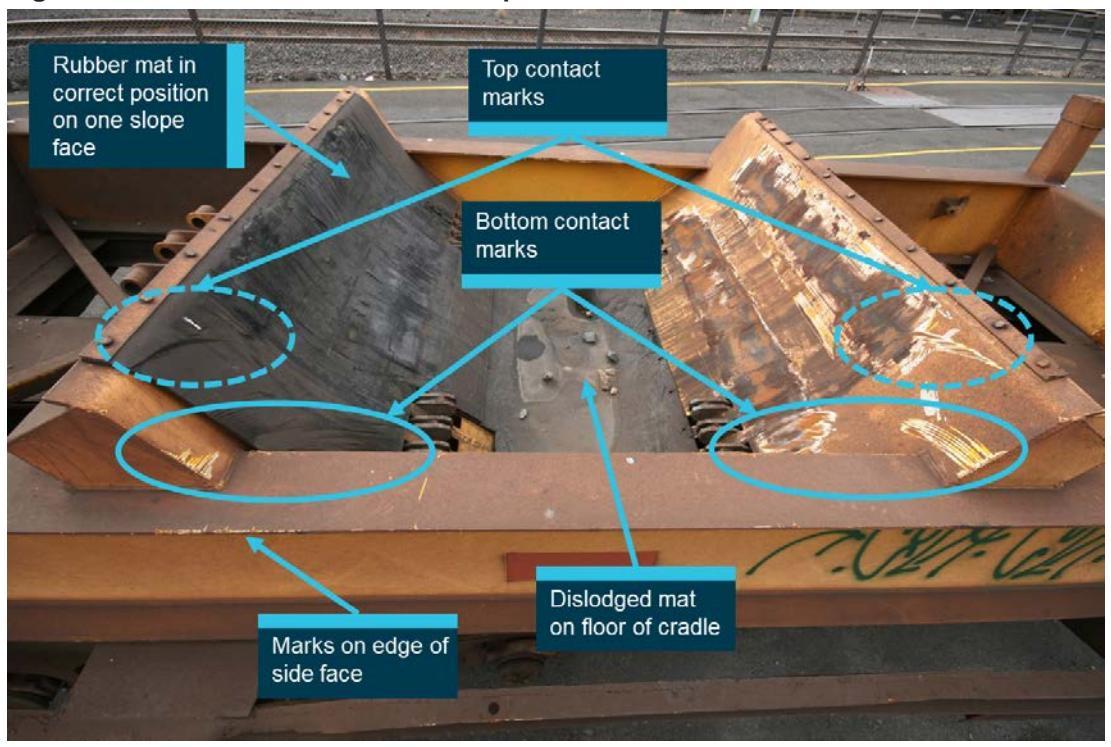
Photographs of both slope faces of the cradle (Figure 14) showed two distinct sets of witness marks consistent with a coil that had toppled to the right side of the cradle. The marks closest to the side of the cradle (bottom of the image) had a distinct layered pattern, which indicated that separate layers of the coil had contacted the cradle at the same time as it toppled. A close-up image of this detail on one face is provided in Figure 15. There were also some indications of contact on the edges of the side face of the cradle, but not on the top, indicating that the coil made minimal contact with the side as it toppled.

As discussed previously, distinct contact marks were observed on the cradle, left by the coil as it fell. The ATSB used multibody simulation software to evaluate the contact path of a coil that was forced to topple from the cradle. The results indicated that a unitised coil (without any telescoping) would have only had one edge in contact with the cradle slope face as it toppled. The path of the contact represented an arc up and outward toward the top edge of the cradle, which was consistent with the path of the upper inboard contact mark ('top contact marks' shown in Figure 14). When the simulation was repeated with a telescoped coil (using 235 mm estimated telescoping) a second contact path was also observed, consistent with the lower outboard marks ('bottom contact marks' shown in Figure 14).

The inspection of the cradle showed that there were two separate bands of witness marks left on the cradle from the coil as it toppled. These marks showed a distinct pattern consistent with multiple layers of the coil coming in to contact with the cradle at the same time, indicating the coil had already telescoped before it toppled. This was supported by the ATSB's simulations, which indicated that the contact path for toppling of a similarly telescoped coil was consistent with the witness marks observed on the cradle.

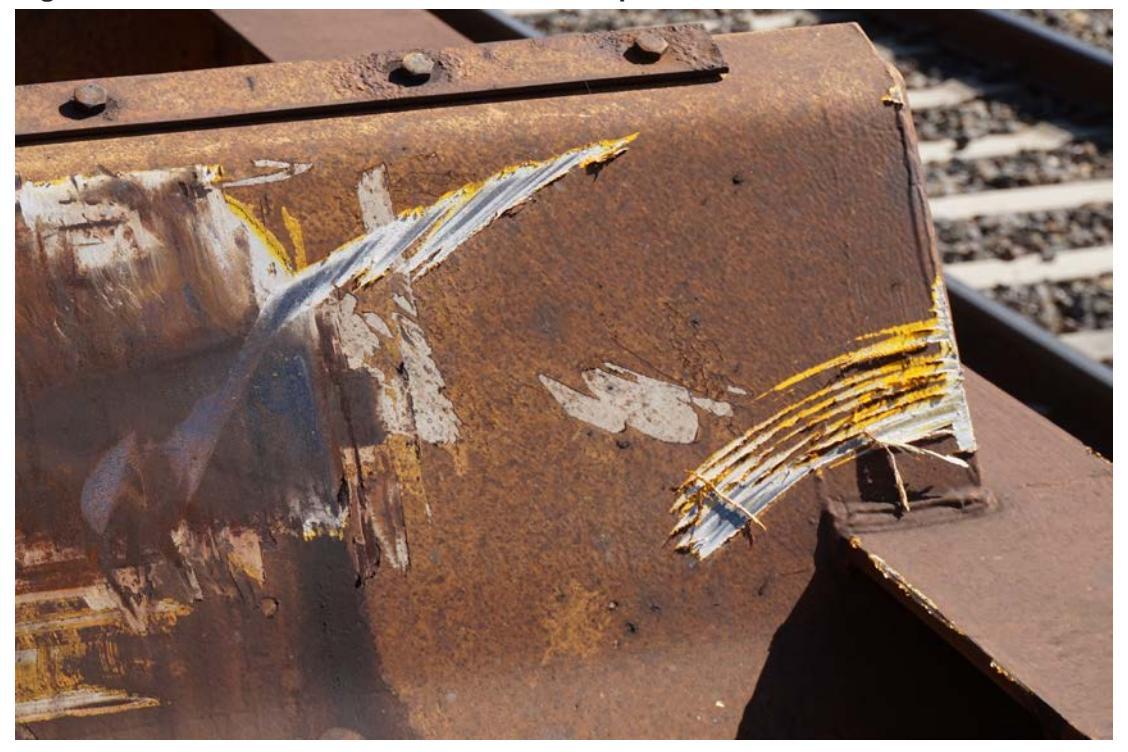
Figure 15: Detail of witness marks on cradle slope face
