Australian Government Australian Transport Safety Bureau

Derailment and collision between coal trains

Ravenan (25km from Muswellbrook), New South Wales, on 26 September 2018

ATSB Transport Safety Report Rail Occurrence Investigation (Defined) RO-2018-017 Final – 4 December 2020

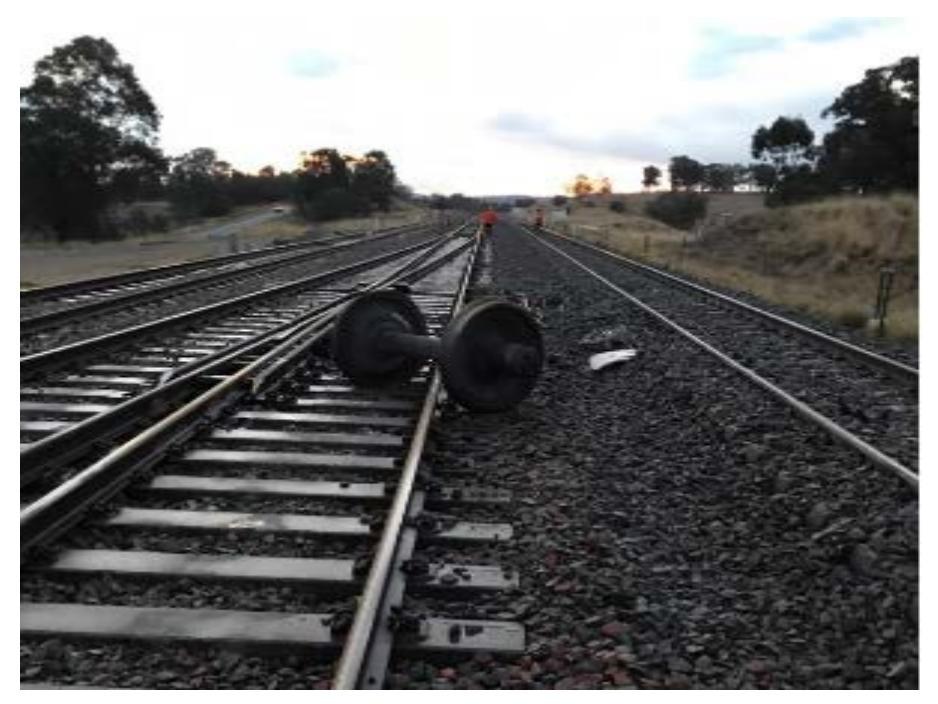
Figure 1: Location of ejected wheelset

Shortly after derailing, a wheelset ejected from its bogie and came to rest at 271.684 kms. The train continued to travel in a derailed state for approximately nine kilometres.

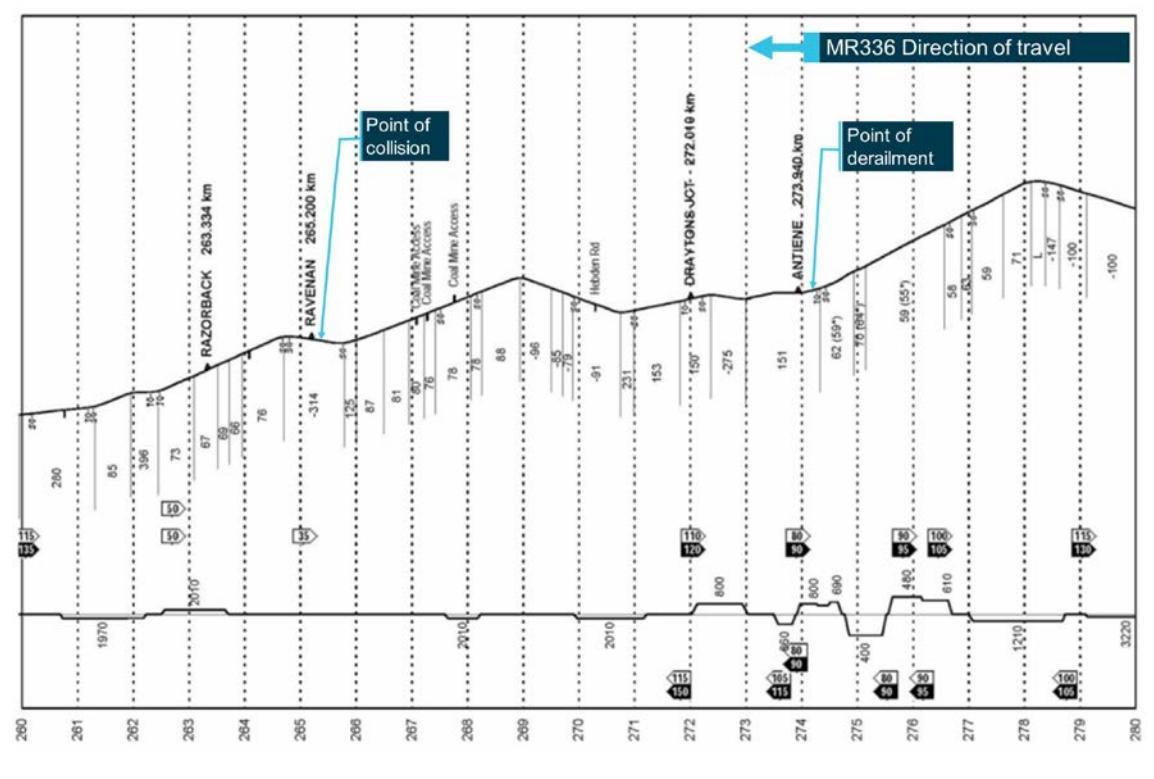
Figure 2: Curve and gradient diagram indicating point of derailment and point of collision

The trailing bogie on the 25th wagon on MR336 was dragging across the down track fouling the down main line. The lead locomotive of WC915 collided with the dragging bogie that had been partly dislodged from the wagon earlier. The collision between the lead locomotive of WC915 and the dragging bogie caused the wagon it was attached to (25th) and the seven following wagons on MR336 to derail and incur damage to varying degrees.

The 25th, 26th and 27th wagons tipped on their side away from the down main line. The 25th wagon was found without coal.

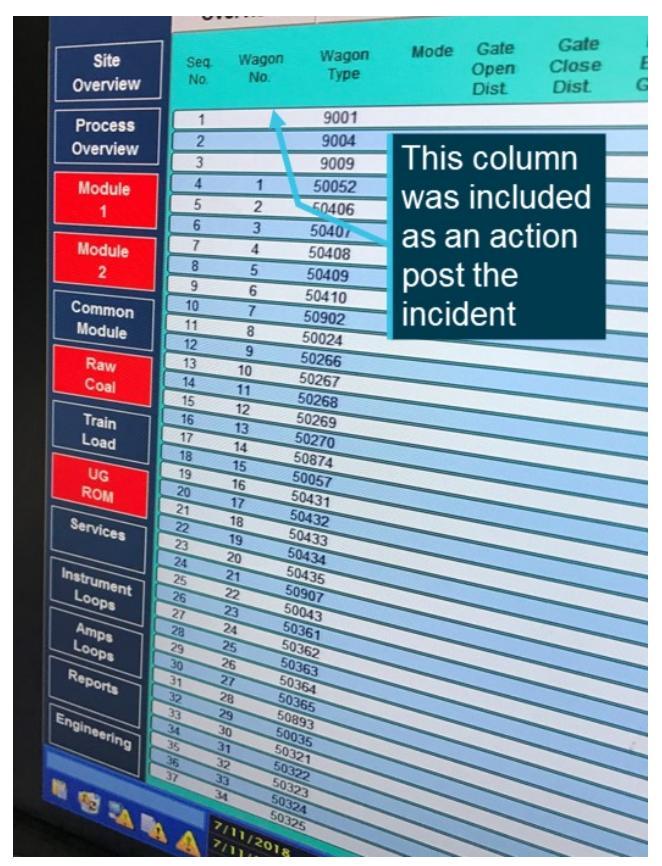
Figure 3: Train loading display screen

Prior to the occurrence (wagon not being loaded), the train loading display screen did not display the wagon number column.

There was no clear delineation between the 'wagon' position in the train consist and the 'vehicle' position in the train consist. That is, vehicle position was the physical count of all vehicles (wagons and/or locos) starting from the first vehicle (in the direction of travel) of the train consist. Whereas wagon position was the physical count from the first wagon in the train consist, not including any locomotives. To be clear, if there were 3 locomotives on the front of a head end powered train, wagon number 25 was the same as vehicle 28. The requirement to distinguish between locomotives and wagons was a recent change as a result of Moolarben's investigation into this occurrence.

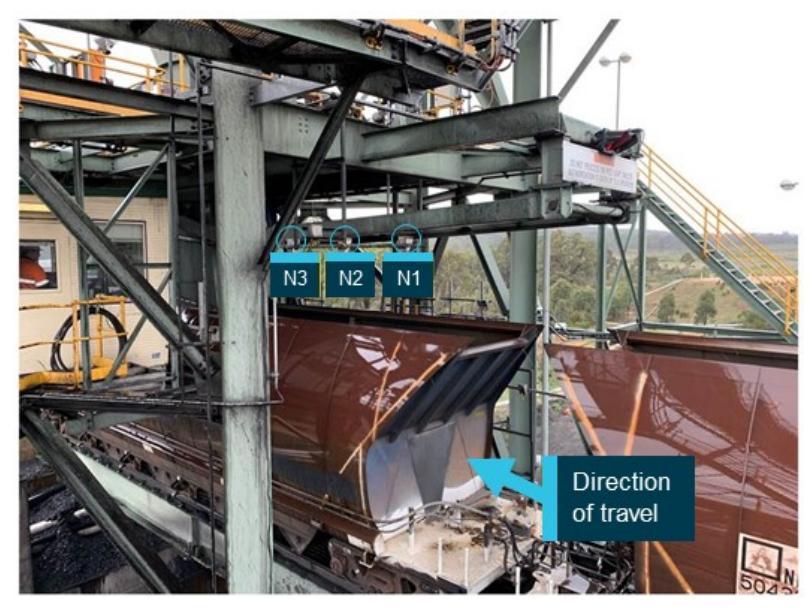
Figure 6: N1, N2 and N3 sensors

Sensors N1, N2, N3 and N3A work to instruct the system to stop loading coal. As a gap emerges at N1, it warns the system that it is approaching the end of the wagon and begins to slow the loading of coal. Once a gap emerges at N2, the system instructs the loading to stop completely and by the time there is a gap at N3, the system should have stopped loading coal.

It was advised by Moolarben representatives that a redundant sensor N3A also existed at the time of the occurrence which was used to confirm what the N3 sensor was detecting. This redundant sensor has since been removed.

The loading system was set up with sensors to detect wagons and automatically load each wagon as it passed underneath the coal loading chute. As loading progressed on the morning of the incident, there was a fault in the system which stopped coal from being loaded into the 25th wagon. Moolarben's post incident analysis of the loading system found the stop loading sensor N3A had malfunctioned. Moolarben loading terminal decommissioned the N3A sensor shortly after.

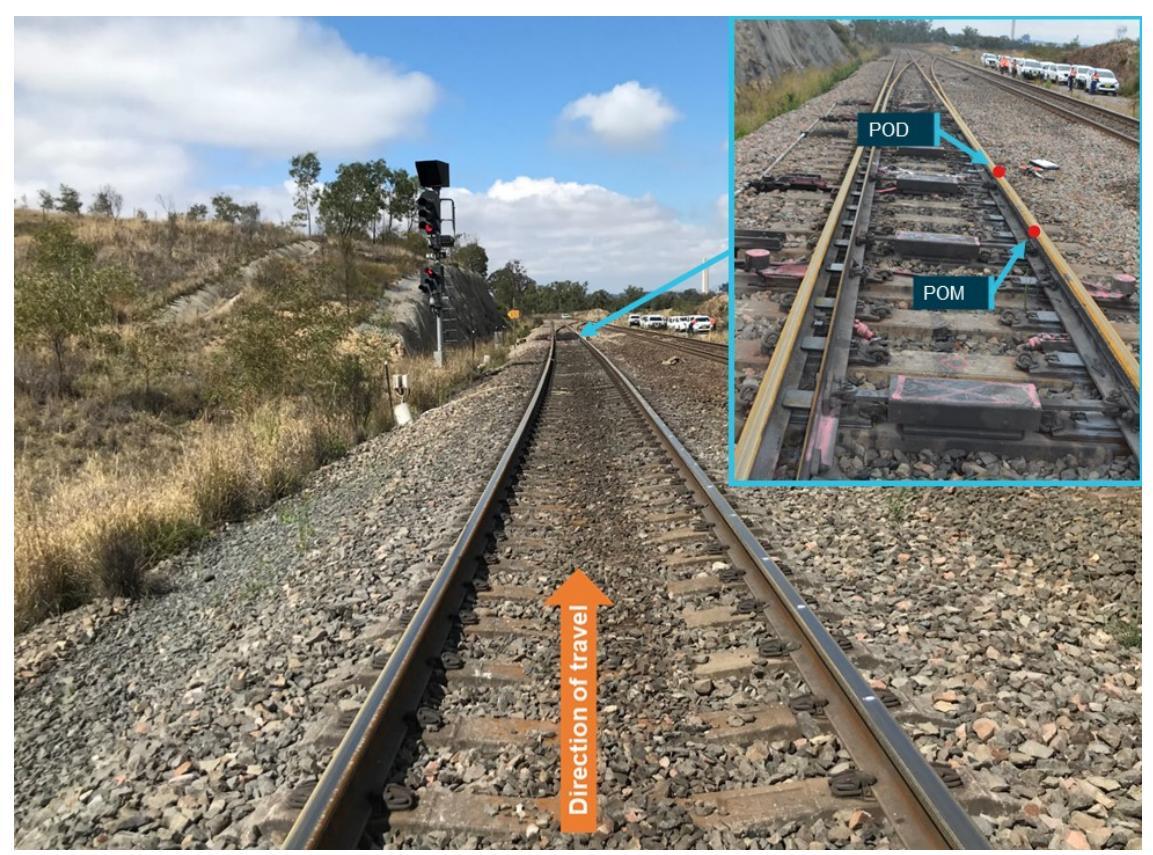
Figure 7: Point of Mount (POM) and Point of Dismount (POD) – Antiene Up direction

The train travelled approximately 160 km without incident. As the train approached Antiene, it is likely a combination of train handling (train braking was being applied), track geometry (a falling grade of 1:59 and a left hand 690m curve radius⁶ into a turnout on tangent track), and the trailing in-train longitudinal forces lifting the 25th wagon and its trailing bogie resulting in the leading wheelset of the trailing bogie mounting the rail at kilometre mark 274.396 km. The wheelset then dismounted the rail in a derailed state at kilometre mark 274.394 km.

The 25th wagon was positioned between two loaded wagons, the front of the wagon was coupled to the 24th wagon and was attached to the 26th wagon by the solid drawbar connection.

Following the derailment the leading wheelset of the trailing bogie was ejected from the bogie and left on the track at kilometre mark 271.684 km. As the driver remained unaware of the derailment, the train continued with the bogie dragging on the down rail of the up main line within the six foot and foul of the down main line.

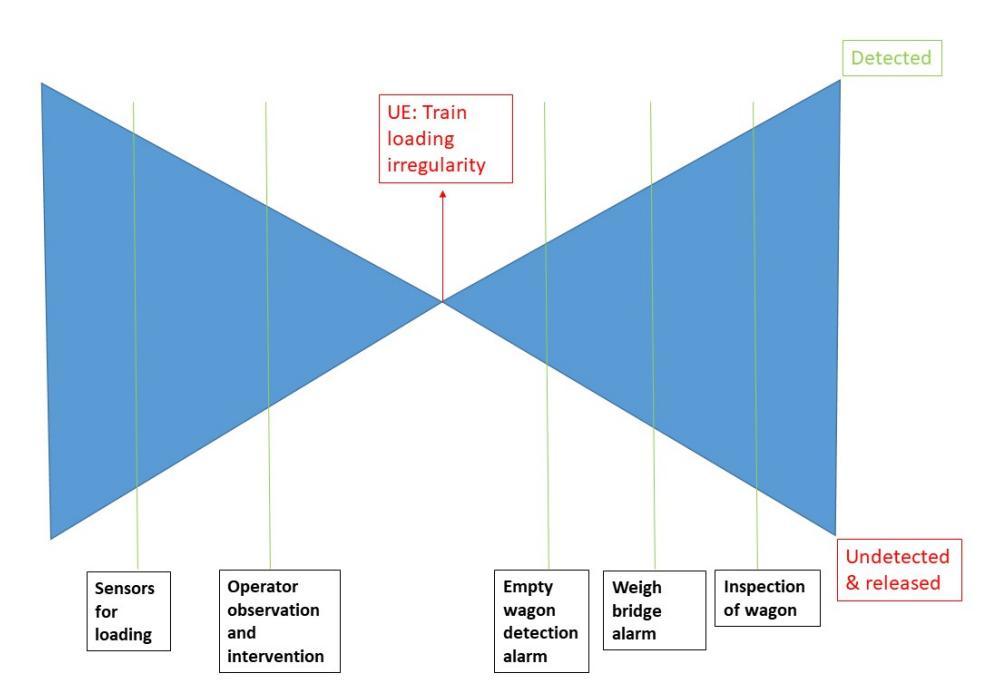
Figure 9: Bow tie risk diagram depicting ineffective risk controls in this incident

A summary of the risk controls that were ineffective which lead to the unwanted event of an empty wagon positioned between loaded wagons is depicted below (see Figure 9).

The layers of control (defences) in place failed to prevent and detect the loading irregularity. As a result, the loading terminal reviewed its risk assessment and controls to confirm the systems level of effectiveness. The outcomes from the review included implementation of additional controls, such as extra lighting on the outbound side of the loading chute, two independent mechanisms for detection of empty wagons and a process of verification of the train load out summary between the TLO and the Control Room Operators to ensure each train is loaded within required specification prior to advising the train operator that loading is complete.
