# Loss of control and collision with terrain involving BRM Aero Bristell S-LSA aircraft, VH-YVF

Moorabbin Airport, Victoria on 12 December 2019

ATSB Transport Safety Report Aviation Occurrence Investigation (Short) AO-2019-071 Final – 5 May 2021 Released in accordance with section 25 of the Transport Safety Investigation Act 2003

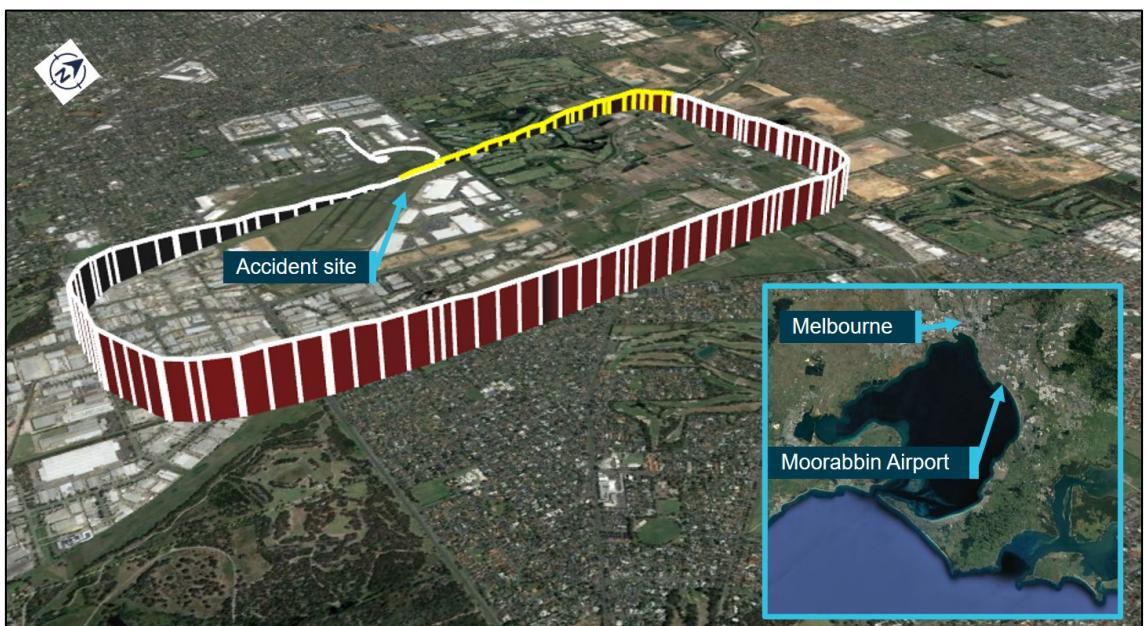
Figure 1: Flight track, with the approach to land phase highlighted in yellow

The student pilot stated that, just after crossing the runway threshold, what felt like a sudden gust of wind pushed the aircraft to the left of the runway centreline. At that point, the student pilot decided to initiate a go-around. The pilot reported that, after commencing the go-around. the aircraft was then 'ripped up very violently, straight up into the air and then ripped very violently toward the left'. They attempted to recover with full right rudder 'as far as it would go, but by that time it was too far gone' (Figure 1).

Witnesses reported observing the aircraft, about 10 ft above the runway, when it suddenly pitched up to about 40 ft. The left wing dropped, with the bank angle increasing to the point where the aircraft became inverted. The nose then dropped, and the aircraft impacted terrain in a steep inverted attitude. The witnesses described what they saw as similar to a spin entry to the left.

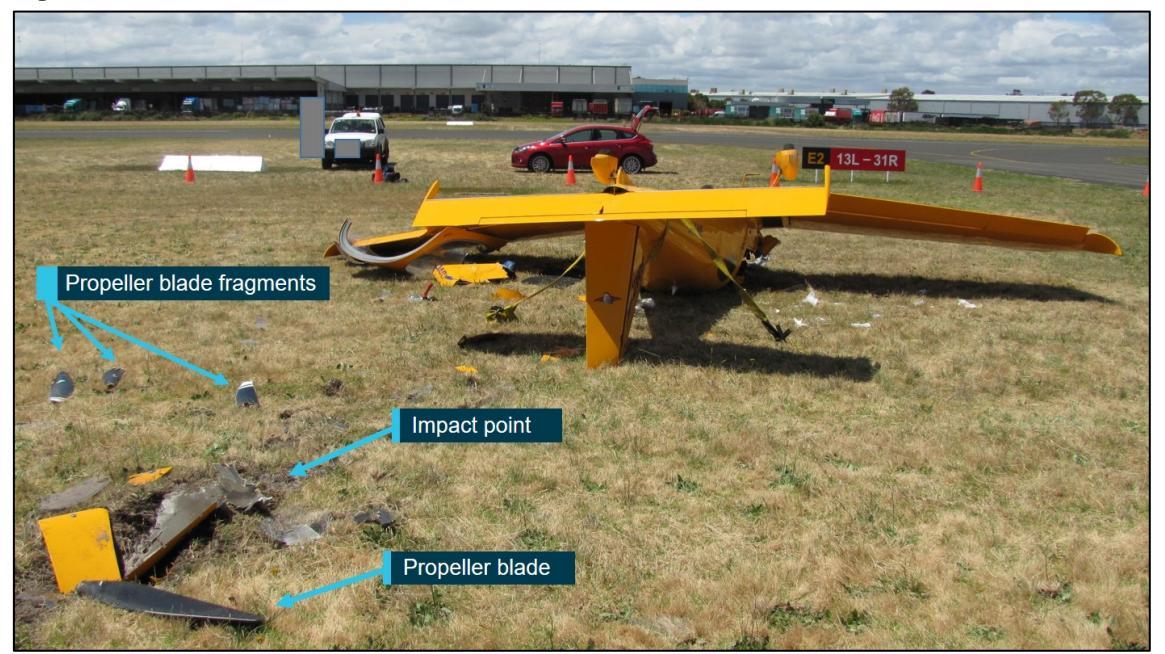
#### Figure 5: Accident site

Examination of the wreckage (Figure 5) did not identify any evidence of pre-existing faults or engine issues which may have contributed to the loss of control.

The site and wreckage examination identified that YVF impacted terrain in a nose-down, inverted attitude. In addition, damage to the airframe and engine was indicative of the aircraft being in a moderate spin/yaw to the left, at the point of impact. This was consistent with witness reports that the aircraft pitched up, rolled to the left and impacted the terrain inverted, in what appeared to be the commencement of a spin.

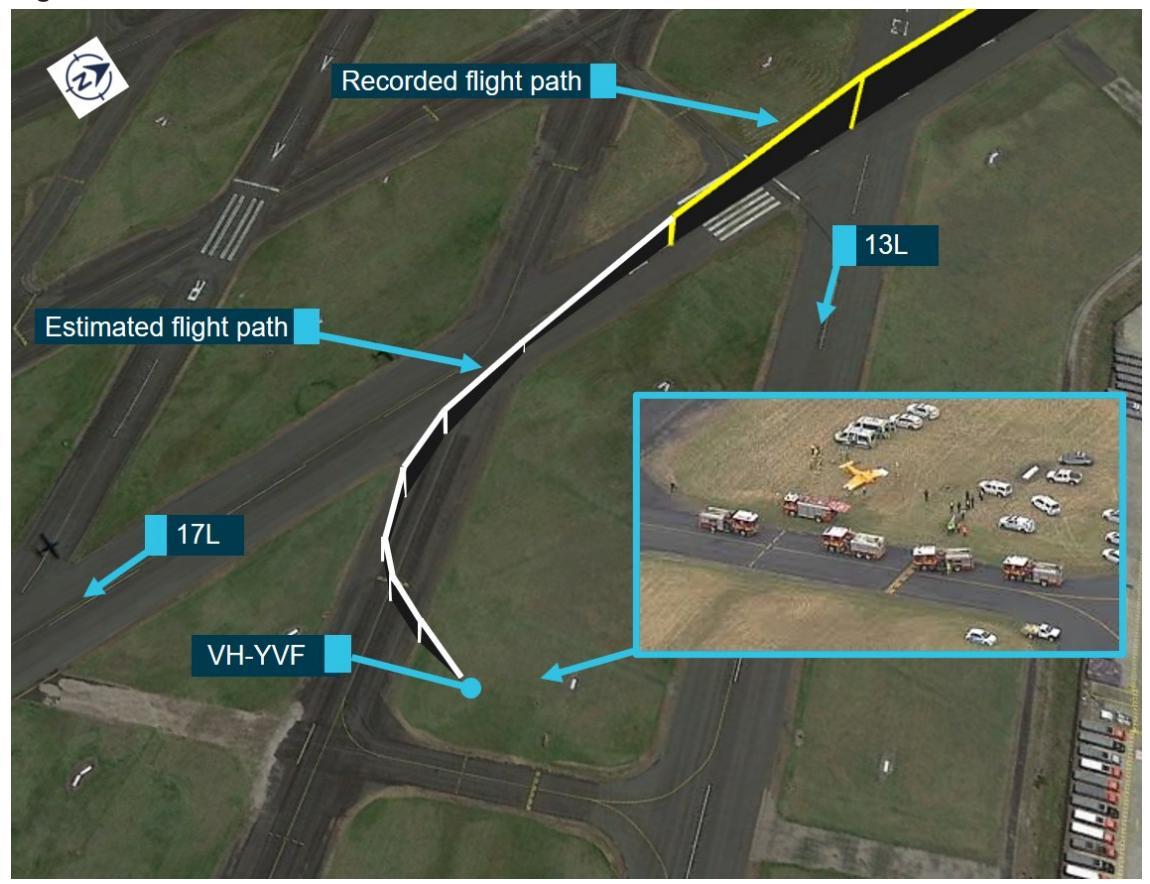
Figure 6: Accident site overview

The ATSB was able to download the data from the occurrence flight however, the data stopped just as the aircraft flew over the runway 17 threshold (Figure 6). It is likely the final seconds of data were lost due to the interruption of electrical power to the unit at impact. The last 5 seconds of recorded data captured:

- indicated airspeed reducing from 60 to 51 kt
- altitude decreasing from 106 ft to 76 ft
- vertical speed stable at -255 fpm
- roll no more than 5° either side of wings level
- pitch increasing from about -0.5 to +5.0° but not stable
- yaw varying from 0 to -5°/s
- wind speed and direction: stable at 223° and 15 kt (13 kt crosswind)
- engine RPM decreasing from 3,730 to 2,580 and fuel flow relatively stable at 2.2-2.4 gallons/hr
- GPS track was aligned with the runway centreline.
