Loss of control and collision with water involving Eurocopter EC120B, VH-WII

Hardy Reef, 72 km north-north-east of Hamilton Island Airport, Queensland on 21 March 2018

ATSB Transport Safety Report Aviation Occurrence Investigation (Systemic) AO-2018-026 Final – 16 June 2021 Cover photo: CQ Plane Spotting

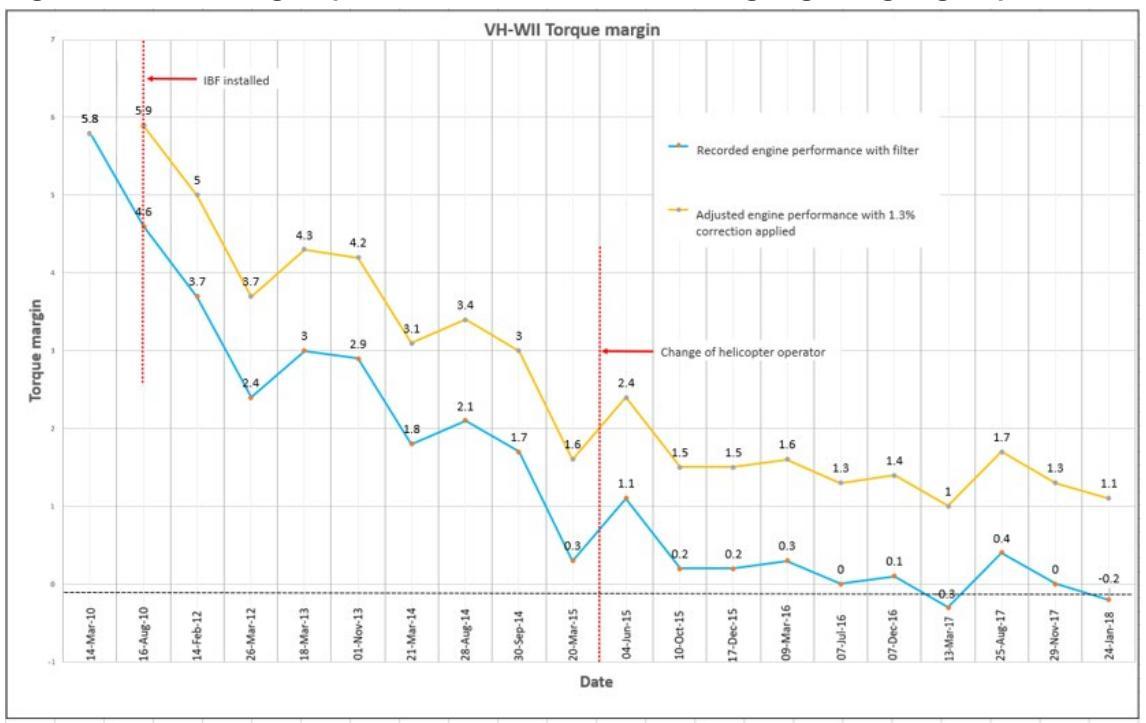
Figure 10: Plotted engine power checks for VH-WII showing degrading engine power

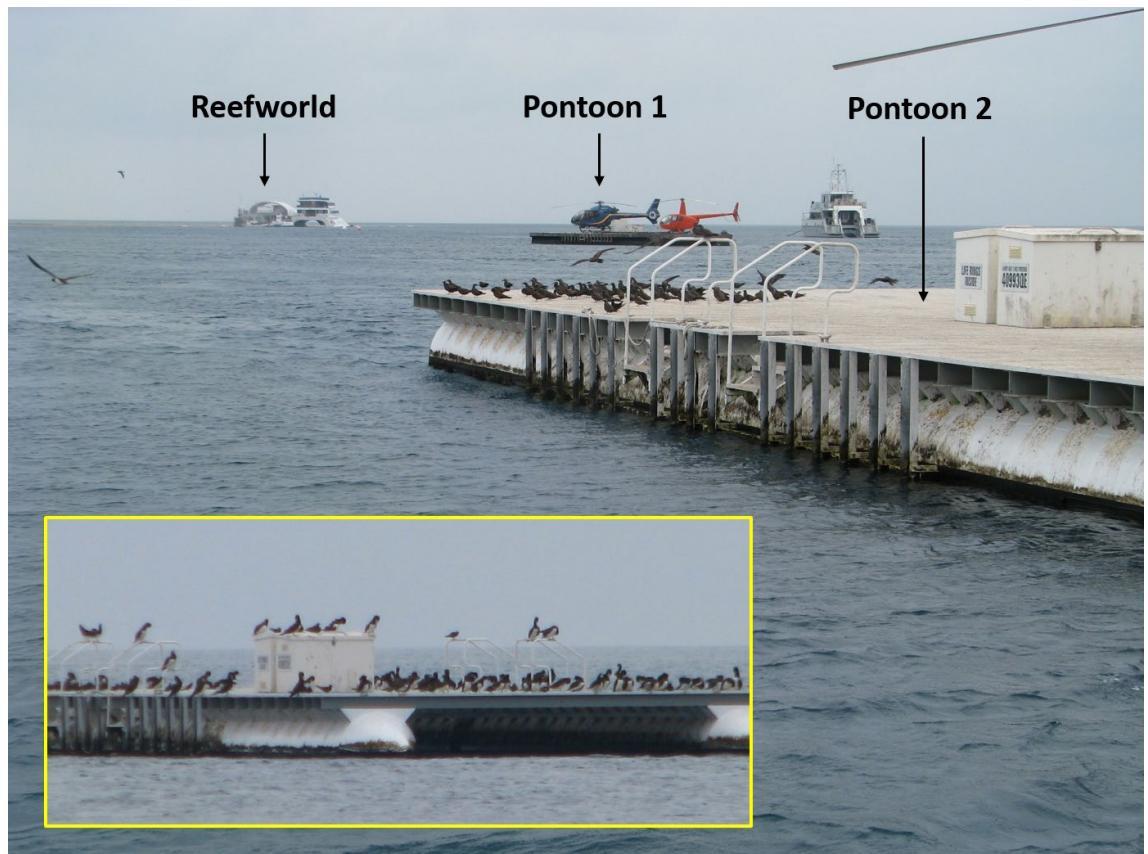
Figure 16: Pontoon positions, insert showing bird hazard

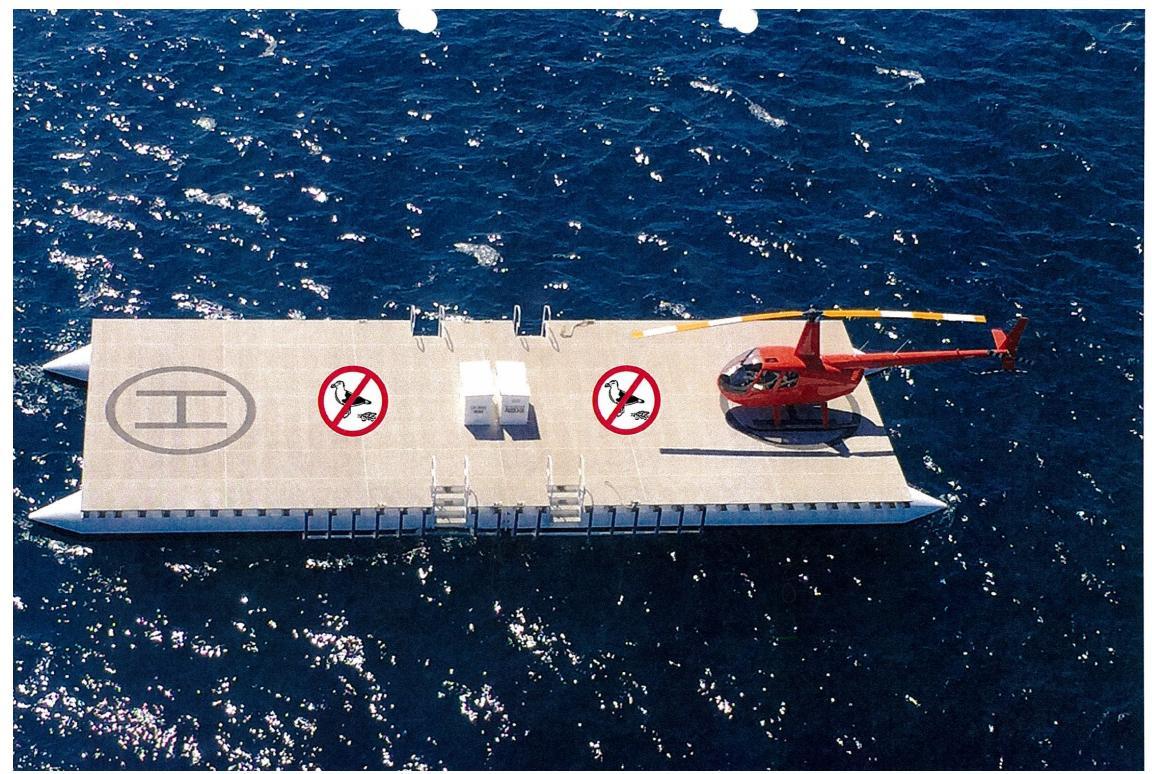
Figure 17: Picture taken from operator's HLS register showing the pontoon layout and hazards

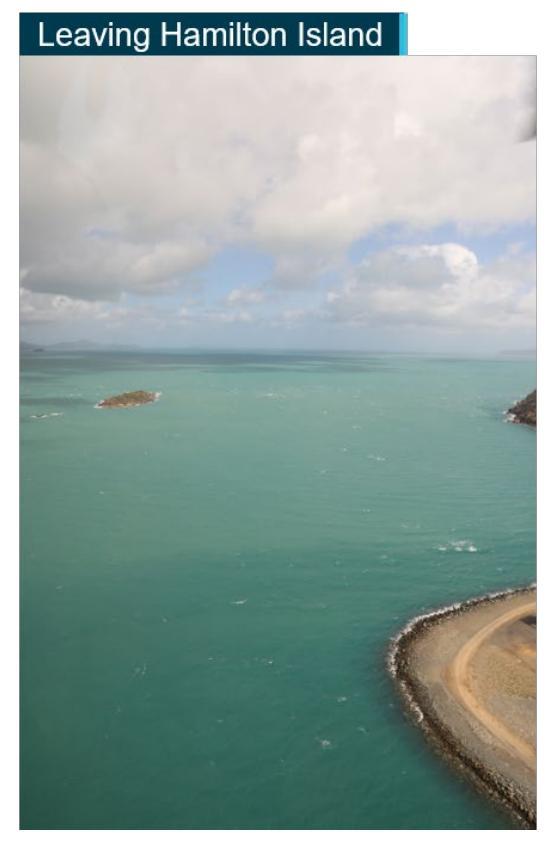
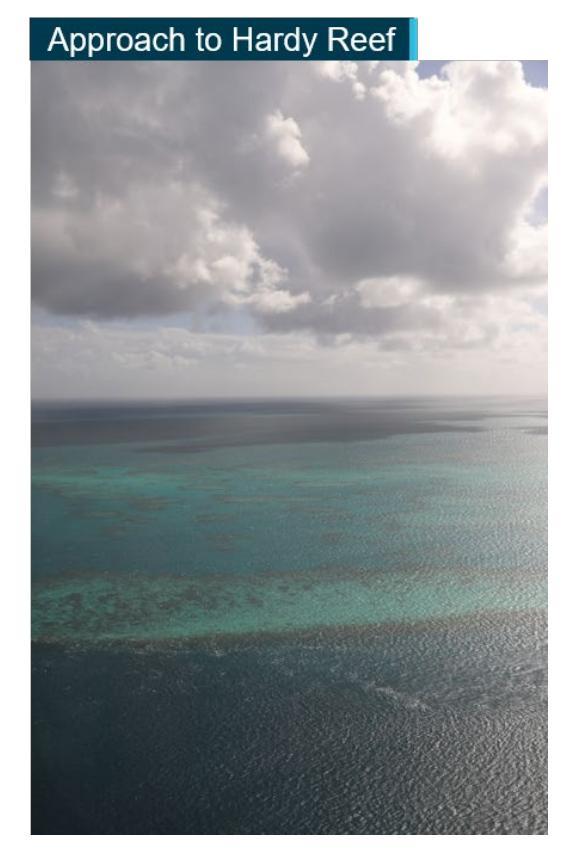
Figure 18: Unedited photographs taken by a passenger on board the accident flight, showing weather conditions

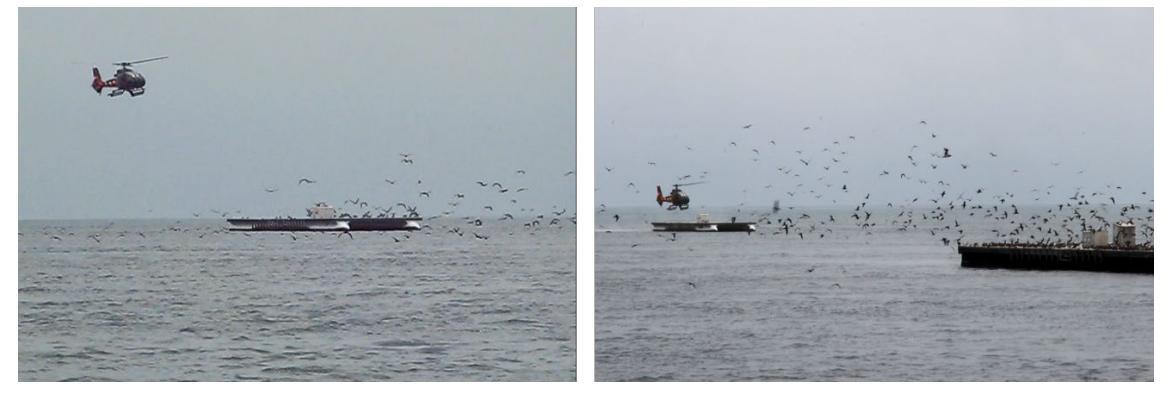
Figure 19: Still images showing bird population at Hardy Reef pontoons

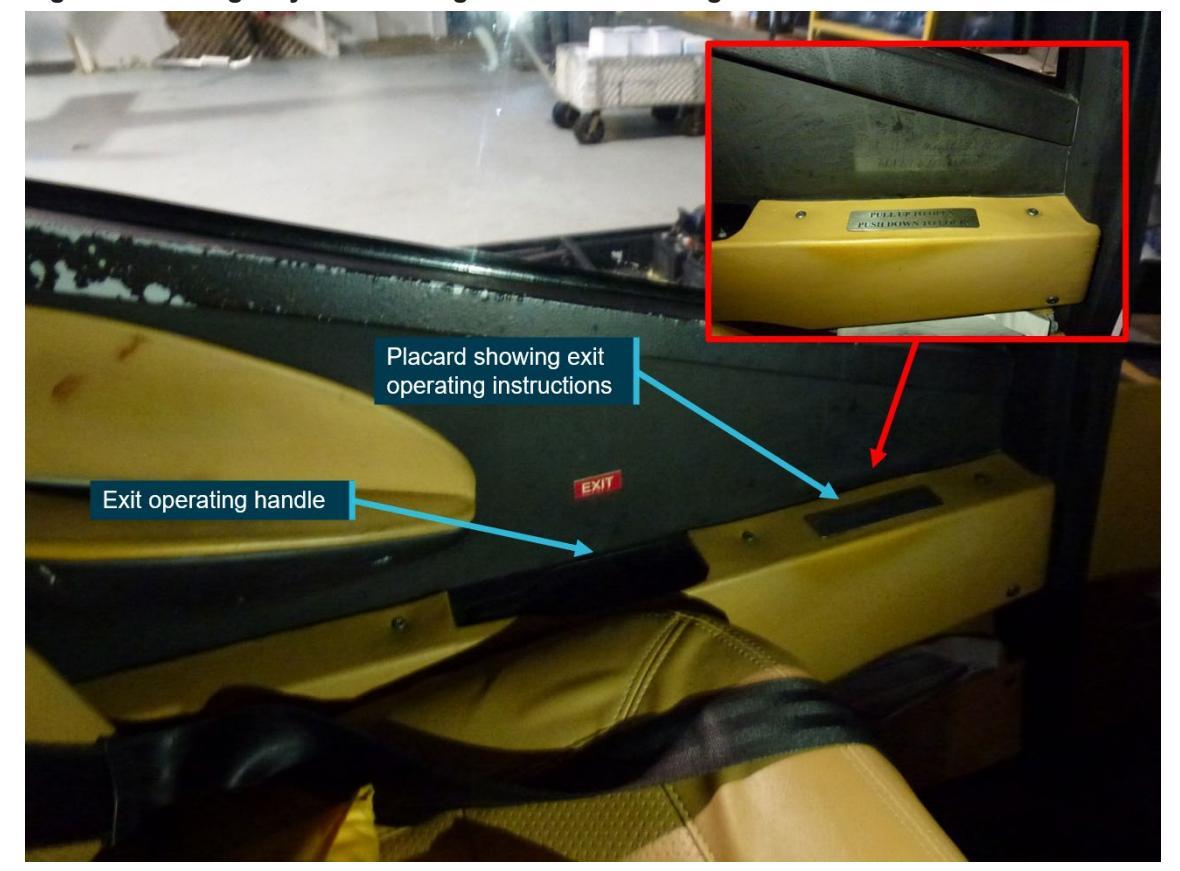
Figure 26: Emergency exit markings on rear left sliding door in VH-HIL

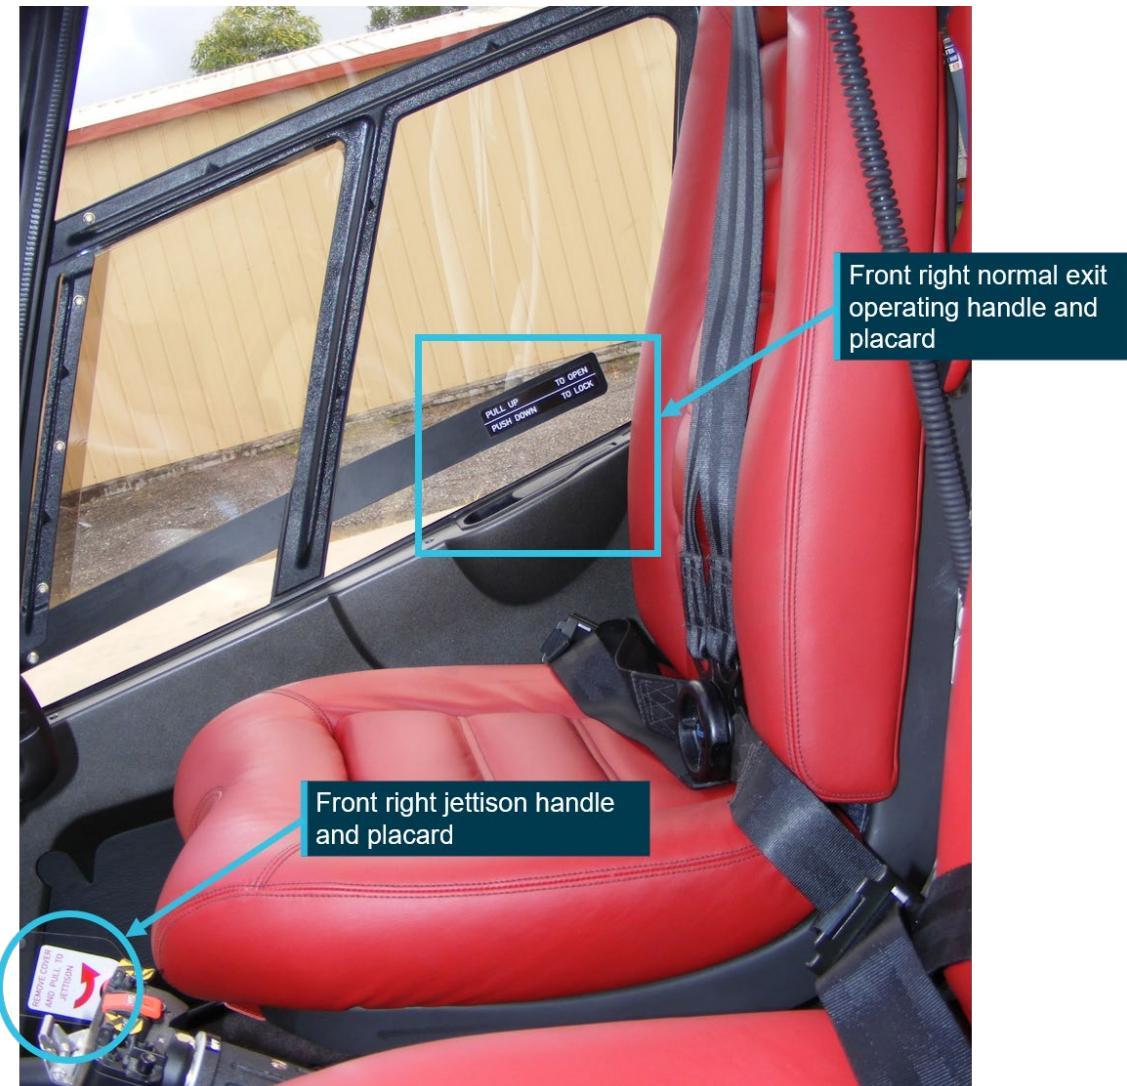
Figure 27: Photograph of VH-WII front right exit, showing the location of the normal and emergency (jettison) exit handles

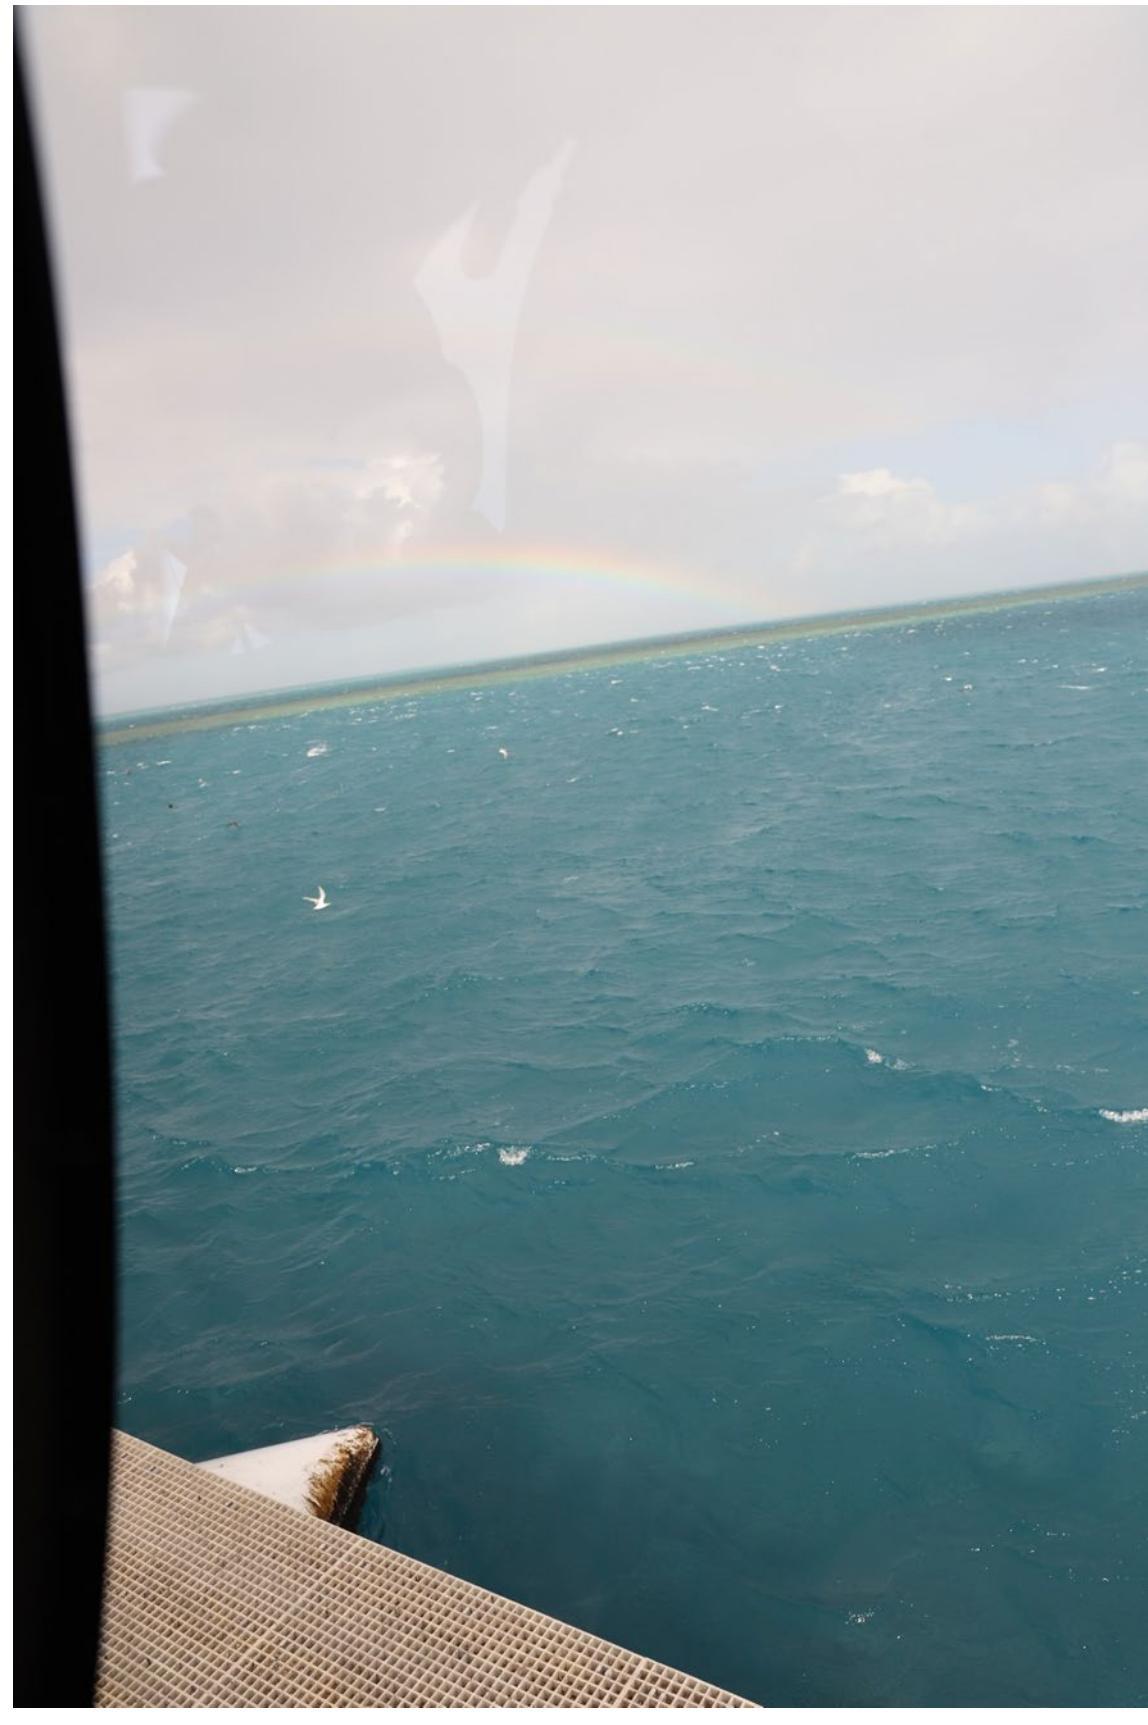
Figure A4: Image 0620 taken when close to and over the northern pontoon

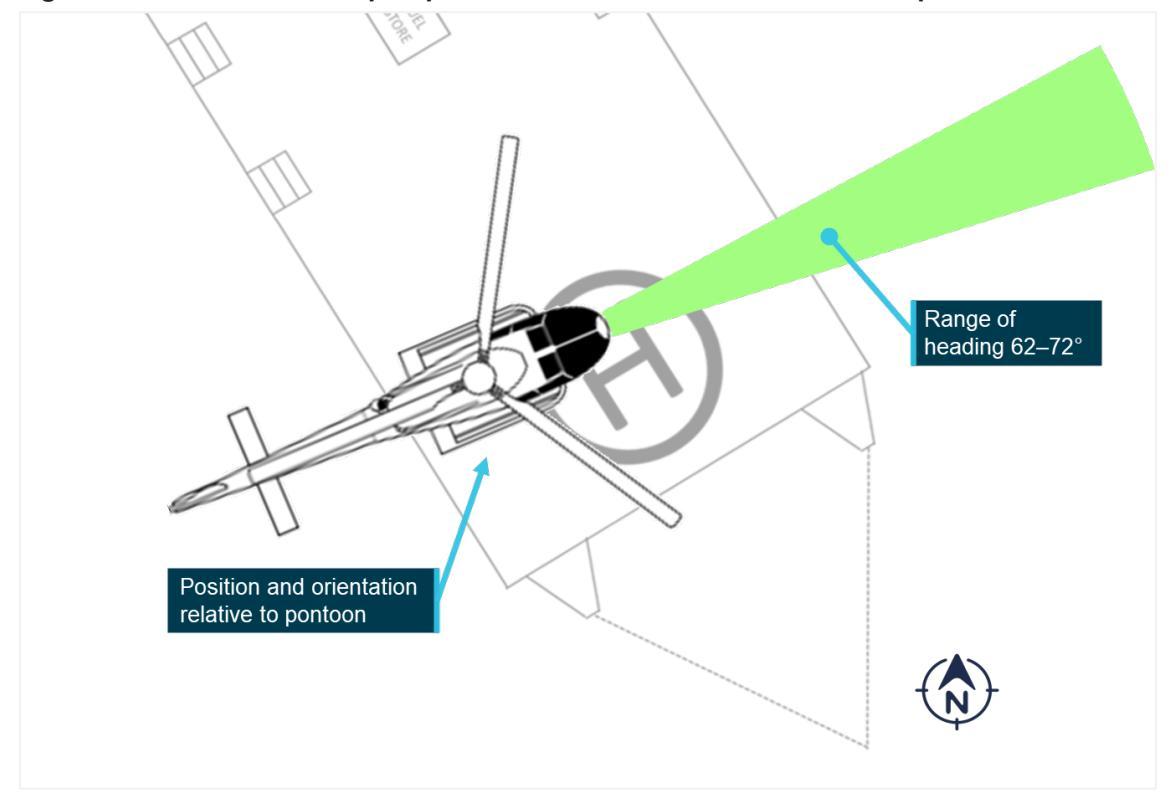
Figure A8: Estimated helicopter position and orientation relative to the pontoon

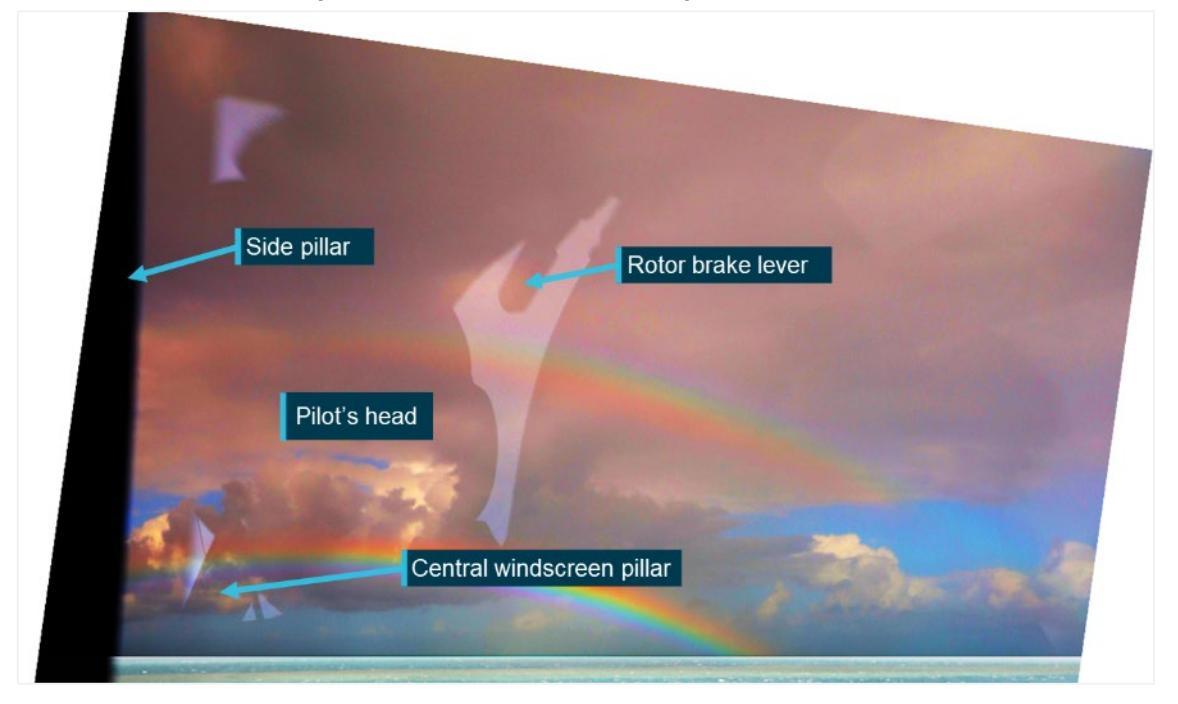
A pillar was visible on the left of image 0620 and was identified as the pillar between the front and rear windows on the right side of the helicopter. Colour enhancement of the image showed a clear reflection of the pilot's head, the central windscreen pillar, and the rotor brake lever above and between the front seats (Figure A9).

Figure A9: Colour enhancement of image 0620, rotated to level the horizon, showing reflections and window pillar used to estimate helicopter orientation

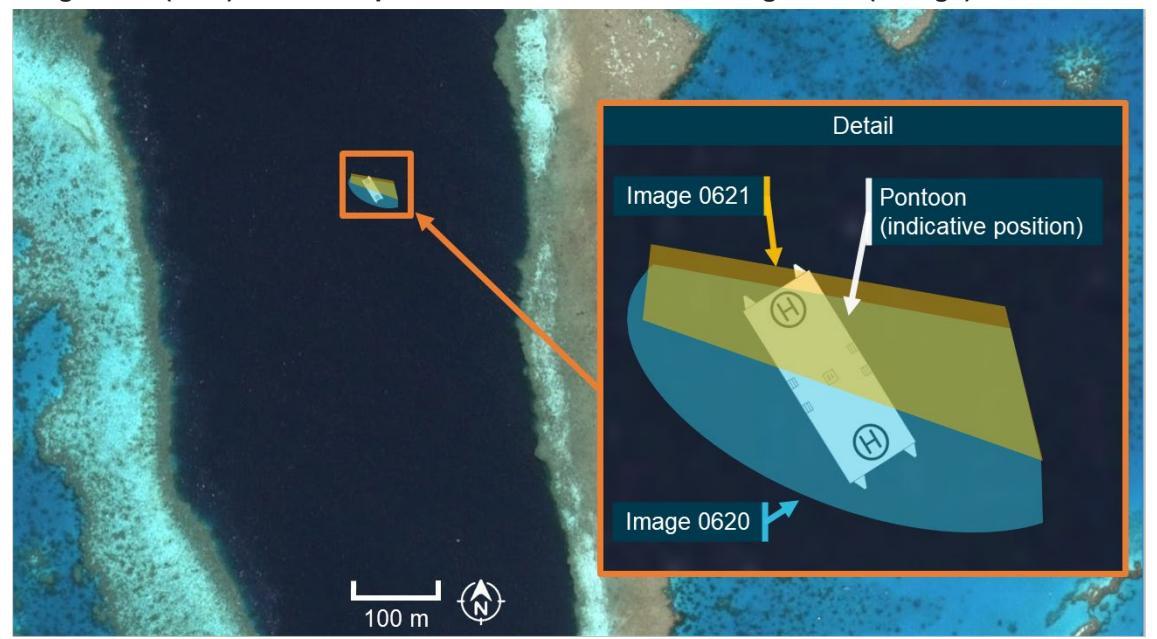
The helicopter's location at the time of image 0620 (when the helicopter was over the pontoon) was close to the position of the pontoon that was estimated from image 0617).

Figure A11: Representation of estimated helicopter and pontoon locations at the time of image 0620 (blue) and helicopter location at the time of image 0621 (orange)
