# Unreliable airspeed indication involving Pilatus PC-12/47E, VH-OWI

on descent to Albany Airport, Western Australia on 22 June 2020

ATSB Transport Safety Report Aviation Occurrence Investigation (Short) AO-2020-030 Final – 21 July 2021 Released in accordance with section 25 of the Transport Safety Investigation Act 2003

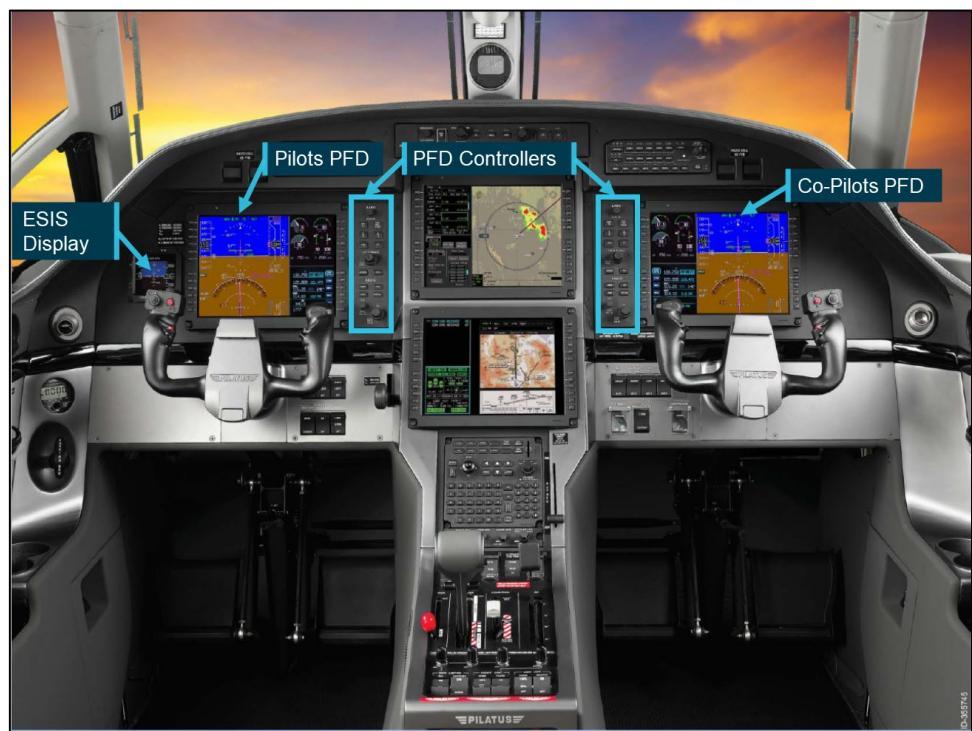
Figure 1: PC-12/47E exemplar cockpit layout

While continuing the descent the pilot compared the airspeeds displayed on the two PFDs with the airspeed indication on the electronic secondary instrument system (ESIS) (Figure 1). Based on the speed readings from the PFDs and the ESIS the pilot determined that the left PFD was likely displaying incorrect information.

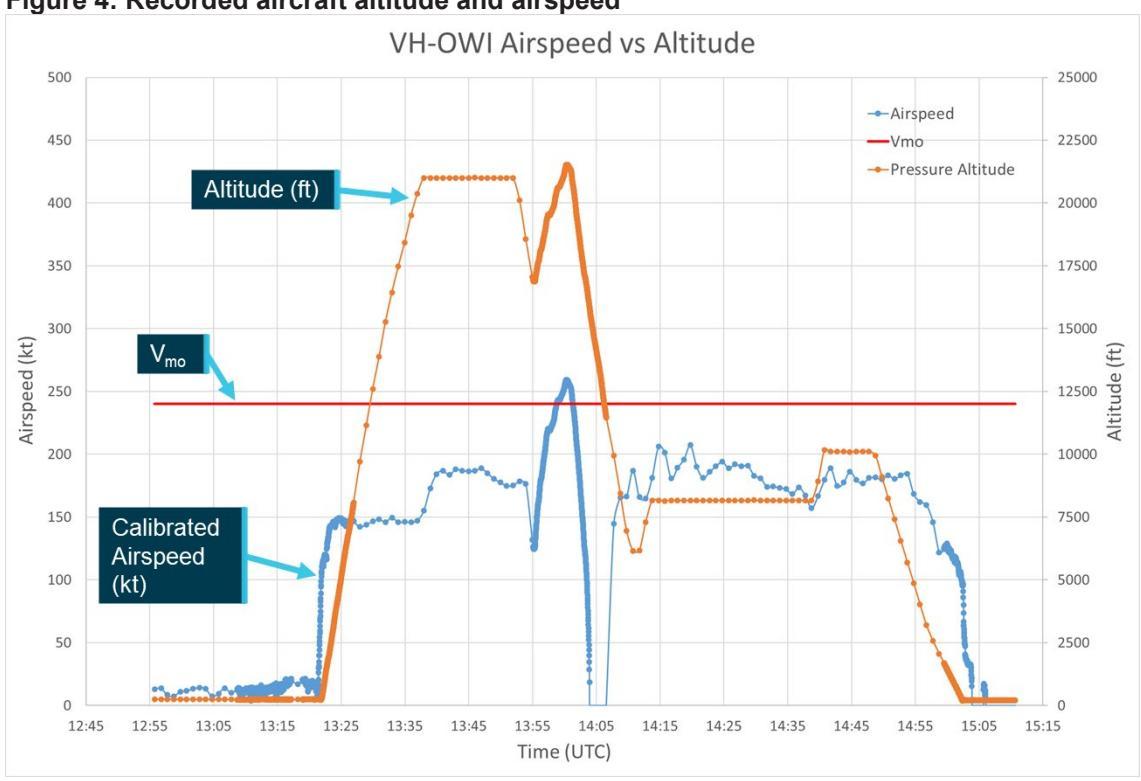
Figure 4: Recorded aircraft altitude and airspeed

The ATSB was provided with aircraft maintenance files (ACMF) data which recorded a range of aircraft parameters for multiple flights, including the incident flight. Only the data feed to the left PFD was recorded. Figure 4 shows the aircraft's calibrated airspeed<sup>12</sup> and altitude for the incident flight. Also shown on the plot is a red line indicating the V<sub>mo</sub> speed of the aircraft.

The indicated airspeed, displayed to the pilot, is calculated by comparing the dynamic air pressure, sensed through the pitot tube, on the aircraft's wing, with the static air pressure sensed at the static ports on the aircraft's tail. A blockage of the pitot tube will cause the pressure in the

tube (dynamic air pressure) to remain constant while static pressure changes with altitude. This will cause the indicated airspeed to over read during a climb and under read during a descent.

The incorrect air pressure being fed into the ADAHRS unit from the blocked pitot tube resulted in the airspeed displayed on the left PFD being incorrect. The airspeed over read during climb and under read during descent. The miscompare monitoring functionality of the ADAHRS unit identified the difference between the two displayed airspeeds, triggering miscompare indications on the PFDs.
