# Engine failure and collision with terrain involving Cessna P210N, N210BA

Near Moruya Airport, New South Wales, on 19 December 2019

ATSB Transport Safety Report Aviation Occurrence Investigation (Defined) AO-2019-075 Final – 2 November 2021 Cover photo: Aidan Pullino

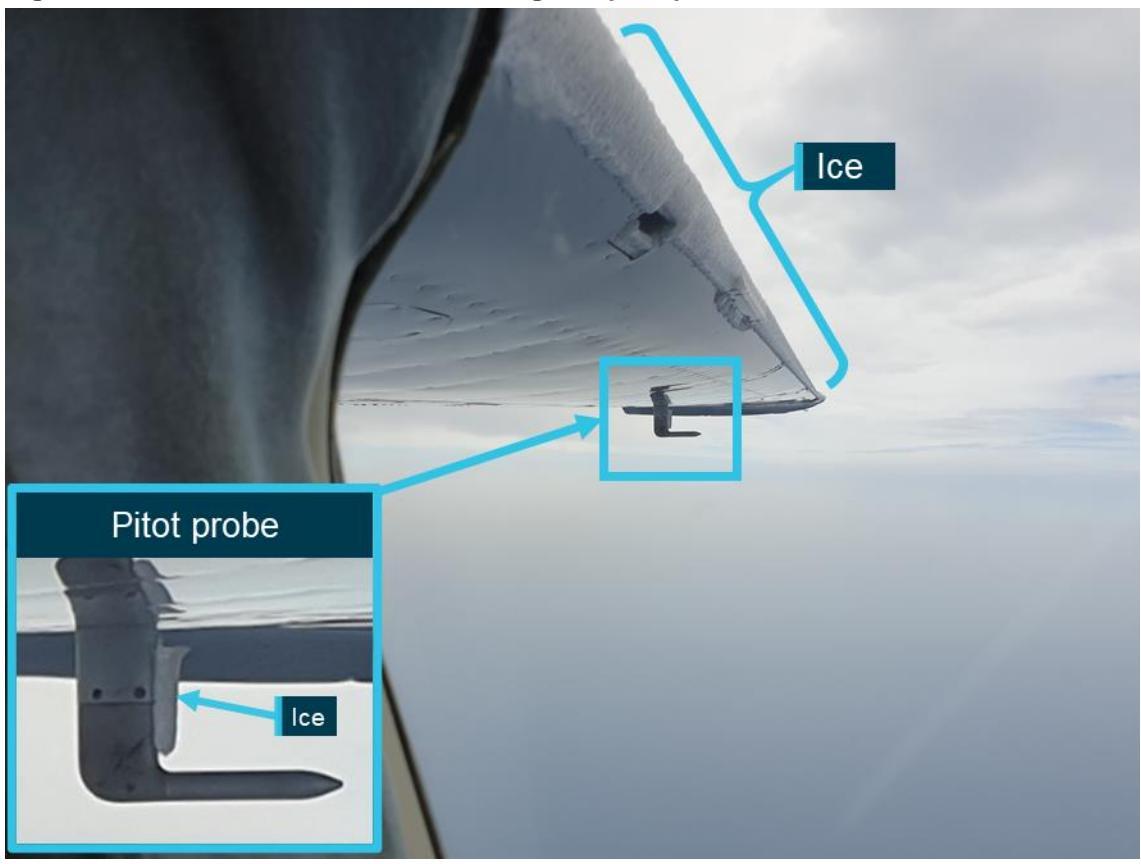
By about 1218, the aircraft was at the planned cruising altitude of flight level (FL) 180.<sup>4</sup> Shortly after, the pilot noted that rime ice<sup>5</sup> was accumulating on the leading edge of both wings and the front windscreen. The pilot recalled that the propeller de-ice and all engine (turboprop) ice-protection systems were activated at the time.

Figure 1: Ice accumulation on the left wing and pitot probe

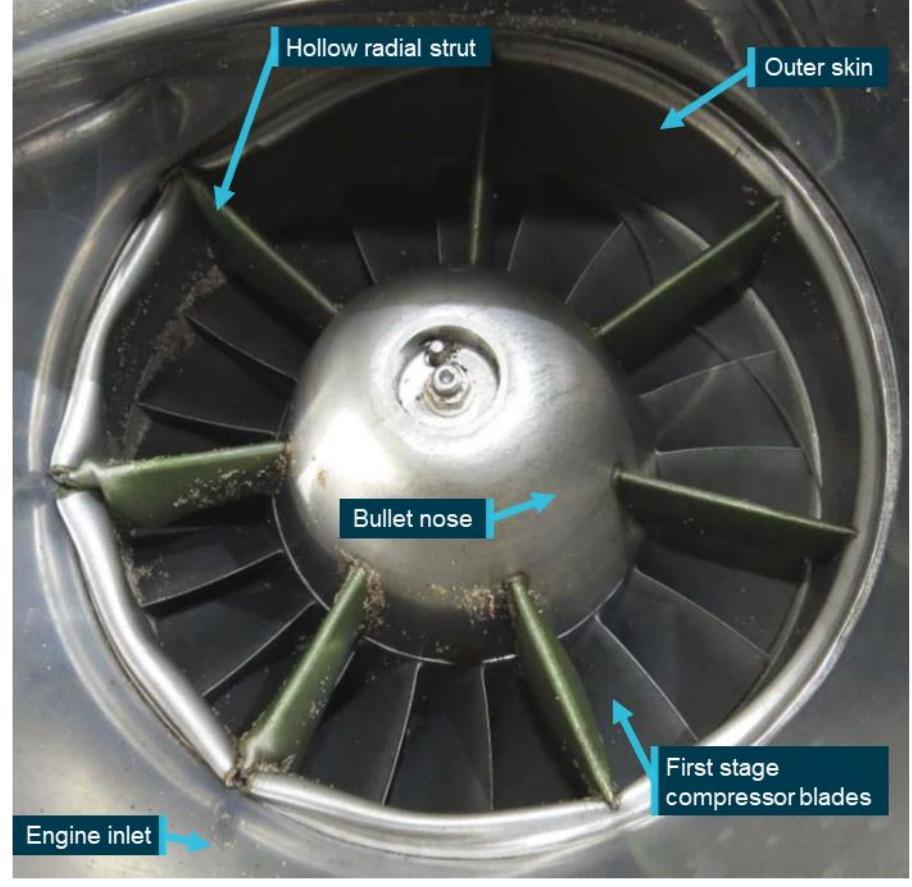
Figure 5: Front view of N210BA engine inlet and compressor inlet (post-accident)

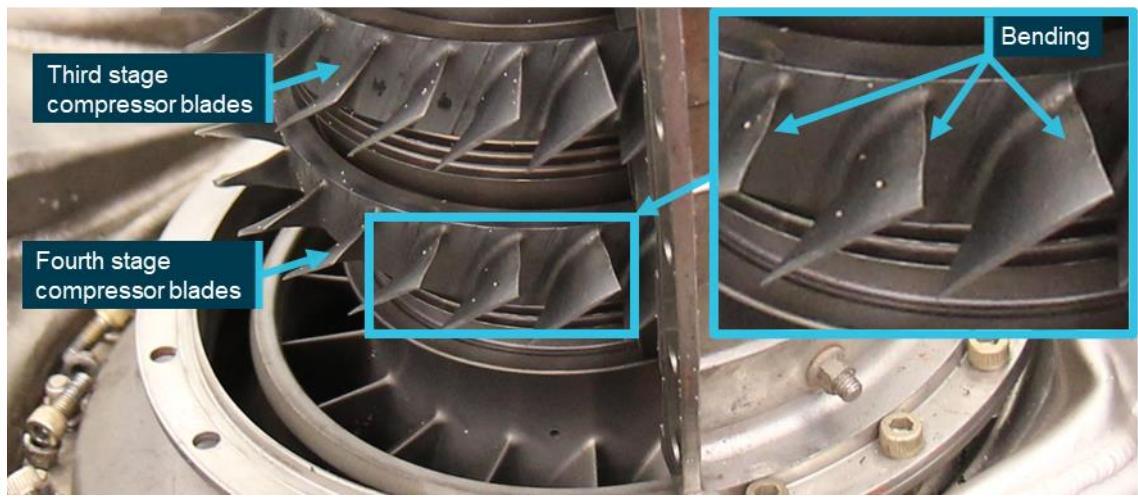
#### Figure 6: Fourth stage compressor blade damage

Rolls-Royce stated that there was insufficient evidence to determine the source of the observed compressor blade damage. With respect to the first stage nozzle crack, Rolls-Royce noted that cracks in this area were typical of in-service experience and were unlikely to grow to critical length between maintenance inspections. Rolls-Royce concluded that there were no pre-existing conditions that should have prevented normal engine operation.

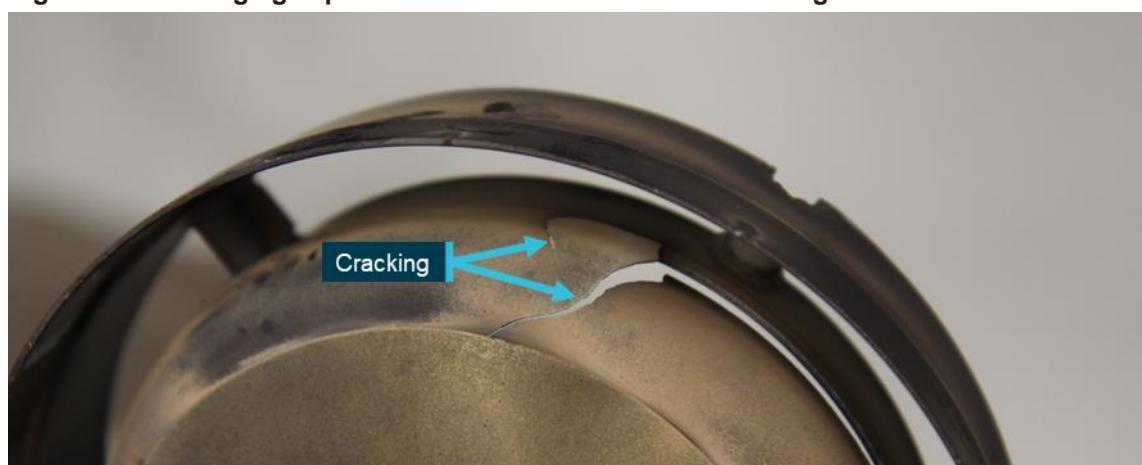
Figure 7: First stage gas producer turbine nozzle shield cracking

Due to in-service cracking of first stage turbine nozzle shields in M250 series engines, Rolls-Royce had issued commercial engine bulletins (CEB) in March 2000 recommending initial and recurring inspections of affected turbine nozzle shields for cracking. Recurring inspections were not needed if the nozzle shields were replaced with unaffected shields. For M250-B17F series engines, CEB A-72-2069 was applicable and outlined that partial, or complete separation of the nozzle shield due to cracking, could result in heat distress and coking of the gas producer turbine bearing, and an oil fire.

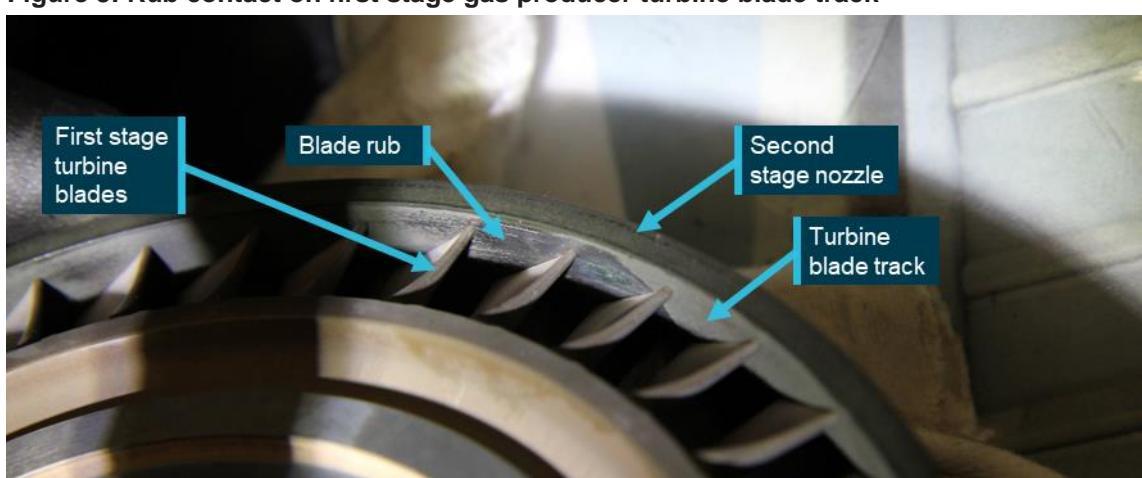
Figure 8: Rub contact on first stage gas producer turbine blade track

Additional blade rub on the turbine blade track was evident but not shown in this photo. Source: ATSB

Rolls-Royce stated that a substantial amount of turbine blade rub along the first or second stage gas producer turbine blade track was usually indicative of rotor lock. Rolls-Royce could not confirm whether or not the blade rub found during the engine examination (Figure 8) was due to rotor lock, but advised expecting to have found more turbine blades rub on the blade track if rotor lock had occurred. Rolls-Royce also pointed out that the starter/generator circuit breaker should activate if a restart was attempted while the engine was in the rotor lock condition.

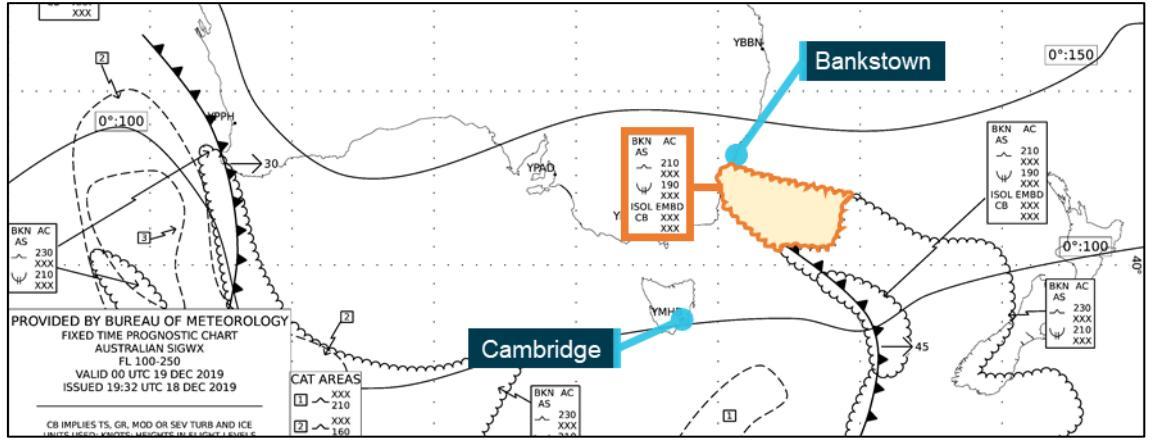
There was no AIRMET or relevant SIGMET applicable to the planned flight but a SIGWX chart covering FL 100–FL 250 was available (Figure 9). This chart included weather associated with a transiting cold front moving east to north-east at about 45 kt that included broken altostratus and altocumulus clouds with moderate icing from below 10,000 ft to FL 190, and isolated embedded cumulonimbus from below 10,000 ft to above FL 250.

Figure 9: BoM forecast significant weather chart applicable to the planned flight

The orange highlighted area shows the transiting cold front that was not included on the ForeFlight FL 250–FL 630 SIGWX chart. The top half of original chart is not shown.

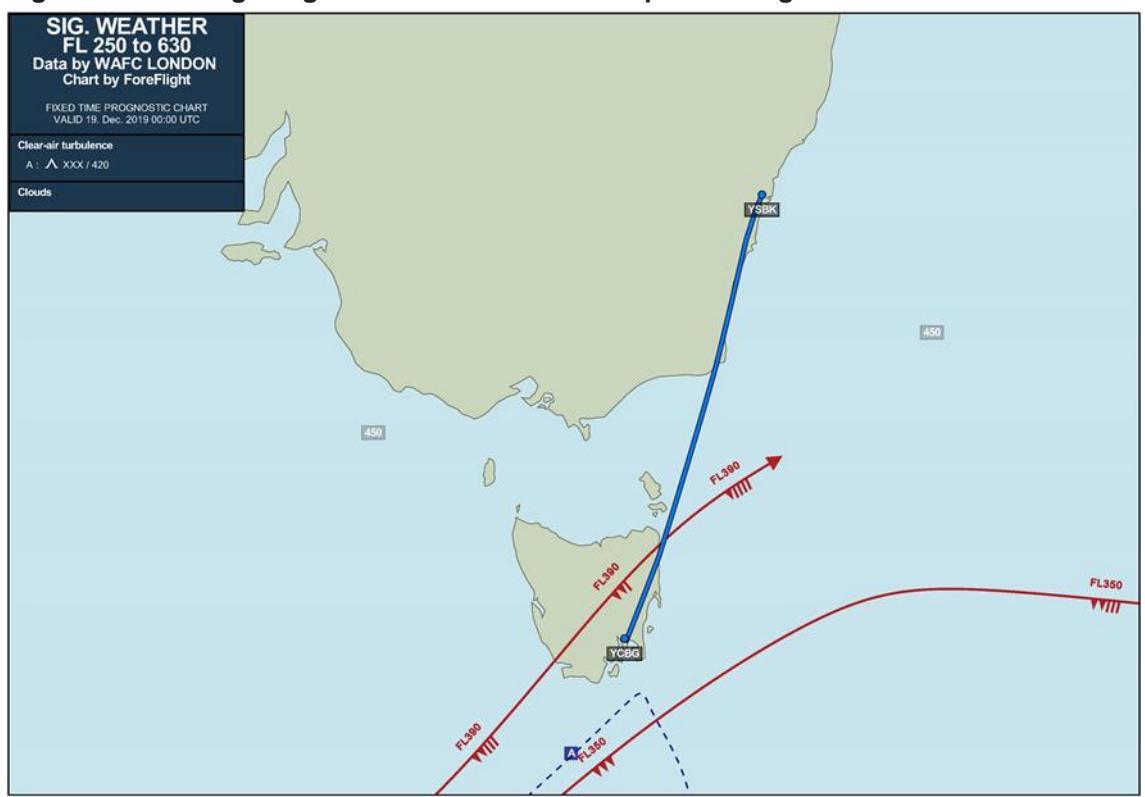
The SIGWX chart covered FL 250 to 630 (Figure 11). The pilot incorrectly interpreted the chart as showing no significant weather at the planned flight level (FL 180), and expressed an understanding that the chart was a graphical representation of SIGMETs.

Figure 11: ForeFlight significant weather chart for planned flight

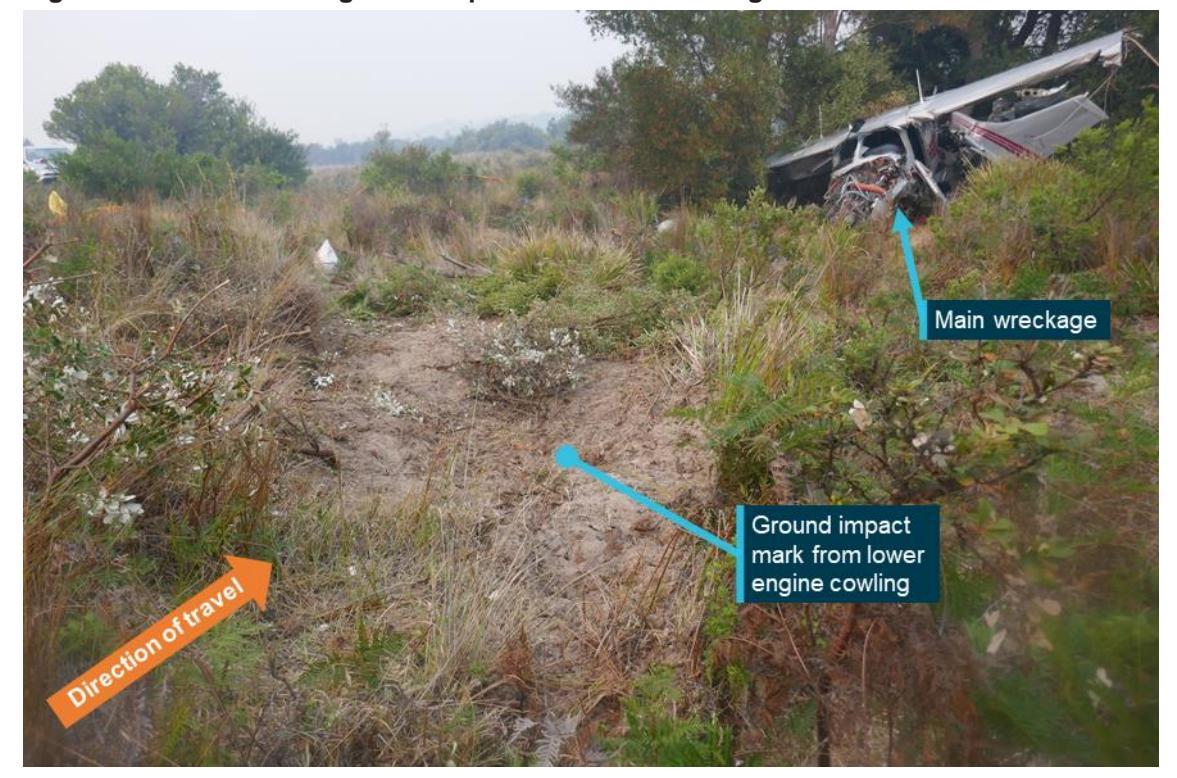
The left wing struck the ground first followed by a single, feathered propeller blade, and subsequent heavy impact on the left engine exhaust and lower engine cowling. The aircraft then yawed left through 180° before impacting several trees, causing the tail assembly to separate. The aircraft came to rest facing the opposite direction to its flight path.

Examination of the wreckage indicated that the aircraft entered the vegetation with approximately 10° of flaps and the landing gear extended.

#### Figure 12: N210BA main ground impact mark and wreckage

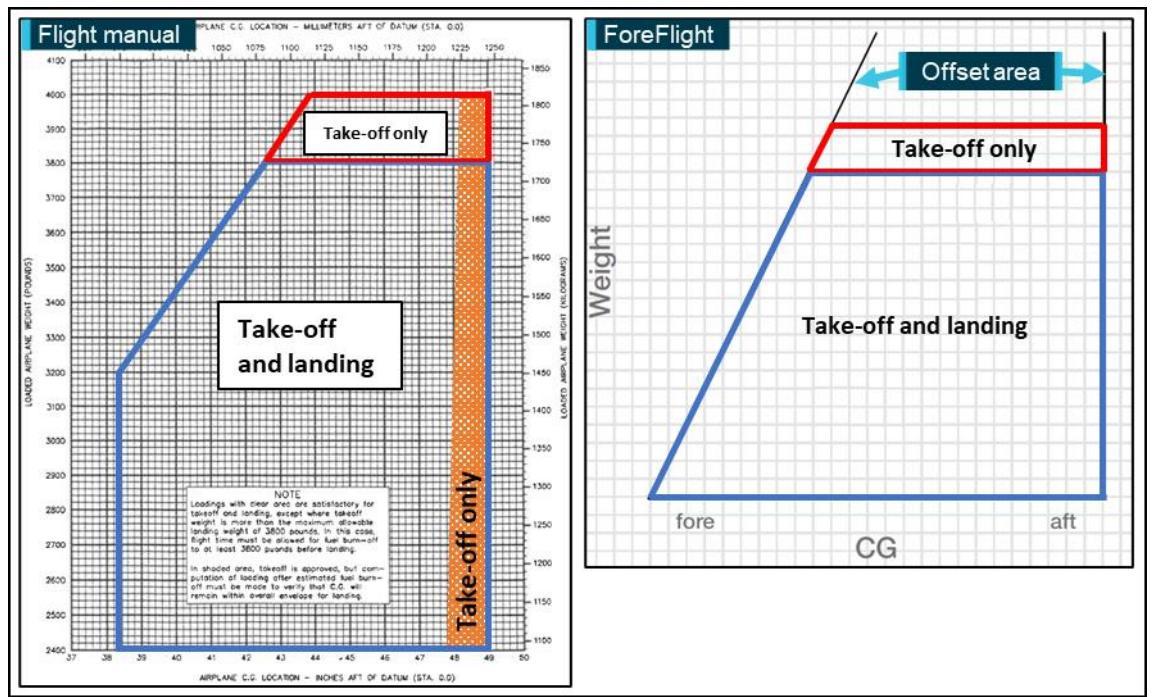
The pilot also provided the ATSB with another ForeFlight document (created after the accident flight) that contained the centre of gravity envelope from the pilot's N210BA weight and balance profile. The maximum take-off and landing weight values mirrored the aircraft's flight manual, but the shape of the envelope was different, and included an offset area with boundaries beyond the maximum take-off weight (Figure 13). Program documentation indicated that the offset area was probably due to data entry errors.

Figure 13: Centre of gravity envelope comparison
