# Flight below minimum safe altitude, Piper PA-31 Mojave, VH-XGW

Near Bankstown Airport, New South Wales, on 22 March 2021

ATSB Transport Safety Report Aviation Occurrence Investigation (Short) AO-2021-014 Final – 6 December 2021 Released in accordance with section 25 of the Transport Safety Investigation Act 2003

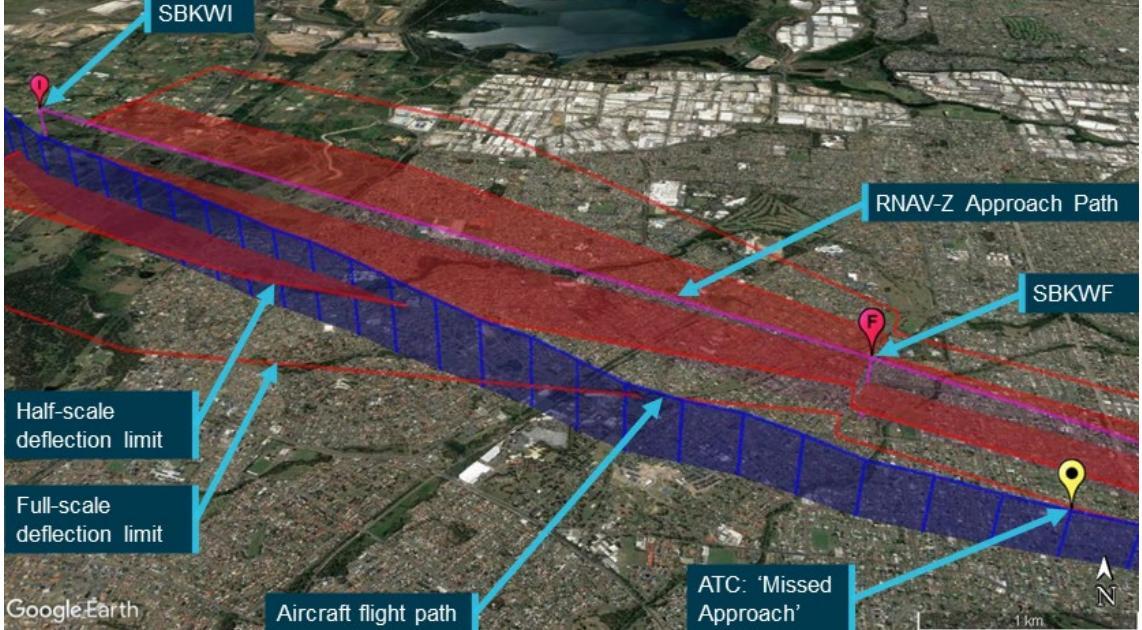
Figure 5: The aircraft's initial approach flight path in relation to tracking tolerances

The aircraft's flight path with respect to the approach tolerances is displayed in Figure 5. The half-scale and full-scale limits are displayed as a surface set to the segment's minimum segment altitude of 1,400 ft. while the full-scale tracking limits are displayed as the outer red line. The transition from the intermediate segment's RNP 1.0 NM to the final segment's RNP 0.3 NM is displayed as a progressively decreasing maximum permissible displacement (decreasing tolerance) from 2.0 NM before final approach fix (SBKWF).

The aircraft's track early in the intermediate approach segment was within tolerances, but progressively diverged from the required approach path. The decreasing tolerance from 2 NM before SBKWF and the divergent flight path resulted in the aircraft rapidly exceeding the required tracking tolerances for the intermediate segment. It was at around this point in the approach that the tower alerted the pilot to the aircraft tracking 0.5 NM south of the required instrument approach path. As the aircraft passed abeam SBKWF, it was significantly outside of the full-scale RNP limit at an altitude of 1,400 ft.

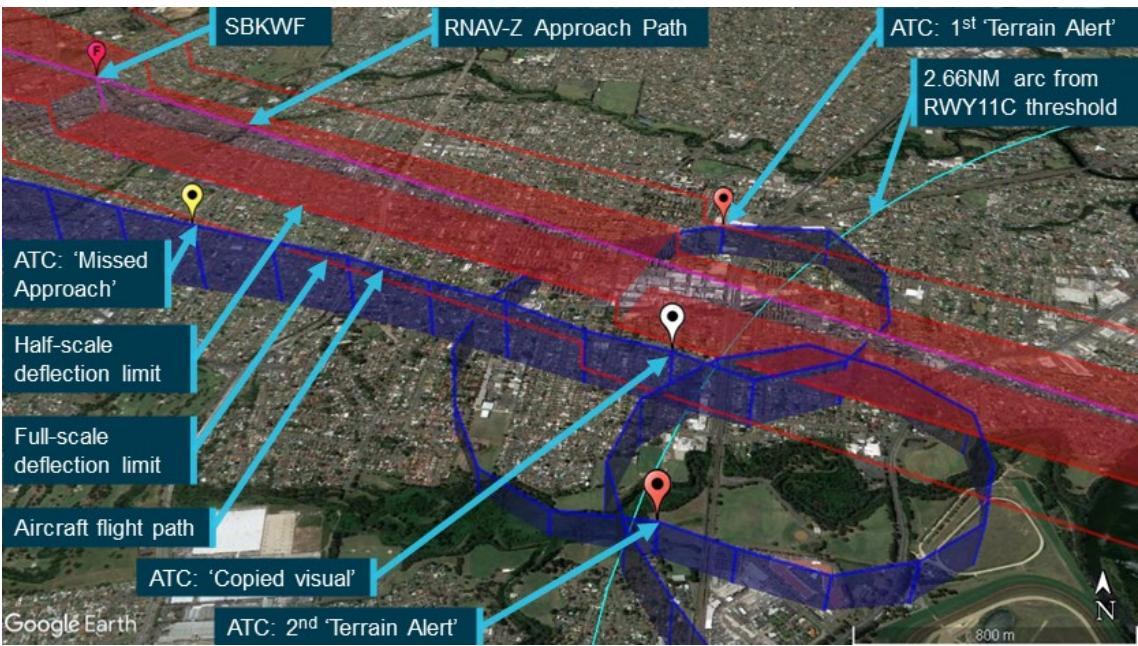
Figure 6: The aircraft's final approach flight path in relation to tracking tolerances

The aircraft's flight path with respect to the approach tolerances in the final approach segment is displayed in Figure 6. After passing abeam the final approach fix the aircraft's lateral displacement from the required approach track exceeded the full-scale RNP limit.

During the final approach segment, the aircraft's track converged with the required track, but the aircraft was not established within the required tracking tolerances until after the pilot reported being visual to ATC.

At the commencement of the left orbit, and as the aircraft crossed the approach track for the first time, the aircraft was above the straight-in approach minimum descent altitude of 580 ft. As the orbit continued and the aircraft crossed the approach track for the second time, the aircraft was below the 930 ft segment minimum altitude and had descended below the 580 ft approach minimum descent altitude. The aircraft was also outside of the CAT B circling area (represented by the light blue arc).
