Australian Government Australian Transport Safety Bureau

Runway incursion involving a SAAB 340B, VH-ZRH

Carnarvon Airport, Western Australia, on 31 August 2020

ATSB Transport Safety Report Aviation Occurrence Investigation (Short) AO-2020-045 Final – 15 December 2021 Released in accordance with section 25 of the Transport Safety Investigation Act 2003

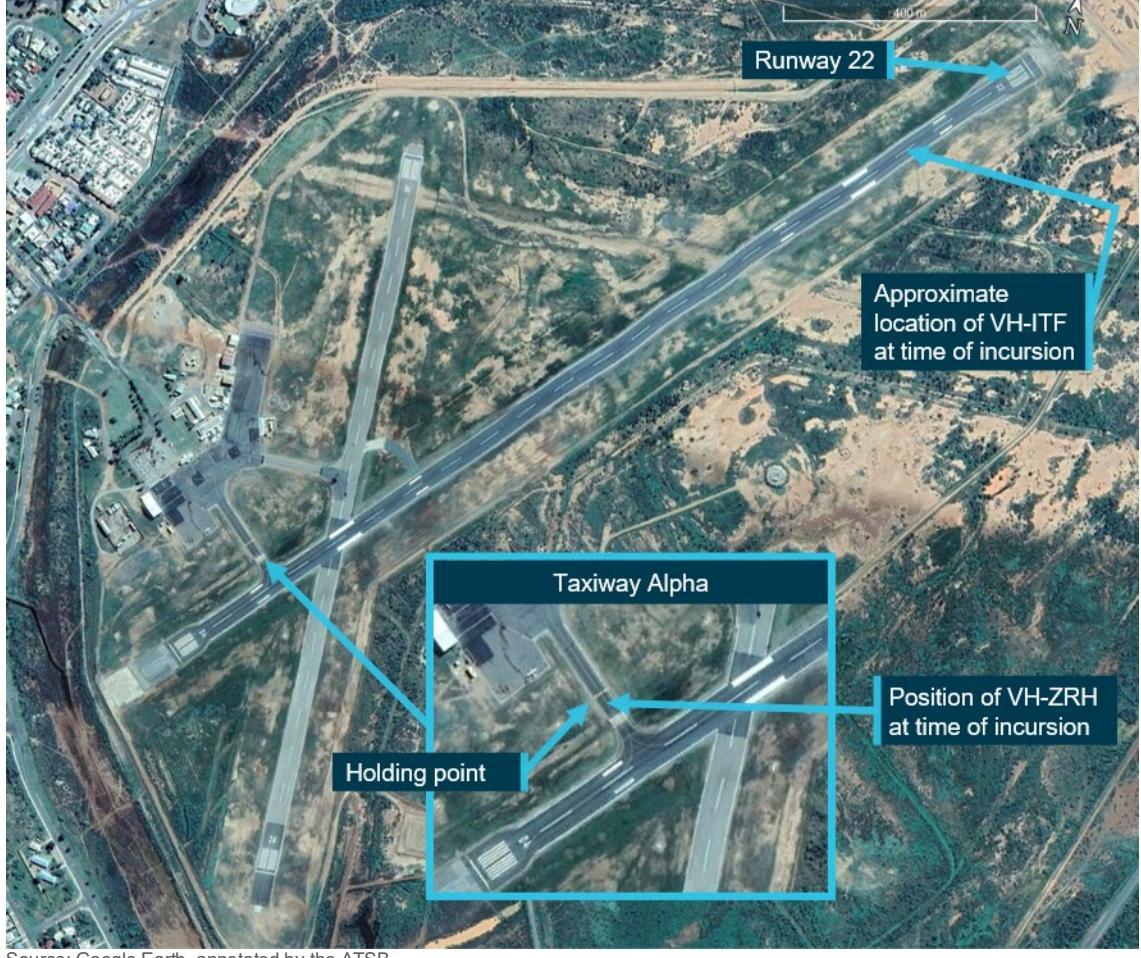
By this time the pilot of VH-ITF had advanced the throttles to about three quarters (of full travel) and they had commenced the take-off roll. The pilot heard and observed VH-ZRH enter the runway and they immediately advised VH-ZRH they were rolling on runway 22. Shortly after, the Carnarvon aerodrome reporting officer (ARO) also advised the crew of VH-ZRH that VH-ITF was on the runway. The pilot of VH-ITF subsequently rejected their take-off and commenced backtracking on runway 22.

The flight crew of VH-ZRH did not hear the pilot VH-ITF's full transmission but did realise what had occurred and immediately stopped a few metres past the holding point (Figure 1) and prior to crossing the edge of the runway. They then advised the pilot of VH-ITF that their transmissions were readability two⁴ and quite scratchy.

Figure 1: Aircraft positions at the time of the runway incursion

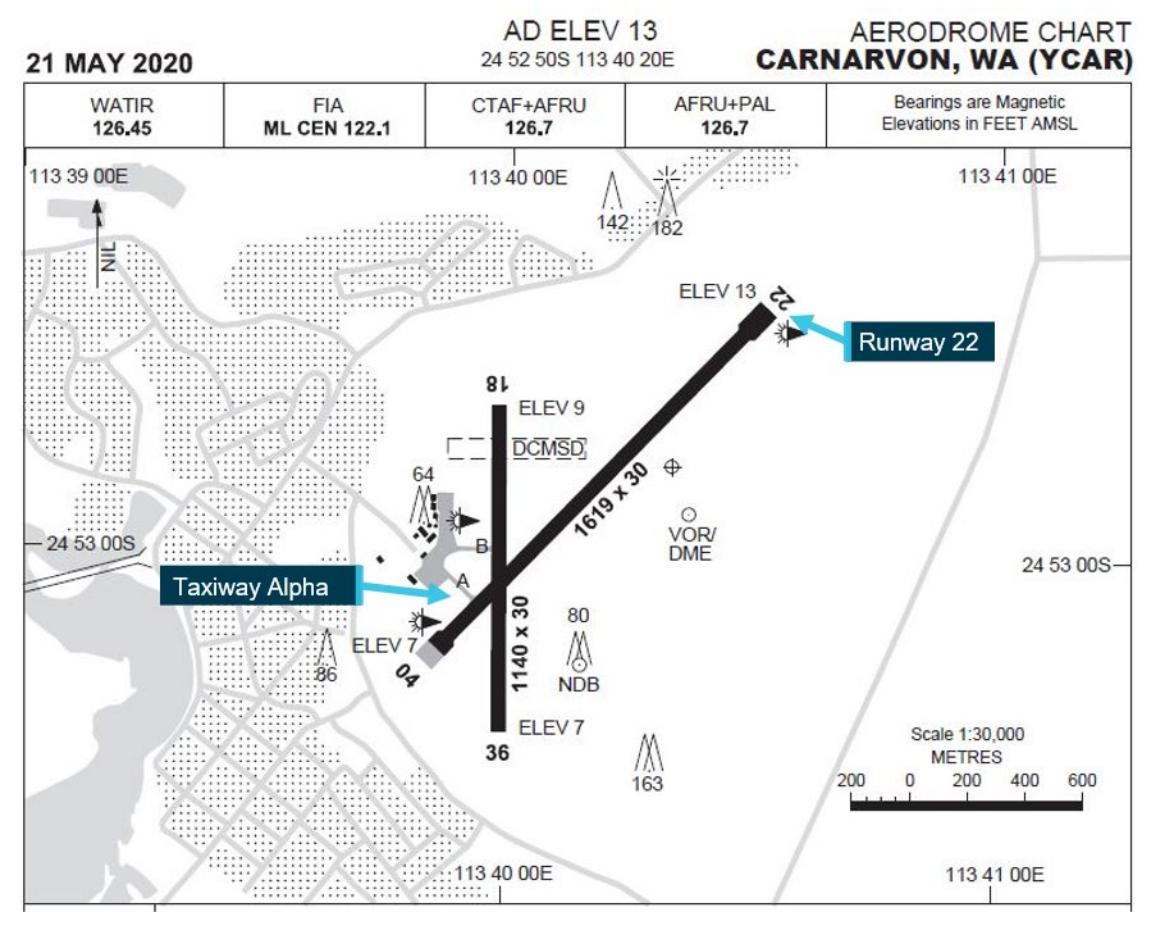
Figure 2: Carnarvon aerodrome chart
