Collision with water involving Cessna 182, VH-WNR

6 km north-west of Moreton Island, Queensland, on 22 January 2020

ATSB Transport Safety Report Aviation Occurrence Investigation (Defined) AO-2020-006 Final – 10 February 2022

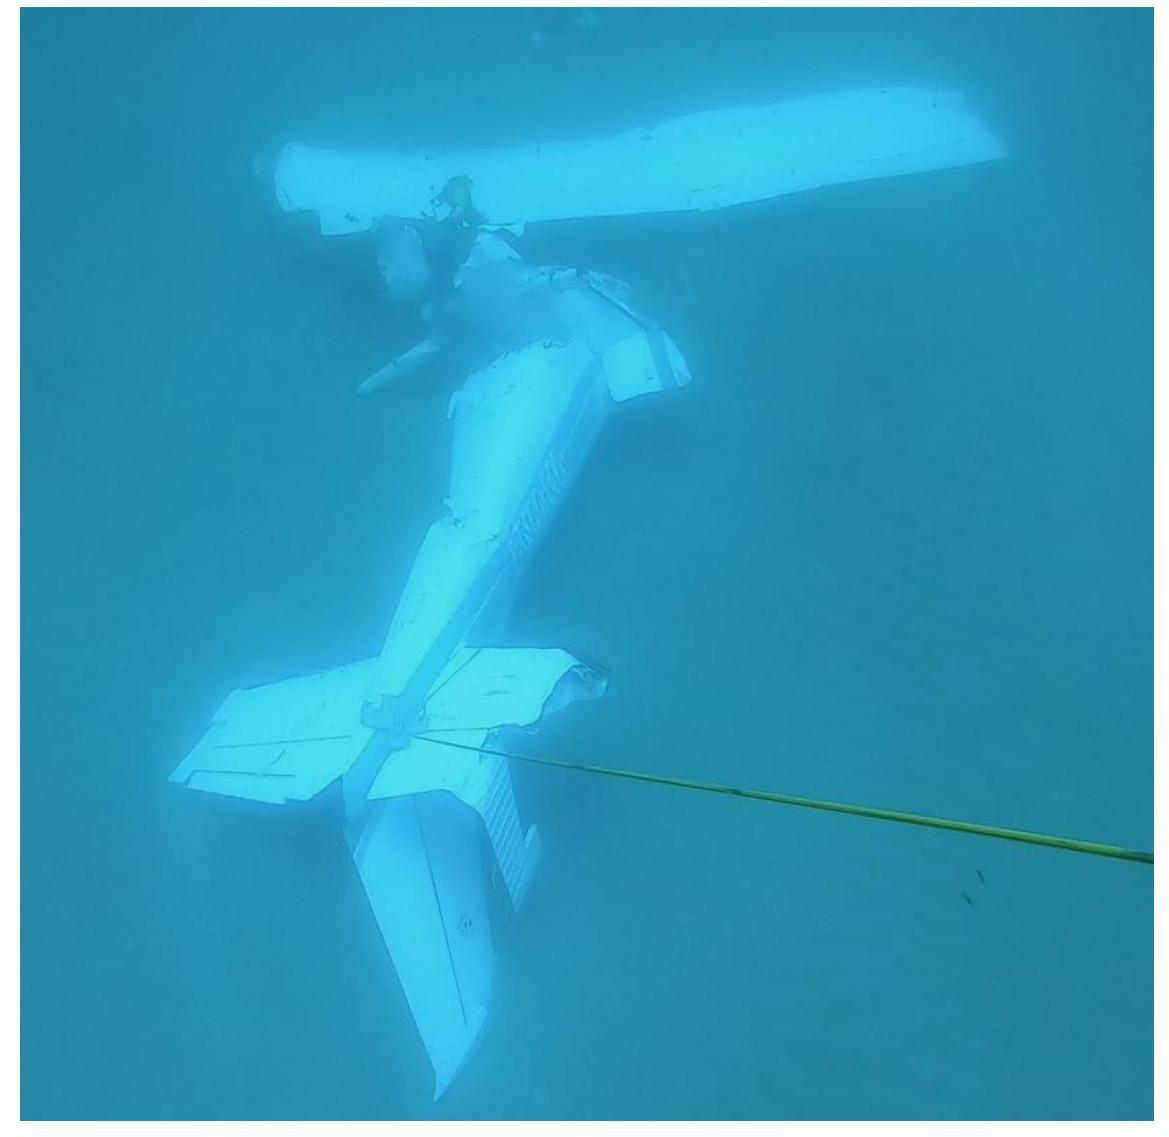
Figure 4: Wreckage of VH-WNR on the ocean floor

ATSB examination of the underwater video identified that the aircraft was likely destroyed by collision with water at a moderately high speed (Figure 4). Damage to the aircraft cabin from the collision with water indicated that it was unlikely to be survivable. There was no evidence of fire.

All major aircraft components were accounted for, and there was no evidence of pre-impact defects or structural failure. As far as could be established, cockpit switch positions were configured as expected for normal flight.

The flap control and right flap were found in the 'up' position. The left flap was observed to be displaced towards the down position from disruption caused during accident sequence to the adjacent wing structure. One of the front seats was found floating some distance from the wreckage, and the other front seat was not located. The seatbelts for both front seats were found to be attached to the airframe and latched.

The carburettor heat control, used to prevent or recover from engine icing, was in the 'off' position. However, due to the disruption of the wreckage, this may not have been indicative of its position prior to the accident.

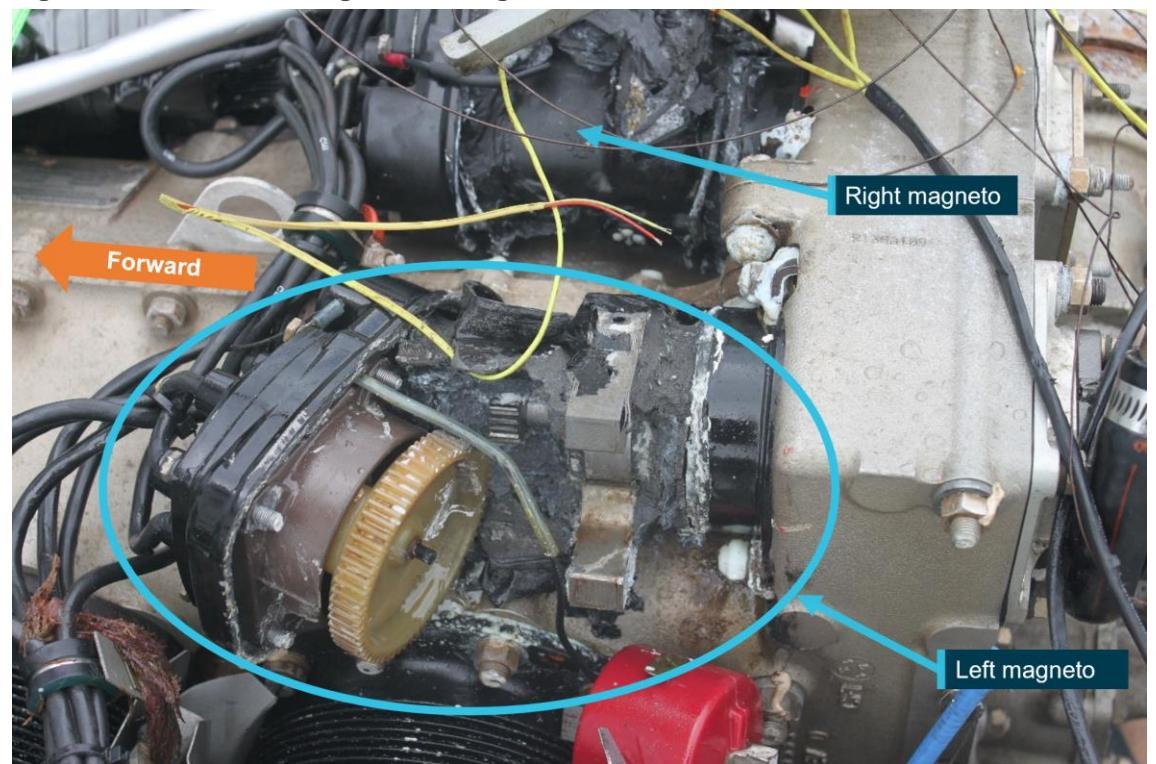
Figure 5: Corrosion damage to the magnetos

The engine was disassembled and examined at a Civil Aviation Safety Authority (CASA) approved overhaul facility under the supervision of the ATSB. Apart from impact and submersion damage, the engine was generally in good condition. Some components such as the magnetos, alternator and voltage regulator were extensively damaged by their immersion in seawater and their function

could not be tested. No pre-existing defects were evident, and there was no evidence of fire or overheating (Figure 5).

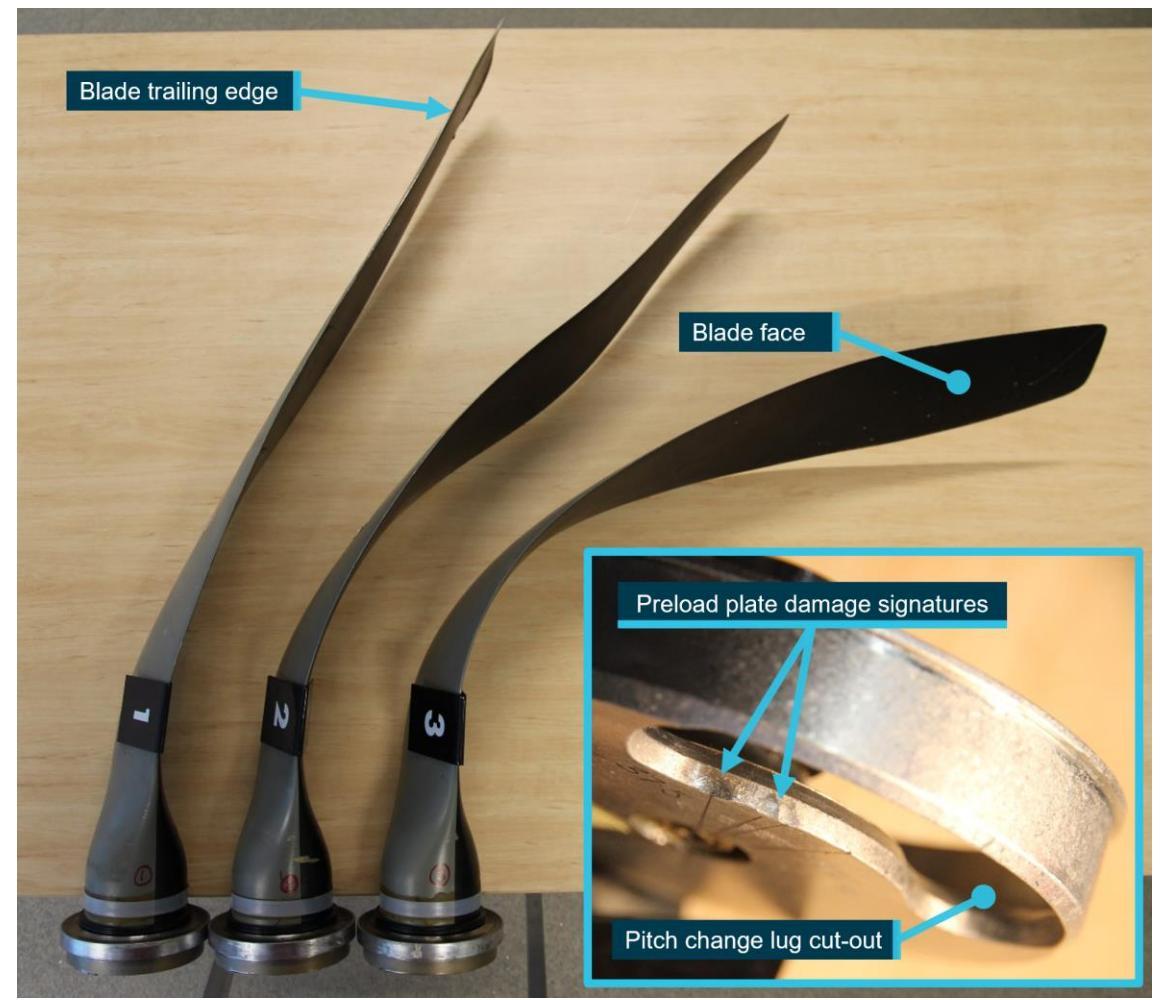
Figure 6: VH-WNR propeller blade bending and inset image of example preload plate damage signatures

The propeller blades were observed to be progressively bent out of plane (Figure 6), in a manner indicative of low but non-zero power. The pitch change lugs on all three blades were sheared off, with the direction of the fracture surface smearing being consistent with the blades being forcibly rotated towards low (fine) pitch, which is an indication of low power or windmilling.

Preload plates are fitted to each propeller blade at their base, within the propeller hub. Each blade pitch change lug transverses through a cut-out in the plates. Using damage signatures made by the propeller blade pitch change lugs onto the preload plates (Figure 6, inset), and estimating the propeller speed from the known velocity of the aircraft in the moments prior to impact, an estimate of power and the blade angle at impact was made using established datums with the assistance of the propeller manufacturer. These calculations were limited in accuracy as the preload plates are not indexed (such as with a key or slot), and so during assembly there could be slight variations with their position. The results of the calculations indicated that the propeller was rotating under low power, and with a blade angle at or near the low pitch stop.

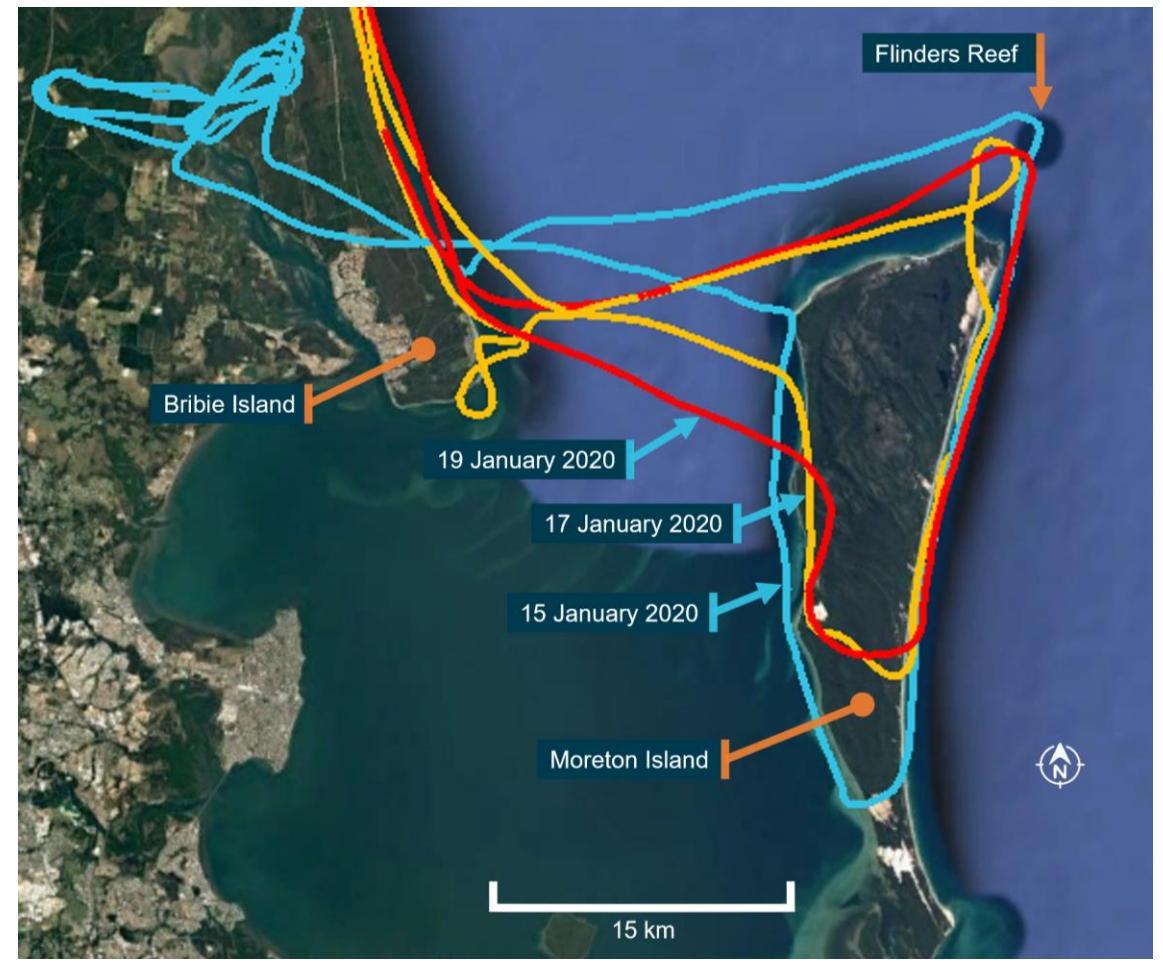
Figure 7: Accident pilot's previous flights in VH-WNR

On the 15 January flight, the pilot transited between Bribie Island and Moreton Island at about 2,000 ft and 80–90 kt groundspeed. The flight profile was broadly similar to the accident flight past Cape Moreton towards Flinders Reef (Figure 8). On the return leg, the pilot flew from Flinders Reef direct to Bribie Island at about 1,800 ft.

ATSB analysis indicated that two segments of the 15 January flight, including between Moreton Island and Flinders Reef, were further from land than the aircraft was capable of gliding with no engine power. Although complete analysis of glide distances was not feasible, the ATSB estimated that the aircraft was also flown near or beyond the limits of its glide range to land on other flights in this area. During the accident flight on 22 January, the aircraft similarly reached a point further from glide distance to land about halfway between Moreton Island and Flinders Reef.

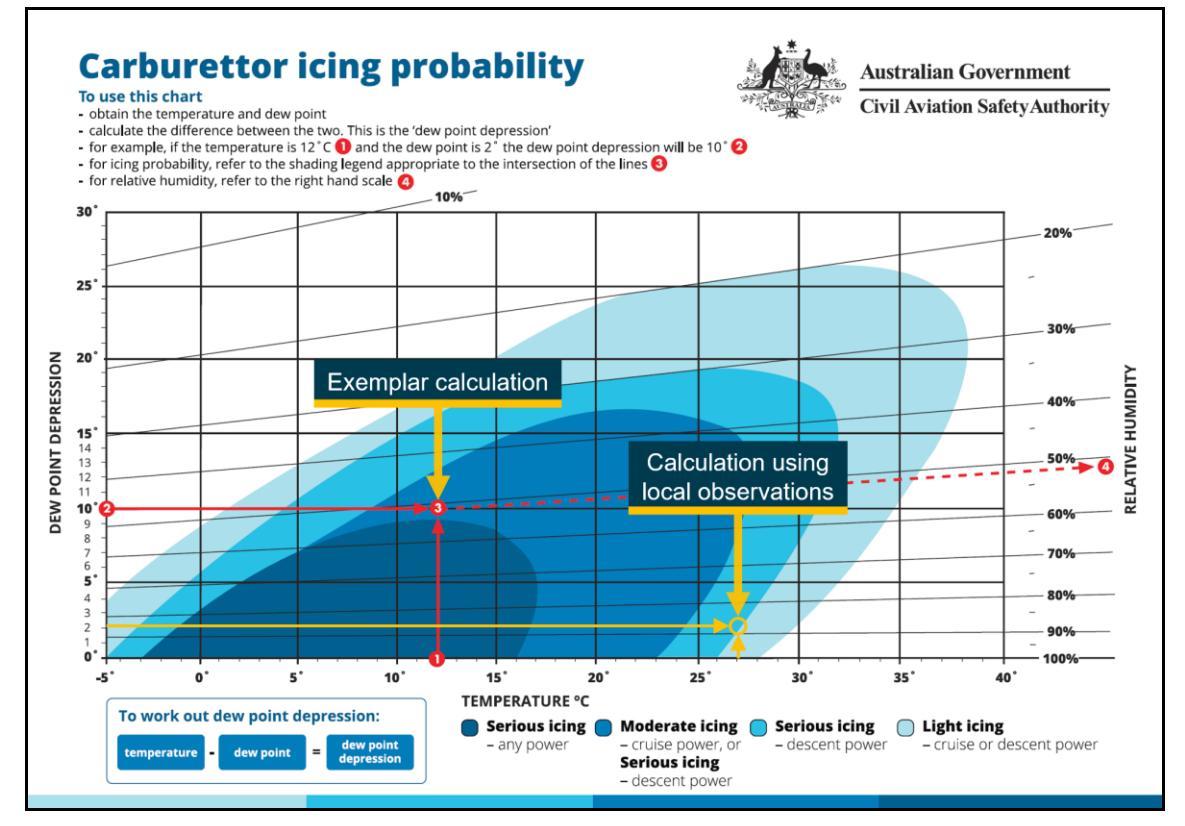
intersection between the resulting temperature and dewpoint lines was just inside the shaded area where 'serious' icing under descent power is possible.
